Ballybeg Commonage

2020 Ecological Survey

Final Report

21st April 2021

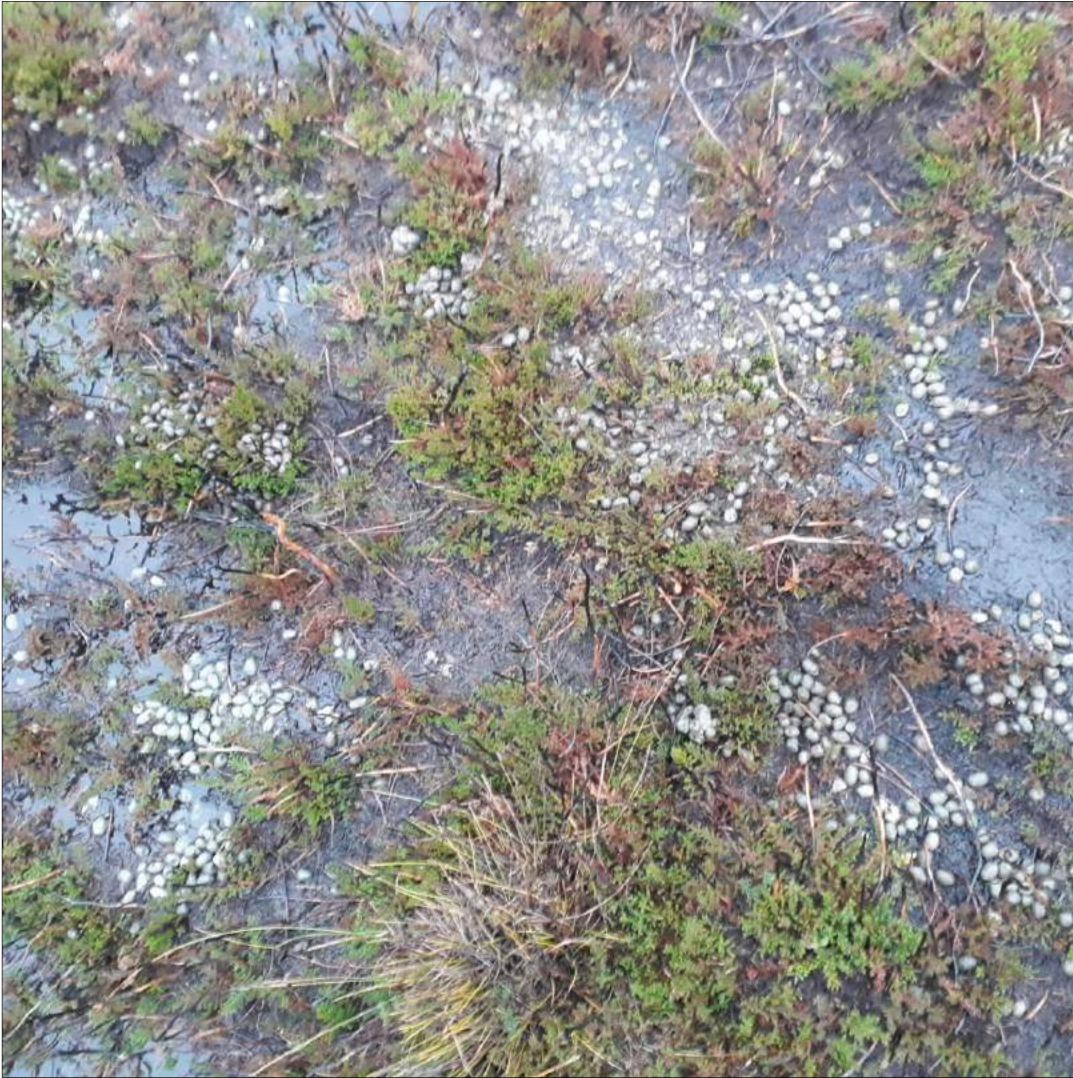
A very large congregation of sheep was recorded here in November 2019 as evidenced by significant dunging and browsing pressure as can be seen in **Plate 1**. When surveyed in November 2019 there was some regeneration of bilberry with some deergrass, tormentil, sedges (*Carex flacca* and *Carex binervis*) and some parts of moss remain intact. It was noted that the peat and moss layer was

Plate 1. Congregation of sheep within the flailed/burnt areas was noted in November 2019 resulting in bare peat and dunging and intense grazing pressure which is limiting the regeneration of ling heather and bilberry.

generally more intact in the flailed areas. The recommendations were that this may be the more appropriate management technique to use than burning.

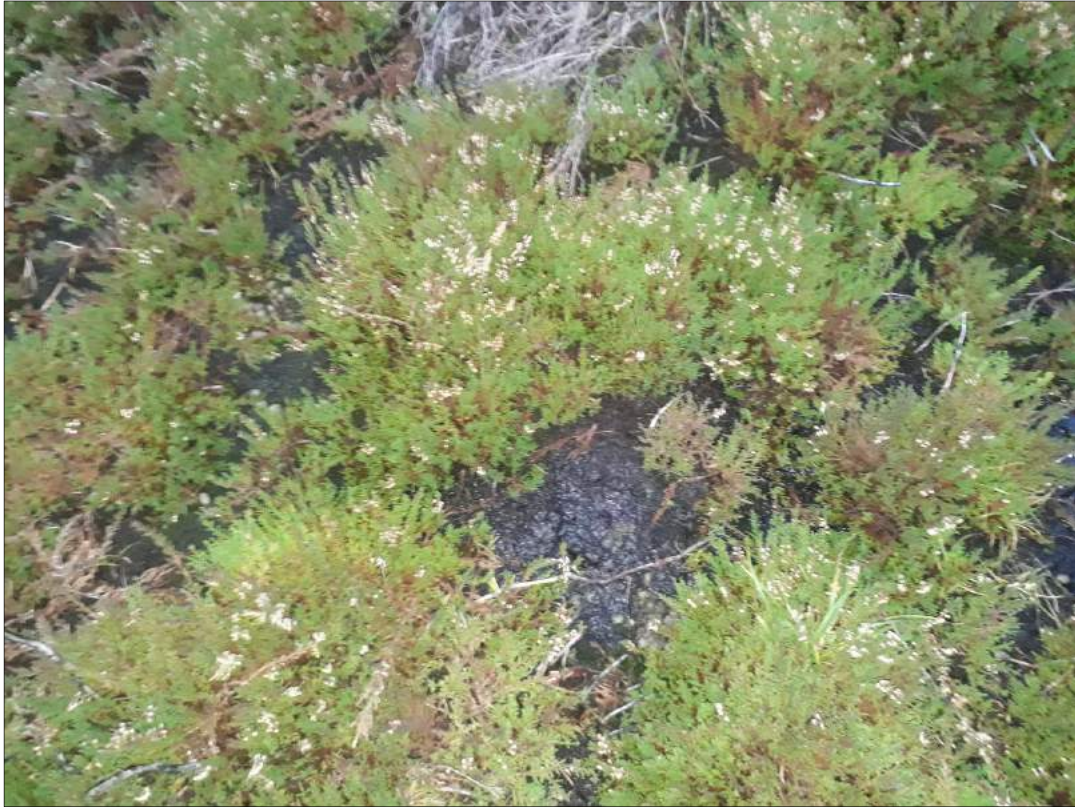
The burnt area was re-examined in November 2020 and there are still areas of exposed peat which have not regenerated, which would indicate that the burn was too intense. Other areas are beginning to recover slowly as recorded in November 2019.

Plate 2. Areas of bare peat remain amidst regrowth of ling heather one year later in November 2020.

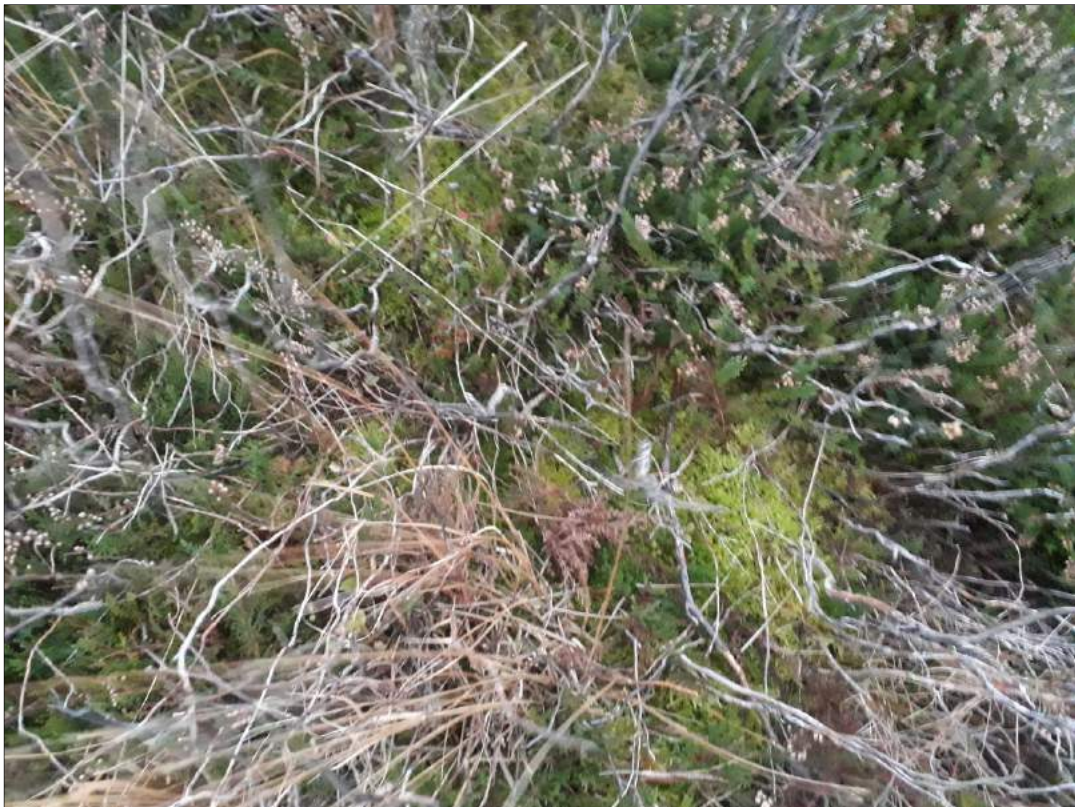
Plate 3. There is some localised regeneration of the bryophyte layer in the burnt area – in 2020.

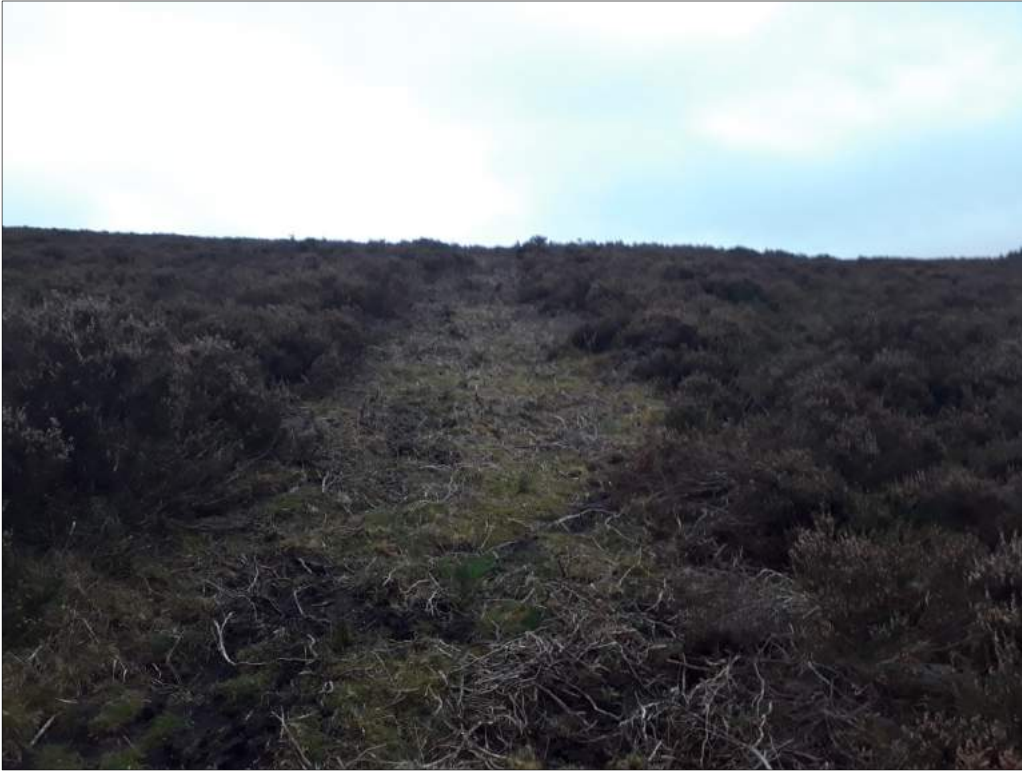
Plate 4. Acid grassland in flailed areas – this may be indicative of dunging from sheep.

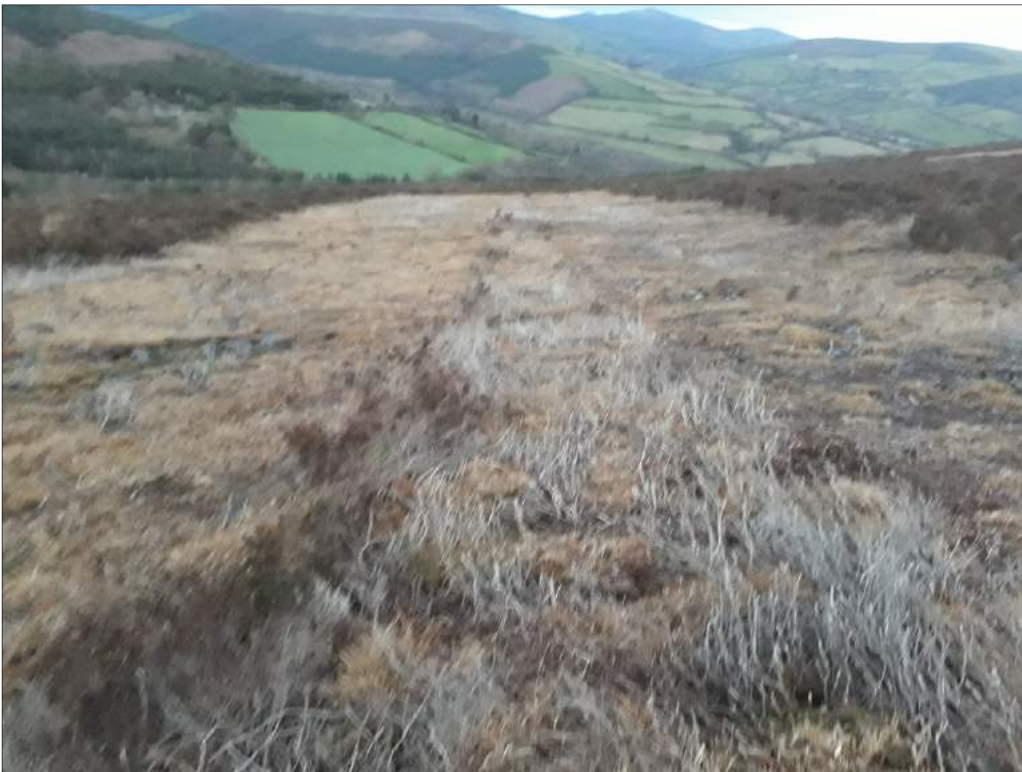
Plate 5. *Molinia* is dominating much of the recently flailed areas.

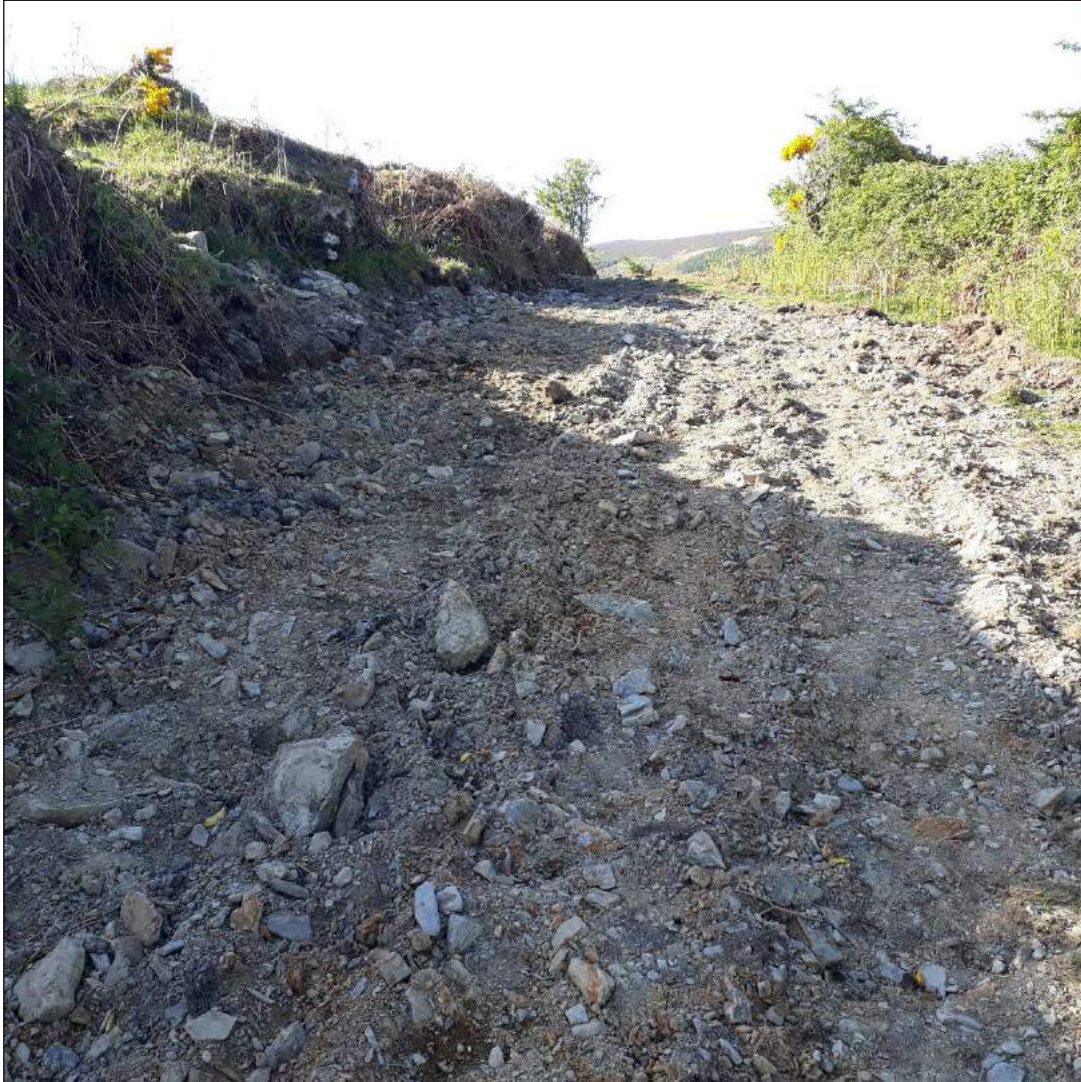
Disturbance to the Wicklow Way walking track.

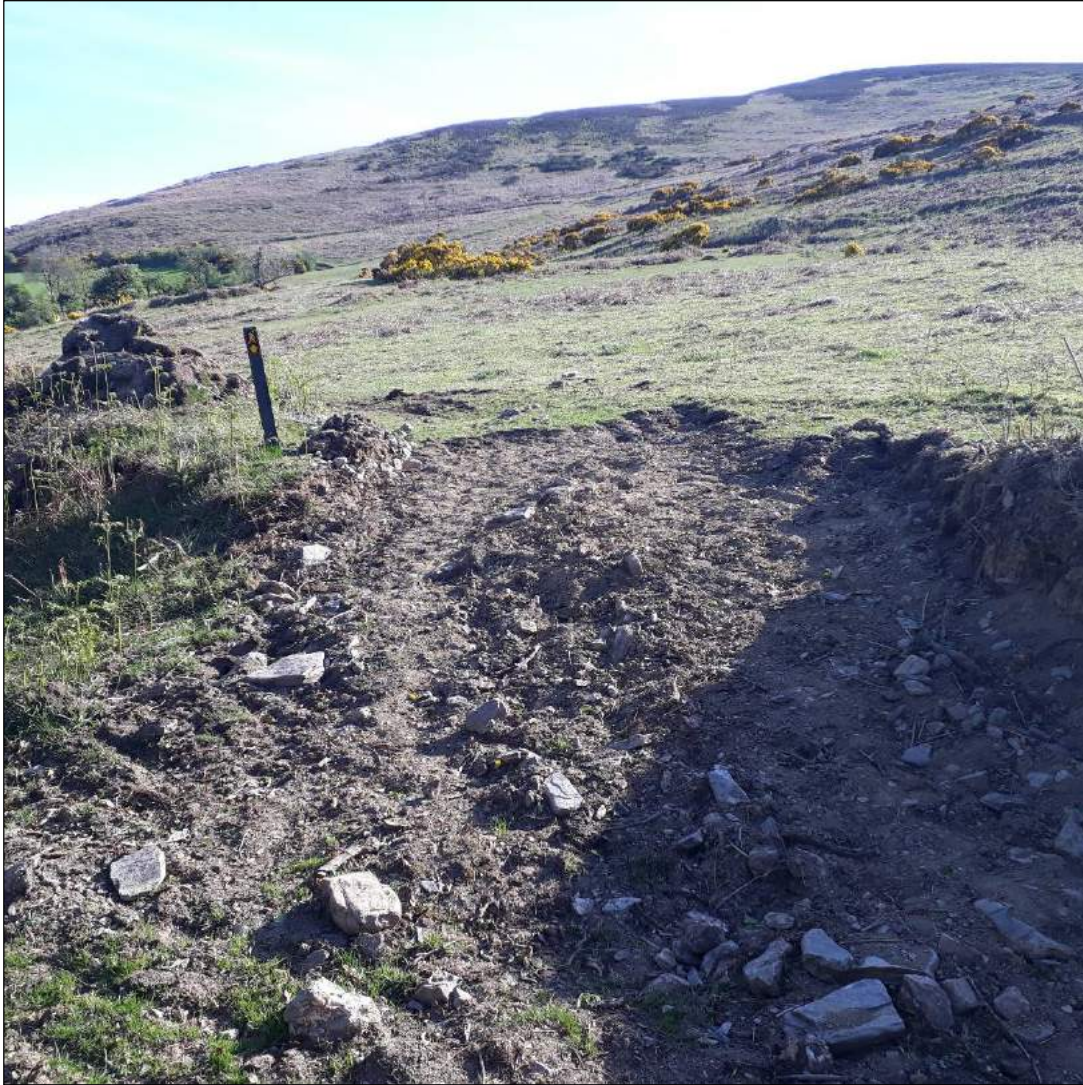
Damage to the field boundary/earthen bank accessing the commonage from the Wicklow Way.

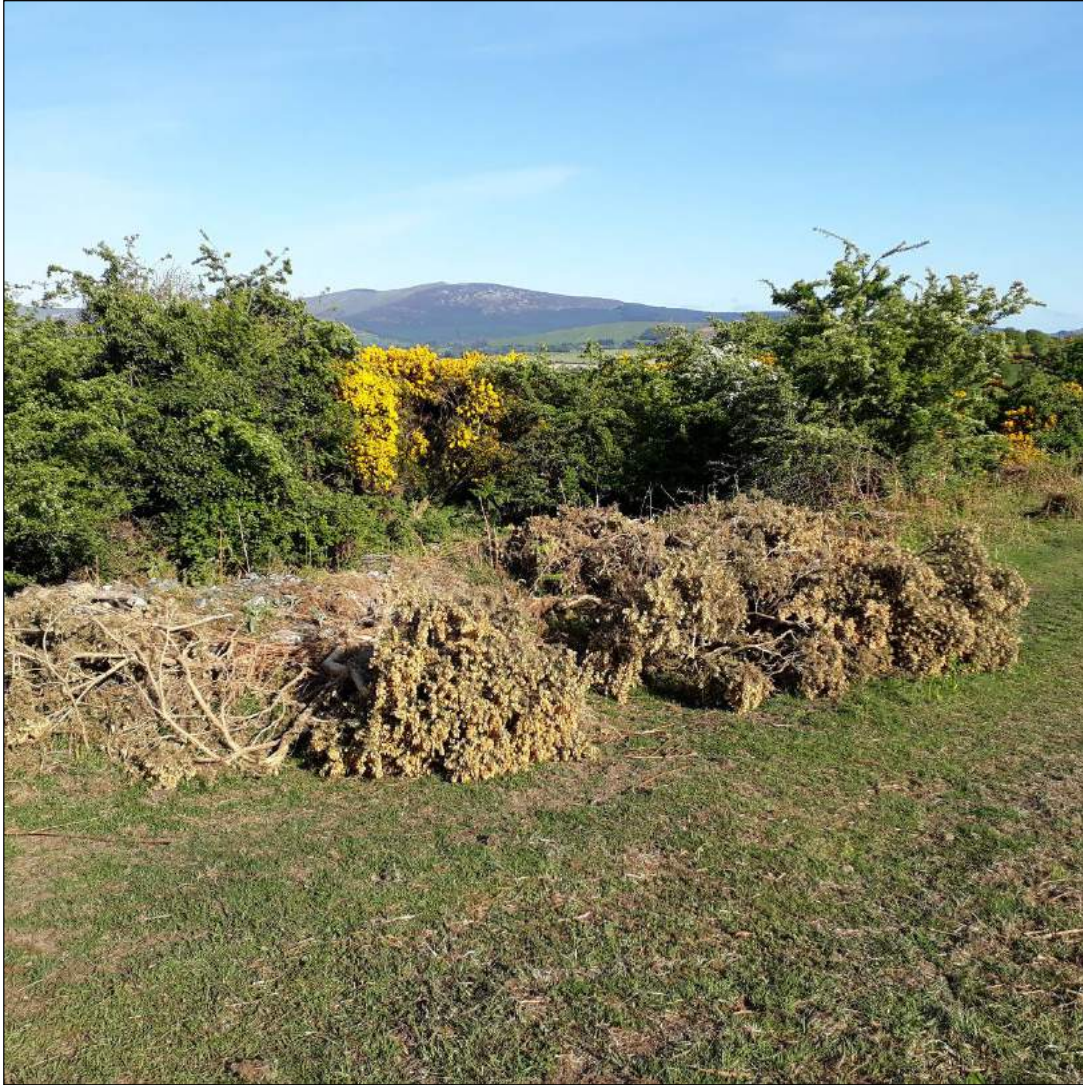
Unnecessary removal of vegetation, which was conducted during the bird breeding season in contravention of the Wildlife Act 1976 (amended 2000).

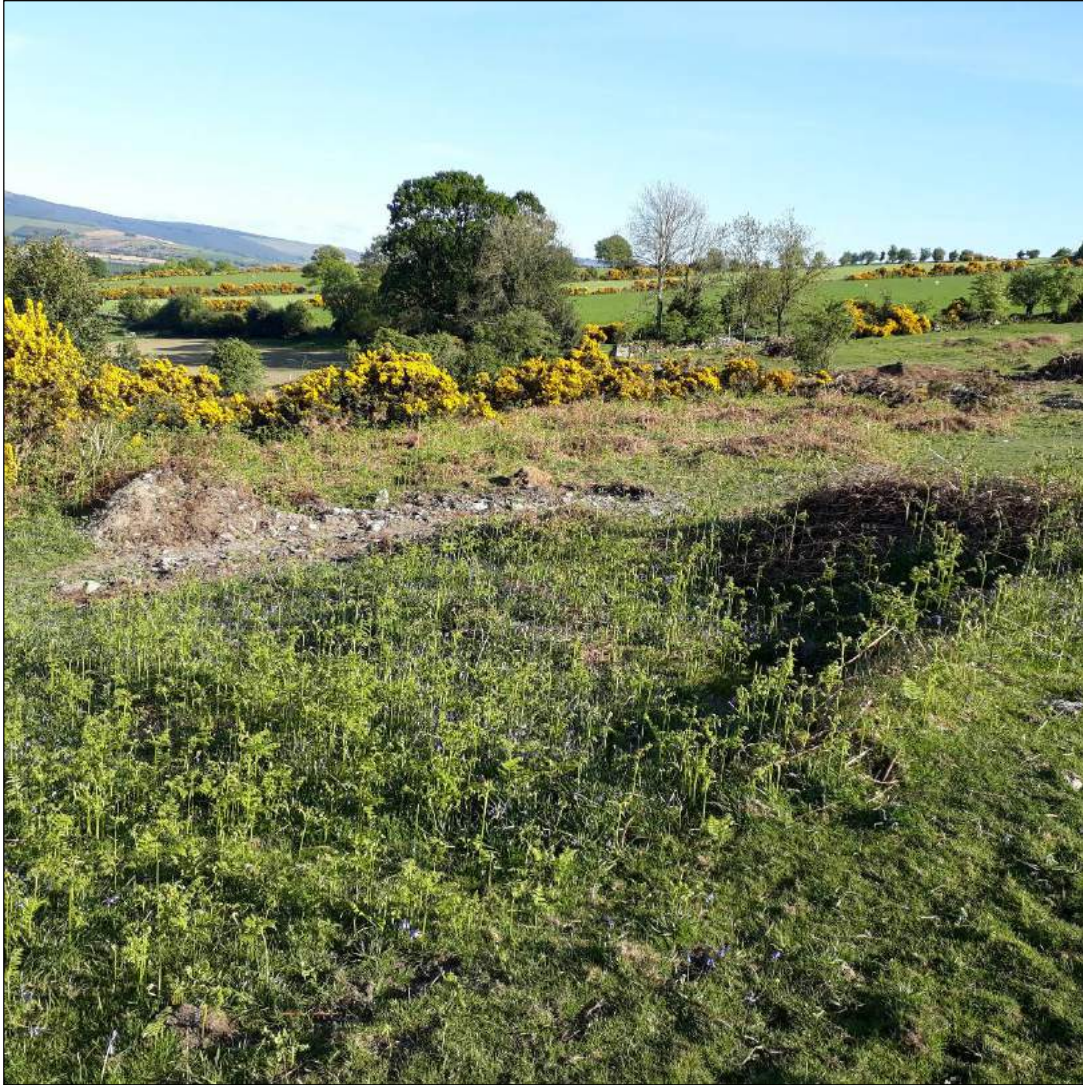
The machine has accessed the area adjoining the springs and seeps in compartment 15.

This area was flagged in the ecological baseline report as being of very high sensitivity with 'fragile habitats, whose hydrology can be easily damaged by poaching and overgrazing or machinery tracking'.

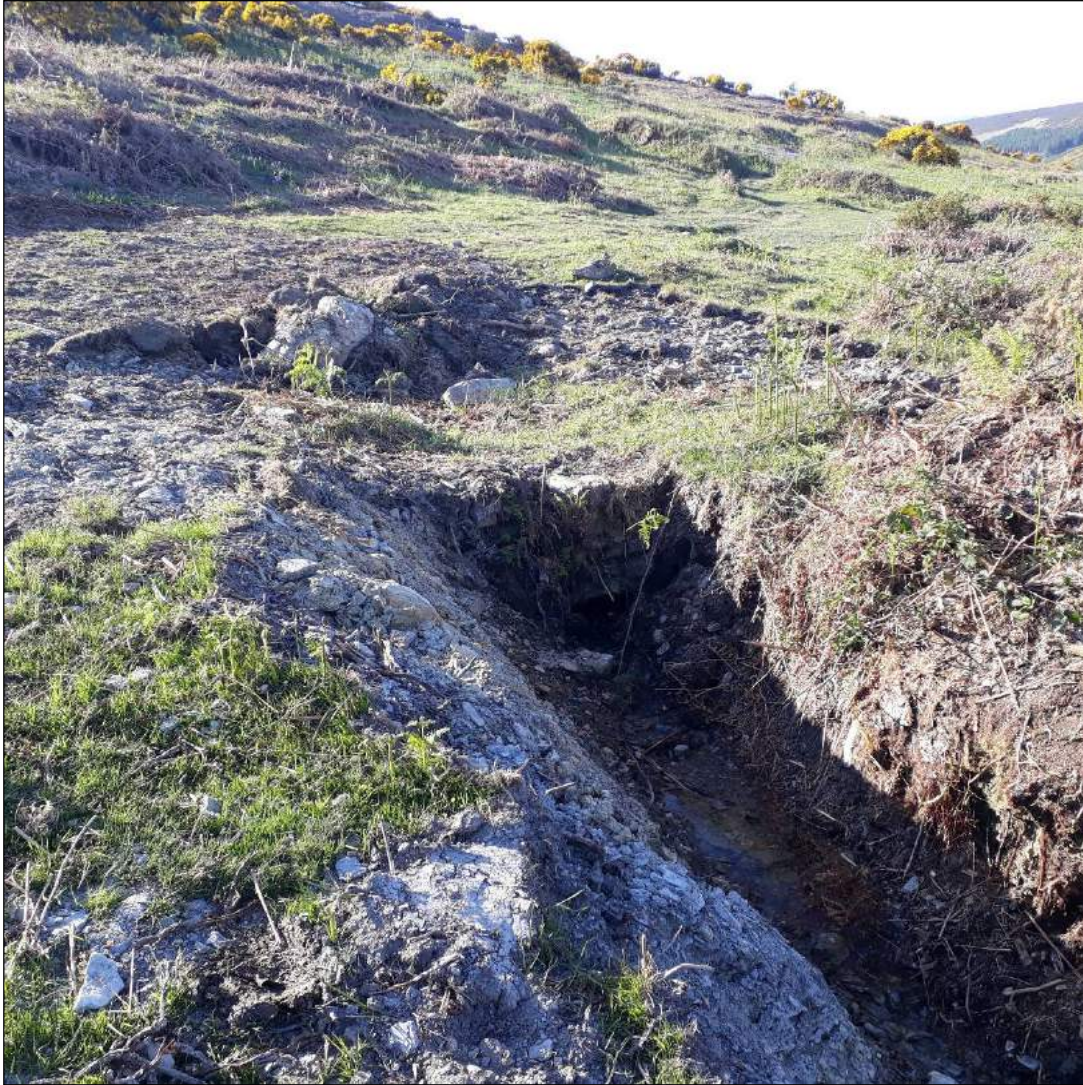
The spring/seep has been damaged by machinery and a deep drainage ditch has been excavated in this area.

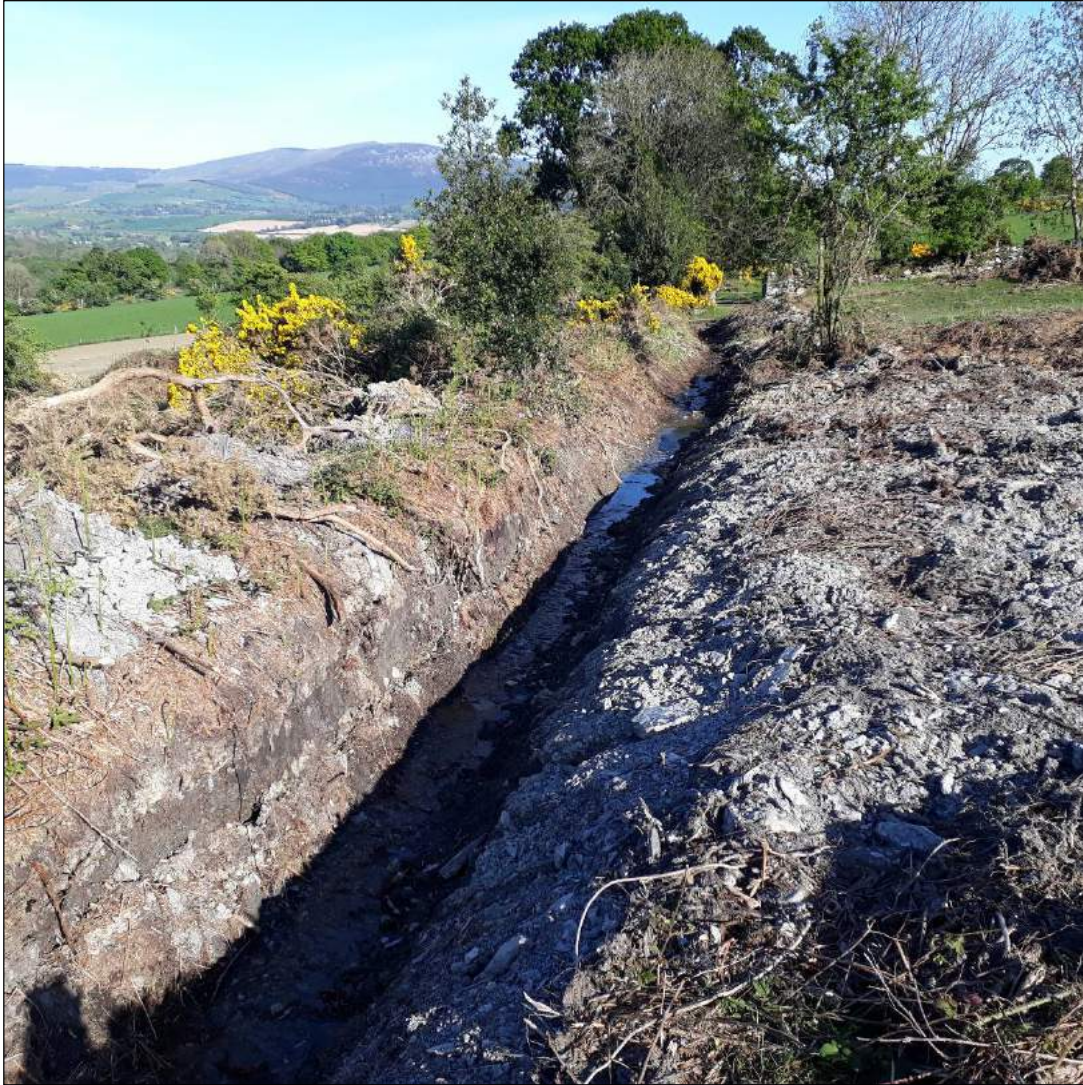
The gorse scrub in this area (compartment 13 and environs) was to be fenced to allow natural regeneration and woodland development to continue.

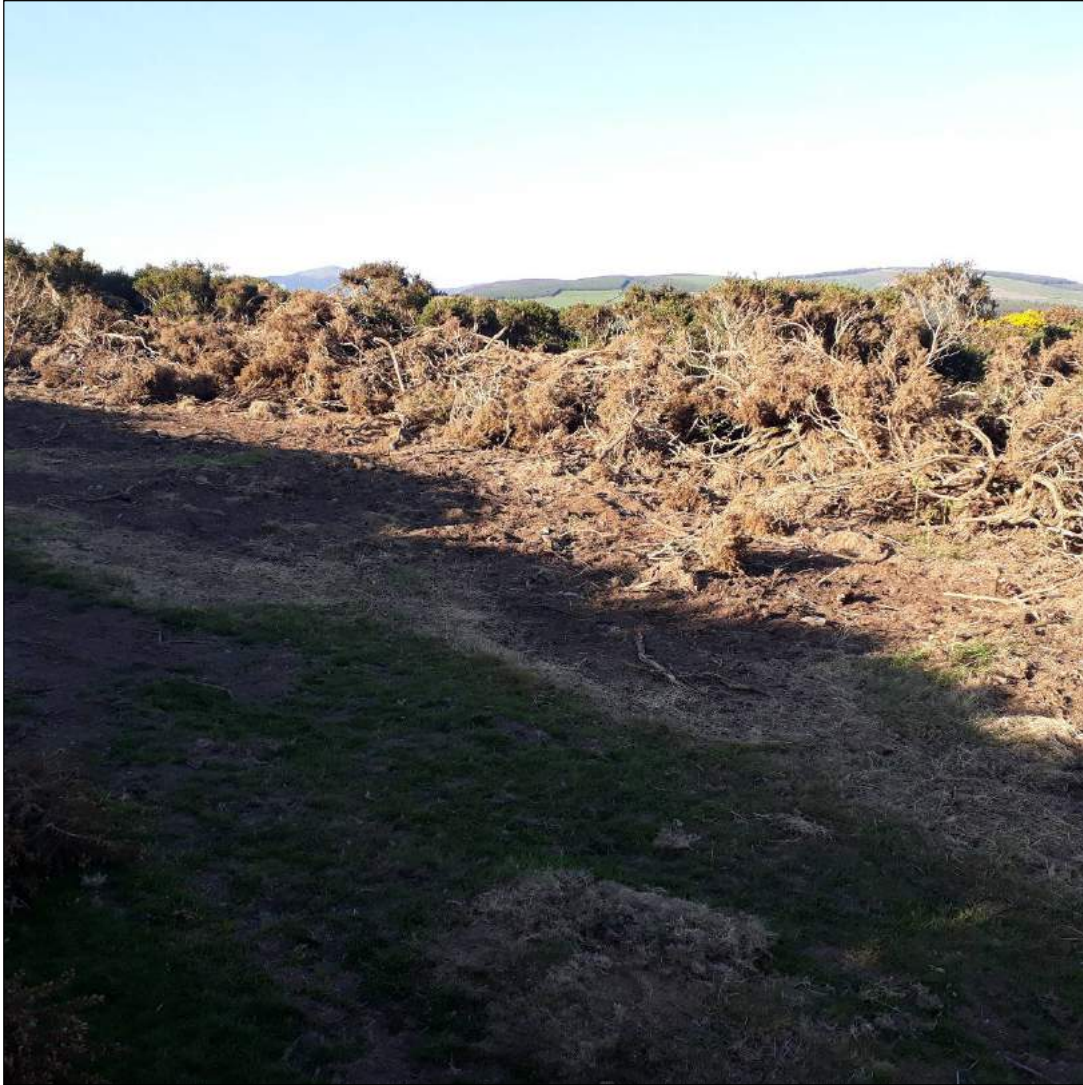
There has been widespread clearance of gorse vegetation in some areas – during the bird breeding season.

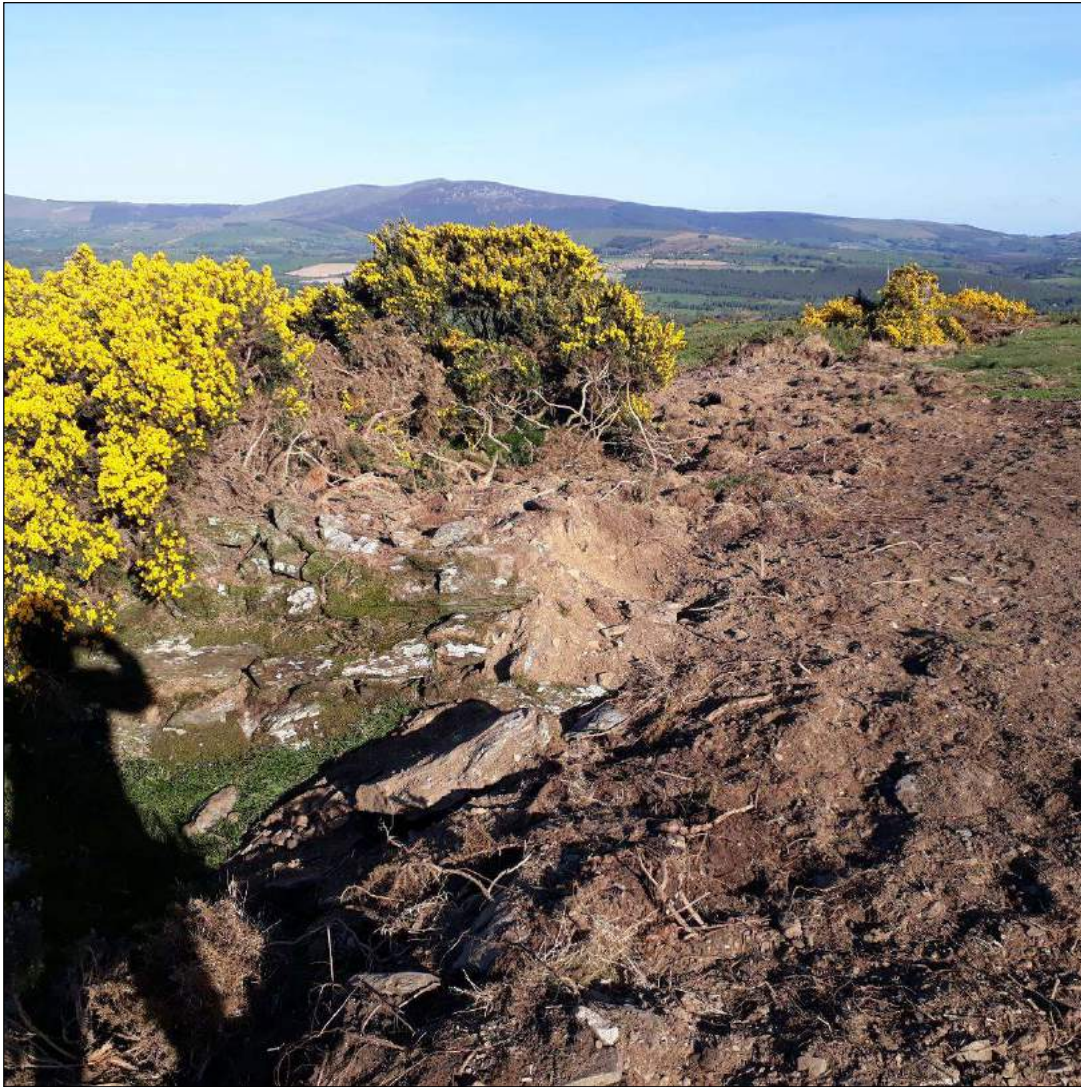
Damage to the built heritage of the commonage – these original field boundaries date from the late 1800s.

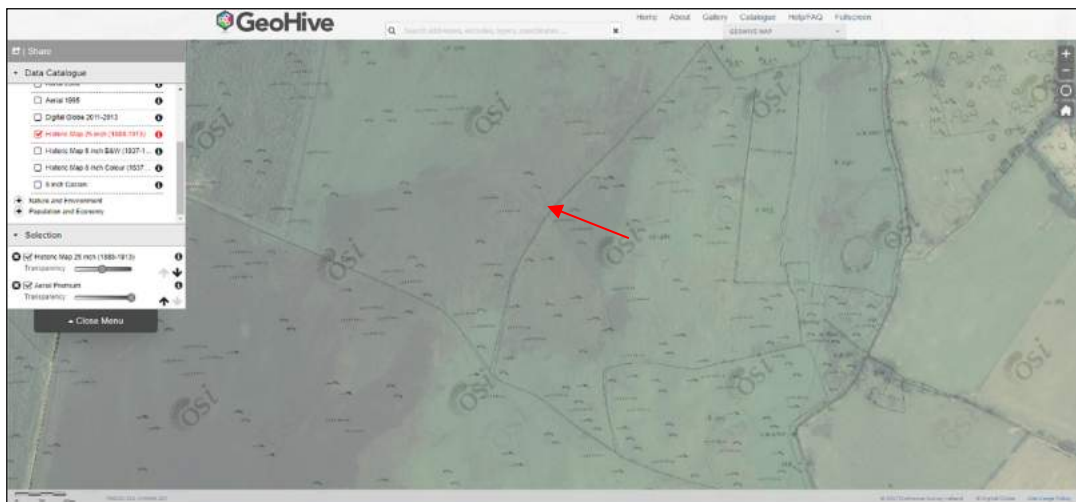
Damage to the historic field boundaries of the commonage.

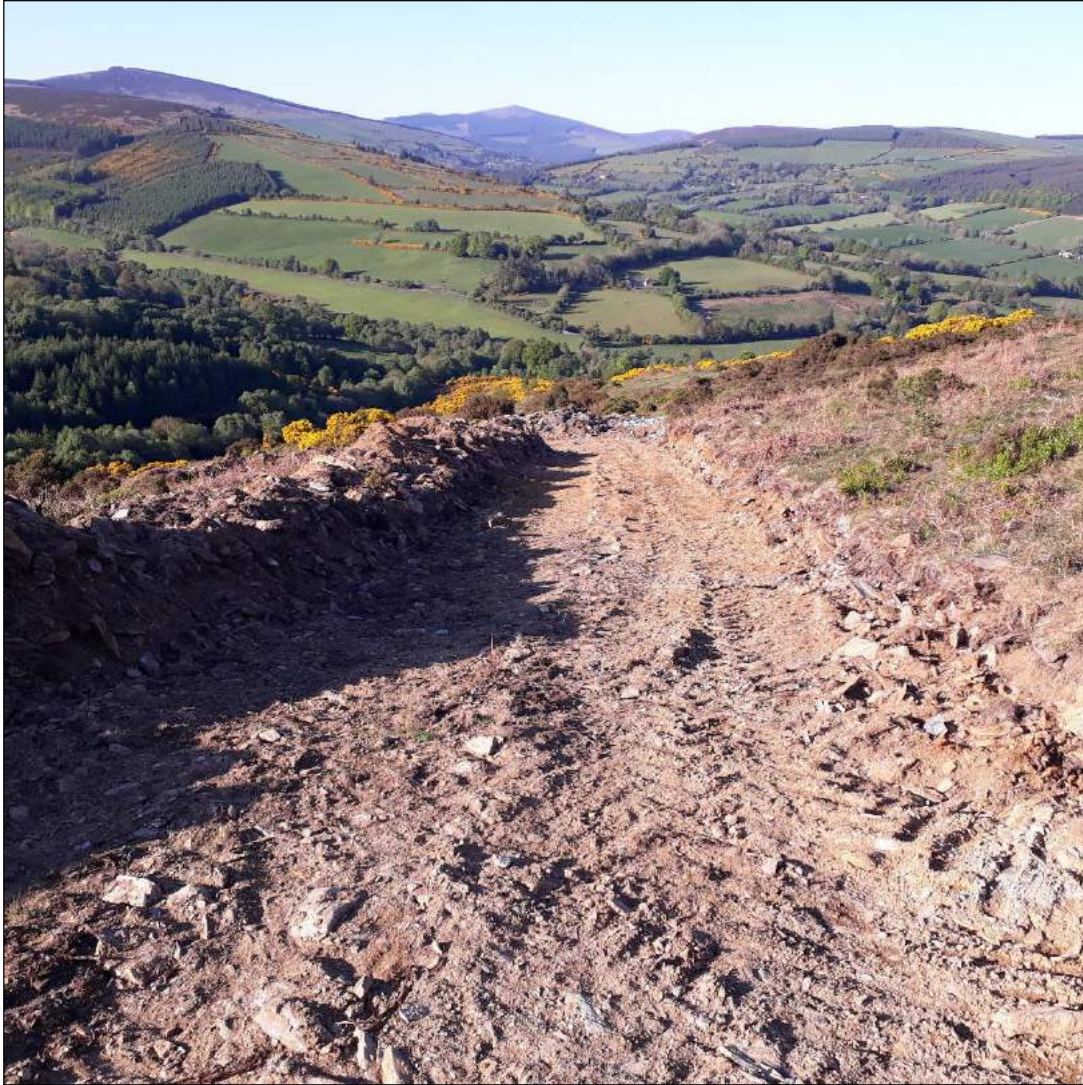
Damage to the commonage caused by track development.

- Damaged areas of habitat across the commonage must be reinstated,
- Siltation risk to the Ballycumber Stream with subsequent impacts on water quality and fisheries habitat must be remediated,

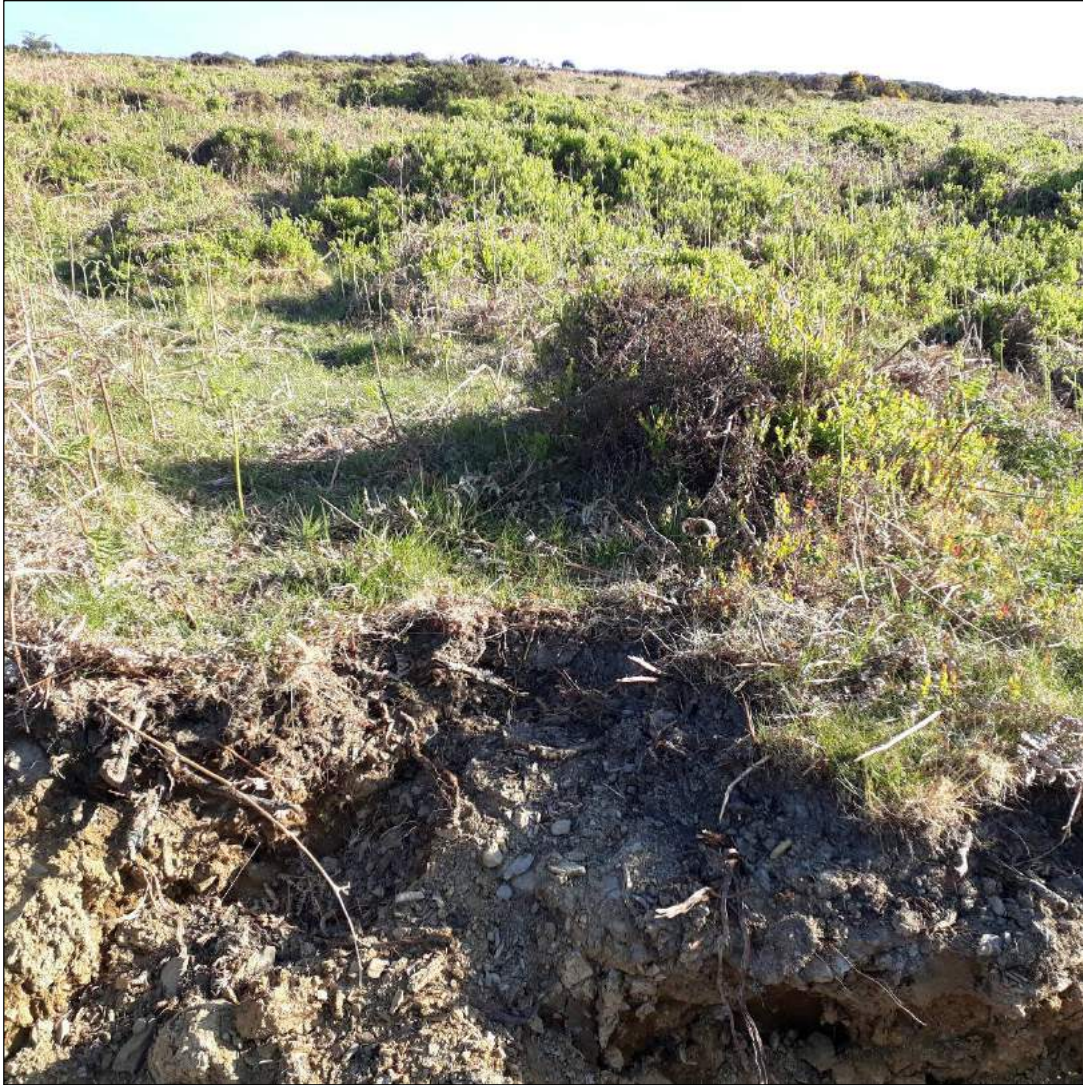
The track has been developed through an area dominated by dense bracken with underlying acid grassland, ling heather and bilberry (which is recovering Annex I habitat).

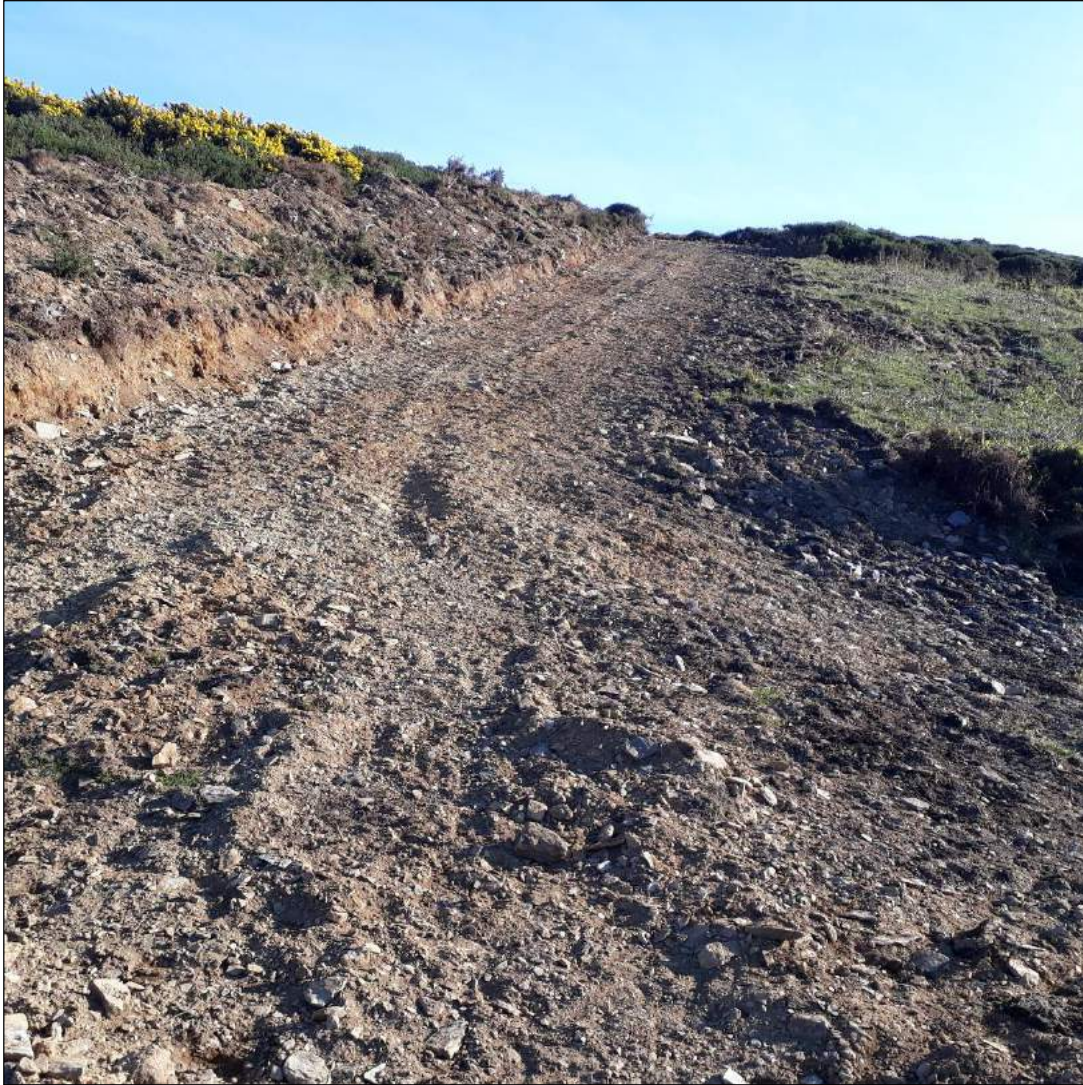
The track poses a serious runoff and erosion risk to the commonage.

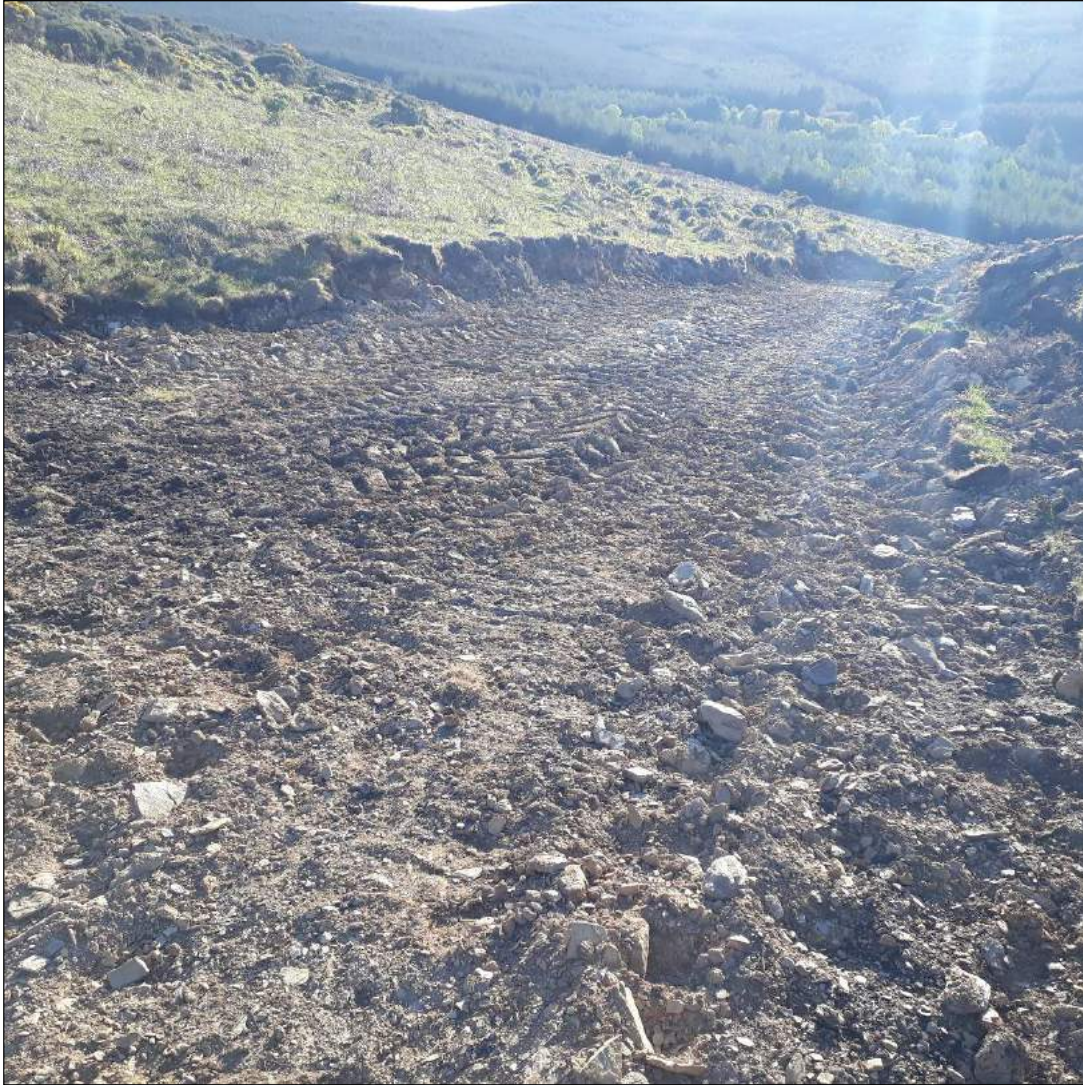
The steep slopes which the track has been developed on can be seen here. No water bars or other design features have been incorporated into the track to prevent gullying and significant erosion. The track leads downhill towards the Ballycumber Stream.

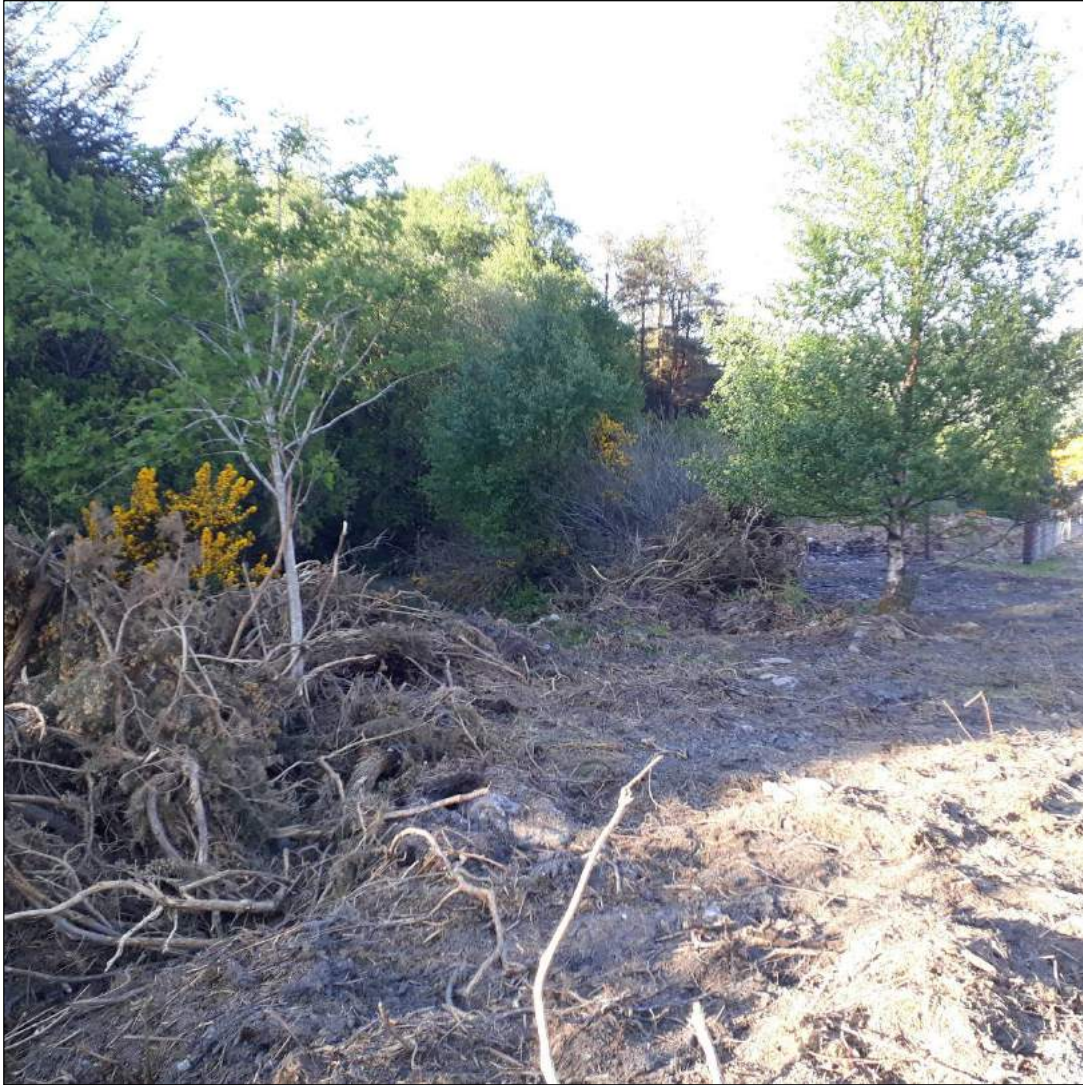
Clearance of gorse scrub and emergent woodland adjoining the steep slopes of the Ballycumber Stream. This habitat was to be protected to protect the water quality in Ballycumber Stream.

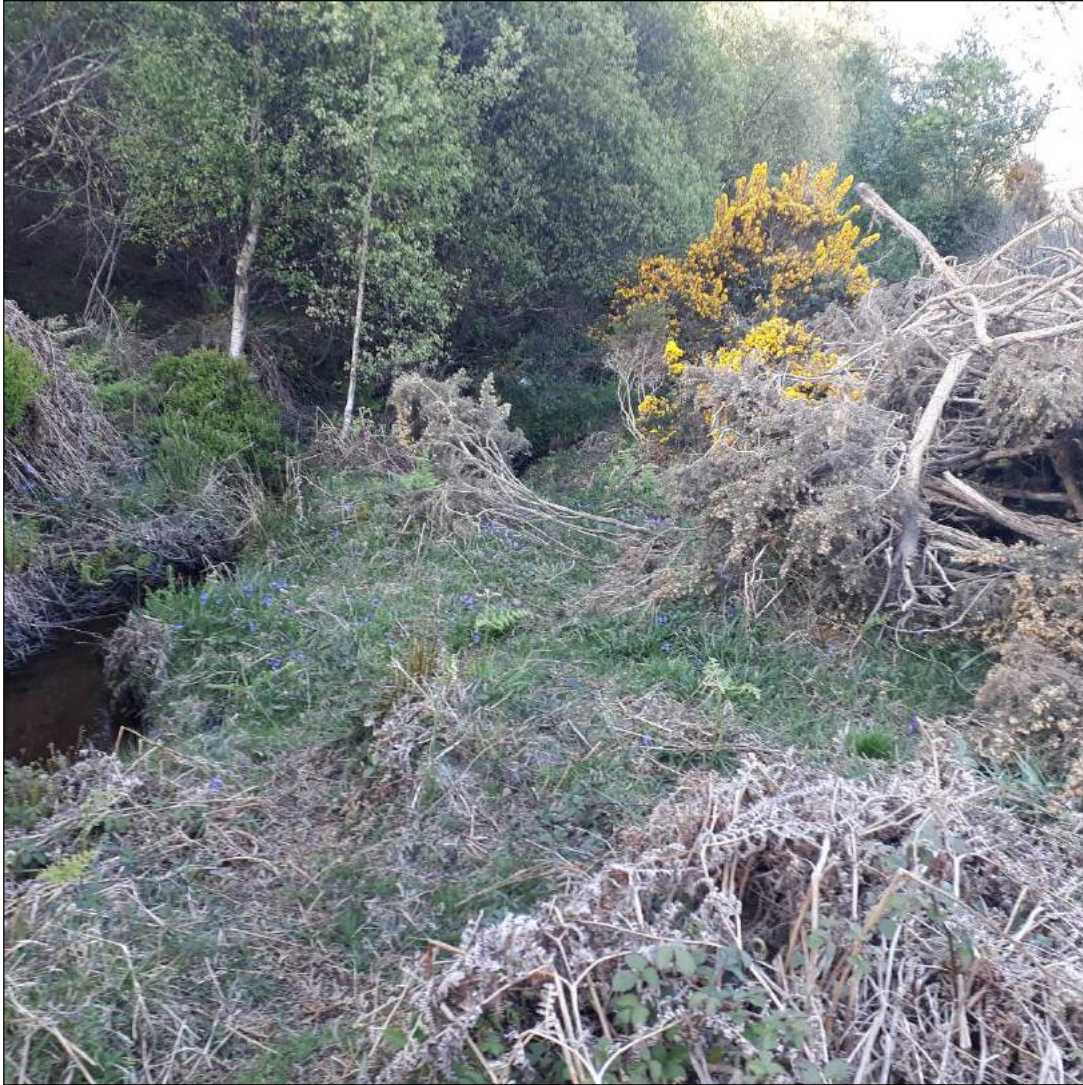
Removal of vegetation on stream banksides.
