Ballybeg Commonage

2020 Ecological Survey

Final Report

21st April 2021

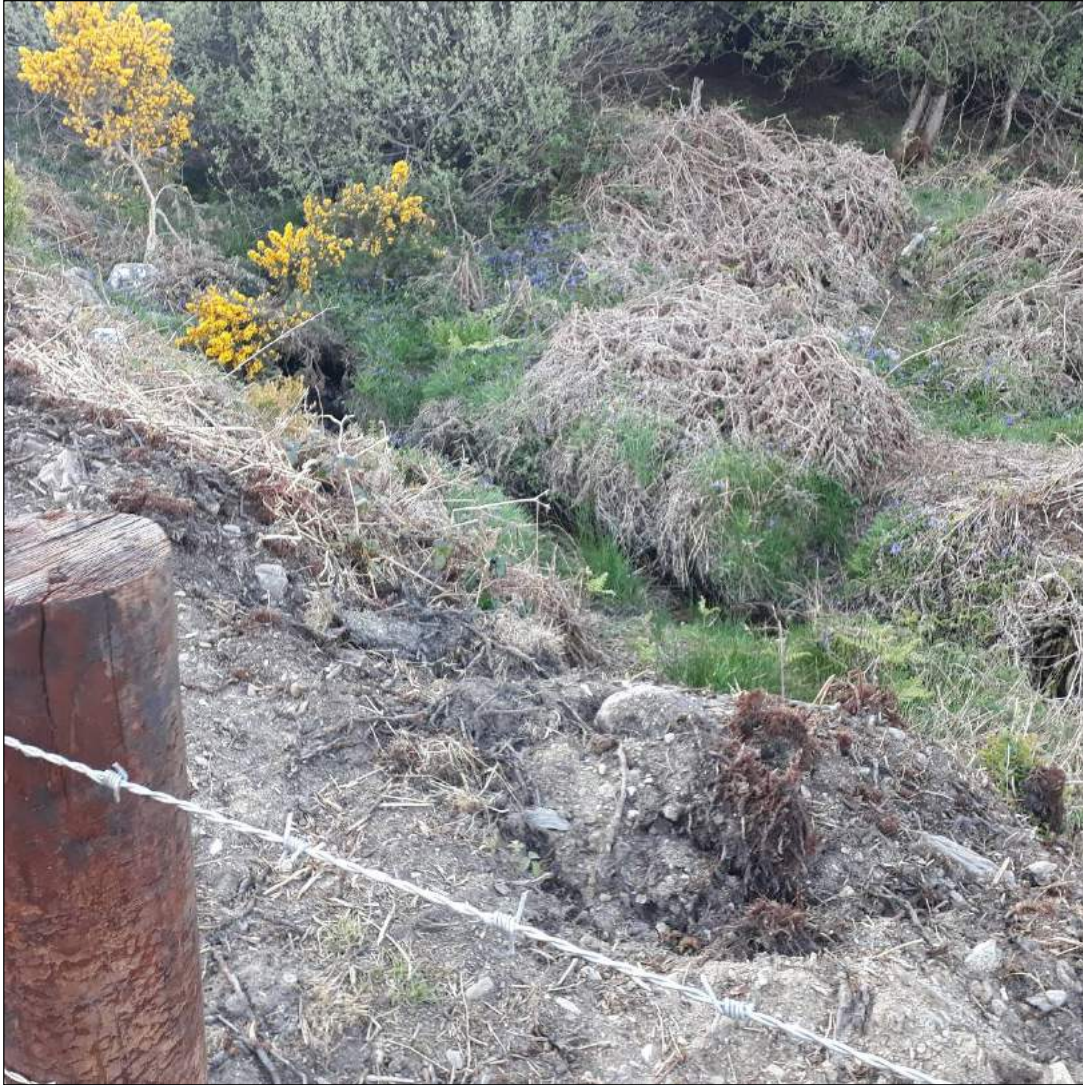
Earth movement and spreading of spoil in very close proximity to the watercourse with subsequent runoff and siltation risk.

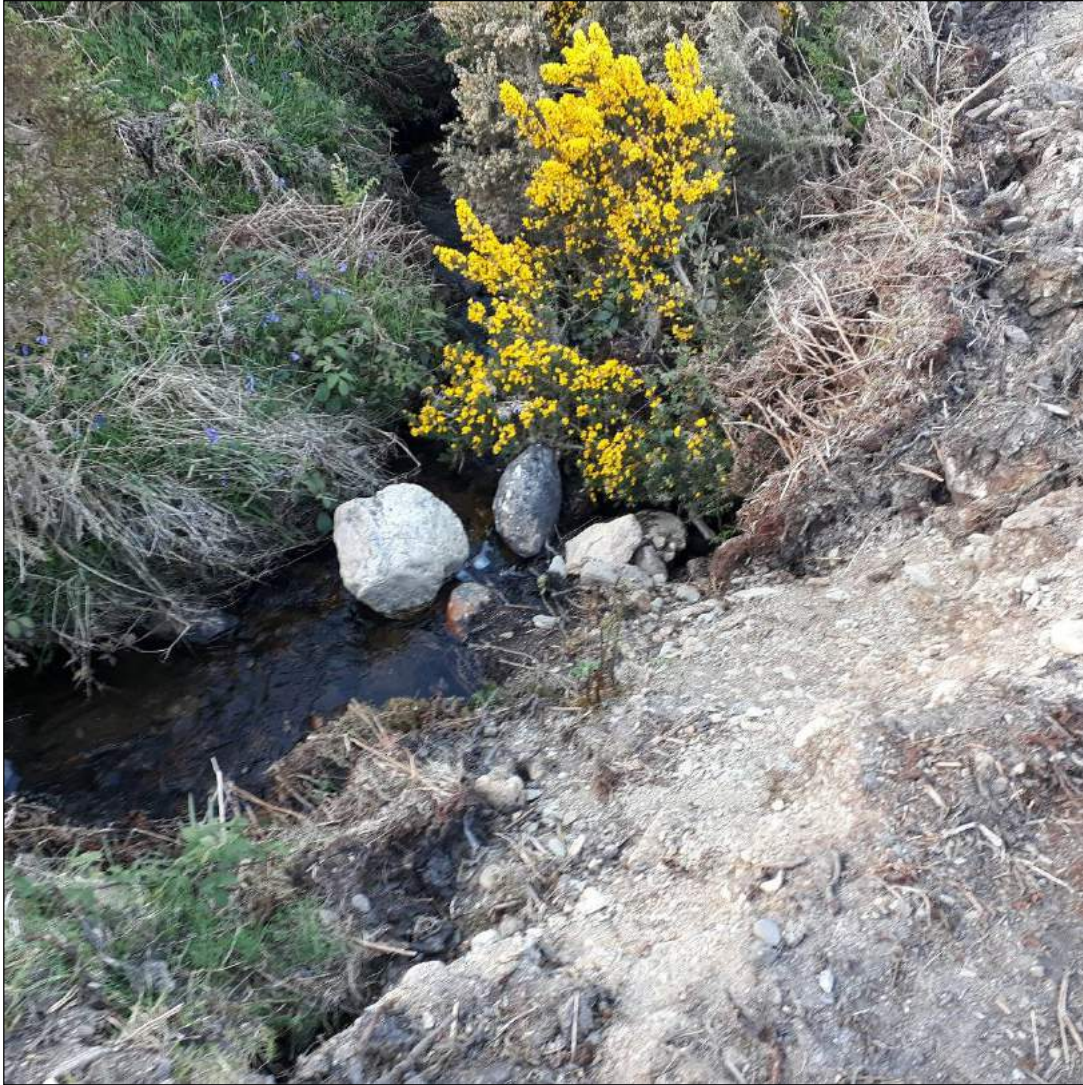
Excavated material and dislodged boulders have entered the watercourse.

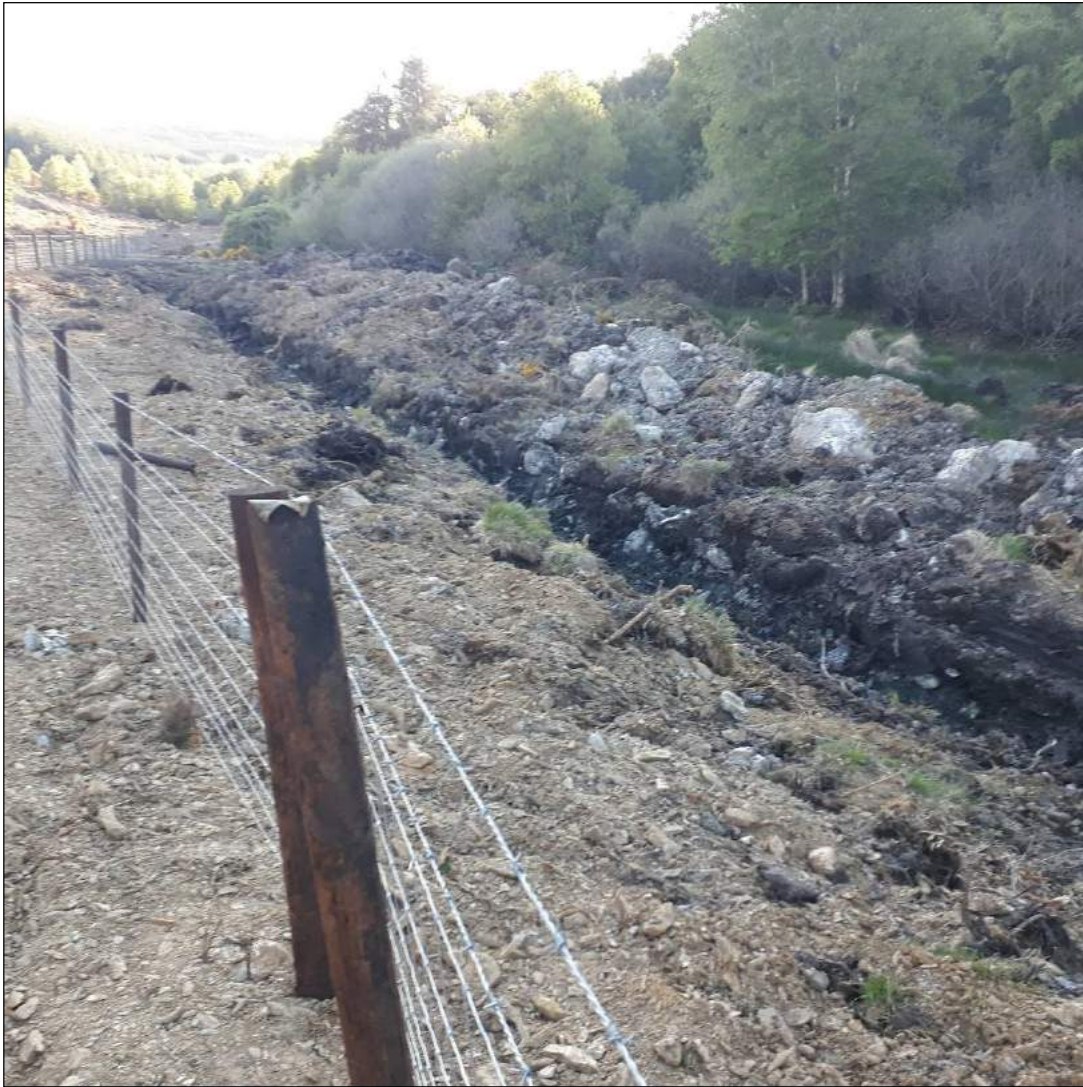
The natural floodplain of the river has been completely destroyed through vegetation clearance, disturbance and drainage with subsequent hydrological and water quality impacts.

The wetland habitats which form the floodplain of the river have also been damaged through the drainage works. Under the Planning and Development (Amendment) (No. 2) Regulations 2011 these works would constitute drainage of a wetland and would require planning permission from the statutory local authority (Wicklow County Council). No planning permission was sought for these works by the project.

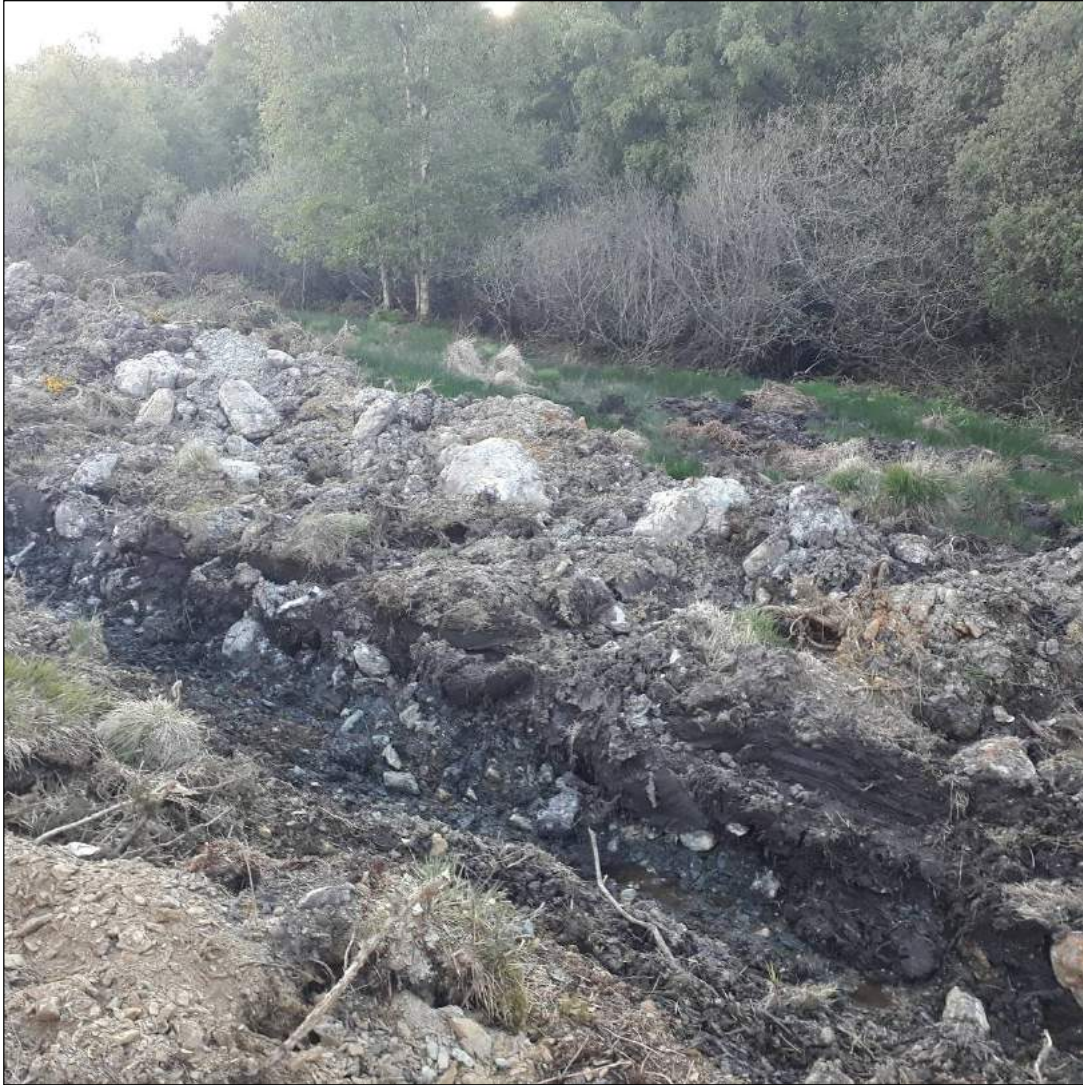
Extensive drainage works and disturbance within the floodplain of the river.

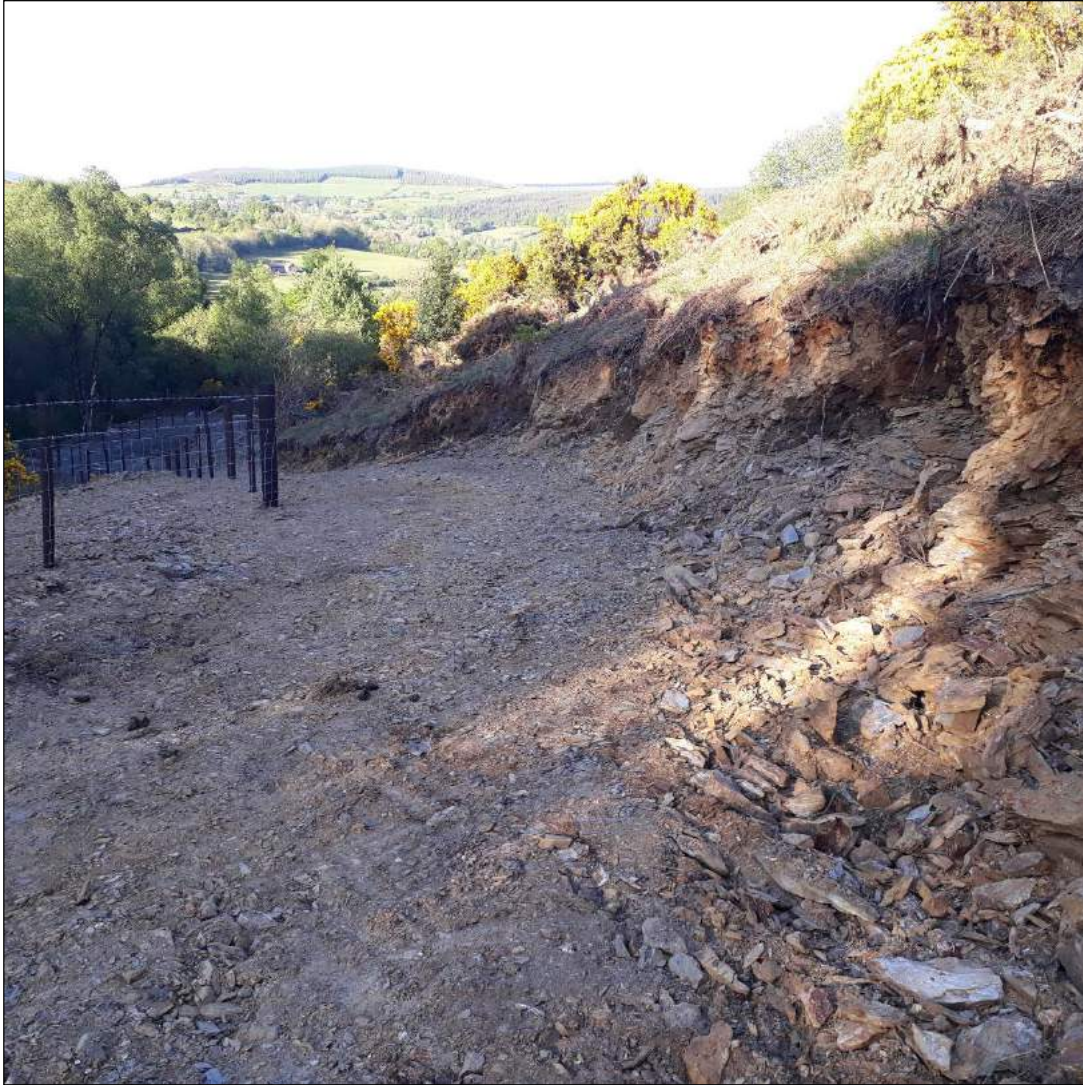
Excavation of ground in some locations is in excess of c.2m.

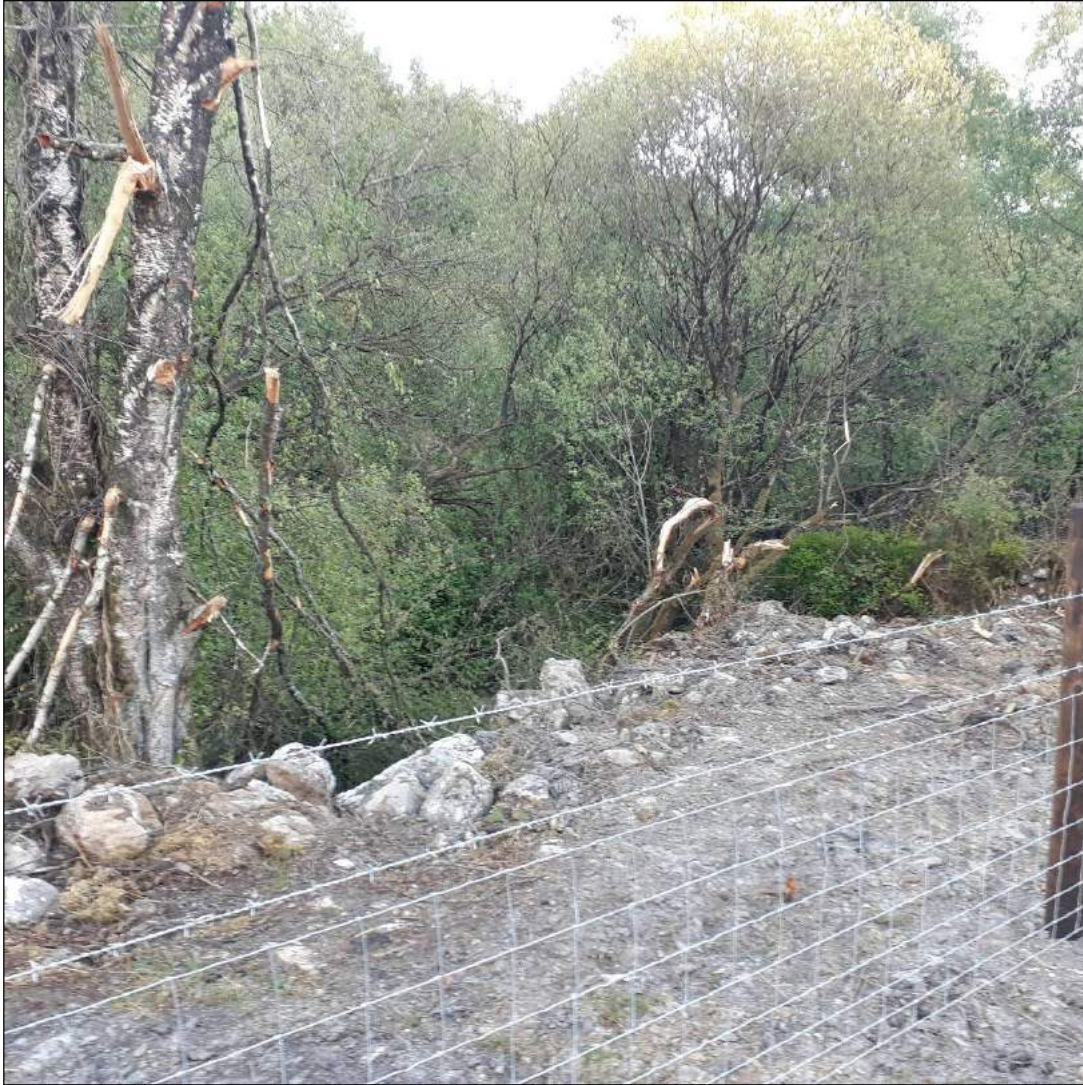
Spoil and excavated material has been pushed into the riparian zone with damage to mature trees and other vegetation.

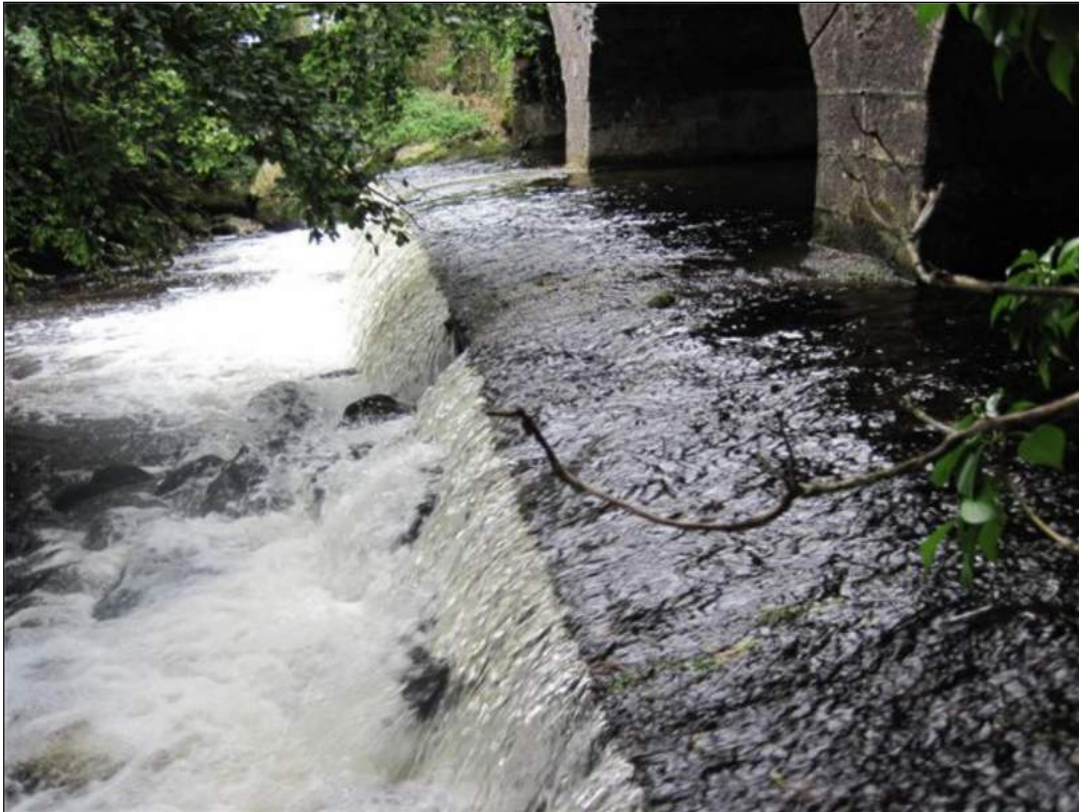
Ballinglen Bridge: This photo demonstrates the fish passage issues associated with laminar flow, flow velocity and the perching associated with this scour protection apron.

Discussions are currently underway between Wicklow County Council, Inland Fisheries Ireland and the East Wicklow Rivers Trust to remove this barrier to improve the fisheries habitat upstream of Ballinglen Bridge and highlights the importance of this watercourse for salmonids.
