Survey date: Apr 28, 2021

Length: 7979m

Sections: 11

## Camaderry (Section 1)

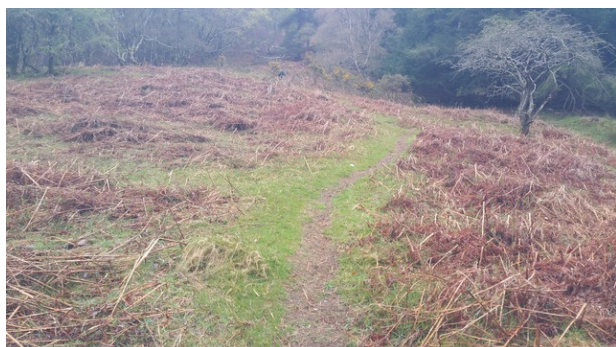
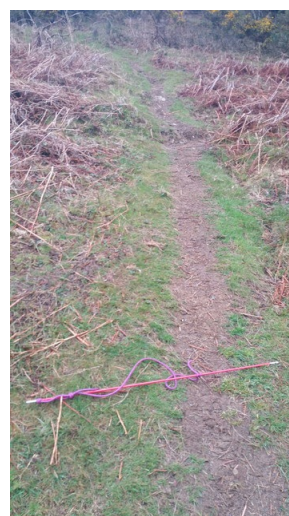
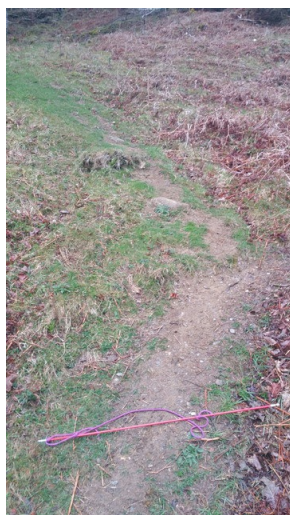
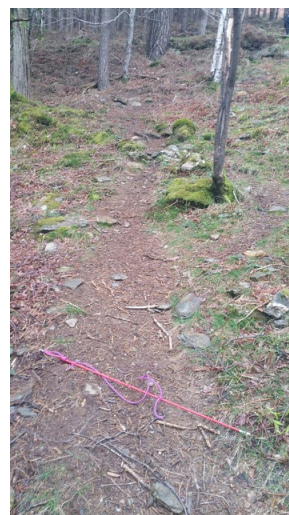
**Section description:** Start of path - direct (steep) ascent up hillside

**Site Assessment:** Very steep unsustainable line

| Work type | Estimated input | Work Summary |
|---|---|---|
| none | | Close to car park so major repair would attract large numbers - would need to be pitched if anything. Better to encourage alternative routes |

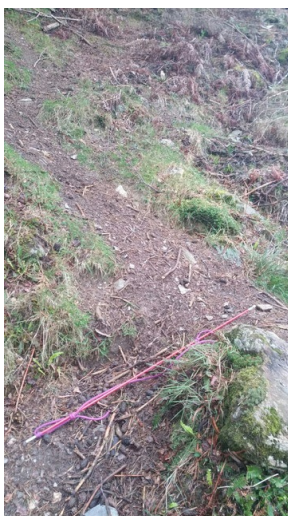
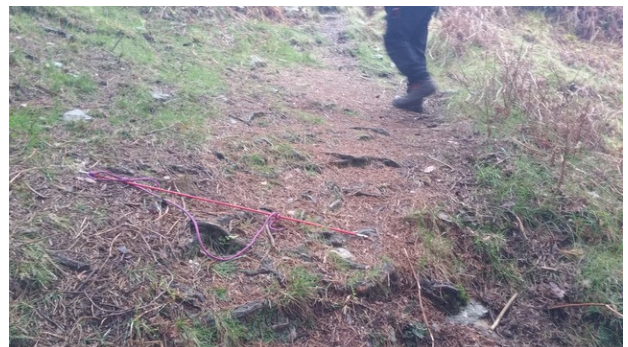
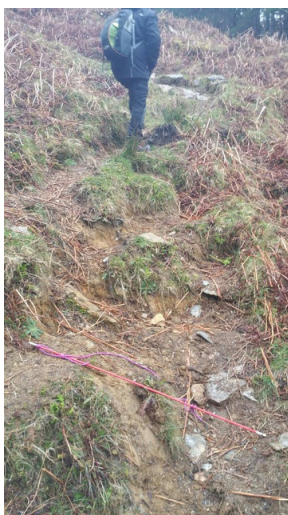
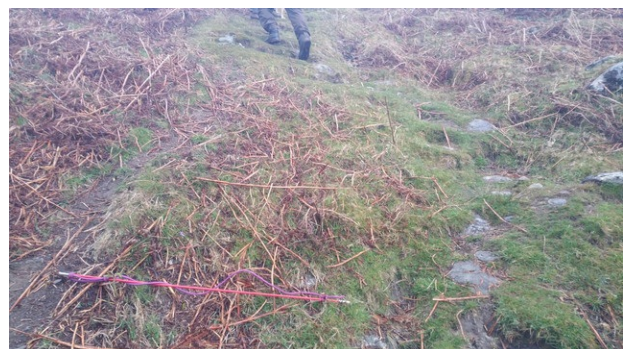
Section description: Forest track crossing - direct uphill

| Work type | Estimated input | Work Summary |
|---|---|---|
| none | | Would require pitching if any work was done - not recommended |

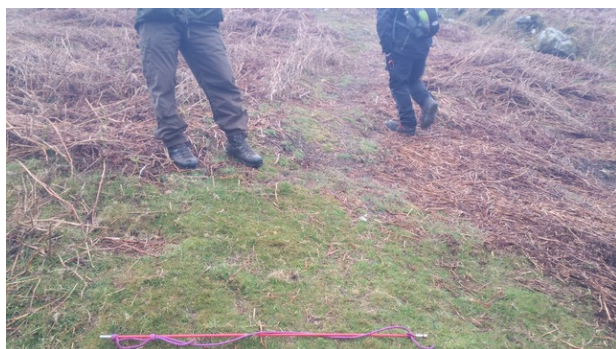
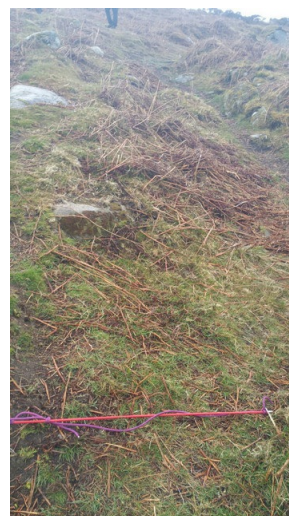
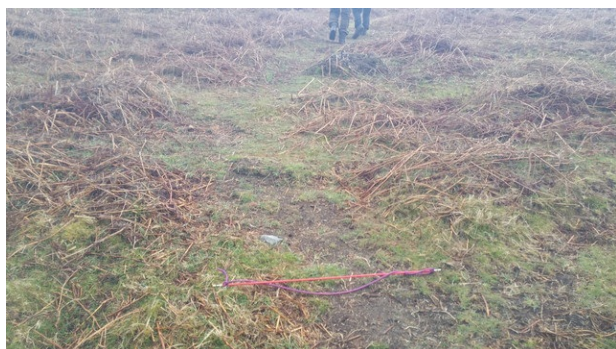
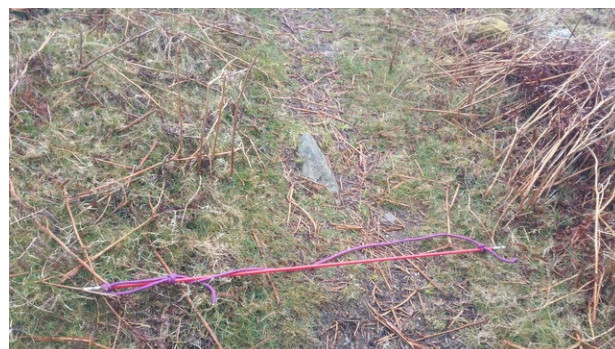
**Section description:** Change of slope - open ground. A number of deer tracks cross this area

**Site Assessment:** Don't touch

| Work type | Estimated input | Work Summary |
|---|---|---|
| none | | Would require pitching if use increased significantly |

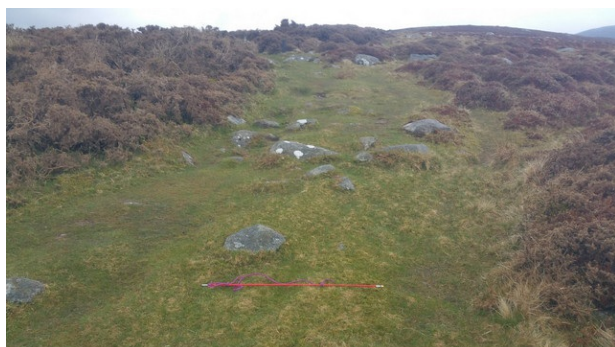
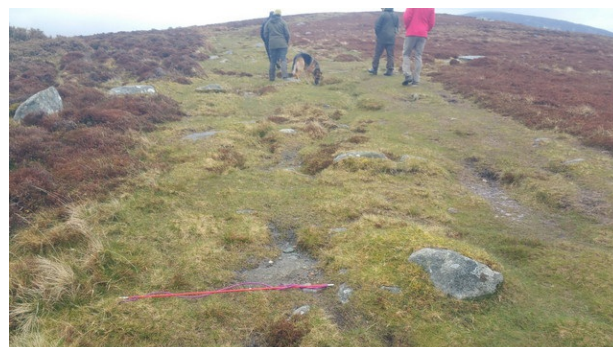
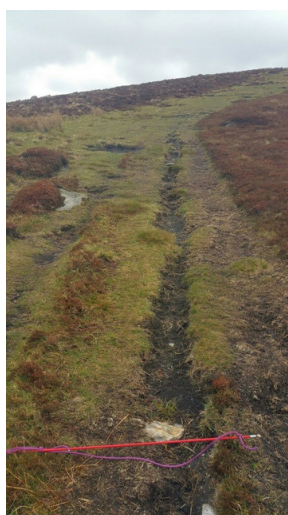
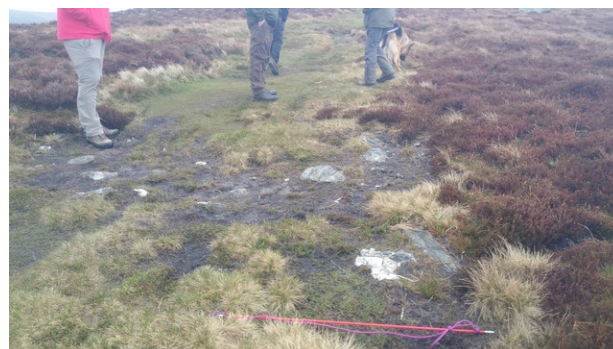
**Section description:** Junction with route from Forest track - follows up shoulder of hill

**Availability of Materials:** Some aggregate but not enough for full repair; no block stone

| Work type | Estimated input | Work Summary |
|---|---|---|
| none | | Plastic Ecogrid has been used (upside down). Would be a major job to replace or improve which may not be viable. Likely to need extensive import of materials |

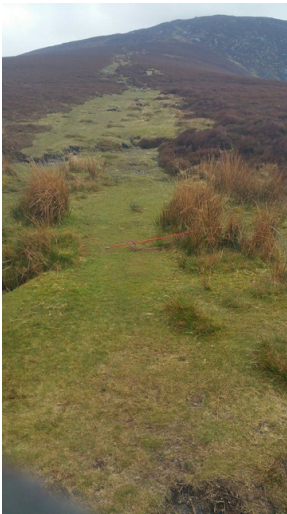
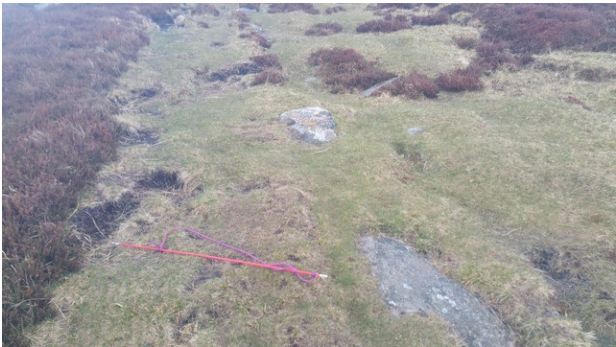
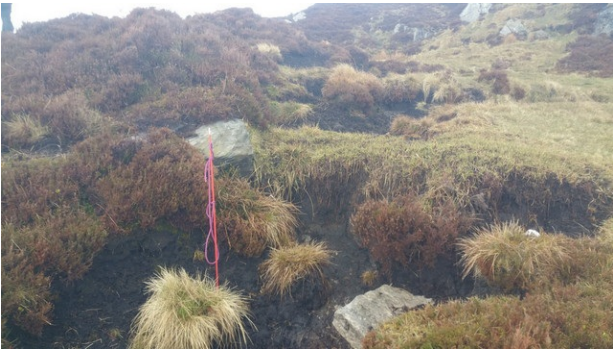
**Site Assessment:**Open hill

| Work type | Estimated input | Work Summary |
|---|---|---|
| Light_touch | 50 days labour | Line definition on lower part of the section - areas of deep peat are more tricky to resolve. |

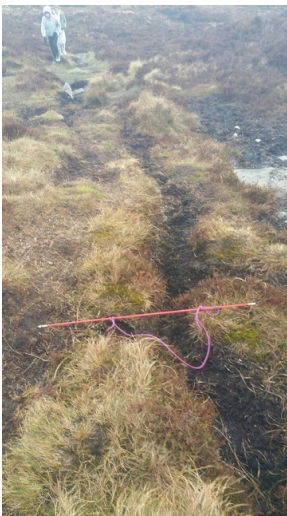
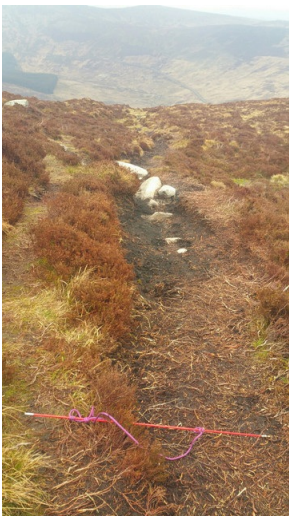
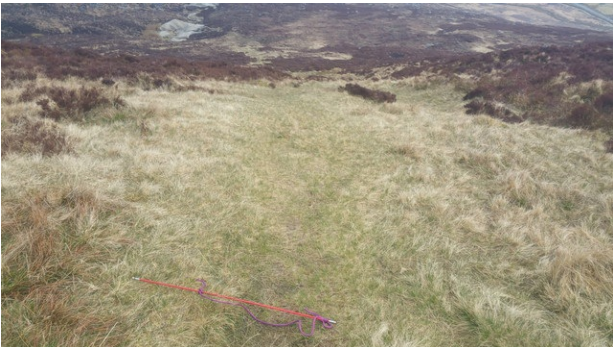
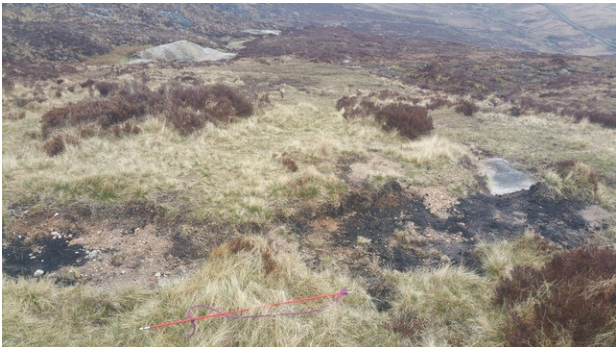
Site Assessment:Deep peat and steep. Leave well alone

| none | | No work advised on this steep section with deep peat |

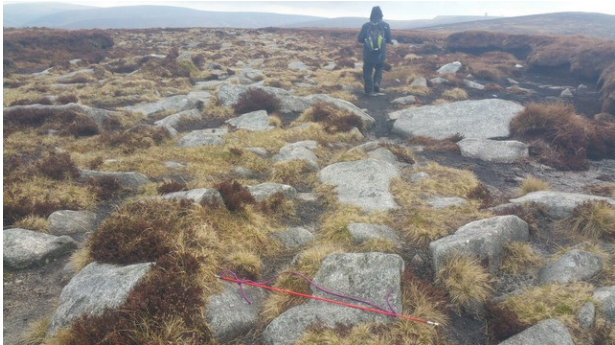
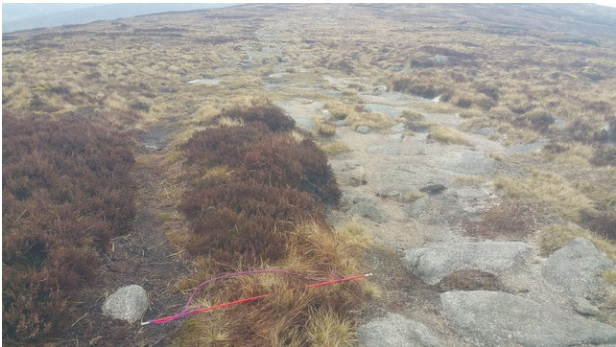
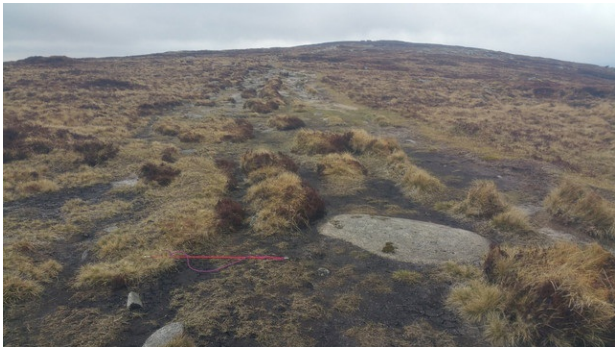
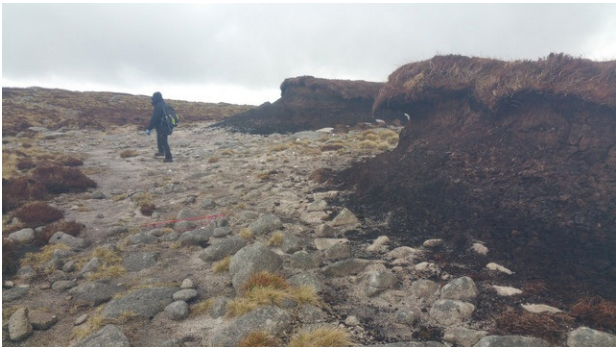
Section description: Minor summit and junction with section 6

Site Assessment:Machine access possible

| Work type | Estimated input | Work Summary |
|---|---|---|
| Light_touch | 50 days labour | Line definition is feasible. Peat restoration is desirable |

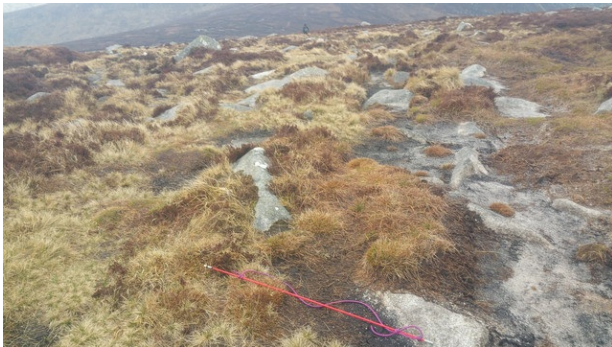
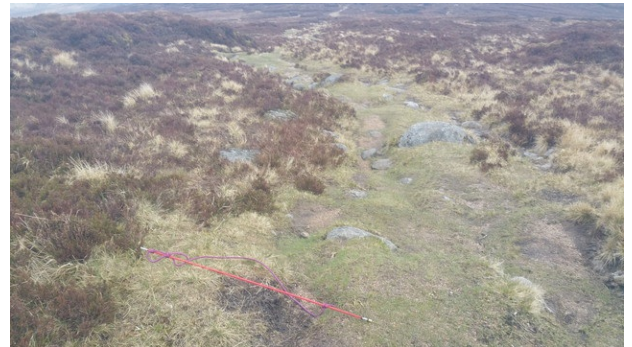
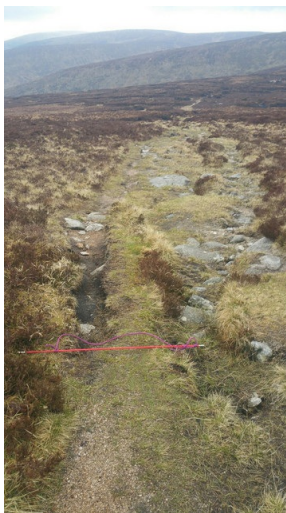
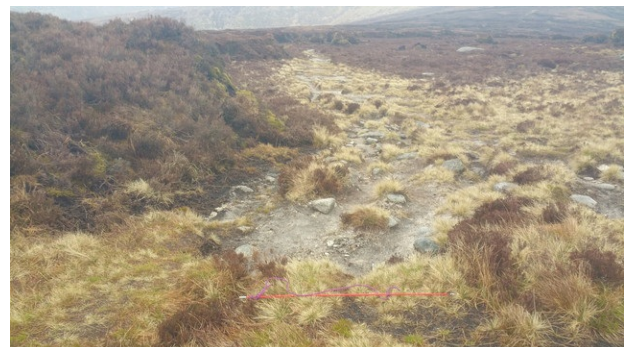
**Section description:** Section starts at main summit

**Site Assessment:** Deep peat need restoration

| Work type | Estimated input | Work Summary |
|---|---|---|
| Light_touch | 40 days labour | Drainage and line definition is possible due to eroded peat down to underlying rock. Peat restoration desirable |

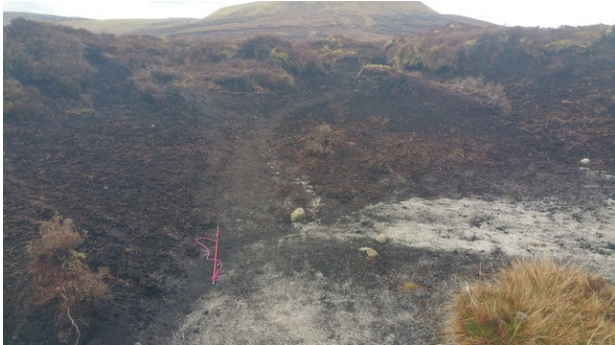
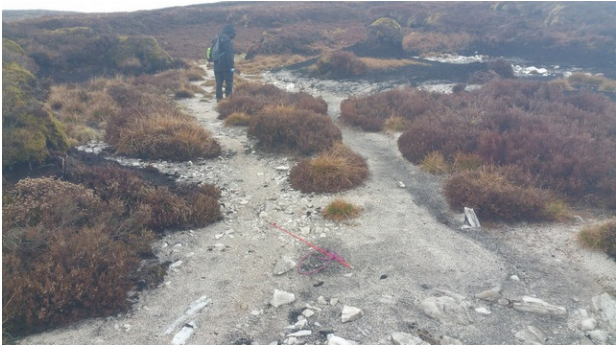
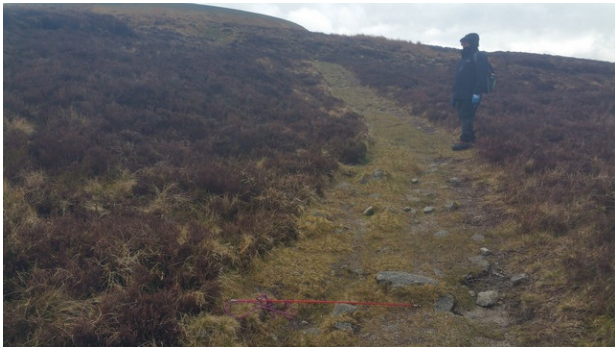
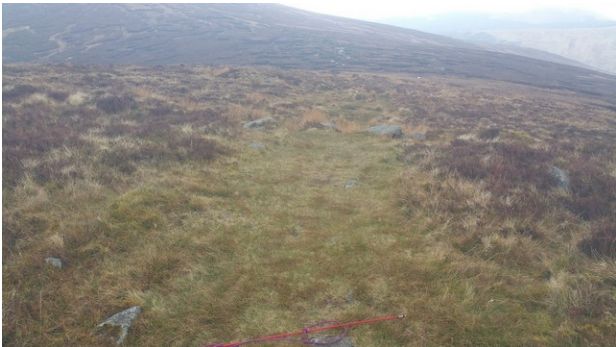
Section description: Section starts at the col and crosses deep peat to Turlough Hill Reservoir

| Work type | Estimated input | Work Summary |
|---|---|---|
| none | | It may be possible to select a line through the eroded peat but restoration of peat is a higher priority than recreation |

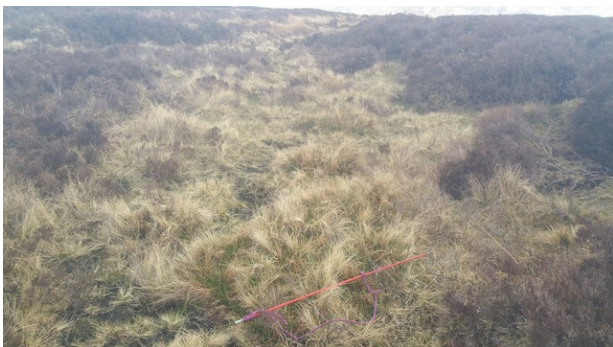
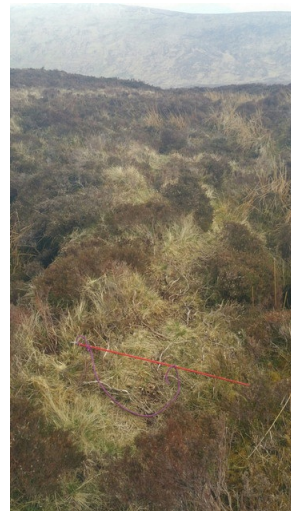
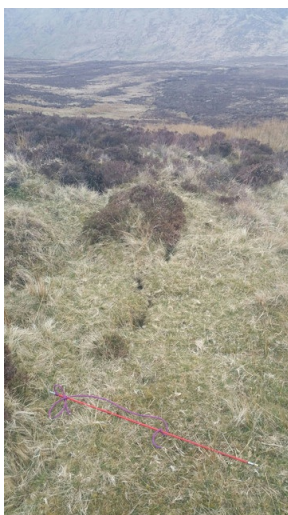
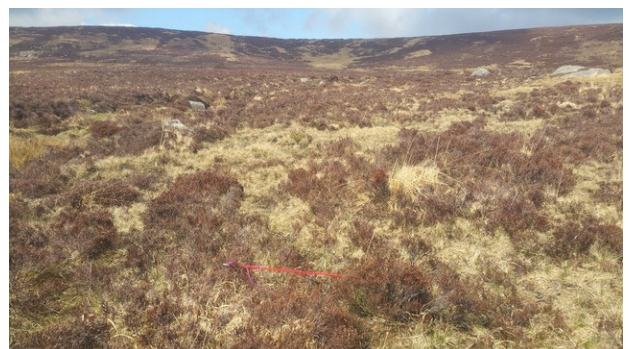
**Section description:** Junction at the col - start not well defined / obvious

**Site Assessment:** No obvious path line (not continuous)

| Work type | Estimated input | Work Summary |
|---|---|---|
| none | | Deep peat makes any work challenging especially on the gradient |

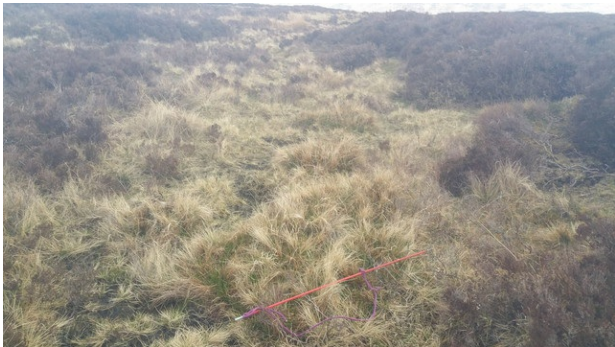
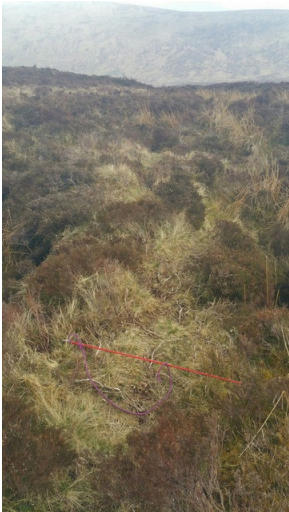
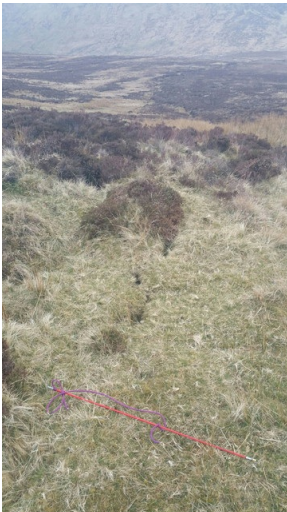
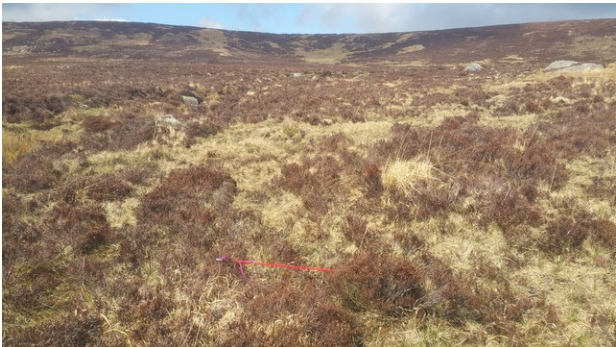
**Site Assessment:**No path

| Work type | Estimated input | Work Summary |
|---|---|---|
| none | | No work is recommended as there is no sign of demand / use |
