**Overall description:** Circuit from Lough Dam to Scarr summit via Kanturk - well define line

**Overall assessment:** Level of use is limited by parking availability. Not deteriorating rapidly

# Kanturk – Scarr (Section 1)

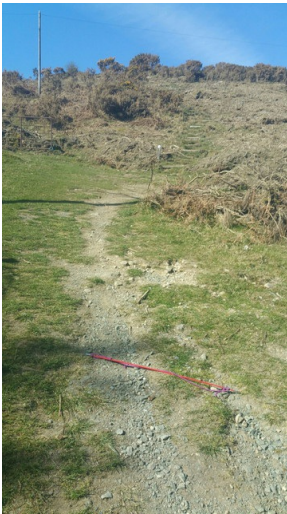
1619429869782.jpg - O 14800 03696 (± 9m)

**Site Assessment:**Easy access on agricultural track

| Work type | Estimated input | Work Summary |
|---|---|---|
| part_repair | 10 days labour | Replace 30m steps; finish the bypass route or add 5 steps; |

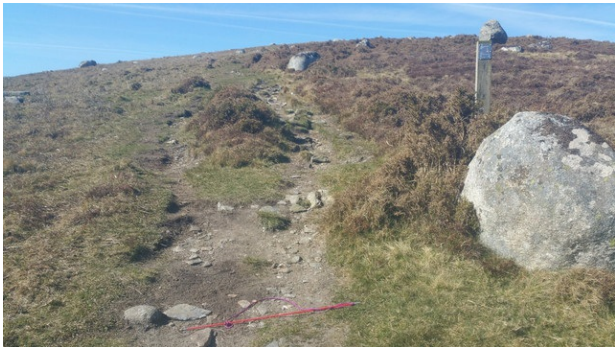
1619430913575.jpg - O 14626 03639 (± 4m)

Availability of Materials: Large granite boulders  
 Site Assessment:Easy site access

| early_intervention | 5 days labour | 5 Water bars at top of steeper sections |

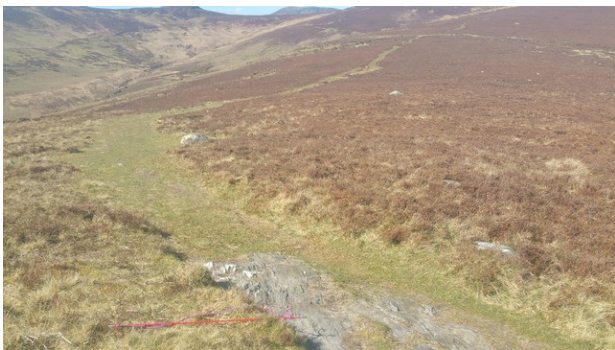
1619432788042.jpg - O 14362 03490 (± 4m)

**Site Assessment:**Open ground

| Work type | Estimated input | Work Summary |
|---|---|---|
| early_intervention | 20 days labour | 10 Water bars and 2 cross drains; 50m line definition |

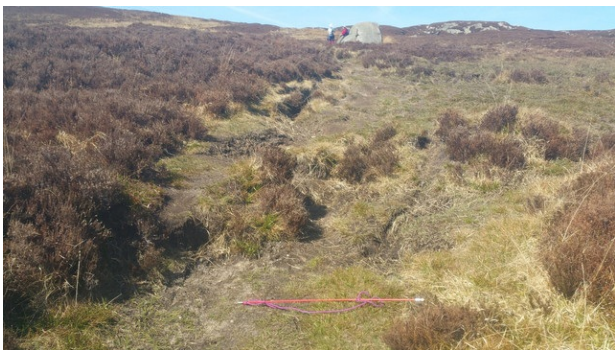
1619434254743.jpg - O 13463 03620 (± 9m)

**Site Assessment:**Deep peat in pockets. Bog bridge needs importing by air

| Work type | Estimated input | Work Summary |
|---|---|---|
| early_intervention | 8 days labour | Minor drainage but generally peat too deep - 15m bog bridge at p2; 3 water bars |

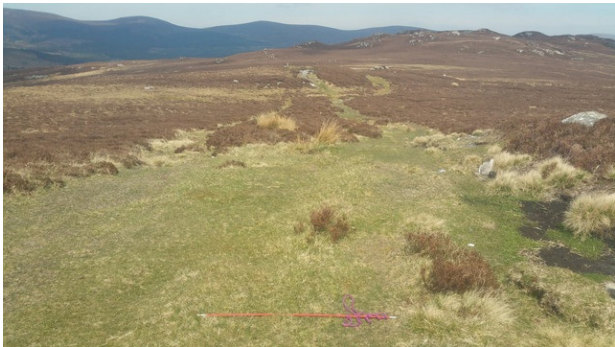
1619438460745.jpg - O 12535 02672 (± 9m)

Site Assessment:Visible scar

| early_intervention | 9 days labour | Block 3 braids by landscaping |

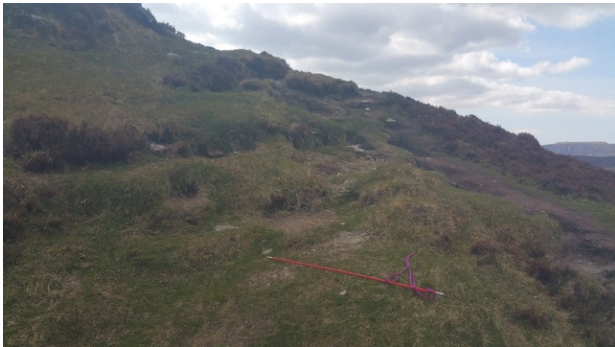
1619438929368.jpg - O 12567 02569 (± 4m)

Site Assessment:Steep cross slope keeps line tight

| Work type | Estimated input | Work Summary |
|---|---|---|
| early_intervention | 10 days labour | 3 water bars and close braids with landscaping |

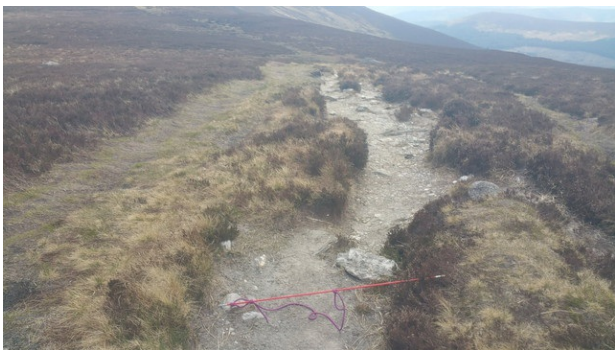
1619439429047.jpg - O 12596 02453 (± 4m)

**Site Assessment:**Remote work site

| Work type | Estimated input | Work Summary |
|---|---|---|
| early_intervention | 10 days labour | Containment and line definition plus 5 cross drains |

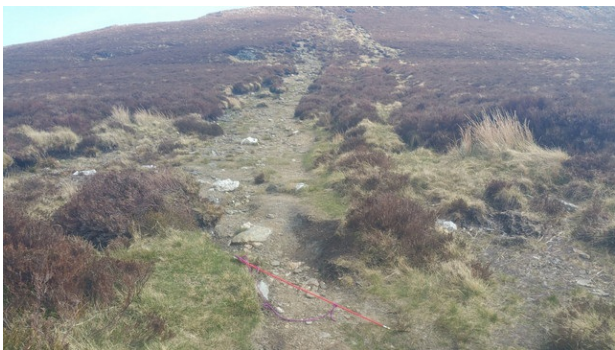
**1** 1619442458312.jpg - O 13149 02003 (± 4m)

**Site Assessment:**Mostly stabilised within damaged zone

| Work type | Estimated input | Work Summary |
|---|---|---|
| early_intervention | 12 days labour | 8 water bars and close 2 braids with landscaping |
