Survey date: Jul 22, 2021

Length: 4357m

Keadeen (Section 1)

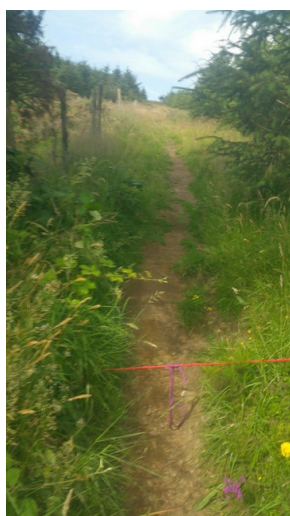
1626945522943.jpg - S 98458 89510 (\pm 3m)

Section description: Start of path by car parking area - runs along forest ride up to the corner of a field.

Length (m)	Max gradient (%)	Min gradient (%)	Crossfall (%)
249	20	15	0

Minimum	Maximum	Typical
Trampled width (m)	0.5	1	1.5
Bare width (m)	0	0.3	0.5
Eroded depth (m)	0	0	0.2

Work type	Estimated input	Work Summary
early_intervention	3 days labour	Surface drainage to deflect water off the path - 3 water bars (could be wooden in this location)

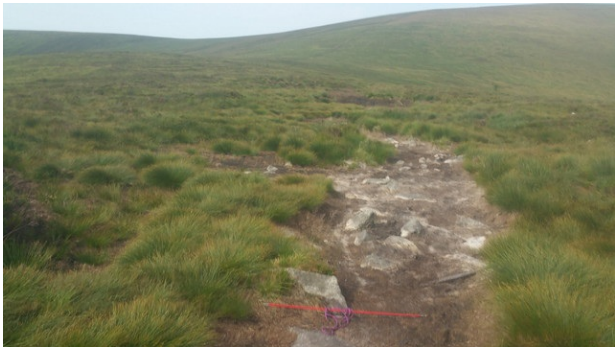
1626947887410.jpg - S 96630 89794 (± 3m)

Minimum	Maximum	Typical
Trampled width (m)	6	10	30
Bare width (m)	1.5	3	6
Eroded depth (m)	0.1	0.3	0.4

Work type	Estimated input	Work Summary
early_intervention	20 days labour	Remove off road vehicles and restore exposed / eroding peat

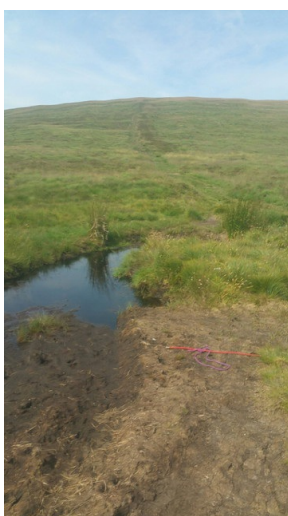
1626948936378.jpg - S 96180 89540 ($\pm 3\text{m}$)

Minimum	Maximum	Typical
Trampled width (m)	3	4	6
Bare width (m)	0	0.5	2
Eroded depth (m)	0	0.05	0.3

Work type	Estimated input	Work Summary
early_intervention	10 days labour	Prevent access by unauthorised off road vehilces. Minor drainage using vegetation-lined ditches

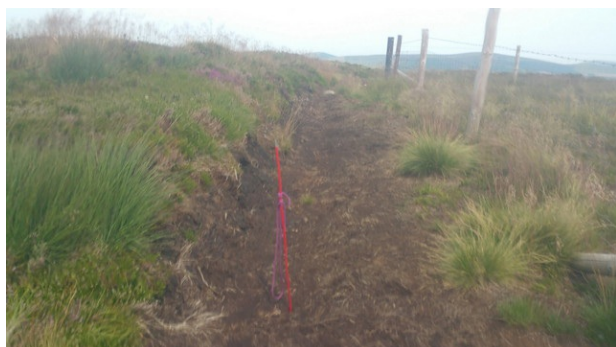
1626953538861.jpg - S 96638 89803 (± 3 m)

Section description: Section starts at corner fence and extends to the plantation boundary. There is some bare peat close to the fence

Minimum	Maximum	Typical
Trampled width (m)	1	1.5	2.5
Bare width (m)	0.5	0.5	2
Eroded depth (m)	0	0.2	0.6

Work type	Estimated input	Work Summary
none		It may be possible to remove the peat layer and landscape the edge to provide a robust surface - this would be a major intervention so needs to be considered strategically. Not recommended with current use.

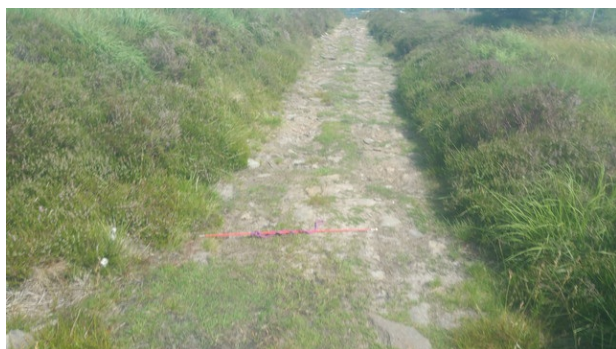
20210722_123750.jpg - S 96837 89852 ($\pm 0\text{m}$)

Section description: This section is a disused track on the boundary of the plantation

Minimum	Maximum	Typical
Trampled width (m)	2	2	2.5
Bare width (m)	1	1.5	2.5
Eroded depth (m)	0	0.1	0.3

Work type	Estimated input	Work Summary
minor_repair	6 days labour	Installation of drainage (6 water bars) to divert surface water would slow the deterioration of this track.
