# Kippure to White Rock Road

Survey date: 2021-07-18

**Overall description:** Walking route from peat road to the summit with communications mast

**Overall assessment:** Extensive areas of deep peat - makes intervention difficult to justify

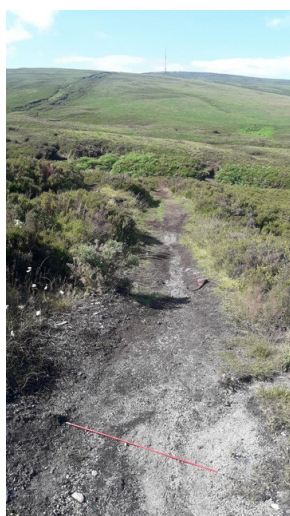
1626599877409.jpg - O 12862 17465 ( $\pm 5m$ )

**Kippure to White Rock Road (Section** Start: O 12863 17464 ( $\pm 4\text{m}$ ) End: O 12811 17290 ( $\pm 5\text{m}$ )  
**Section description:** Start of route after turfers access track

Minimum	Maximum	Typical
Trampled width (m)	0.5	1	2
Bare width (m)	0.3	0.5	2
Eroded depth (m)	0.1	0.2	0.6

Work type	Estimated input	Work Summary
early_intervention	5 days labour	Deep peat means limited work is possible. Address two stream crossings where with bank erosion problems. Block several braids.

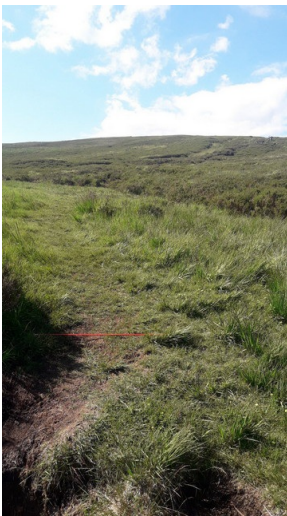
1626600957362.jpg - O 12810 17294 (± 4m)

**Section description:** Change of gradient after last stream crossing. Middle section with steeper ground with several braids and deep erosion. Drainage problems with an area where mineral soil begins to be exposed.

Minimum	Maximum	Typical
Trampled width (m)	0.5	1	6
Bare width (m)	0	0.5	6
Eroded depth (m)	0	0.2	1

Work type	Estimated input	Work Summary
none	10 days labour	Block landscaping required. Deep peat means light touch work would not be viable

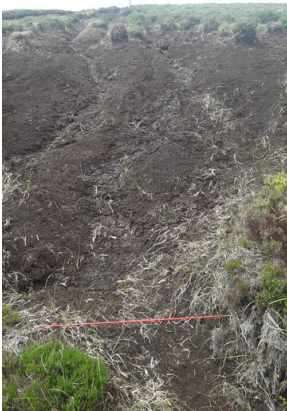
1626606442903.jpg - O 11891 15941 (± 5m)

**Section description:** Path line not defined, just through wide peat eroded area immediately before summit

Work type	Estimated input	Work Summary
none		Peatland restoration techniques
