Survey date: Jul 21, 2021

Length: 6899m

Sections: 12

## Lobawn (Section 1)

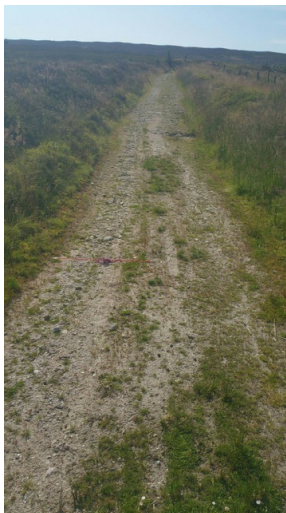
1626858335578.jpg - N 95762 00922 ( $\pm 3\text{m}$ )

**Site Assessment:** Under used forestry track accessible from farm years by vehicle

| Work type | Estimated input | Work Summary |
|---|---|---|
| minor_repair | 5 days labour | 2 grade reversals top side ditch option |

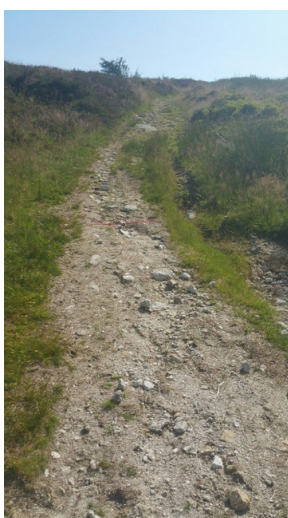
1626859183595.jpg - N 96041 00635 ( $\pm 9\text{m}$ )

**Site Assessment:** Easy access for excavator - Best done with skilled excavator operator - 8 days hire

| Work type | Estimated input | Work Summary |
|---|---|---|
| part_repair | 80 days labour if done by hand | 600m Side ditch and 12 cross drains or culverts; 4 water bars on first slope |

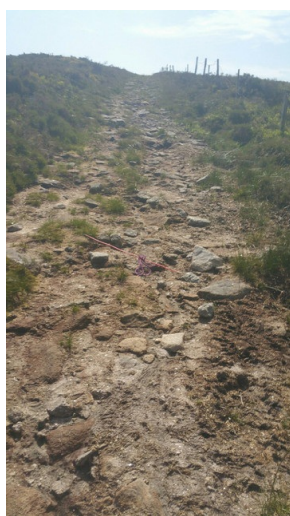
1626860588849.jpg - N 96287 00097 ( $\pm 3\text{m}$ )

**Site Assessment:** Still accessible by machine

| Work type | Estimated input | Work Summary |
|---|---|---|
| minor_repair | 5 days labour | 3 water bars; 20m line definition at end |

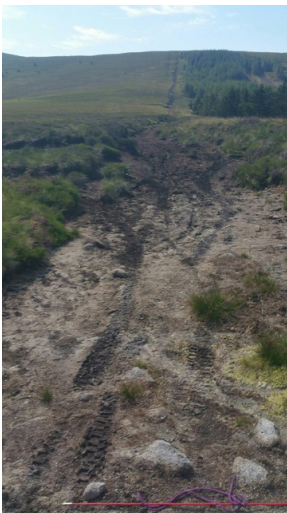
1626862661528.jpg - S 96811 99226 (± 3m)

Section description: End of track / exposed substrate used by scrambler bikes

Site Assessment:Peat col

| Work type | Estimated input | Work Summary |
|---|---|---|
| none | | Deep peat exposed - minor work not viable, peatland restoration advisable |

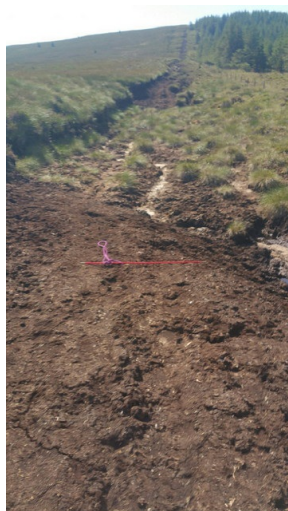
1626863840764.jpg - S 96866 98946 ( $\pm 3\text{m}$ )

**Section description:** Peat bank cutting at base of slope

**Site Assessment:** Materials could be driven in if other sections are upgraded

| Work type | Estimated input | Work Summary |
|---|---|---|
| none | 200 days labour plus machinery | Technically challenging and may not be viable for level of use. Full build is the only viable option: 730m aggregate plus anchors with major peat reprofiling that needs to be done by machine |

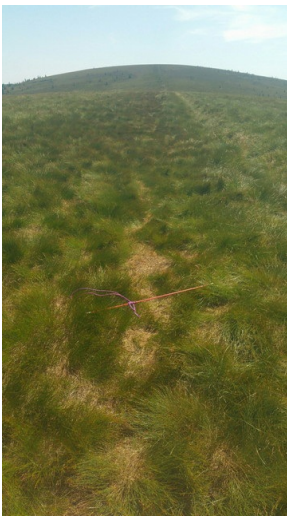
1626867103854.jpg - S 96994 98229 (± 9m)

**Site Assessment:**Degraded blanket bog.

| none | | Deep peat - minor work not viable - may be impacted if other sections are upgraded |
