Survey date: Apr 24, 2021

Length: 3134m

**Overall description:** Ascent from valley base with multiple route options

## Luggala (Section 1)

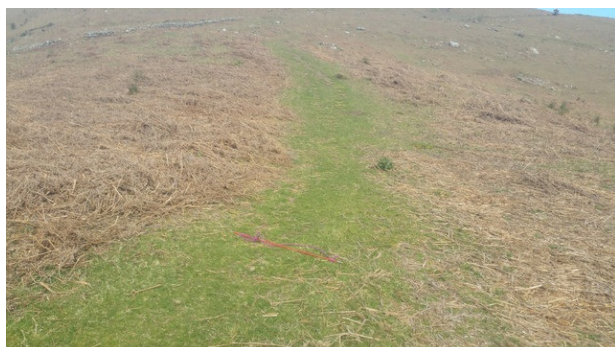
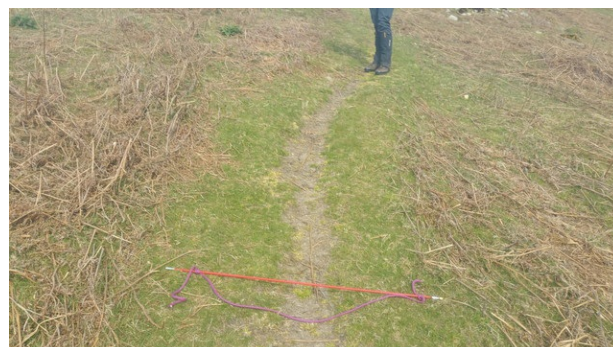
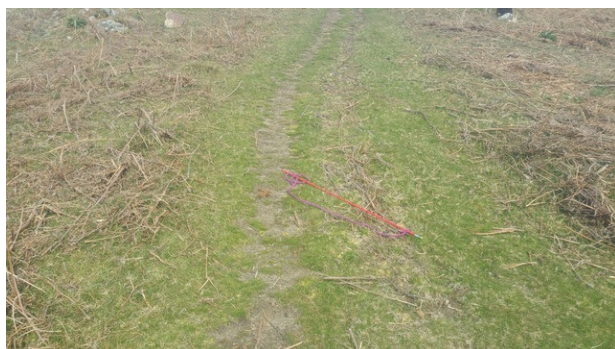
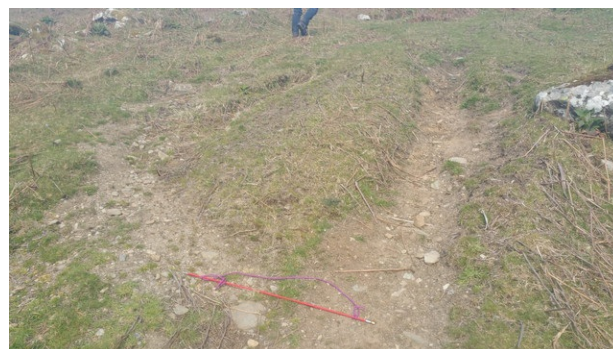
**Section description:** Start of path - highly visible desire line that ascends straight up the slope

**Site Assessment:** Easy access to site

| Work type | Estimated input | Work Summary |
|---|---|---|
| early_intervention | 9 days labour | At top of section (steeper) a short (5m) section of pitching. Install 4 waterbars to divert water off the line |

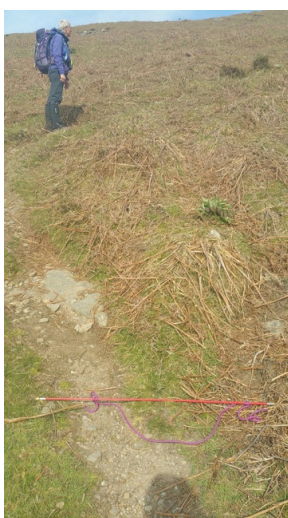
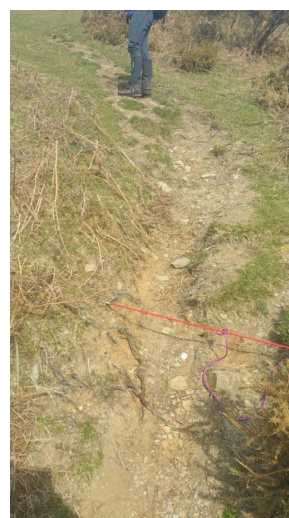
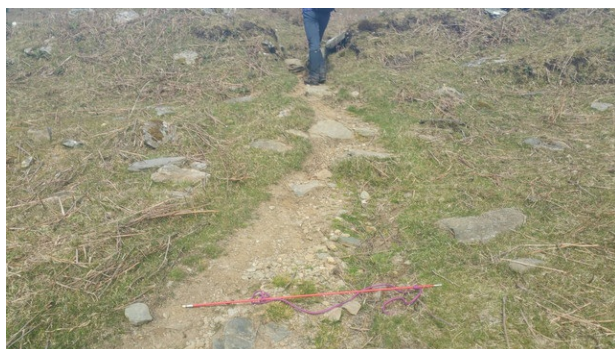
**Section description:** This section is between two stone walls and goes straight up the slope

**Site Assessment:** Walls should not be used as source of stone.

| Work type | Estimated input | Work Summary |
|---|---|---|
| early_intervention | 16 days labour | There is scope for spot repairs and minor drainage to prevent deterioration - approximately 10m of pitching (split into 2 parts) and 6 waterbars |

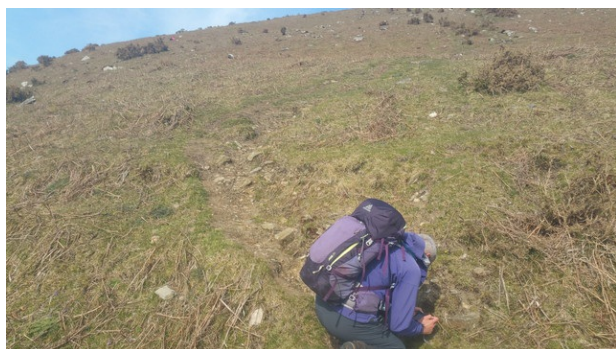
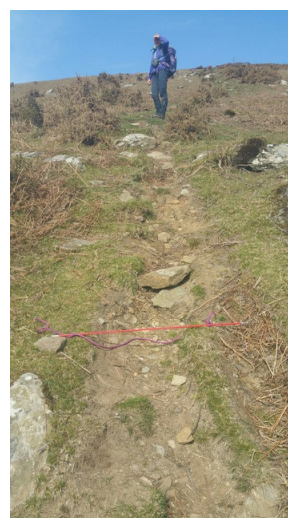
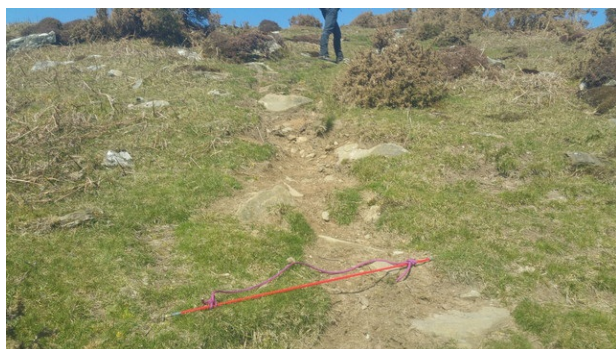
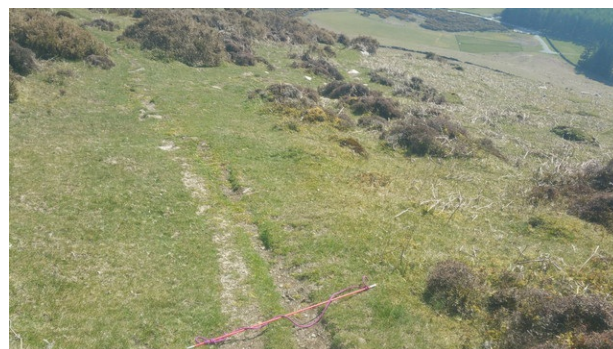
**Section description:** Section starts at wall and runs straight up hill to another wall at the beginning of the heather moorland and junctions with other sections

**Site Assessment:** Relatively open slope but steep - very difficult to constrain

| Work type | Estimated input | Work Summary |
|---|---|---|
| early_intervention | 30 days labour | 10m pitch on 40% gradient; short sections of pitching and drainage. Possible realignment along wall that forms top of section |

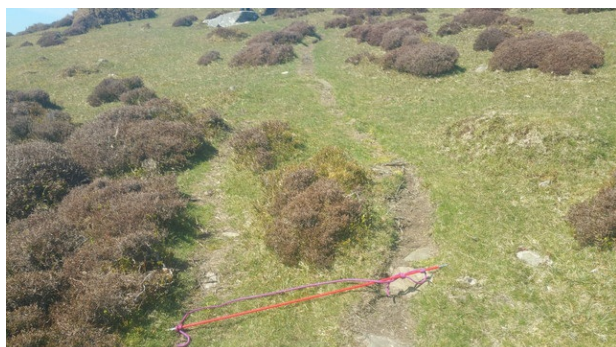
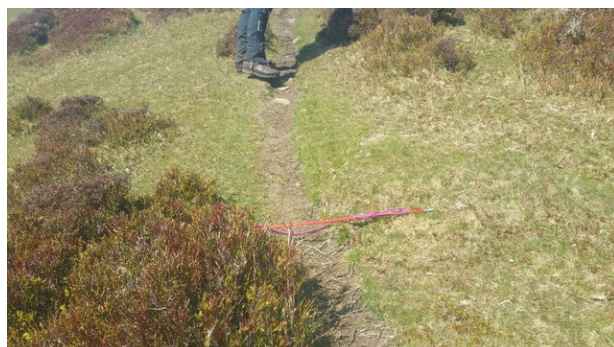
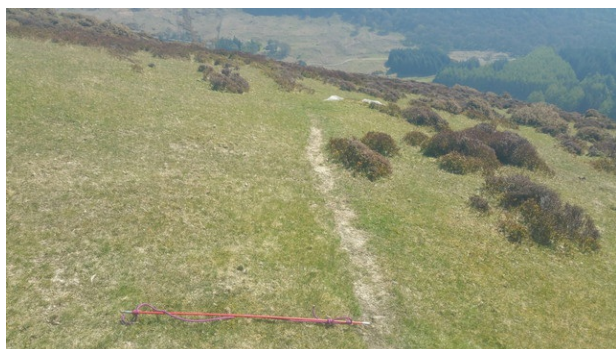
**Section description:** Section starts at change in vegetation at a wall - it is an obvious desire line, but not the most direct route to the summit

**Site Assessment:** Lower gradient than the direct route

| Work type | Estimated input | Work Summary |
|---|---|---|
| none | | Decreased gradient (and possibly lower use) means that work is not required with current levels of use |

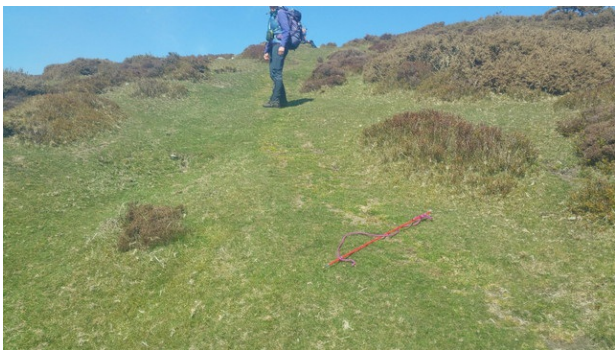
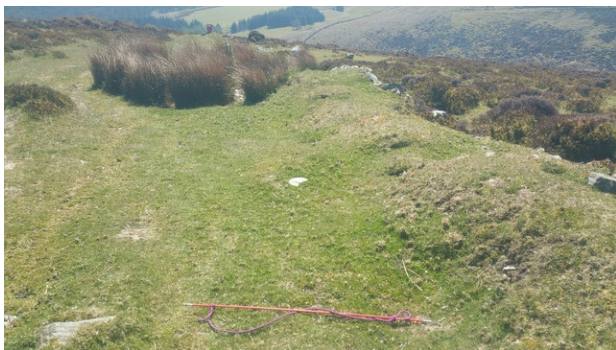
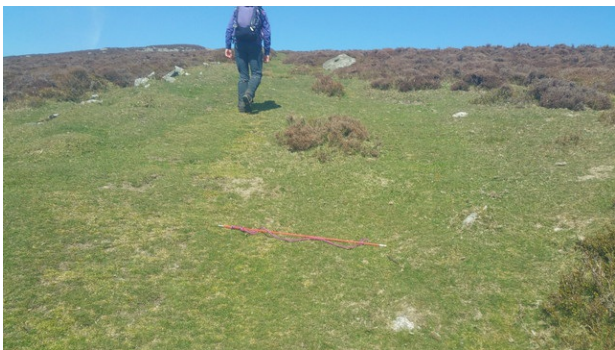
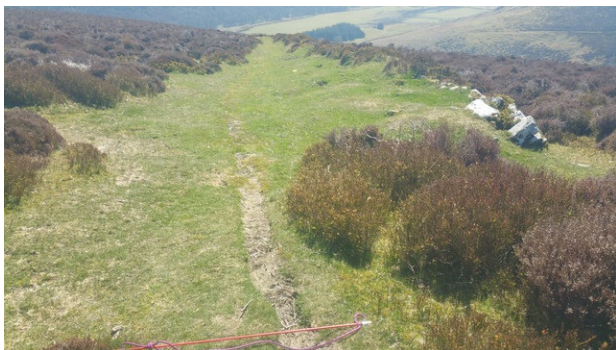
**Luggala (Section 5)**  
**Section description:** Route follows wall

**Site Assessment:**Robust grassy surface

| Work type | Estimated input | Work Summary |
|---|---|---|
| early_intervention | 3 days labour | Minor drainage would help to deflect surface water (3 water bars). Not urgent but desirable. |

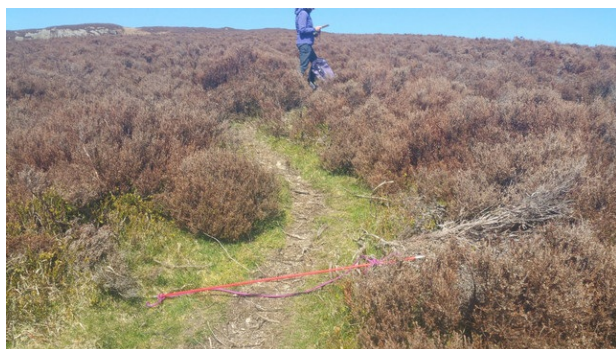
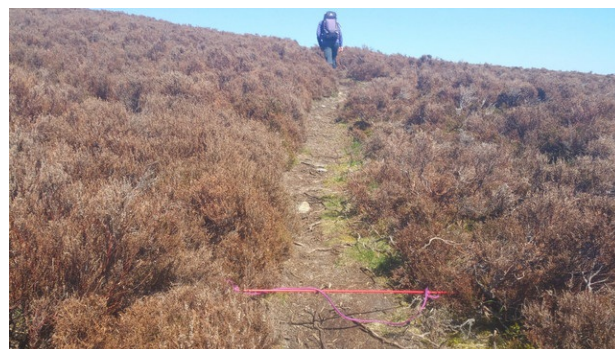
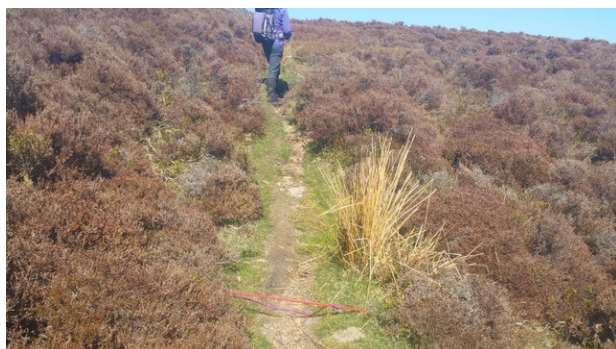
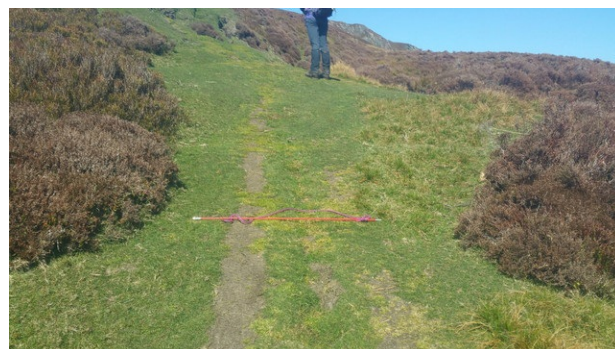
**Section description:** Section begins at the end of the wall and is a narrow trod through tall heather (constrains trampling)

**Site Assessment:** Sustainable line due to cross slope and gradient

| Work type | Estimated input | Work Summary |
|---|---|---|
| early_intervention | 3 days labour | Minor drainage would help to deflect surface water (3 water bars) |

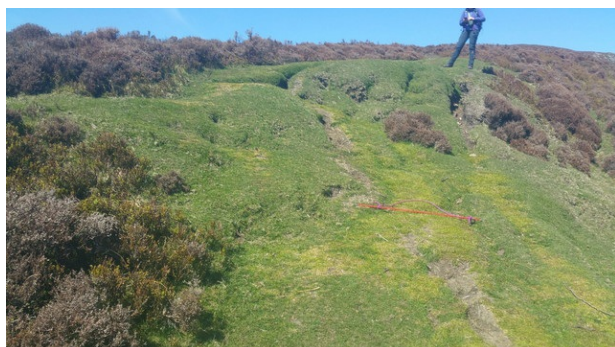
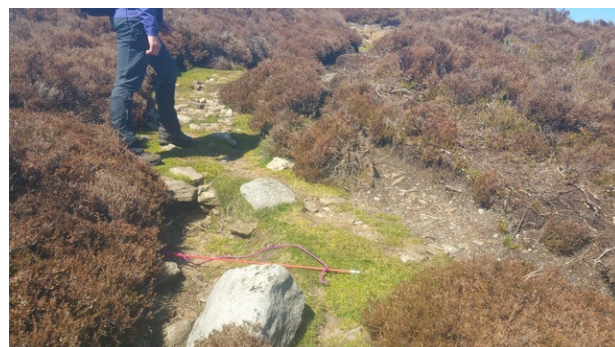
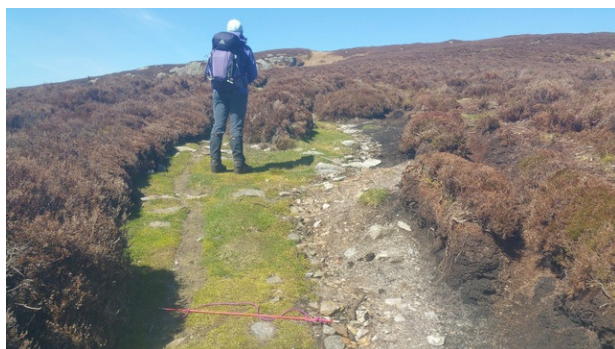
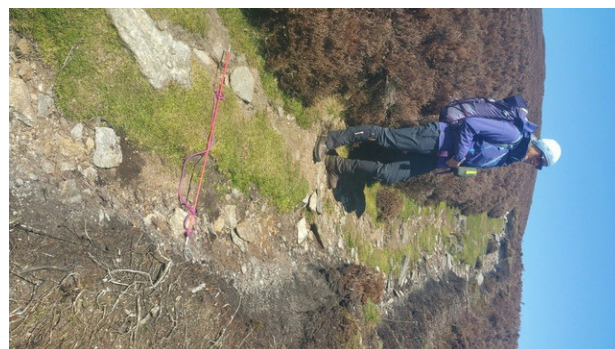
**Section description:** Section starts at junction with another braid

**Site Assessment:** Needs careful specification if a full repair is considered.

| Work type | Estimated input | Work Summary |
|---|---|---|
| early_intervention | 35 days labour | Recommended work is drainage (approx 20 water bars) and landscaping of braids. There is potential for full repair to provide a robust path (not recommended) |

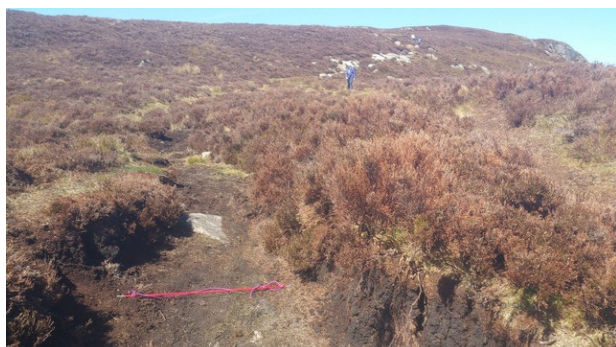
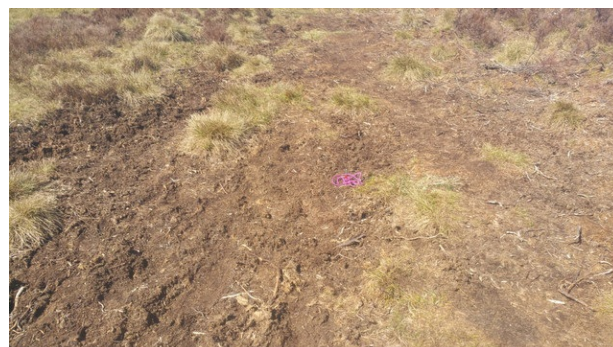
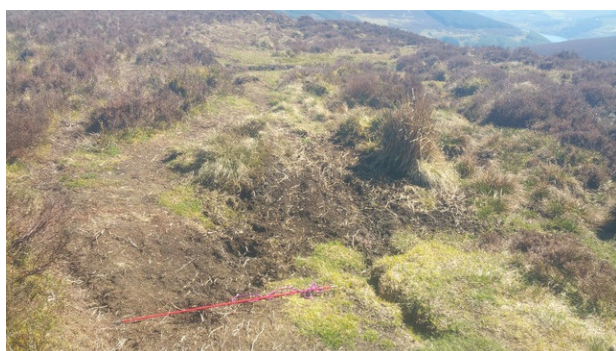
**Section description:** This section starts at a change of slope. Although there are some parts of this section where peat has eroded almost to the substrate, other areas are still deep peat and likely to be awkward to cross in wet conditions

**Site Assessment:** Deep peat makes for a difficult work site

| Work type | Estimated input | Work Summary |
|---|---|---|
| none | | Deep peat means that if any work is considered it would need to be floated on the peat. Not recommended |

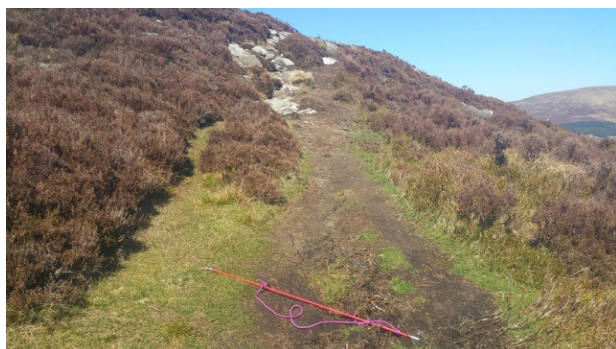
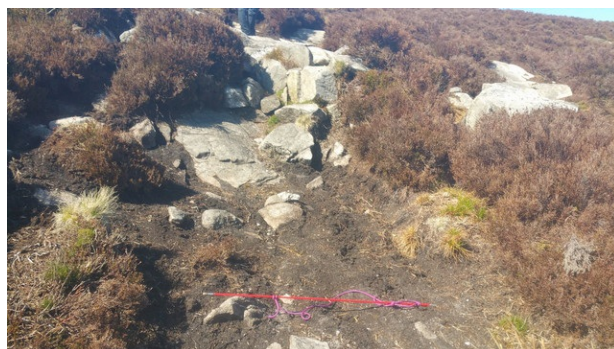
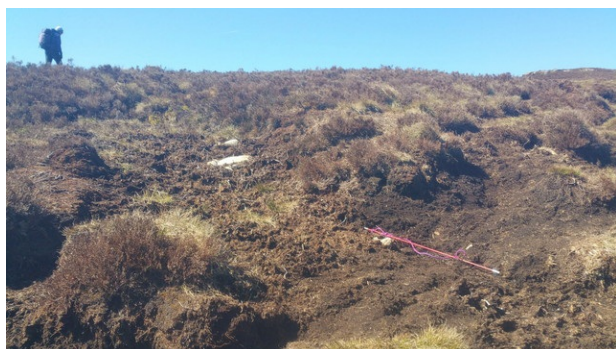
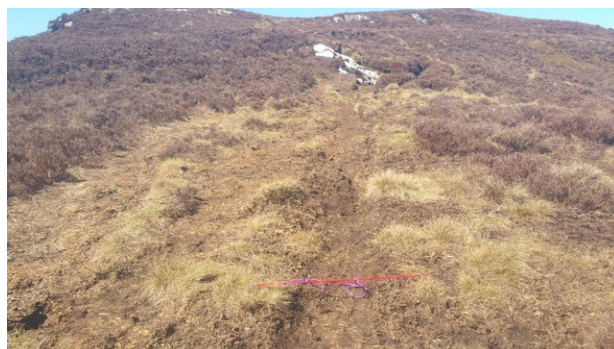
**Section description:** Section begins at an increase in slope

**Site Assessment:** Deep peat difficult to manage on slope

| Work type | Estimated input | Work Summary |
|---|---|---|
| none | | Depth of peat at the top of this section means that path repairs are not viable - a path would need to be floated but the gradient is too steep for this to be left un-anchored. |

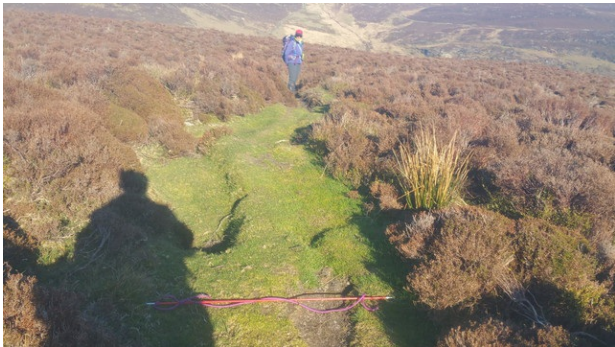
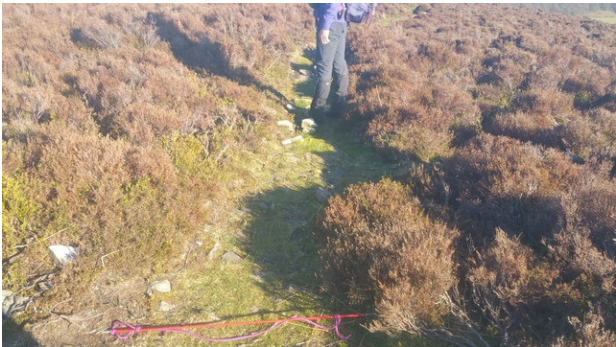
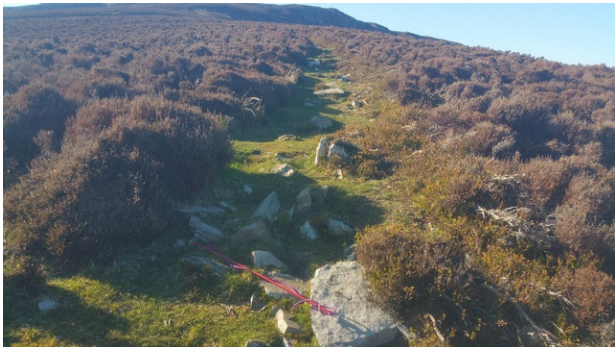
**Luggala (Section 11)**  
**Section description:** Junction

Site Assessment:Main route

| early_intervention | 10 days labour | Drainage and landscaping |

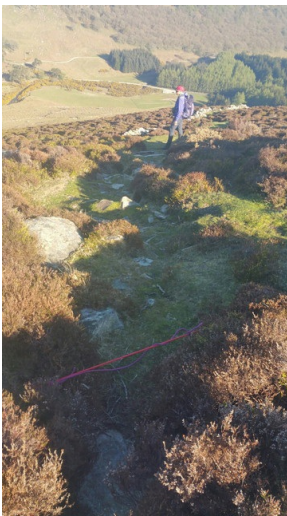
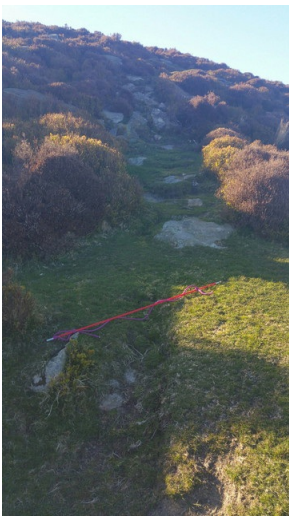
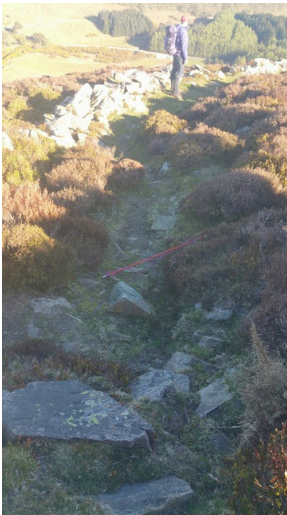
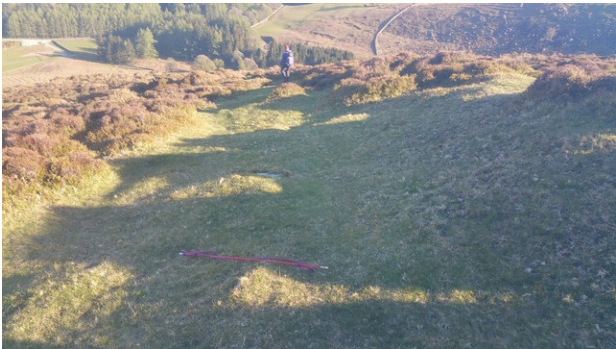
Site Assessment:Stable route with shared pressure

| early_intervention | 5 days labour | 1 water bar; 2m wall repair |

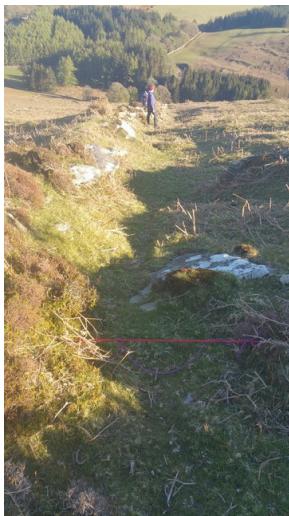
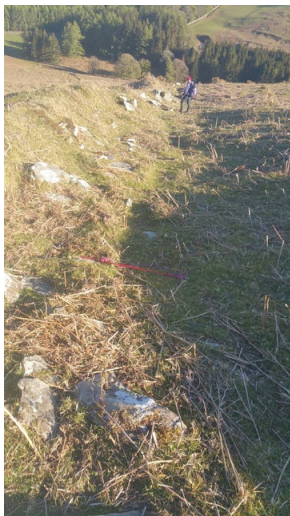
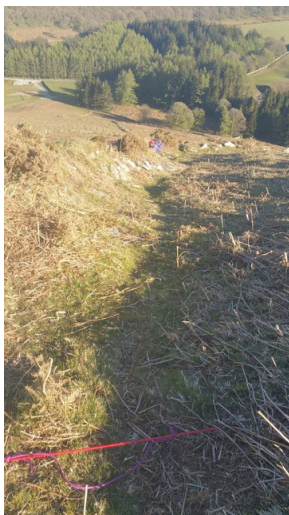
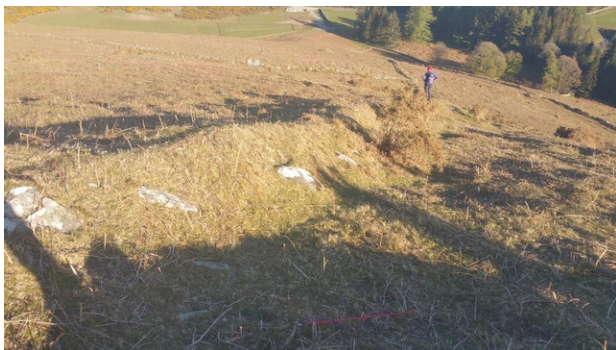
Availability of Materials:
 Site Assessment:Not sustainable line
