Survey date: Apr 23, 2021

**Overall description:** Signposted route from Djouce across deep peat on the col and steep gradients

**Overall assessment:** Col is badly eroded. There is extensive deep peat and steep gradients. Unsustainable line

# War hill (Section 1) Section description: Summit

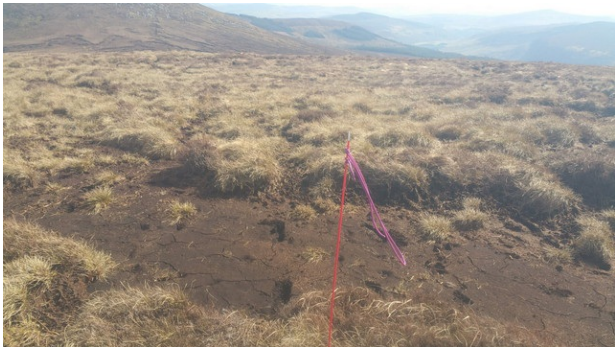
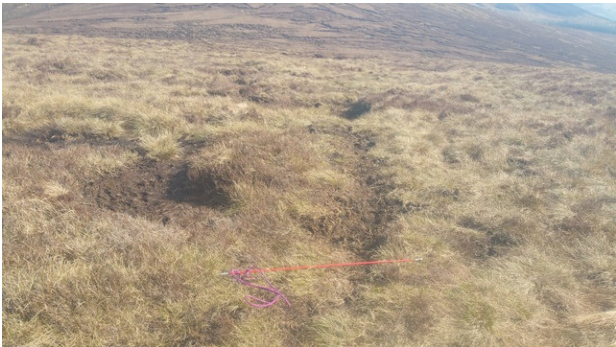
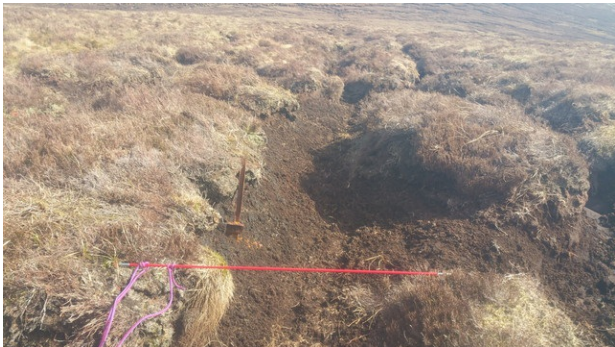
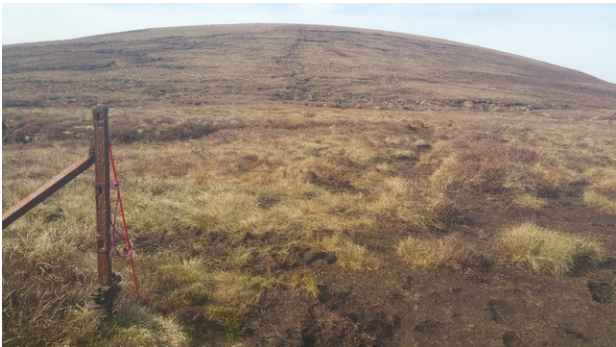
| Eroded depth (m) | 0.2 | 0.4 | 1.5 |

Site Assessment:Open slope impossible to manage access in deep peat

| none | | Block gullies as part of peatland restoration |

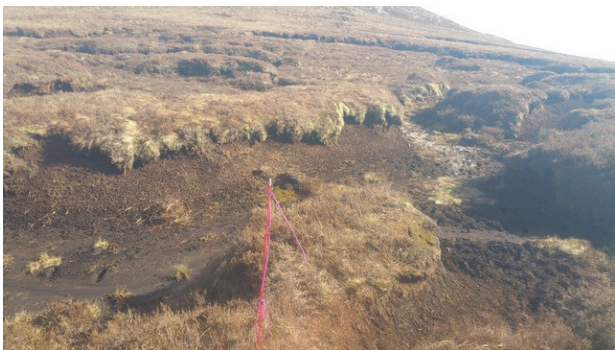
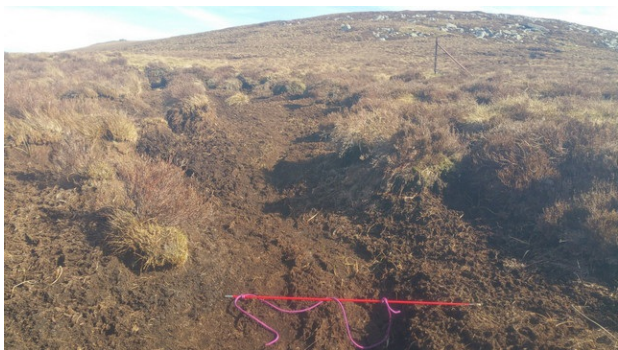
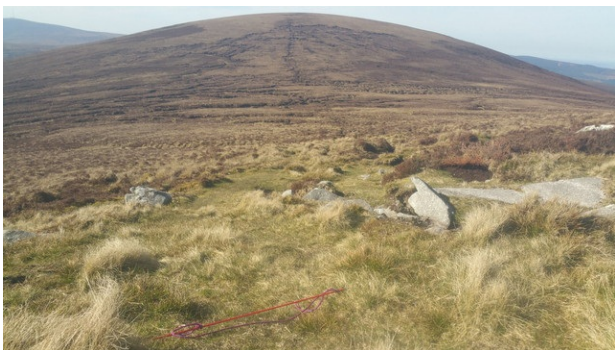
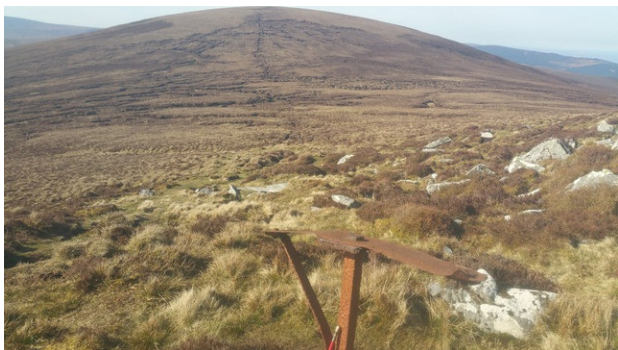
| Eroded depth (m) | 0 | 0.3 | 1.5 |

Site Assessment:Don't do path work

| none | | Peat gully restoration |

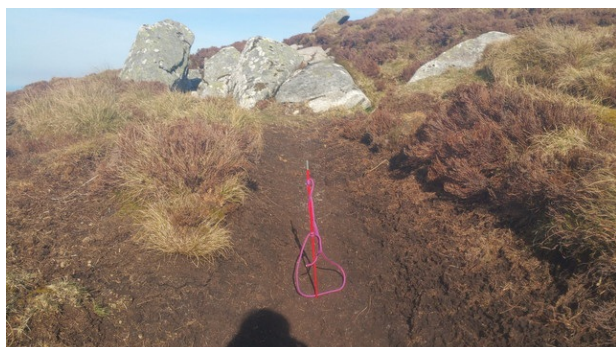
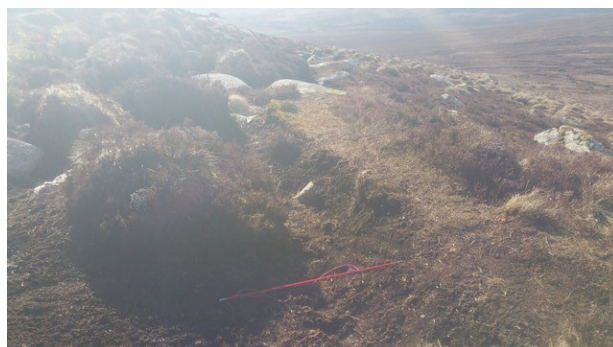
| | Minimum | Maximum | Typical |
|---|---|---|---|
| Eroded depth (m) | 0.2 | 0.4 | 0.6 |

**Site Assessment:** Hard to justify due to deep peat below

| Work type | Estimated input | Work Summary |
|---|---|---|
| none | | Landscape over? |

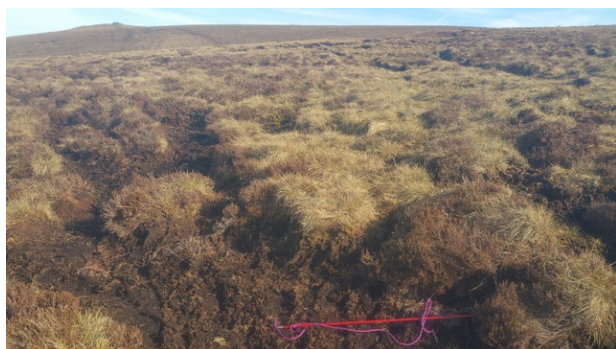
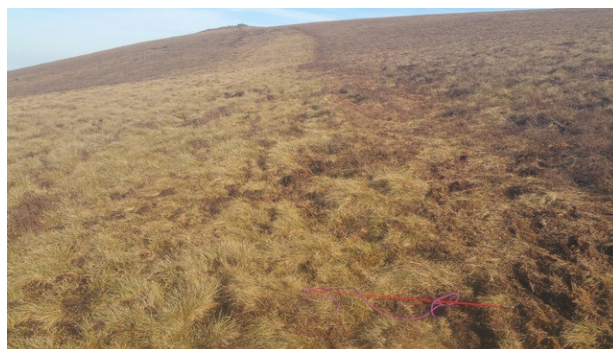
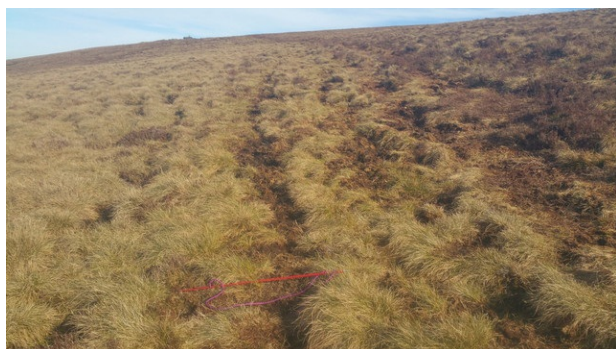
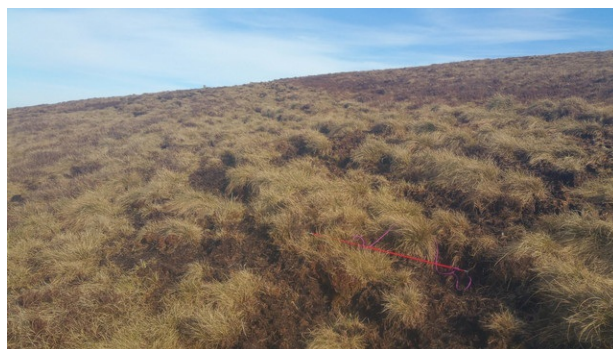
| | Minimum | Maximum | Typical |
|---|---|---|---|
| Eroded depth (m) | 0 | 0.1 | 0.2 |

**Site Assessment:** Don't do any work here

| Work type | Estimated input | Work Summary |
|---|---|---|
| none | | Don't touch |

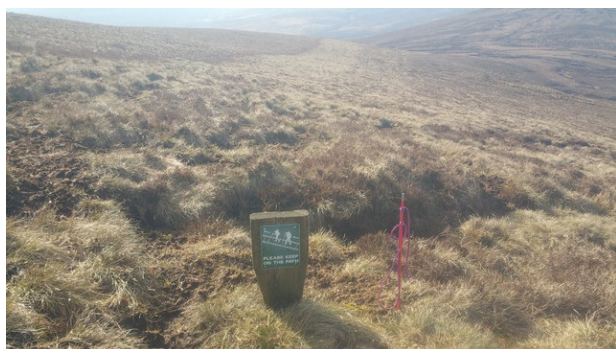
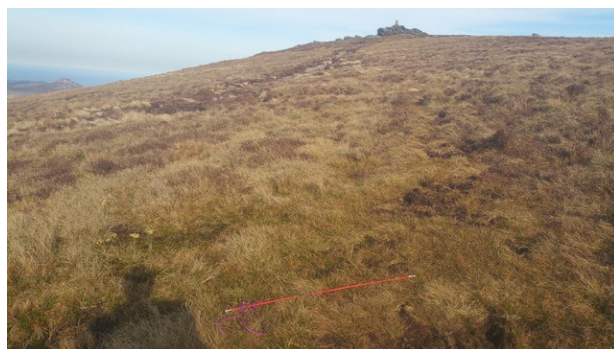
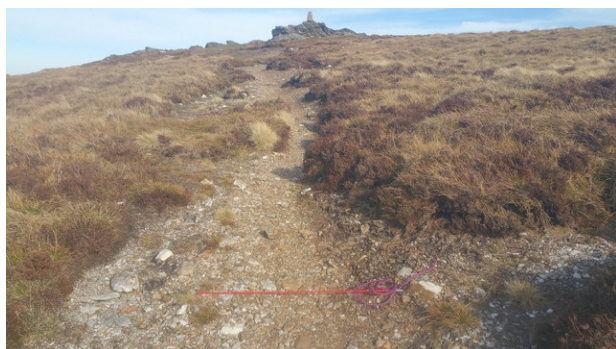
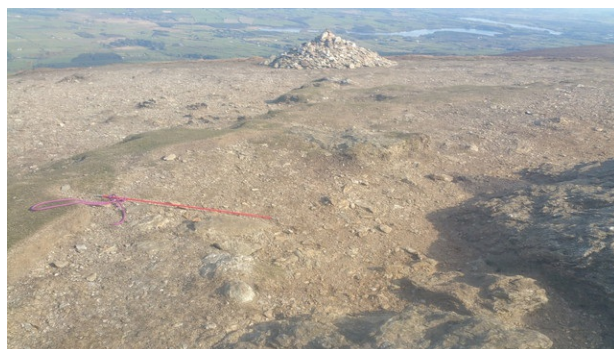
| | Minimum | Maximum | Typical |
|---|---|---|---|
| Eroded depth (m) | 0 | 0.2 | 0.3 |

**Site Assessment:** Sensitive site. Don't promote

| Work type | Estimated input | Work Summary |
|---|---|---|
| Light_touch | 10 days labour | Landscape over this route |
