Survey date: Apr 23, 2021

Overall description: Surveyed path extends from the water gates to the summit of Maulin.

Wicklow Way to Maulin (Section 2)

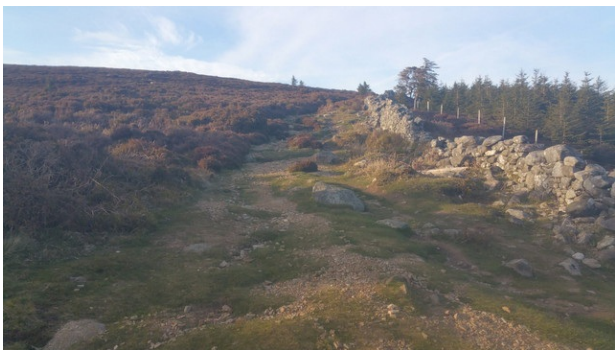
1619201652656.jpg - O 19267 12363 (± 4m)

Length (m)	Max gradient (%)	Min gradient (%)	Crossfall (%)
200	15	10	0

Substrate	Peat Depth (cm)
peat	20

Minimum	Maximum	Typical
Trampled width (m)	1	1.5	2
Bare width (m)	1	1.5	2
Eroded depth (m)	0	0.2	0.3

Availability of Materials: Limited block stone
Site Assessment:Don't take stone from the wall

Work type	Estimated input	Work Summary
minor_repair	10 days labour	Anchor bars and 3 water bars; repair eroded surface

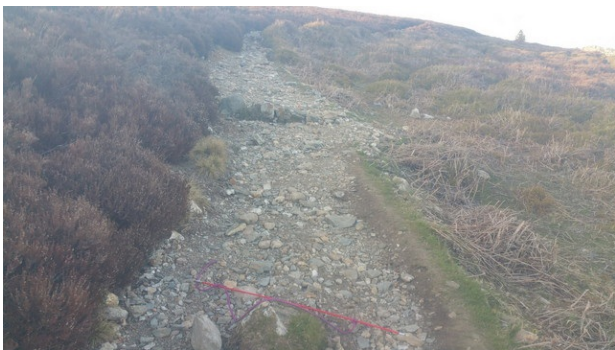
1619202278680.jpg - O 19327 12571 (± 4m)

Length (m)	Max gradient (%)	Min gradient (%)	Crossfall (%)
128	8	5	0

Substrate	Peat Depth (cm)
peat	20

Minimum	Maximum	Typical
Trampled width (m)	0.8	1.5	2
Bare width (m)	1	1.5	1.8
Eroded depth (m)	0	0.1	0.4

Work type	Estimated input	Work Summary
minor_repair	4 days labour	Repair 5m plus cross drain (by p2)

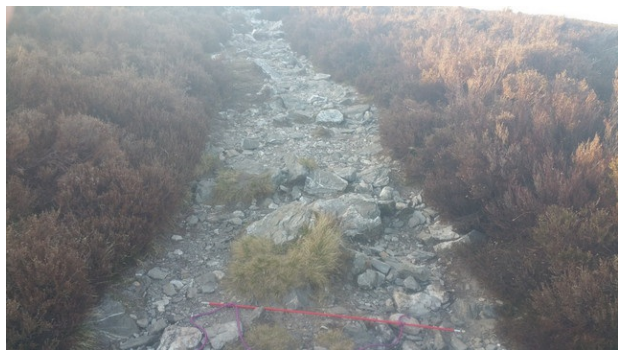
1619202768466.jpg - O 19365 12687 (± 5m)

Length (m)	Max gradient (%)	Min gradient (%)	Crossfall (%)
499	7	0	0

Substrate	Peat Depth (cm)
peat	30

Minimum	Maximum	Typical
Trampled width (m)	1.5	2	6
Bare width (m)	1	1.2	4
Eroded depth (m)	0	0.3	0.3

Work type	Estimated input	Work Summary
early_intervention	8 days labour	Close braids; 5 water bars

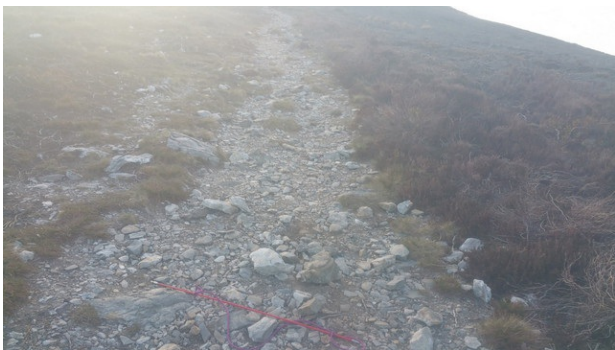
1619203750346.jpg - O 18912 12864 (± 4m)

Length (m)	Max gradient (%)	Min gradient (%)	Crossfall (%)
547	30	15	0

Substrate	Peat Depth (cm)
peat	40

Minimum	Maximum	Typical
Trampled width (m)	3	3.5	7
Bare width (m)	1	2	3.5
Eroded depth (m)	0	0.2	0.3

Availability of Materials: Block stone not big enough

Site Assessment: Might survive for a while

Work type	Estimated input	Work Summary
major_repair	120 days labour	Drainage needs installing as minimum but would benefit from full rebuild
