Corrasillagh Commonage

2021 Ecological Survey

Final Report

2nd October 2021

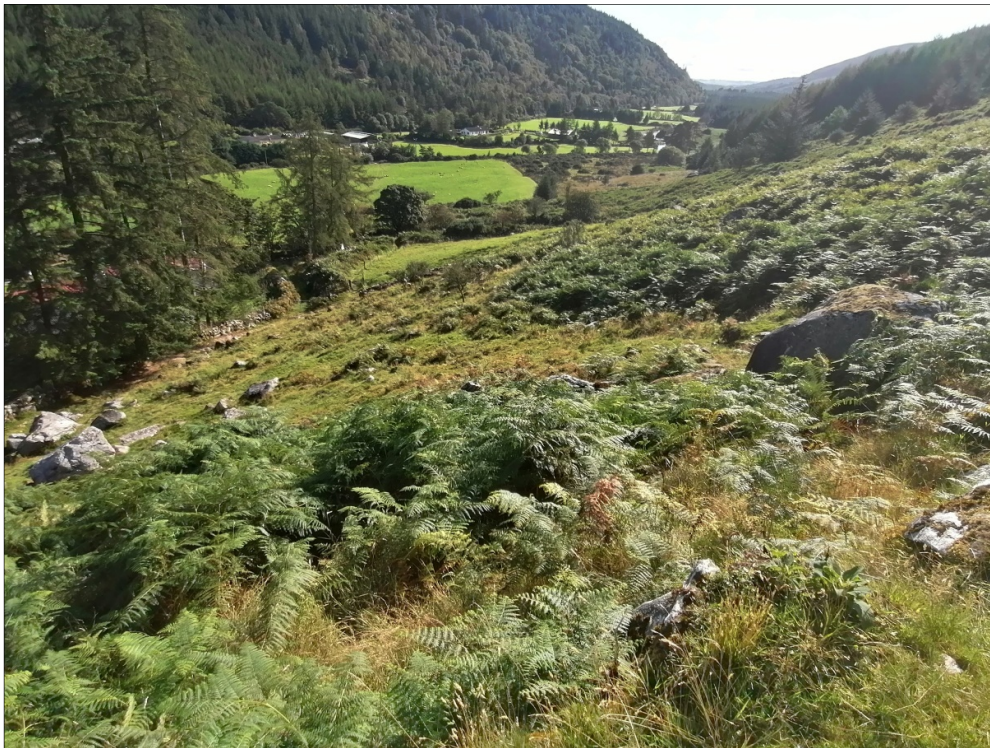
There has been quite a lot of regrowth of bracken that was sprayed previously, so bracken growth seems particularly strong this year. In some areas on the returns on the track there has been a very good kill rate. The cattle are also accessing these areas, which is helping to open them up. The areas where the odd bit of buckler fern had been sprayed have recovered very well. Cattle are definitely moving through some of the bracken areas and opening them up.

Plate 1. Bracken treatment on slopes above the track as you enter the hill.

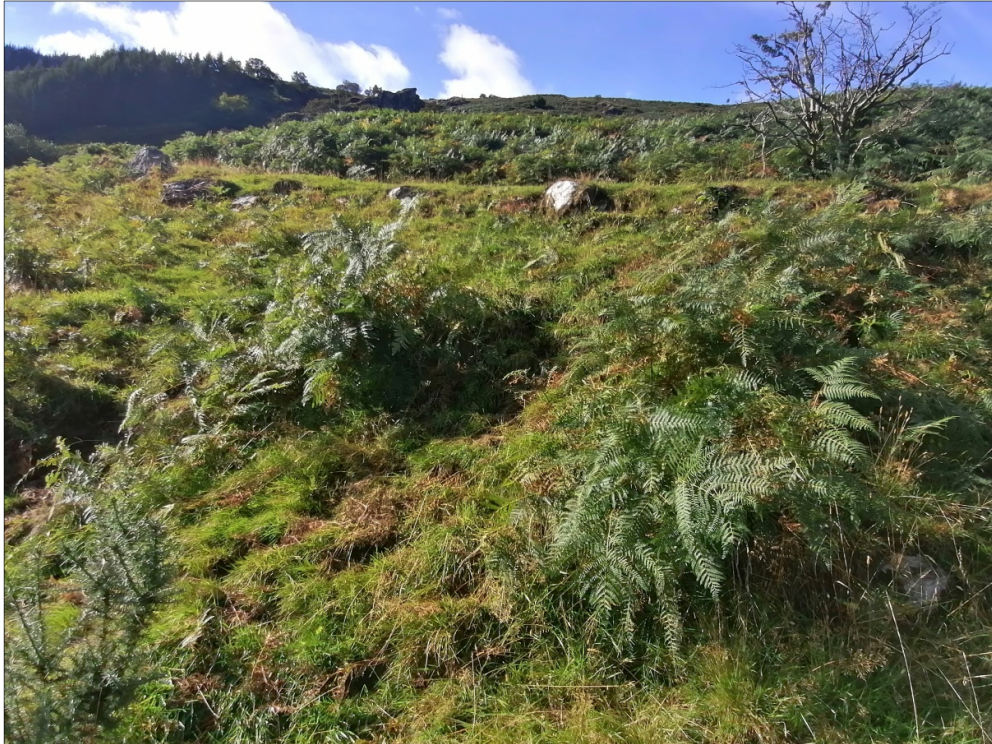
Plate 2. Bracken treatment adjoining the zig zags track.

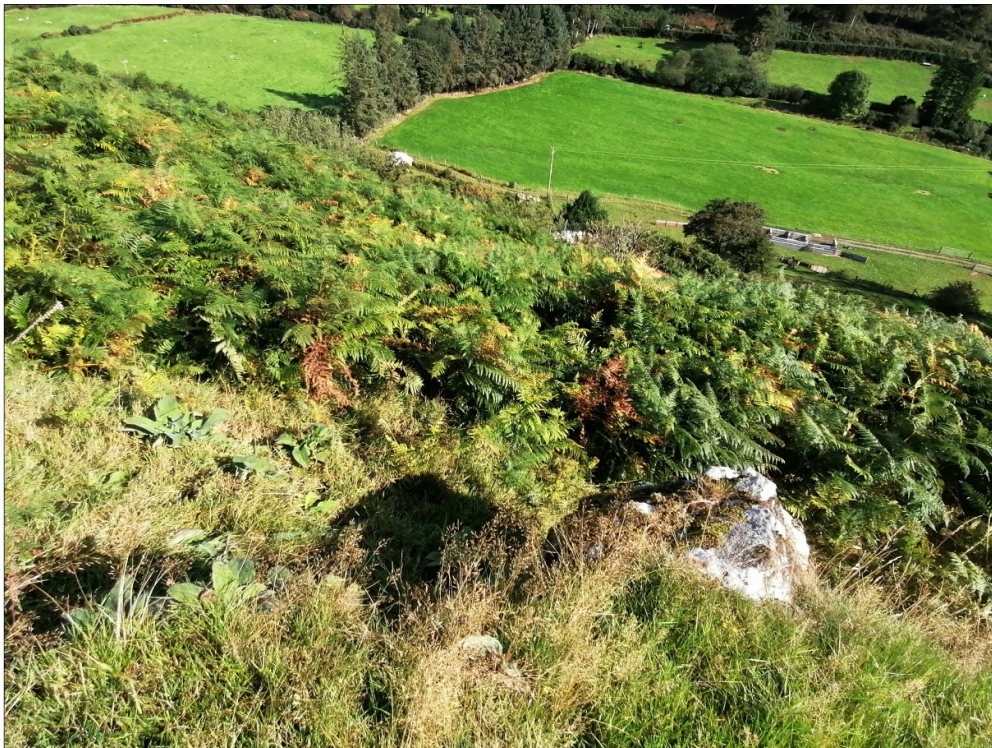
Plate 3. Regrowth adjoining the track has been very strong.

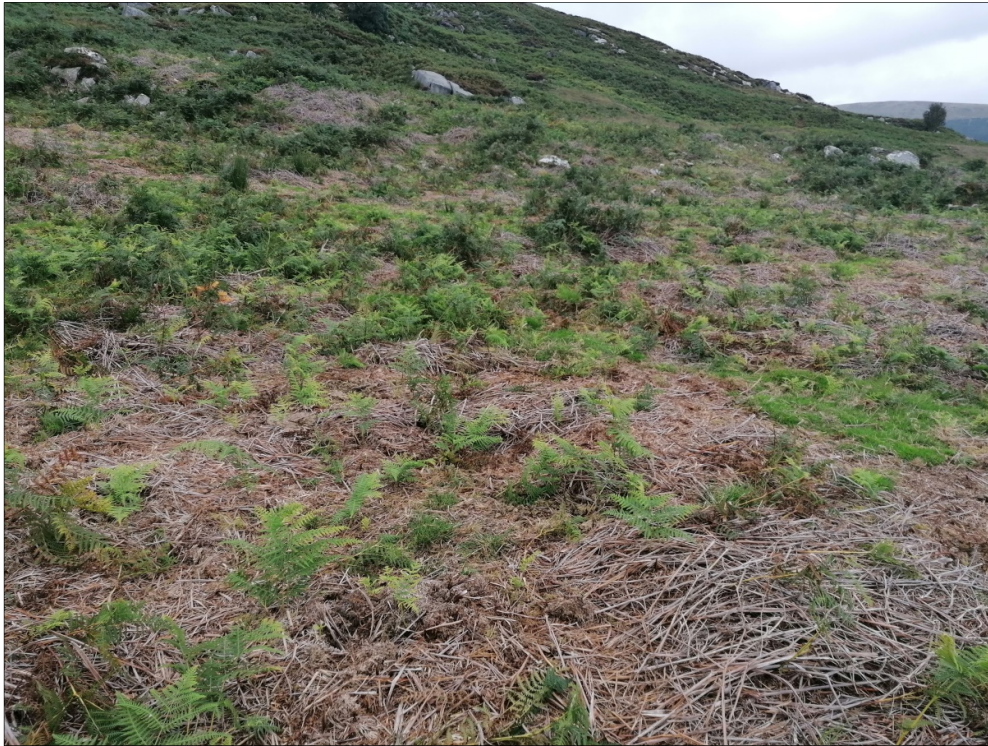
Bracken treatment under the little knoll of Cloghernagh where the bracken is very dense and below the bracken is heavy leaf litter. The bracken here had just been re-sprayed. There is some grass regrowth but still an awful lot of leaf litter. The cattle have been in here which is interesting. It would

Plate 4. Bracken treatment under Carrignagreine.

be interesting to try and keep the cattle in an area and try to assess their trampling impacts as opposed to having both spraying and cattle, if possible.

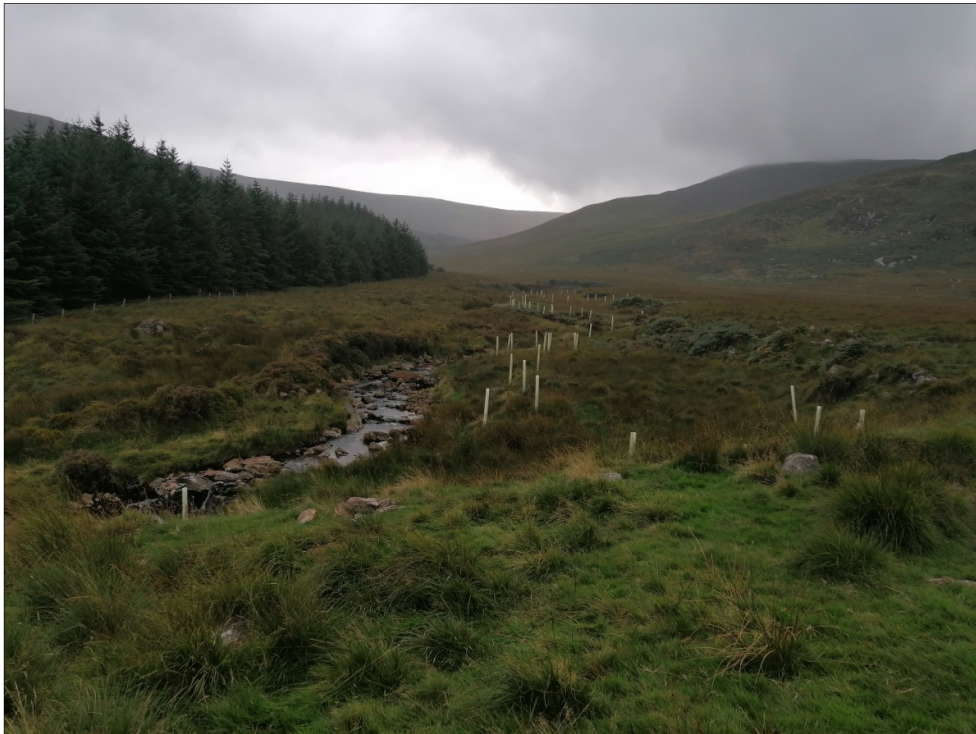
Plate 5. Restoration of native woodland habitat along the watercourses began in 2021.

Along the watercourse where the tree planting has gone in, they are in general very well sited and well placed. Most of them seem to be doing ok. A few shelters have come off, just bent away from the posts so they need another cable tie around them.

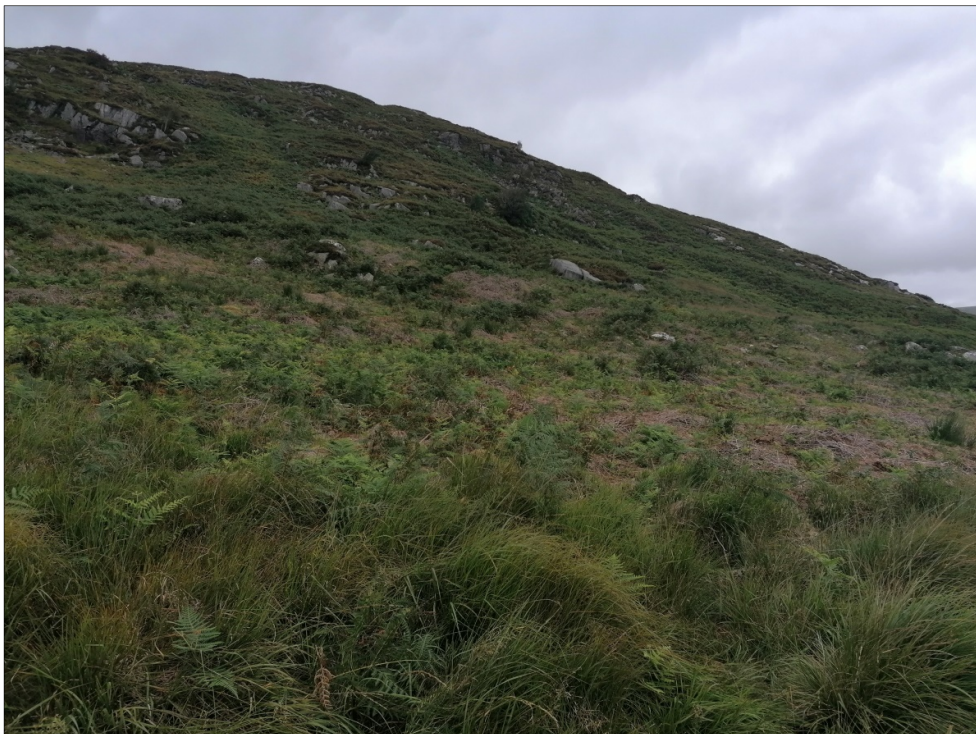
Plate 6. It is recommended that a copse of native woodland is established adjoining the existing trees at Carrignagreine.

It is recommended that a copse of native woodland is established in Area 11 below Carrignagreine.

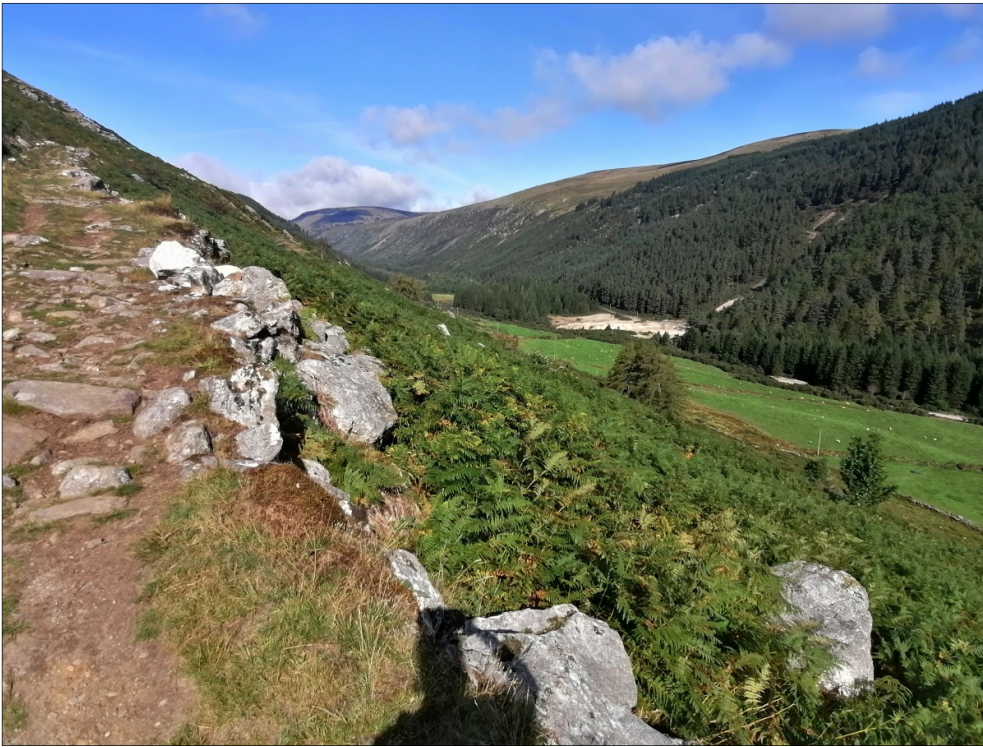
Plate 7. Some enhancement planting or the erection of exclosures is recommended around existing native trees in Area 2.

Small areas of native woodland could also be established in Area 2 in areas of outcropping rock/scree where bracken treatment will be difficult to implement. This could be done through the use of fencing/exclosures (covering several square meters) erected around existing isolated trees to allow natural regeneration to occur or through direct planting.

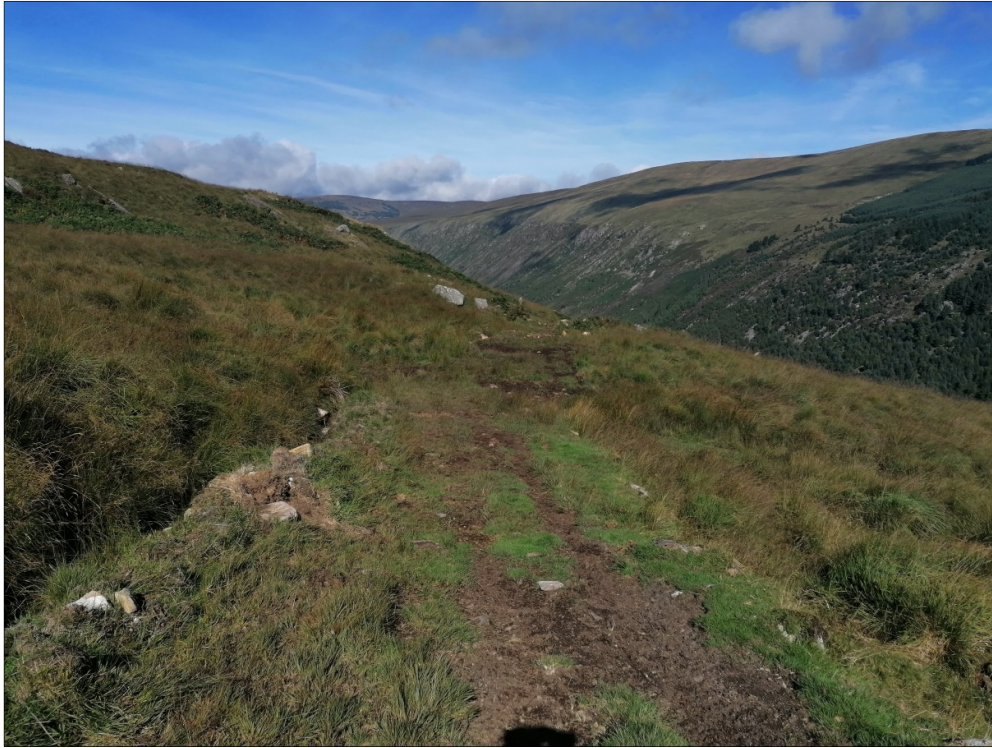
The quad is doing a bit of damage up on the top slope where it is in the purple moor-grass flushed area. There is a lot of bare peat and some tracks are starting to form, so we need to think about doing some track repairs here to make this a sustainable route for the quad.

Obviously, the majority of the zig zags are fine at this point but between the cattle moving up here, but primarily the quad, we're starting to have a lot of bare peat, so it needs to be tackled sooner rather than later.

Plate 8. Repairs are required on the upper section of the zig zags used by the quad.

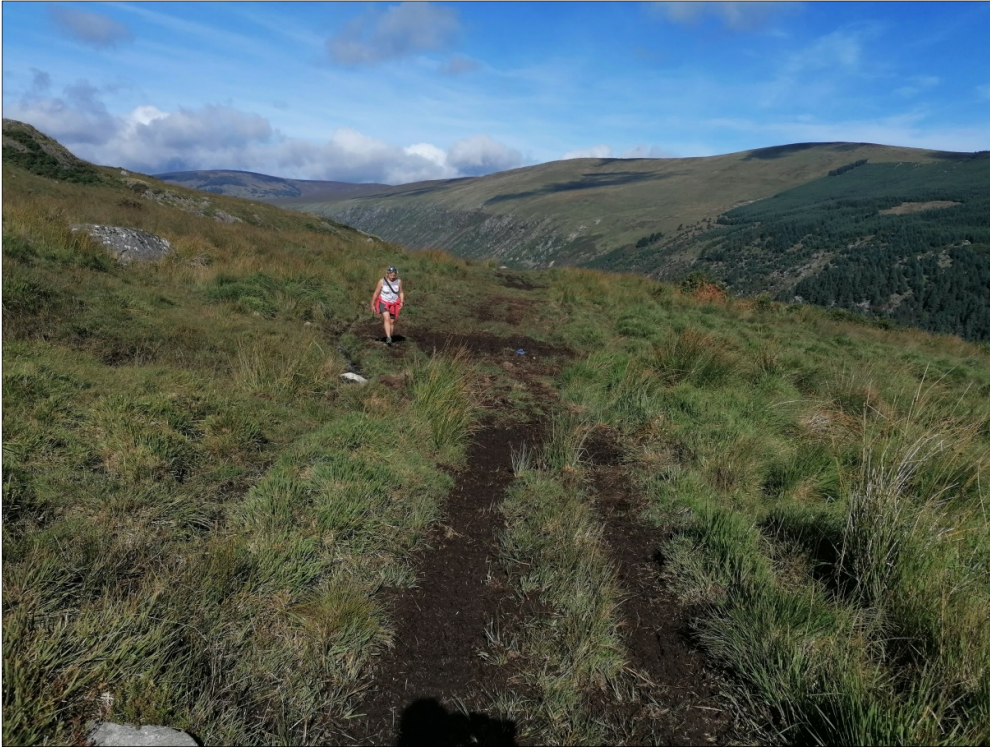
Plate 9. Repairs are required here.

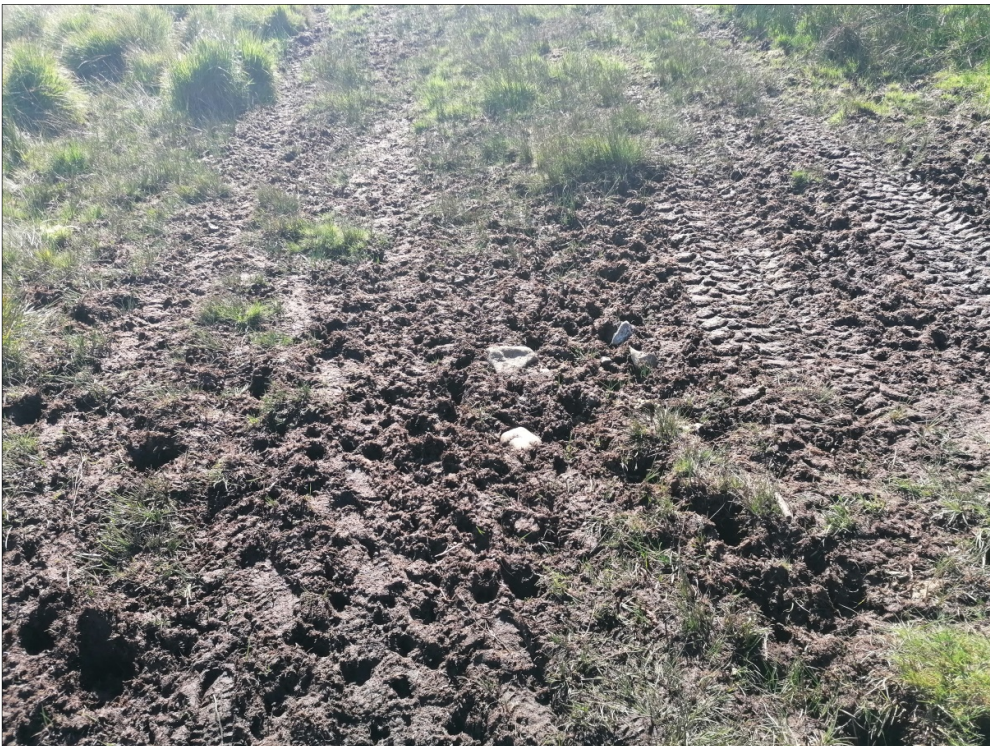
Plate 10. Heavy poaching and eroding peat on the quad route.

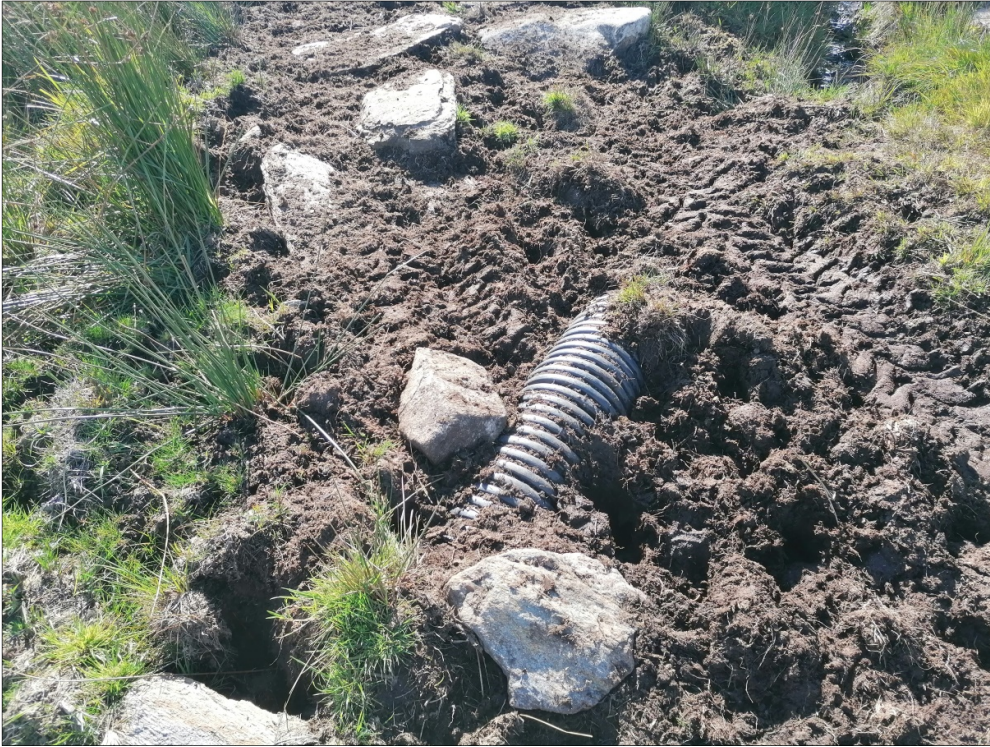
Plate 11. Additional repairs required here.

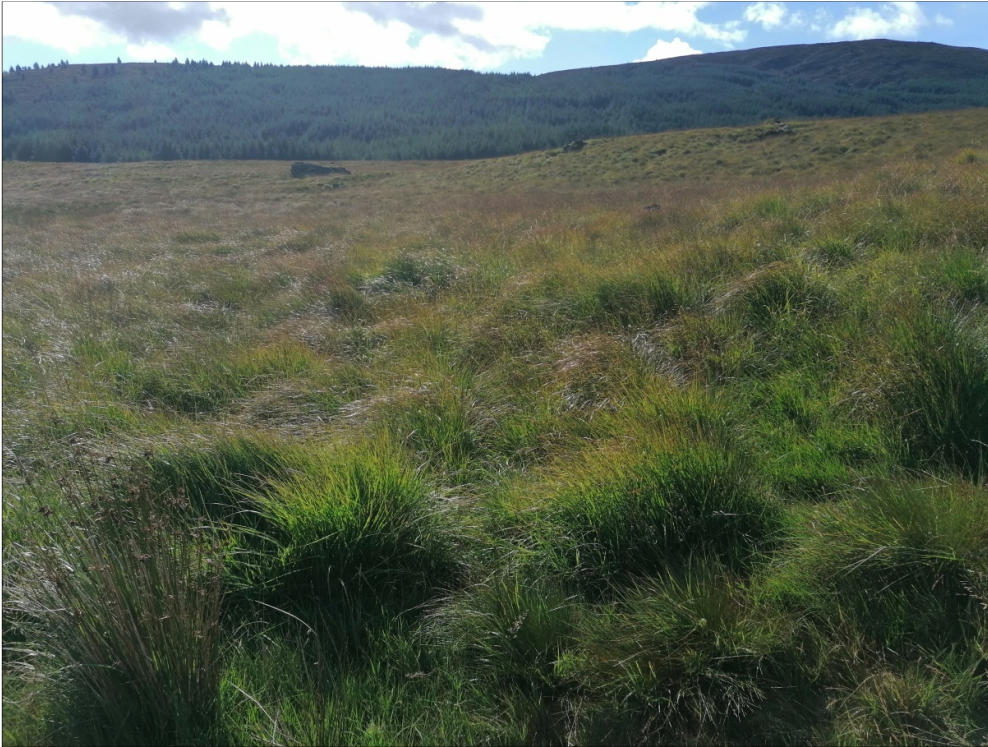
Plate 12. Dense tussocks of *Molinia* in Area 3.

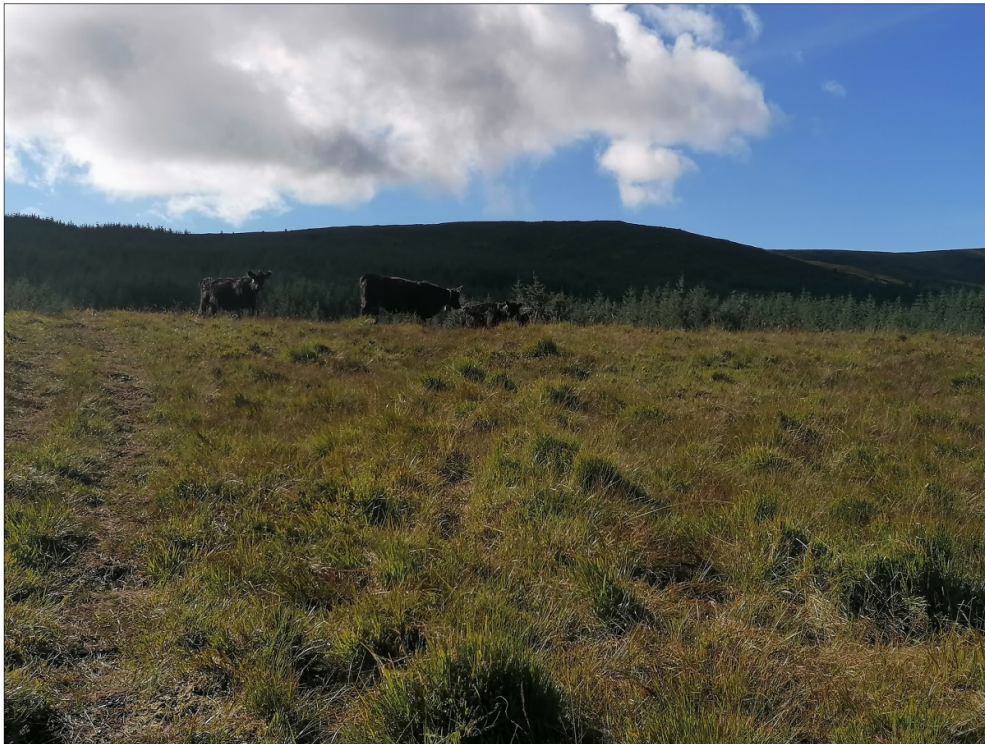
Plate 13. Purple moor grass being favoured by the Belted Galloways on the hill.

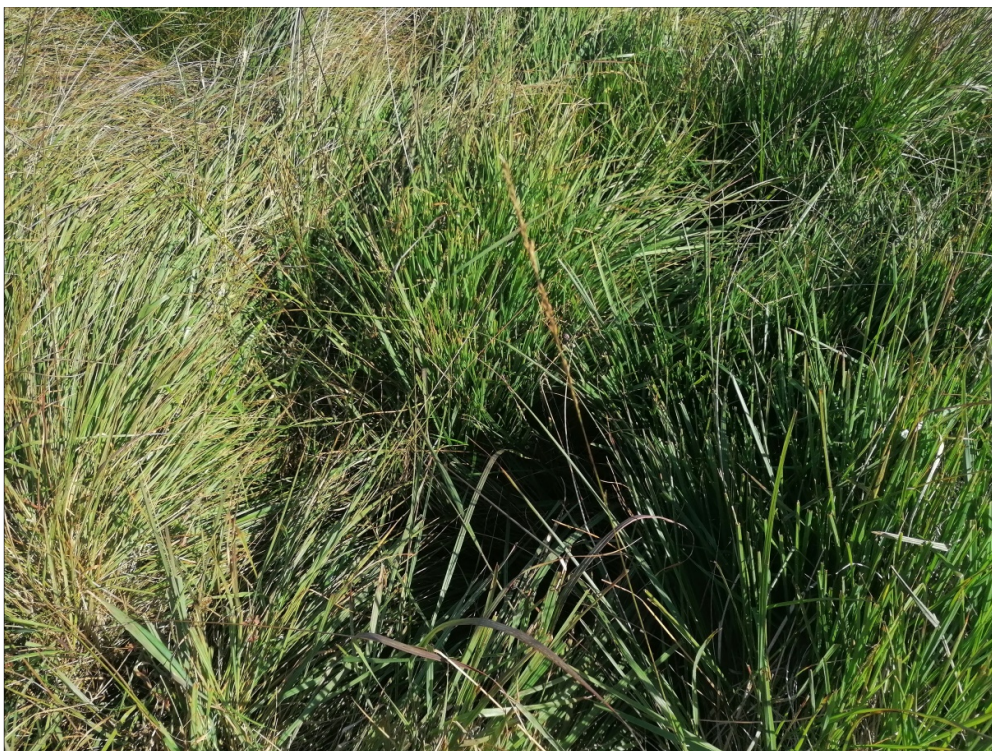
Plate 14. Dense areas of *Molinia* starting to be grazed by the Galloways.

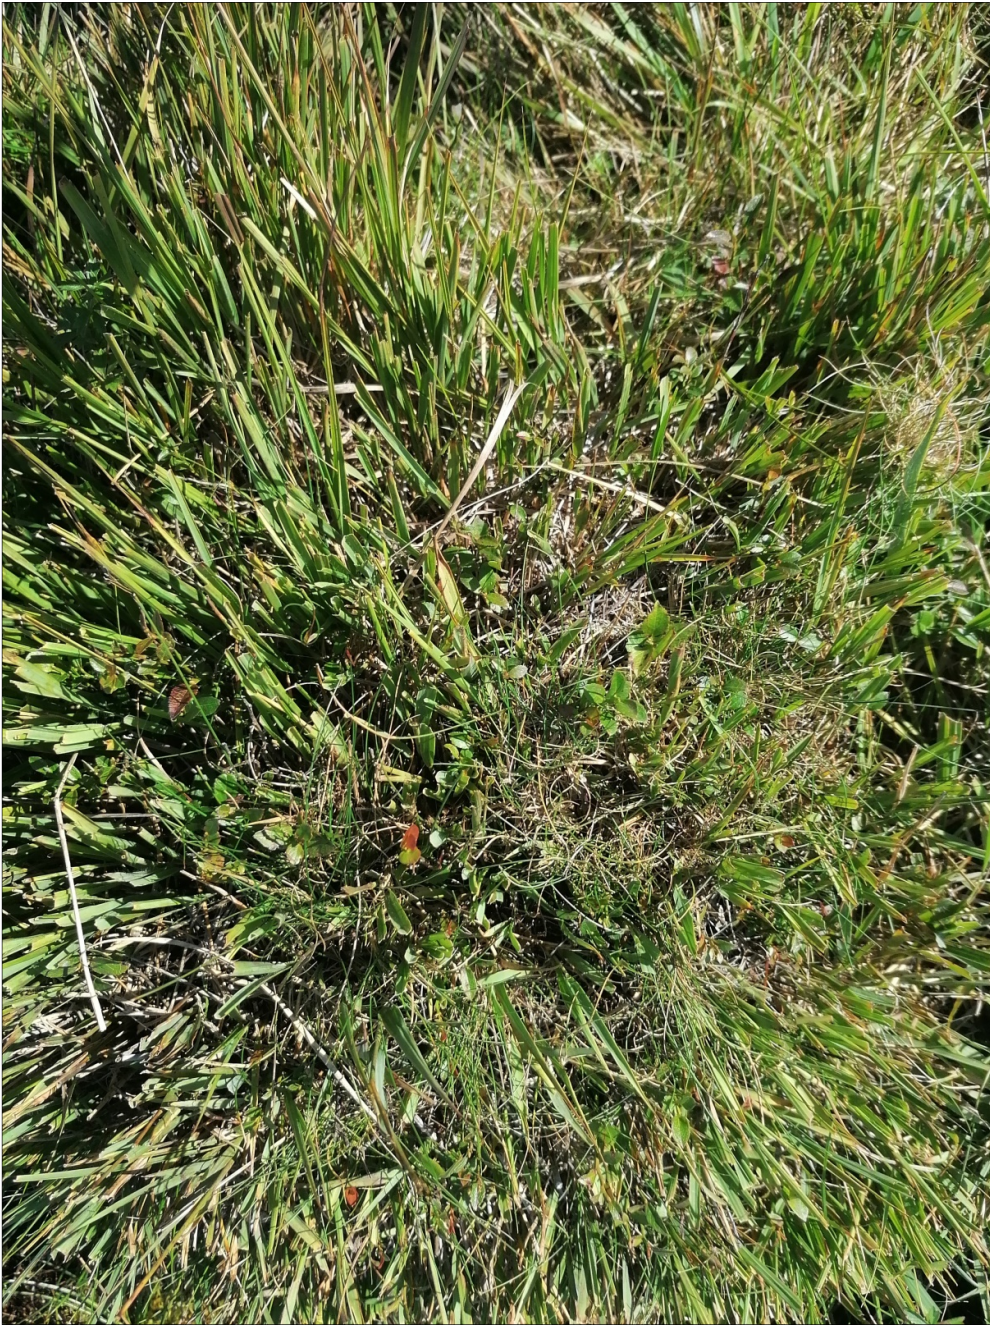
Plate 15. Bilberry regeneration on grazed *Molinia* tussocks.

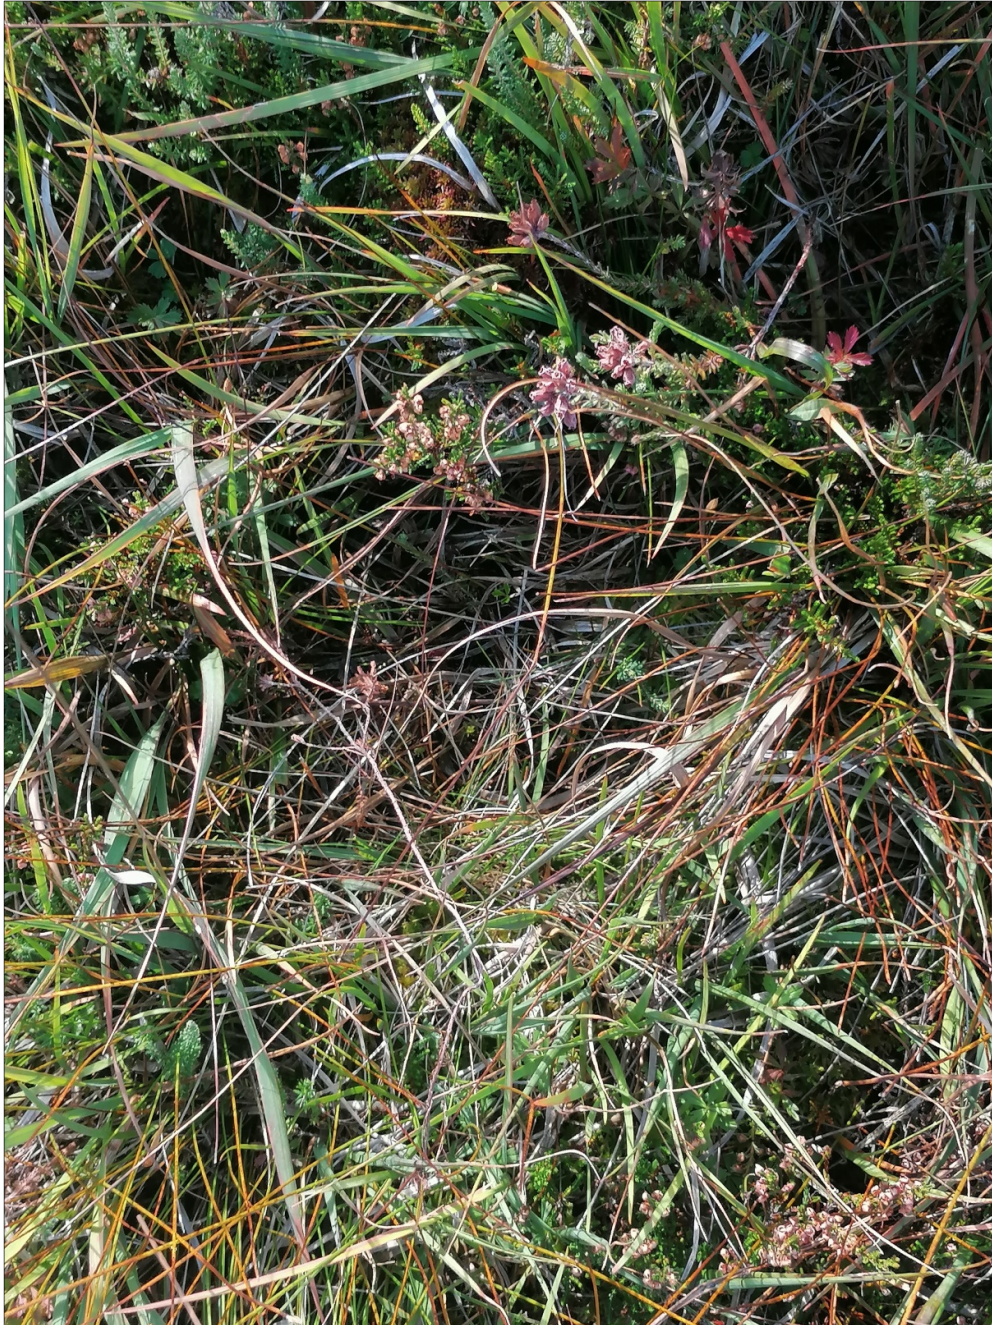
Plate 16. Regeneration of cross leaved heath, deer grass, tormentil and ling in browsed *Molinia* tussocks.

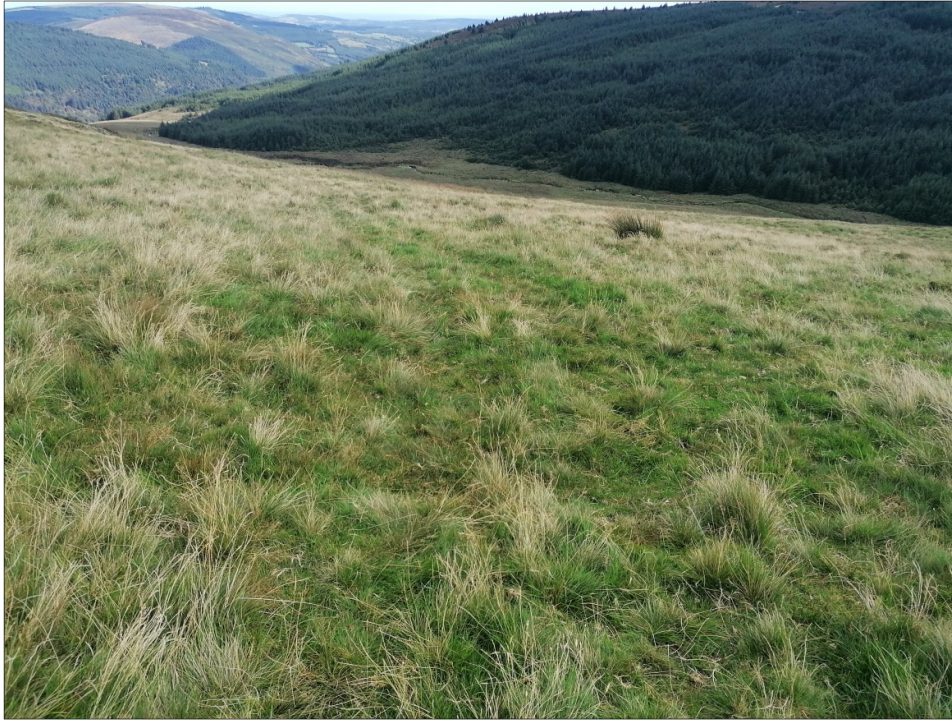
Plate 17. Trial grazing of cattle in areas where mat grass is frequent would be beneficial to assess their impact on same.

Trial grazing of the cattle in Area 20 and 25 might be worth investigating to see what impact they have on the mat grass there.

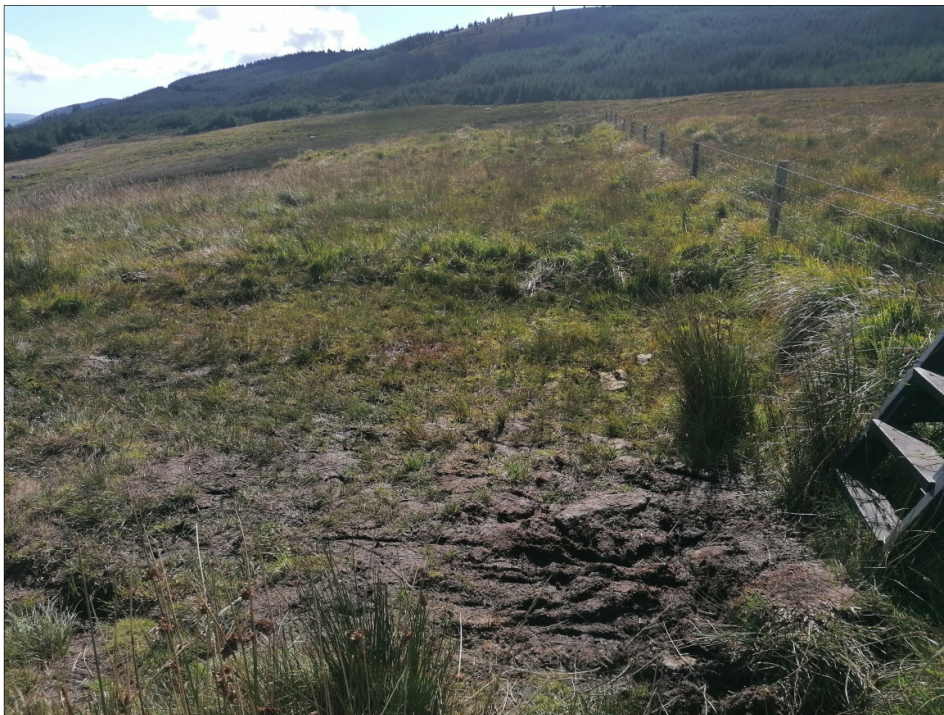
The walking track up Corrasillagh to Leohard is in need of urgent repair works. This track was assessed by Chris York as part of a wider walking track condition survey conducted in 2021 and his recommendations for this part of the main access route to Lugnaquilla need to be implemented.

Plate 18. Trampling pressure on deeper peats at the stile on the walking track from the zig zags.

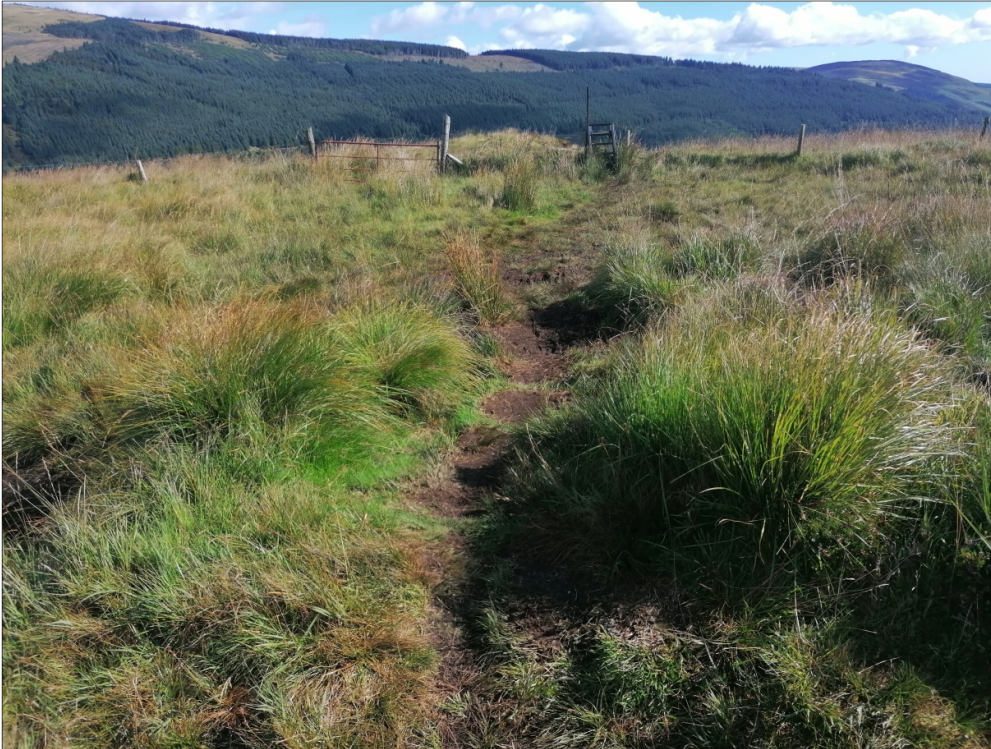
Plate 19. Trampling pressure on the deeper peats above the stile.

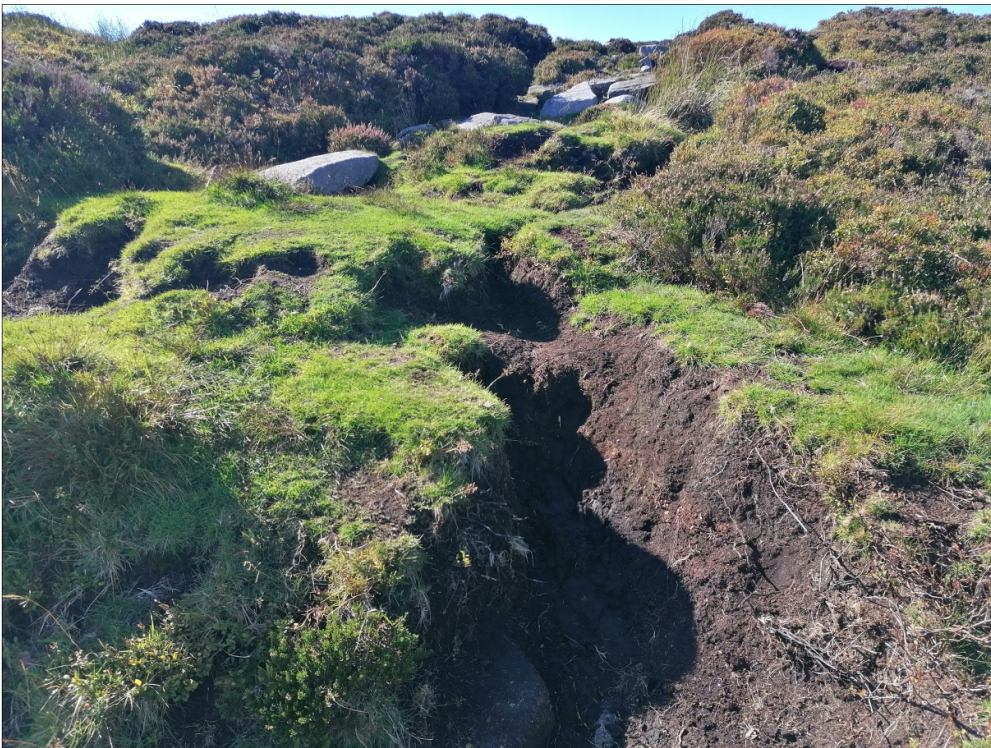
Plate 20. Eroding peat on the walking track.

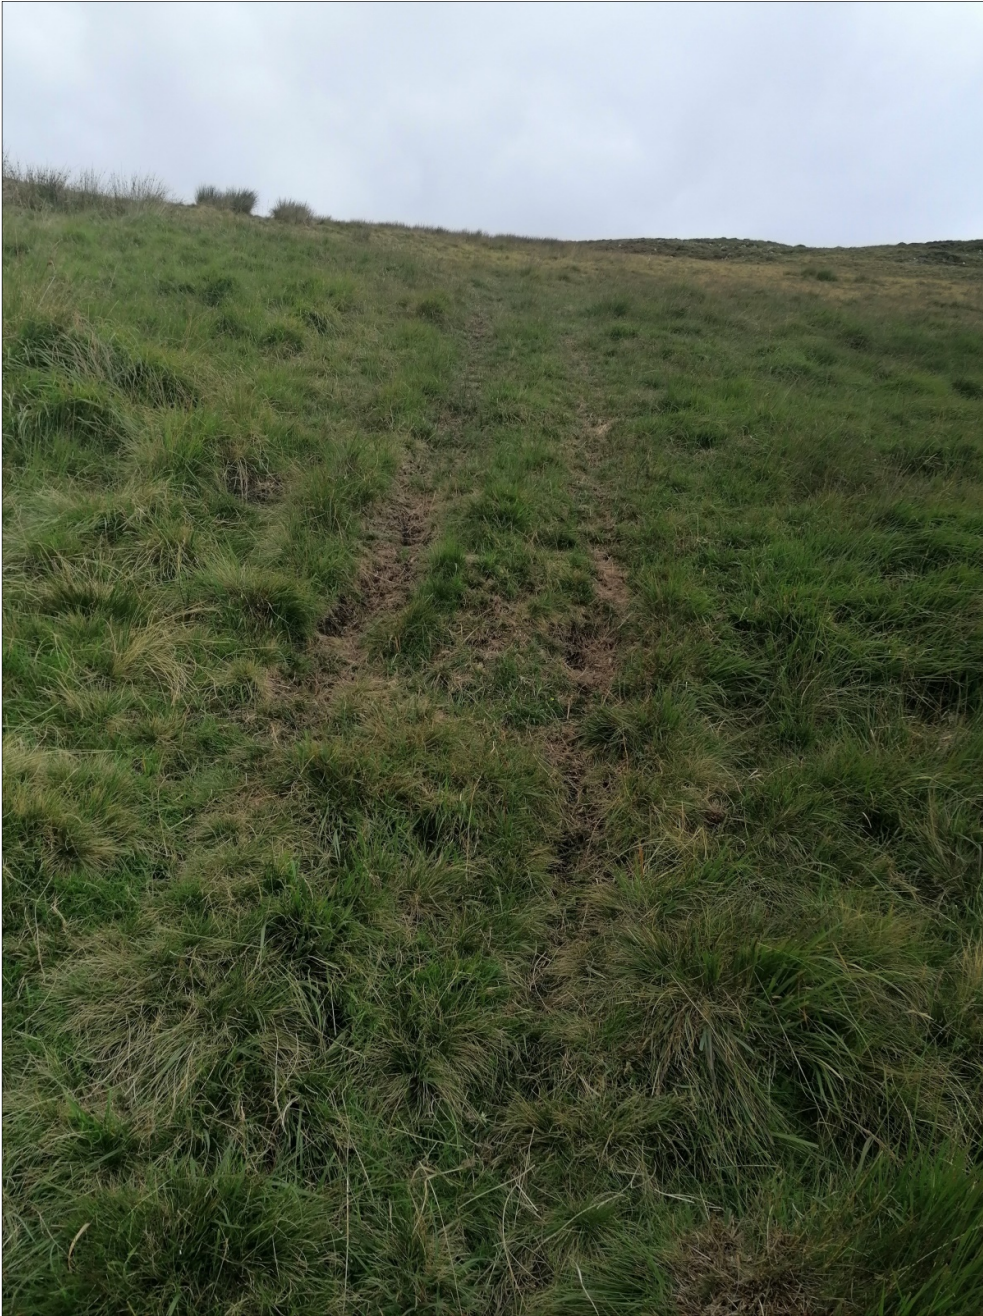
Plate 21. Quad on the hill beginning to cause damage.

The quad seems to be doing a bit of damage coming up and down the open mountain side; a lot of the peat seems very disturbed underneath and it feels like it is possibly the water is coming in underneath the peat layer. I would be a bit nervous about what that is doing and there is a risk of a slippage. The ground is very torn up; I am not sure if that is from the cattle or previous quad damage and ground has settled back or what.
