Glassavullaun Commonage

2021 Ecological Survey

Final Report

1st October 2021

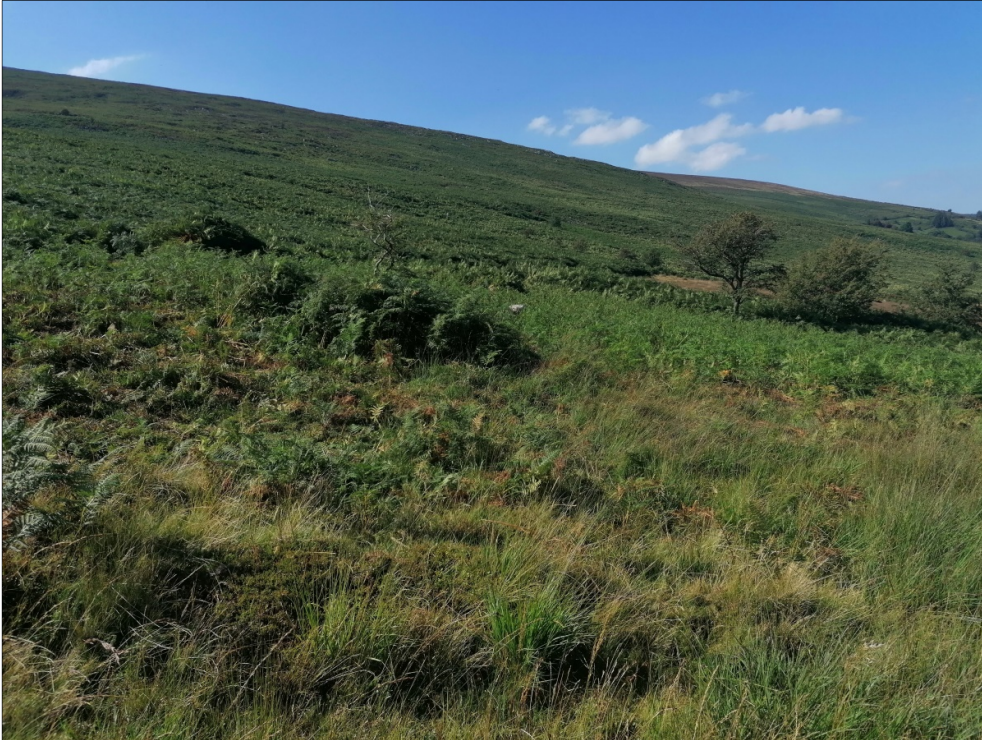
Plate 1. Bracken regrowth following bracken bruising in 2020 in Area 27.

The bracken control measures implemented in 2020 were probably implemented a little late but the bracken does appear to have been knocked back quite successfully in Area 27 with the regrowth of bracken showing half the vigour of areas which were not rolled with the bracken bruiser.

The bracken is much reduced in the larger area that was treated in 2020 – it's only about 90cm high whereas on the other side of the small area of purple moor grass and heather the bracken in some places is almost 1.8m high. So, although we still have bracken it is a lot smaller and a lot reduced. Thus, the work seems to have been successful.

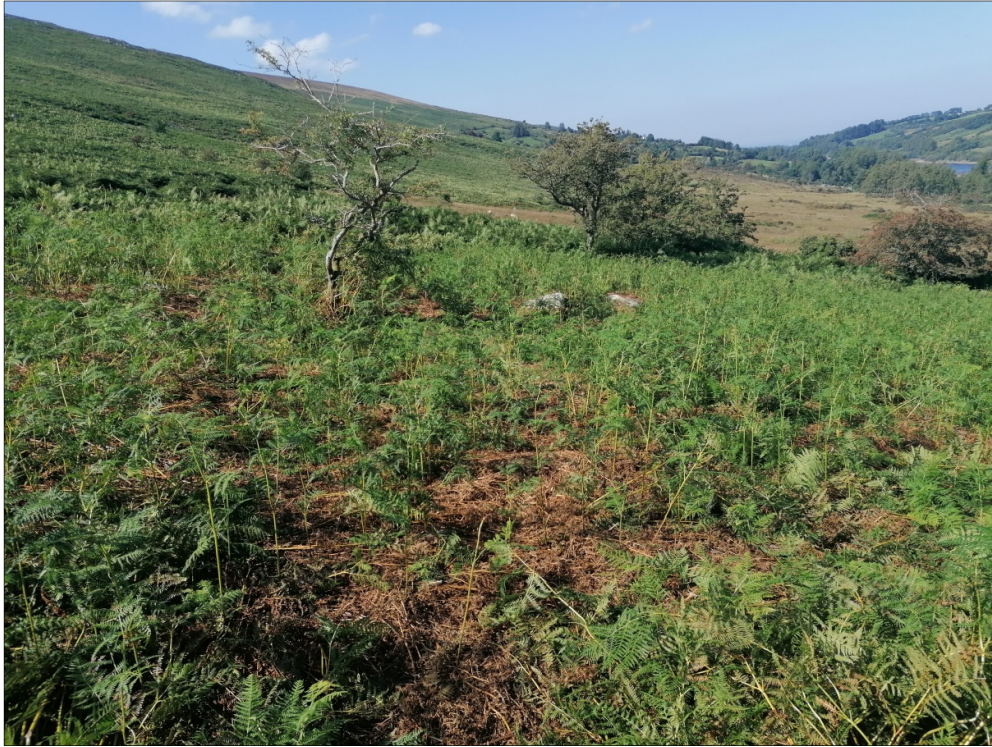
Plate 2. Bracken control in Area 27.

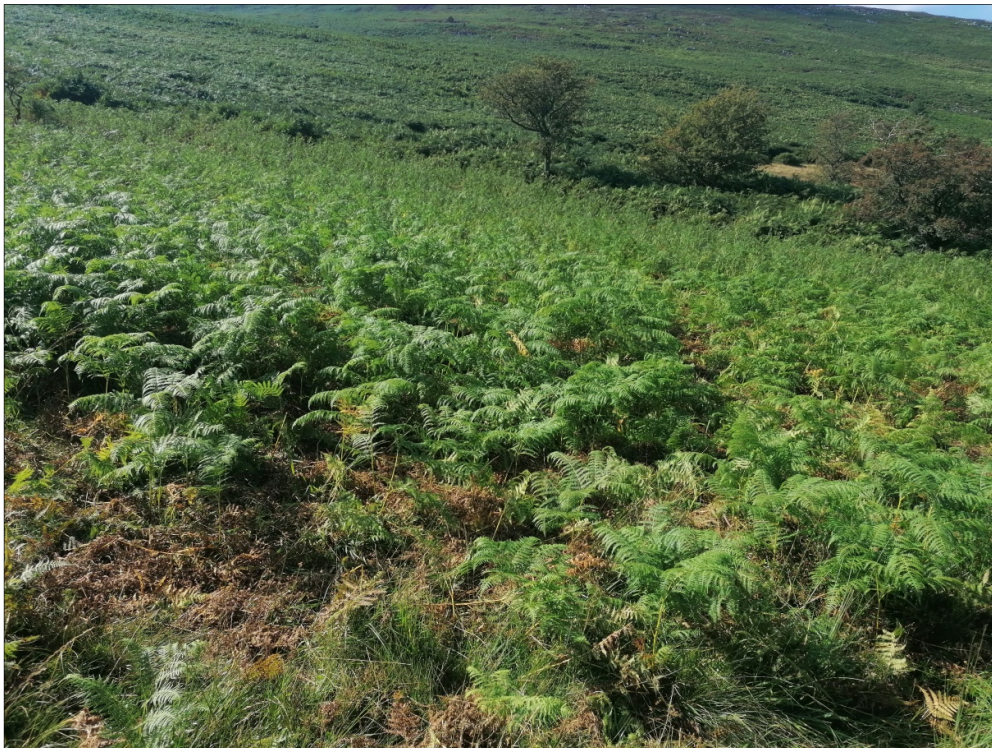
Plate 3. Bracken control in the eastern part of Area 27.

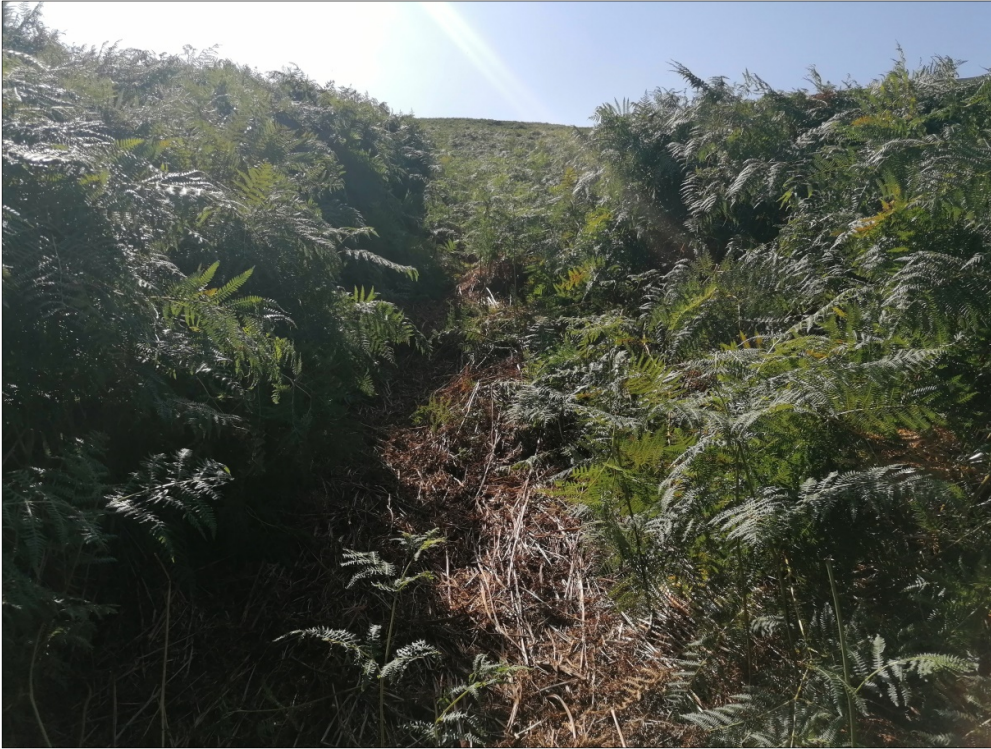
Plate 4. Access track downslope into the eastern part of Area 27.

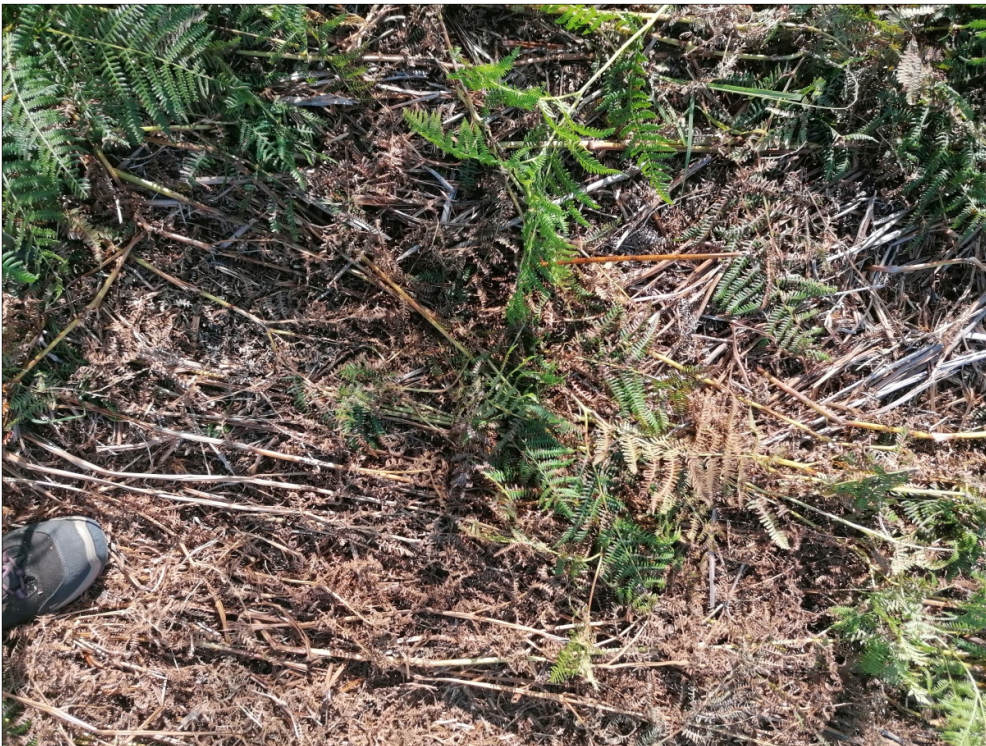
Coming up underneath the bracken that was bruised last year we can still see a lot of dead bracken stems and material from the bruising but underneath that there is some bilberry regeneration plus tormentil and heath bedstraw. There is also glaucous sedge and some grasses. In some parts there is quite deep leaf litter because the bracken was so dense before, so that will take a while to regenerate yet but it is successful in comparison to it being unbruised.

Plate 5. Dense litter below bracken in the eastern part of Area 27.

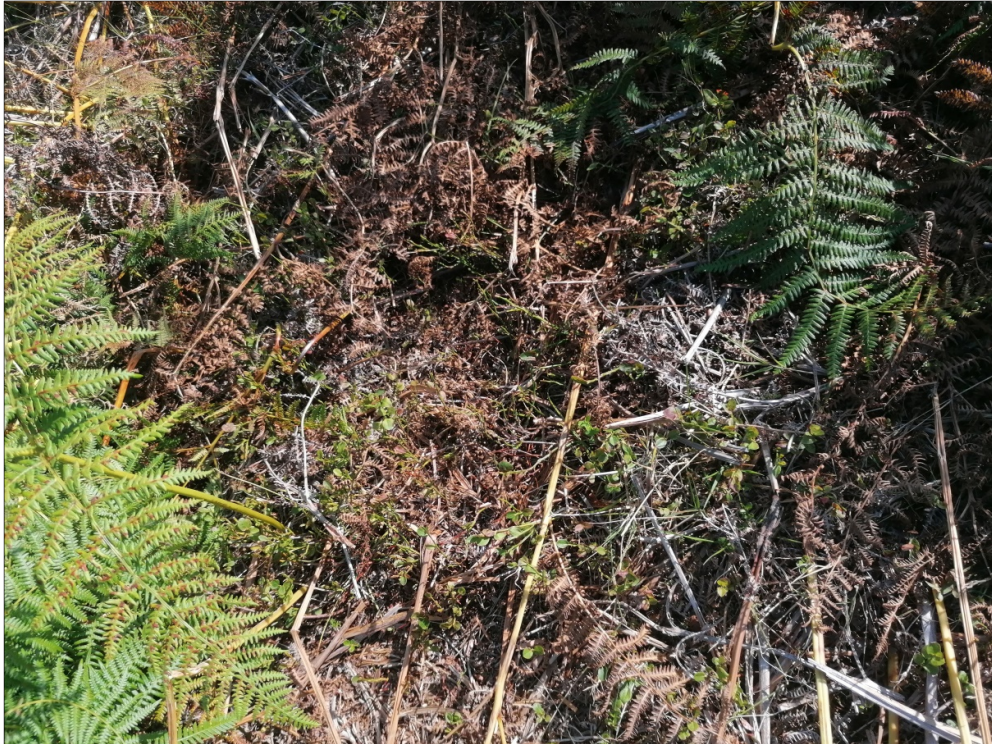
Plate 6. Regeneration of bilberry under treated bracken.

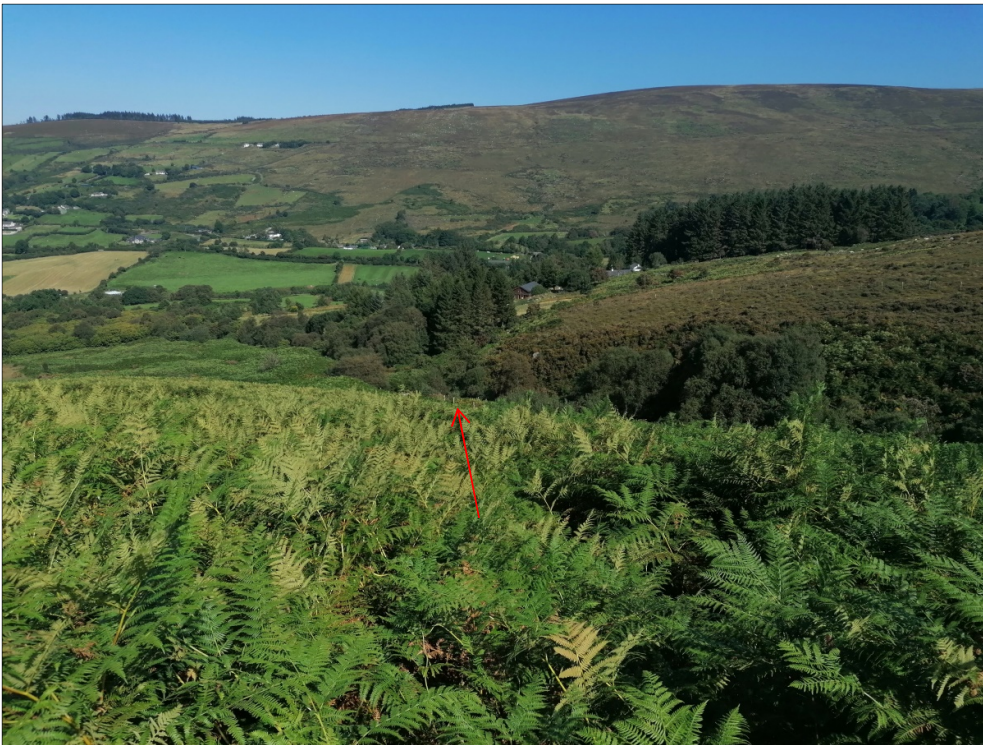
Plate 7. Looking down over areas of untreated bracken to the new planting along the Slade Brook linking up mature gully woodland habitat.

The ongoing planting of trees to link up areas of mature stands of gully woodland, and to expand and connect these to remnant areas with additional planting and tree establishment measures should continue.

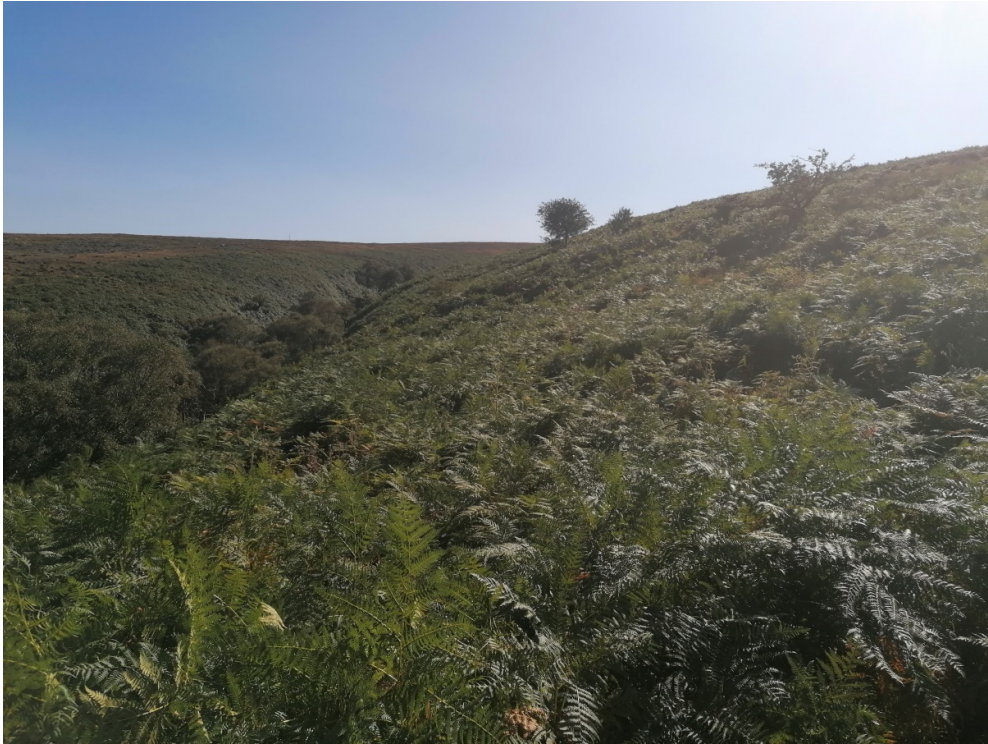
Plate 8. Fencing around trees such as these above the gully will allow us to see if natural regeneration from this seed source can become established in the absence of grazing pressure.

Ground around scattered trees and shrubs on the rocky slopes in Area 20 and 29 will be fenced in 2021 to see if natural regeneration from this seed source can become established in the absence of grazing pressure.

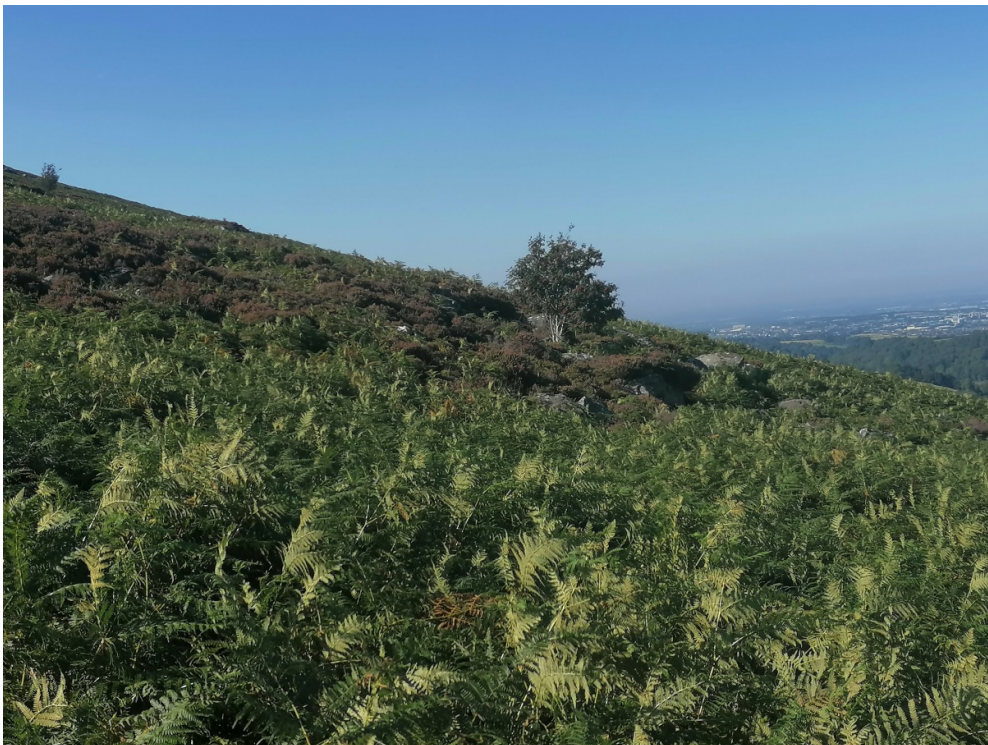
Plate 9. A lone mountain ash surrounded by dry heath and rocks. This would be a great place to put an exclosure. There are a whole load of lovely berries ready to fall and spread so we could see some of these measures on the less profitable bits of the hill.

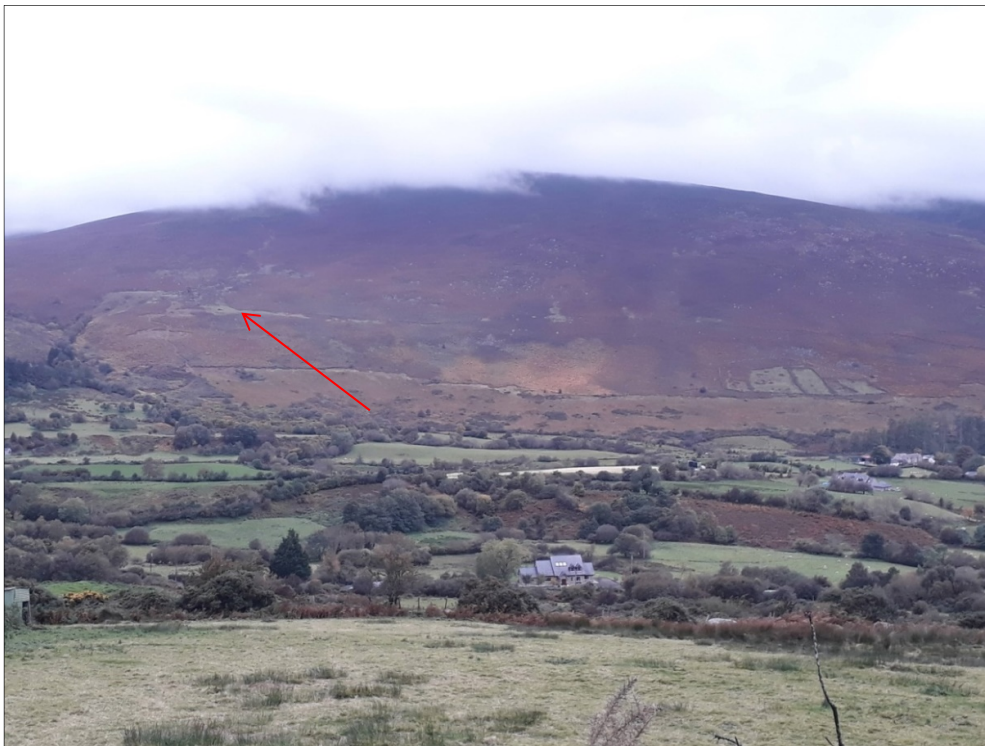
An additional track was created running east from this – possibly to provide access for the quad and bracken bruiser to the eastern portion of Area 27. There was removal of stones and other material here with a machine, significant rutting of ground by a machine and general disturbance of vegetation including areas of wet heath all of which provide a pathway for water to erode the underlying peat. This was further exacerbated by the route chosen, which is directly downslope as opposed to contouring across the hill in a gentle zig zag, travelling on drier ground and avoiding Annex I habitats. **These works still require remediation and considered design repairs.** This new track is visible from the public roads coming down from the Featherbeds into the Bohernabreena Valley.

When examined in 2021 the eroded track has been eroding more. There are some very bare areas, and there is a lot of congregation of animals using it. There are a lot of sheep droppings. So, this is what happens when you start something, you create another problem. Probably the fact that the quad is then continuing to use it to access doesn't give it much of a chance to recover either.

Plate 10. The new track created running directly downslope in Area 27 and the cleared areas of bracken can be seen – repair works are needed here.

I think we need to put in water bars or something like that to try and direct the water off it. There was a lot of movement of rocks and stones off this ground which wasn't part of the plan.

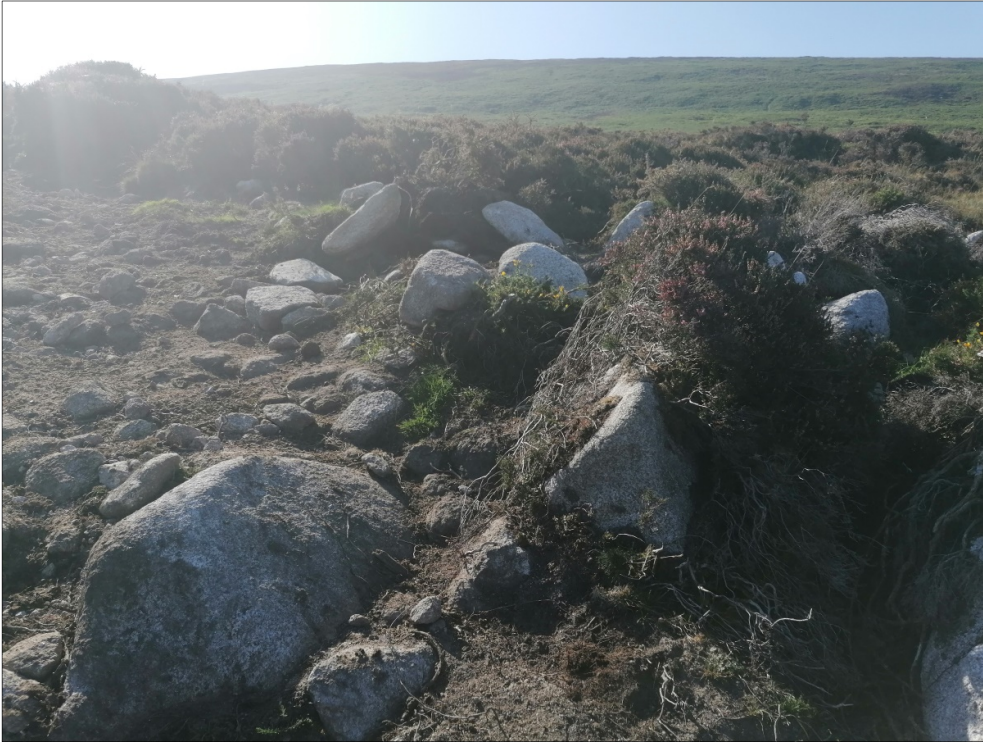
Plate 11. Trampling, bare ground and erosion along the new section of track.

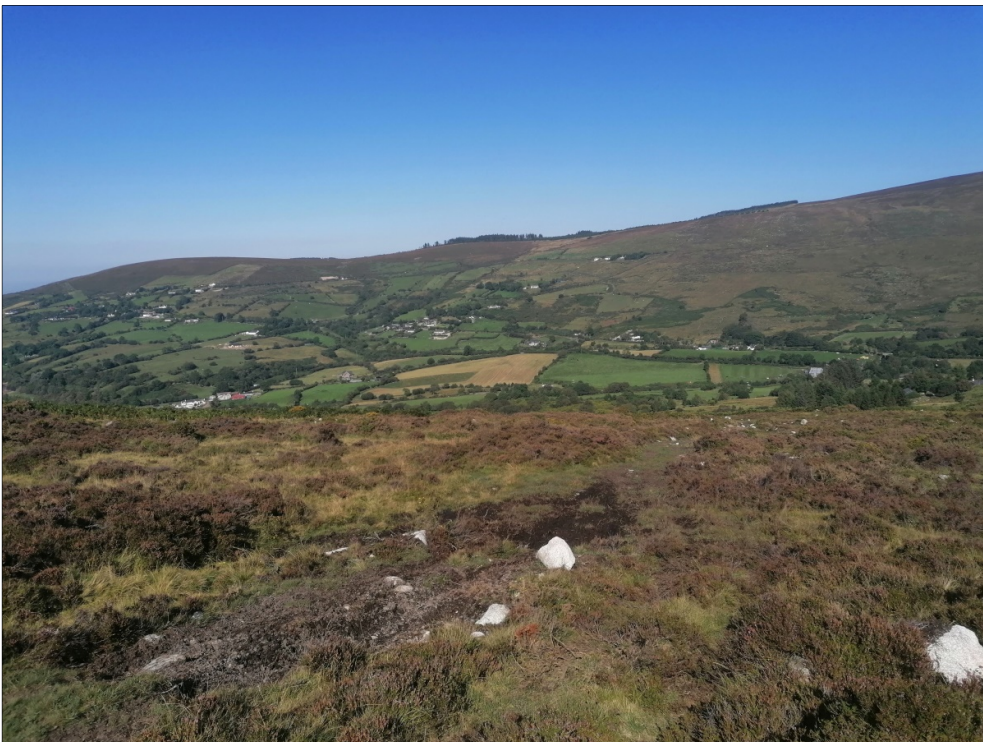
Plate 12. Erosion of peat.

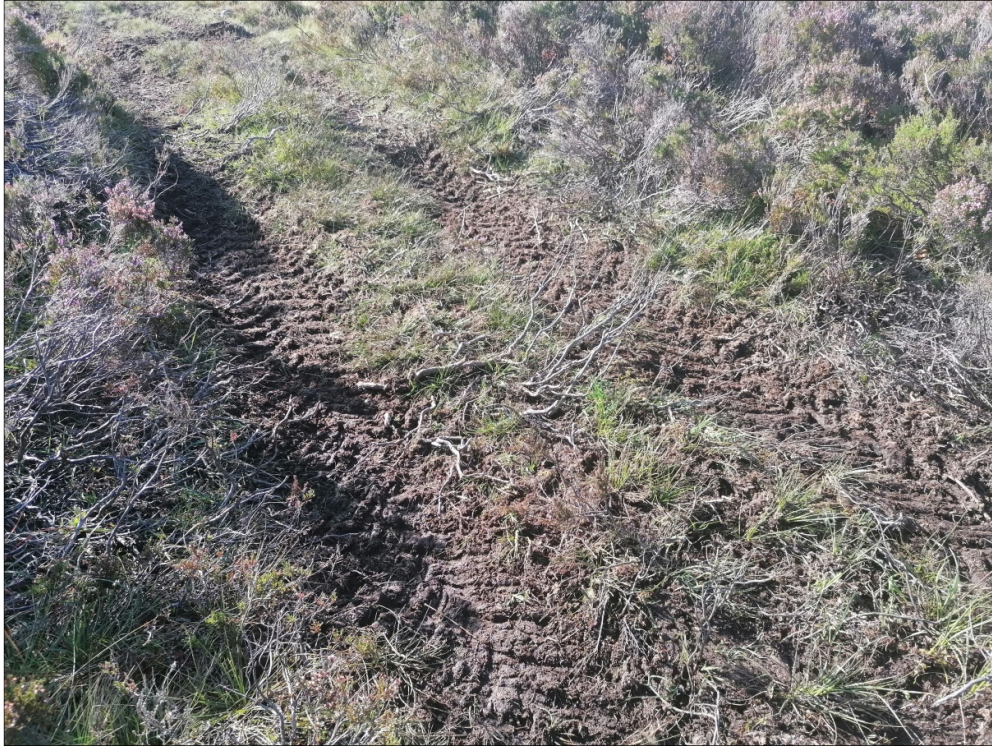
There has been some localised damage to habitats on the hill from quad access and some areas are at risk of erosion.

Plate 13. Quad access - beginning to pose a threat of erosion.

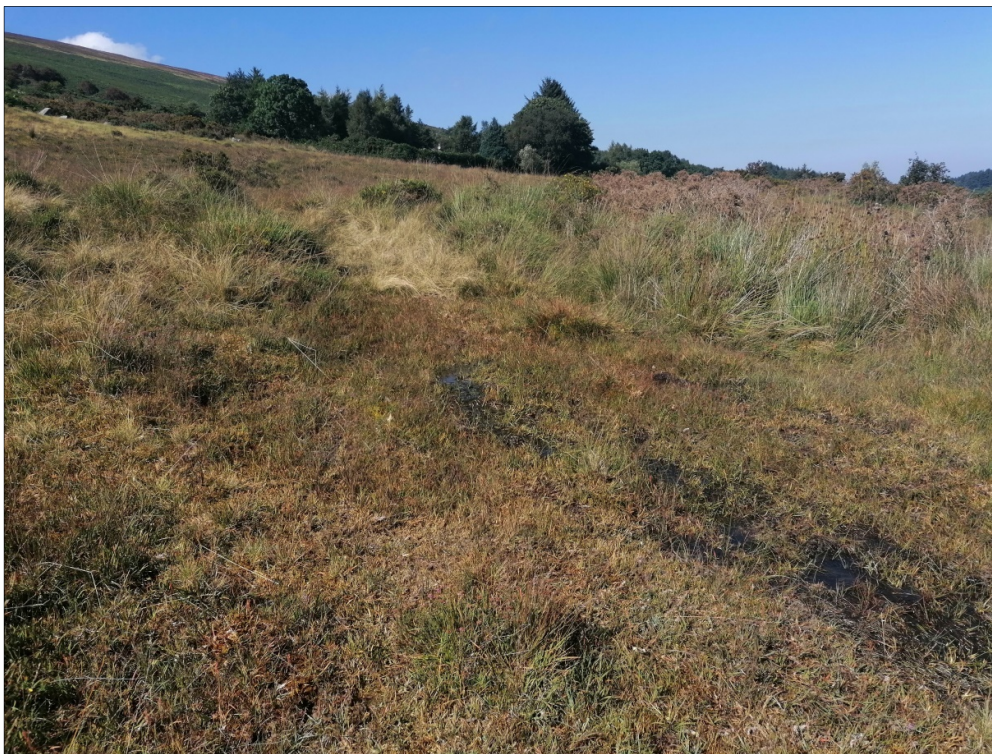
Plate 14. There should be no quad access across the areas of wet heath and flush at the bottom of the hill.

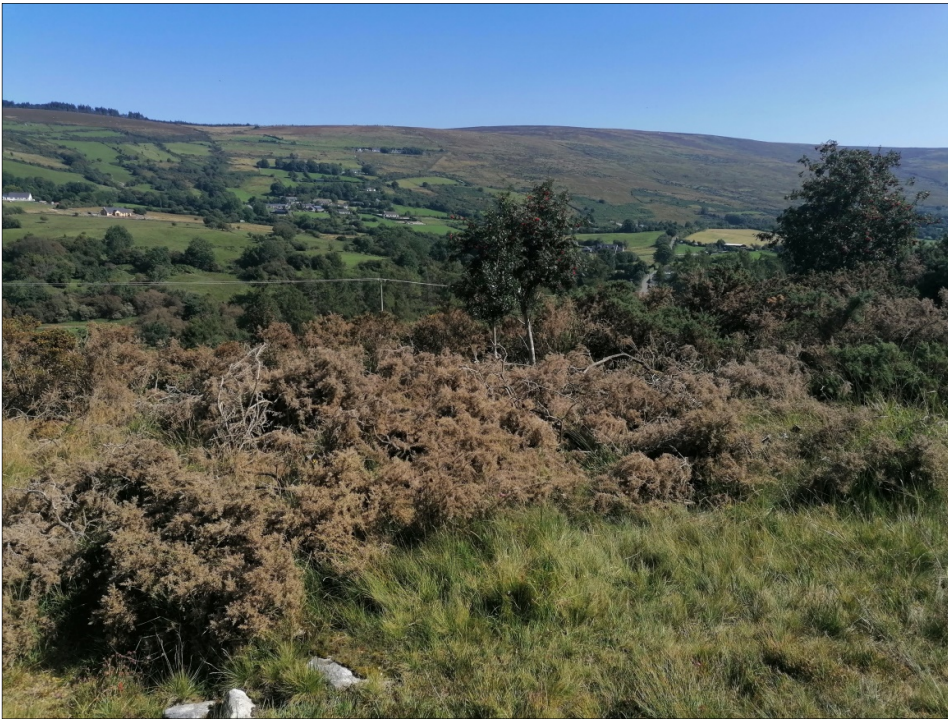
Gorse removal around existing trees has taken place in Area 1. This allows the trees to be frayed and damaged by deer – the gorse is protecting these trees and should be retained.

Plate 15. Gorse around existing trees should not be removed as it is protecting them from grazing animals.

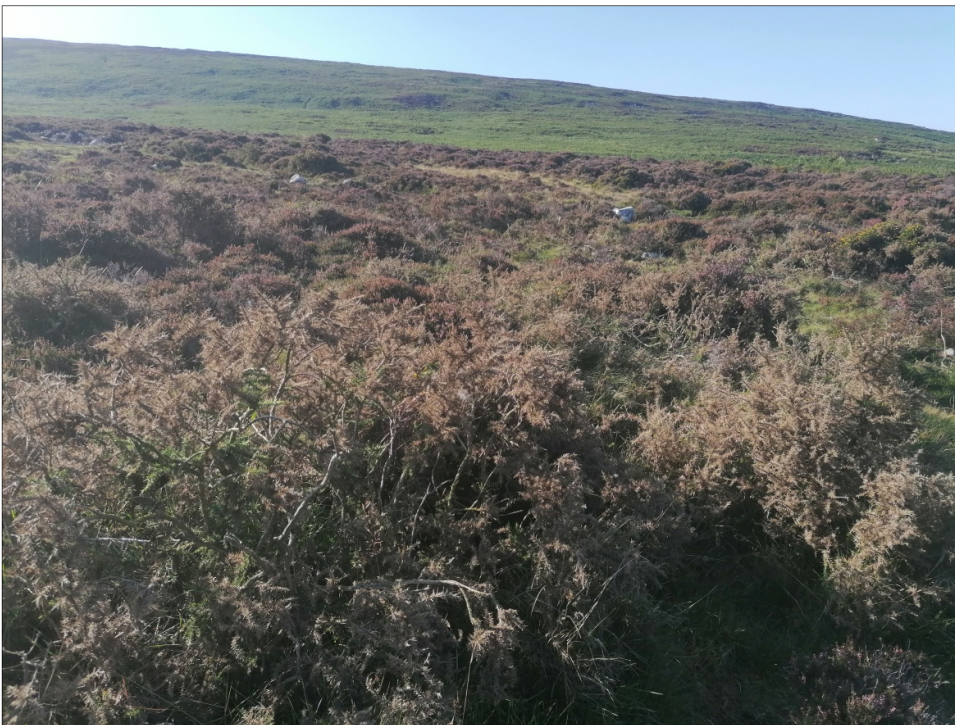
Plate 16. There was widespread die back of autumn gorse in much of the uplands in 2021 as a result of the late frosts and drought.

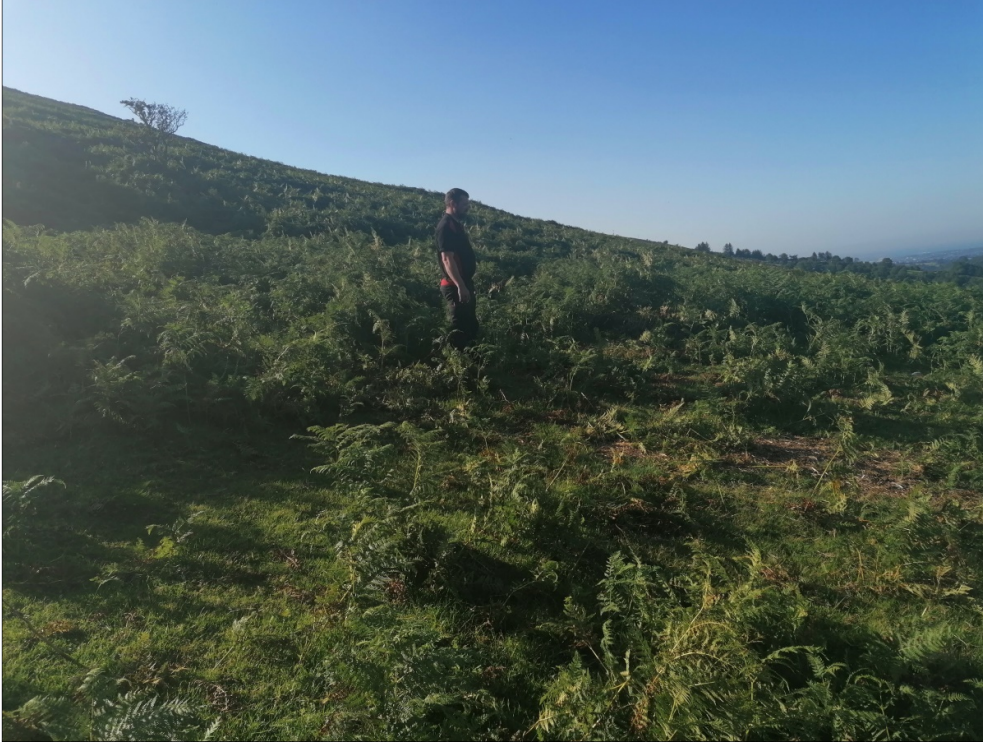
The introduction of cattle to the hill is very welcome and initial observations of their impact in terms of opening up dense bracken through trampling is positive. They were favouring the area of wet heath and flush on the hill which reflects the nutritional value of the minerals found in the vegetation there and access to water.

Plate 17. Cattle were encouraged into this area and have opened up what was dense bracken.
