Granamore Commonage

2020 Ecological Survey

Final Report

20th April 2021

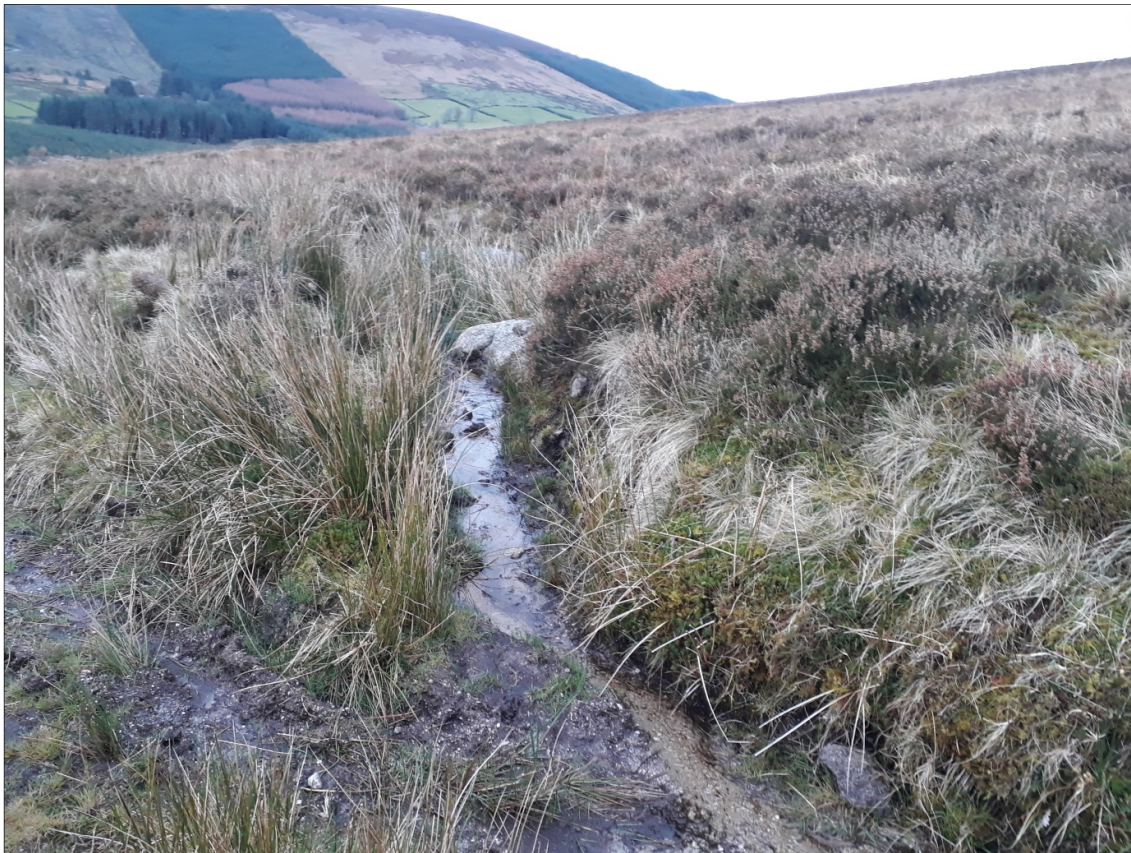
Further works have been done on the roadway to divert the water from the track following consultation with National Parks and Wildlife Service (NPWS) and supervision by them. This work has been done sensitively and has been well executed.

Plate 1. Shores allowing the water to escape off the track.

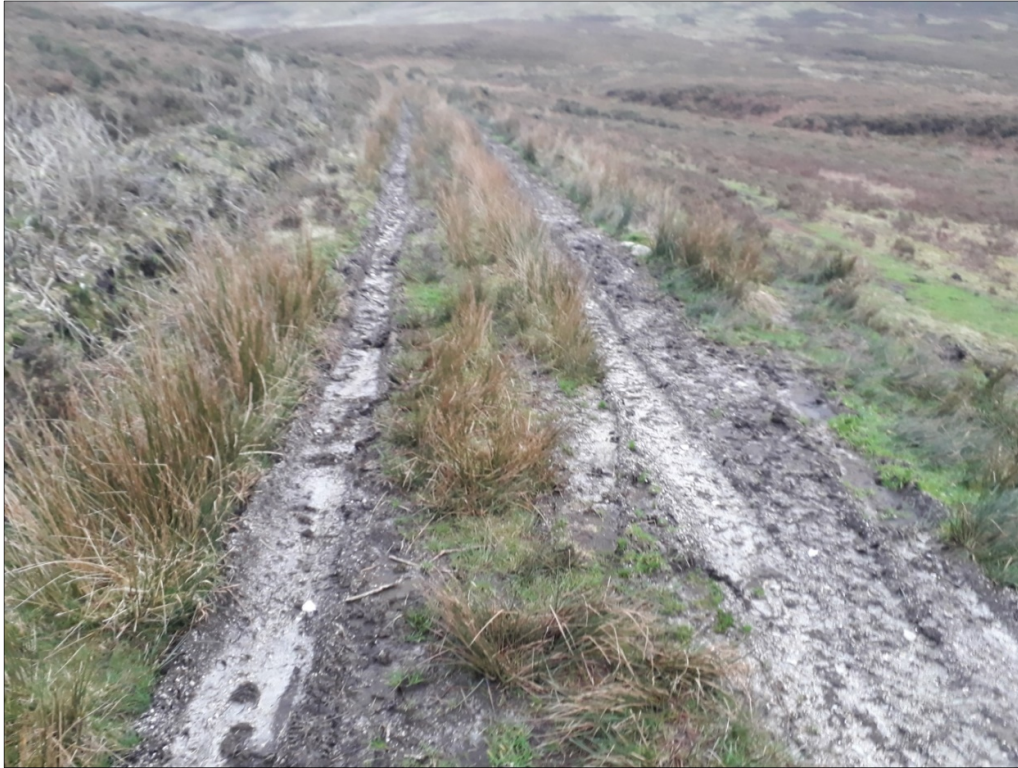
On several visits during 2020 it was noted that there continues to be surface water coming down the track. This is particularly the case above the old borrow pit (in Area 20) where the track is very wet and dominated by rushes particularly in the centre of the track. In some parts this is further exacerbated by rutting from vehicular access, which is creating a channel for water and exacerbating the situation downslope on the track. The installation of a series of water bars along the track – particularly at the shores should be implemented.

Plate 2. Tyre tracks have created deep channels for water to flow down on the track above the old borrow pit.

It is understood that the farmers are waiting for the roadway to dry out before they do anymore, and all works will be in consultation with NPWS (NPWS prefer not grading off the roadway if possible following some investigations by themselves). On the area above the borrow pit, there is no foundation under most of this and any work needs to be carefully planned and Ann Fitzpatrick, NPWS is working with the farmers on this.

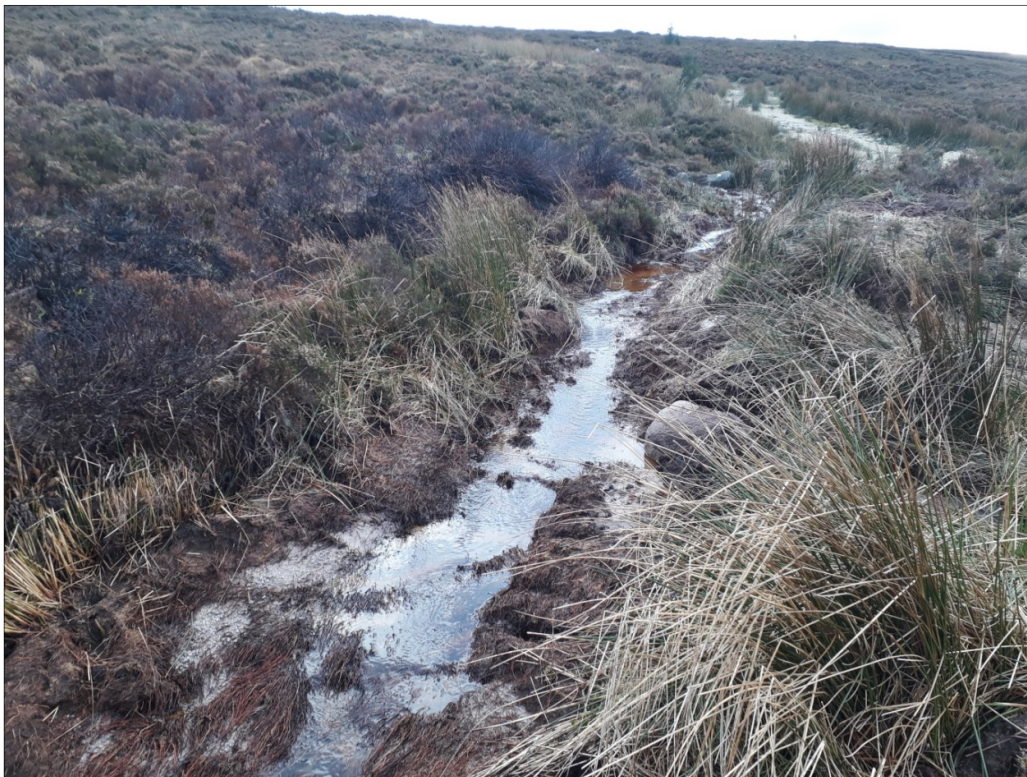
Plate 3. Drainage works associated with the track in Area 1, 23 and 25.

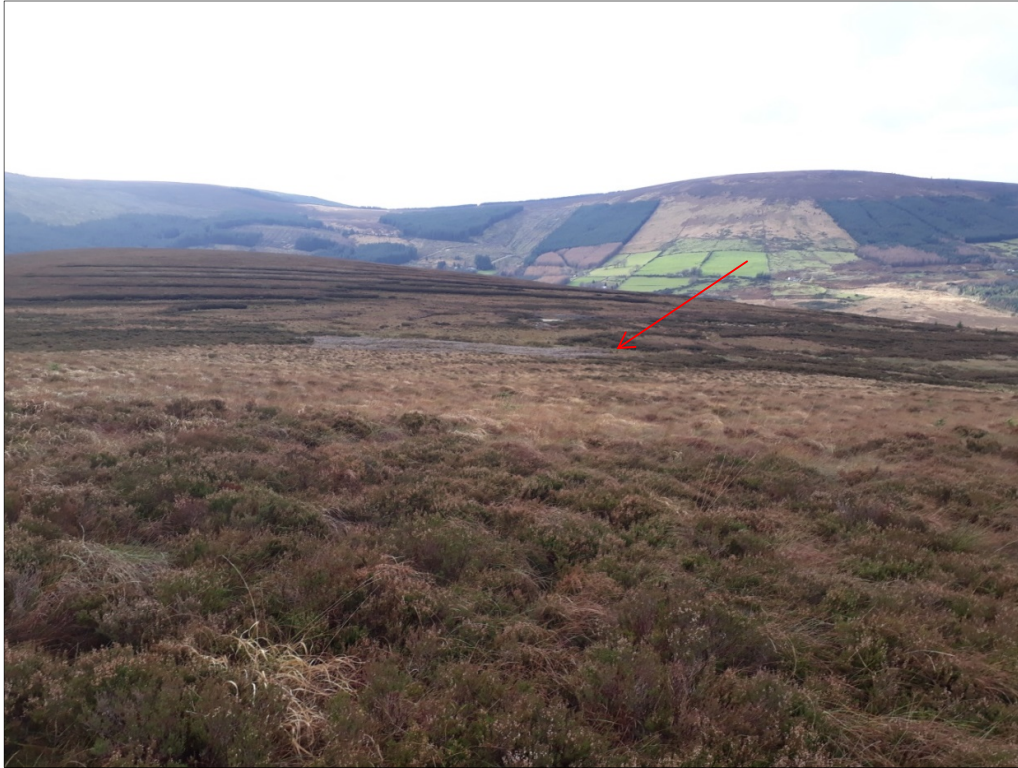
Plate 4. Gravel grit was used to try and reduce peat erosion caused by horses along the track between Areas 1, 23 and 25.

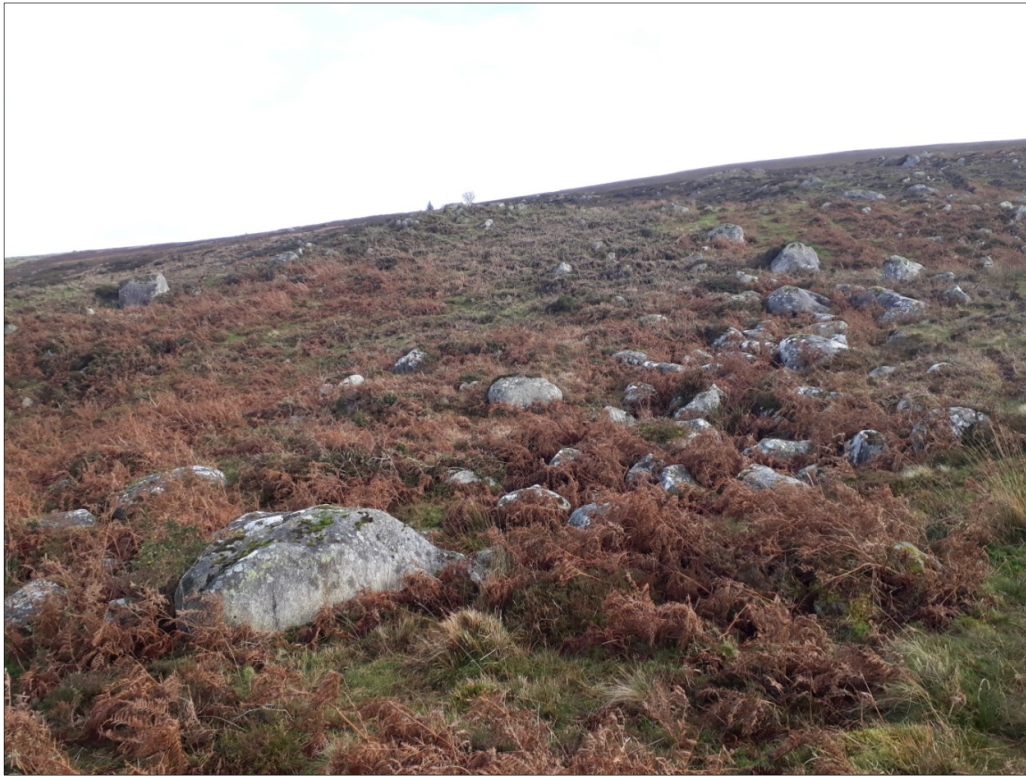
Plate 5. Flailing and cutting of gorse and heather was done manually on the rocky slopes in Areas 10, 2 and 24.

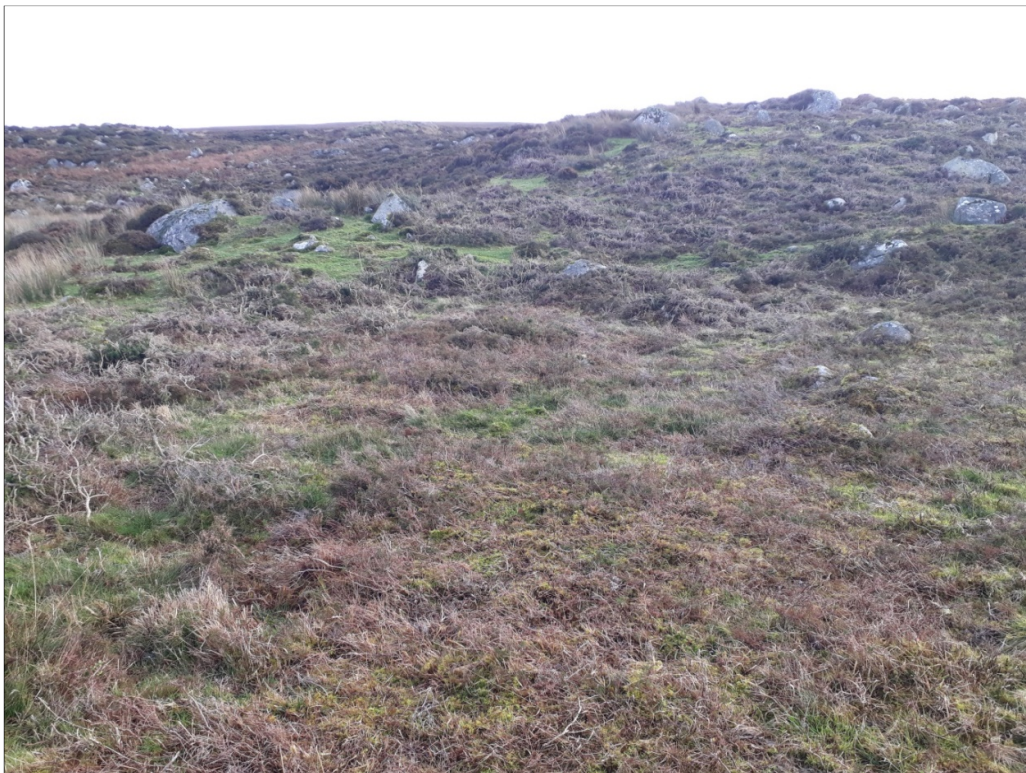
Plate 6. Flailing and cutting of gorse and heather was done manually on the rocky slopes in Areas 10, 2 and 24.

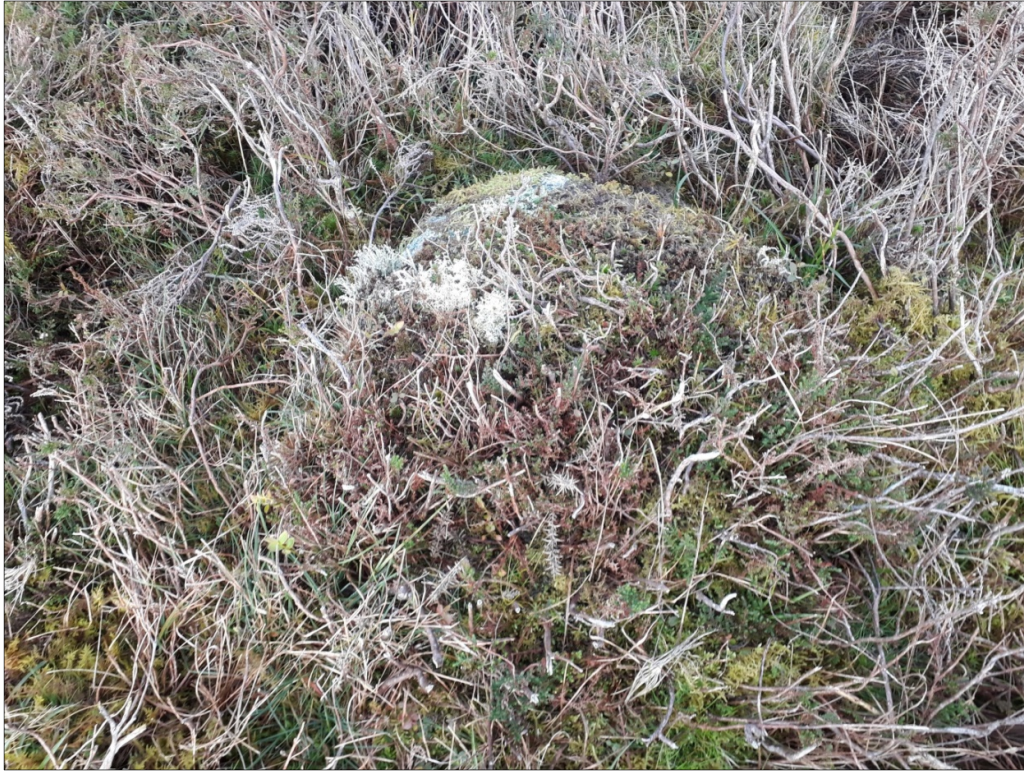
Plate 7. Moss and lichen communities such as these found below heather would be damaged by burning so cutting manually is more appropriate.

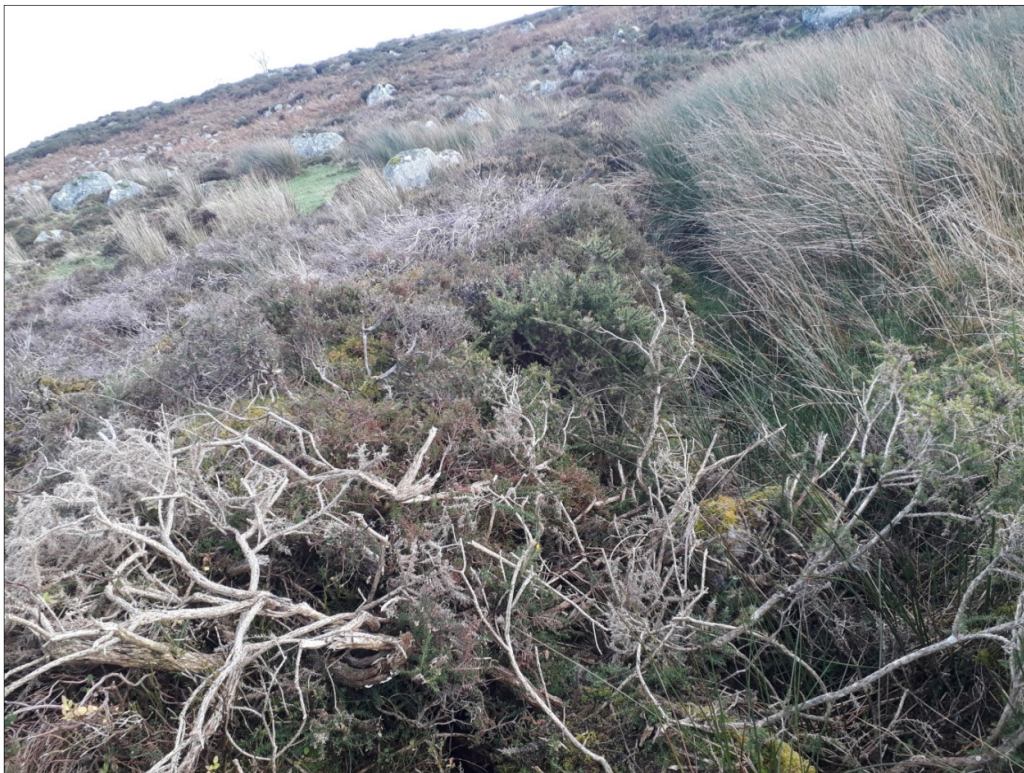
Plate 8. Cutting of gorse on the earthen banks which denote old field boundaries within area 2 and 24.

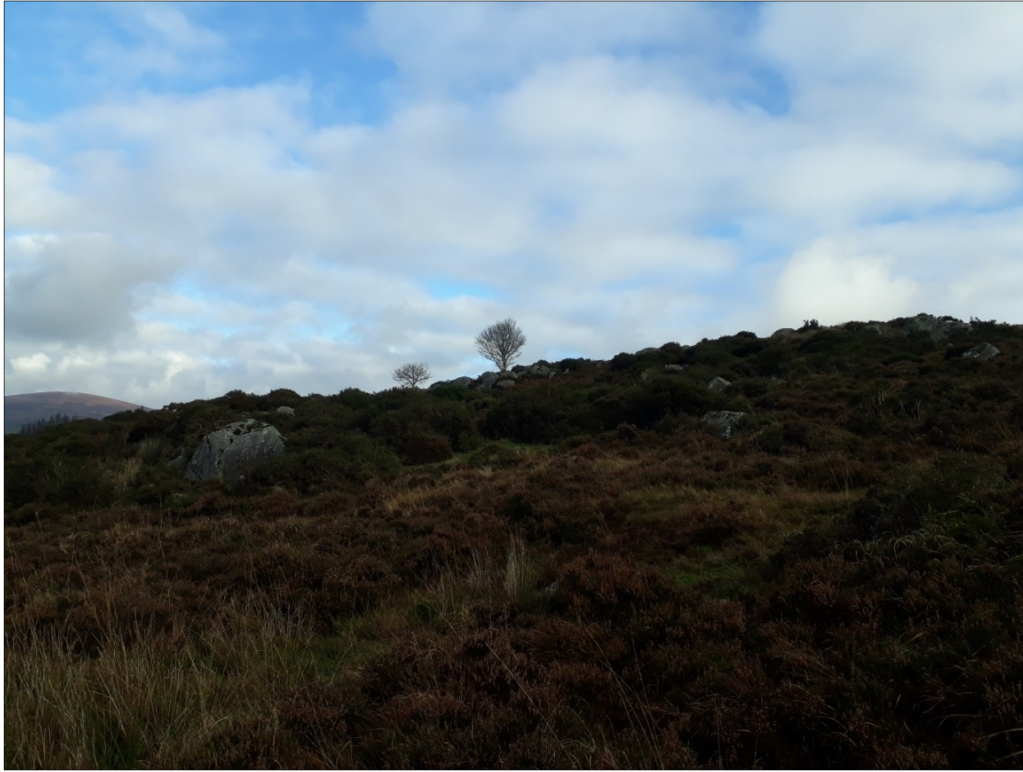
Plate 9. There should be no additional cutting or clearing within area 2 and 24 to allow native woodland to develop here as agreed with NPWS.

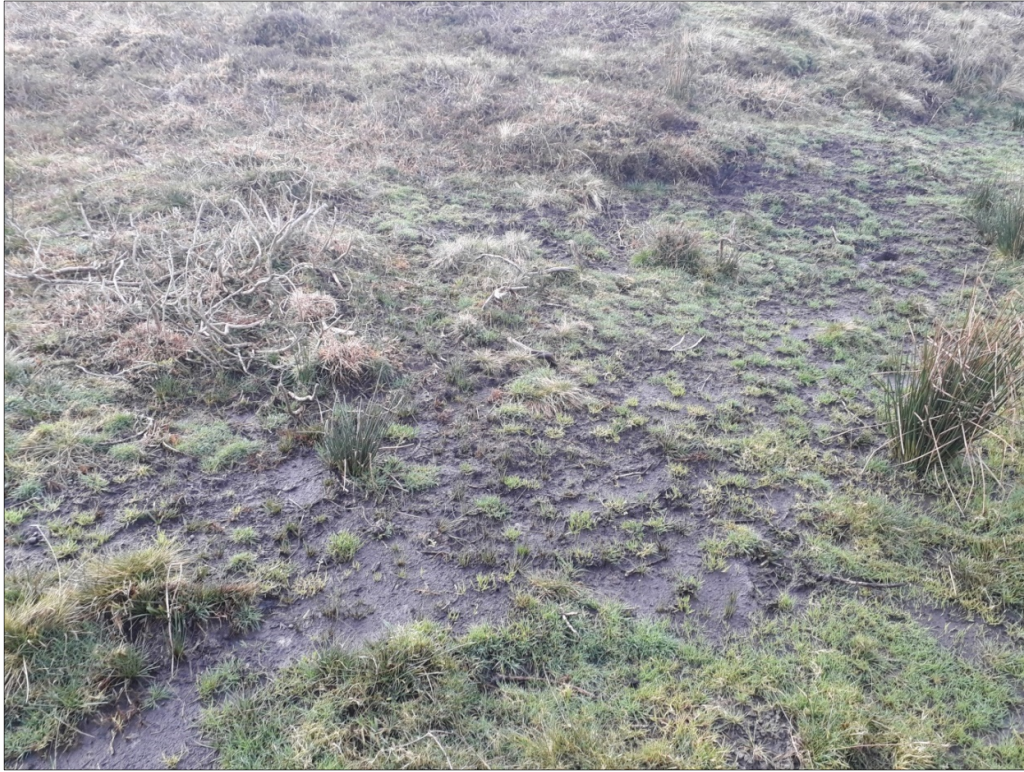
The knolls which were burnt in 2019 were re-examined in 2020. Sheep are congregating in this area post burning with extensive dunging and grazing pressure on the grasses underneath. This has resulted in areas of bare soil and poaching. The sheep need to be shepherded regularly out of this area to reduce browsing pressure on same. Patches of heath rush (*Juncus squarrosus*) are present and if browsing pressure remains too high this species will begin to dominate as it is unpalatable to sheep. Although there is some recovery of heather in these areas it is heavily browsed.

Plate 10. Bare soil at risk of erosion around knolls burnt in 2019.

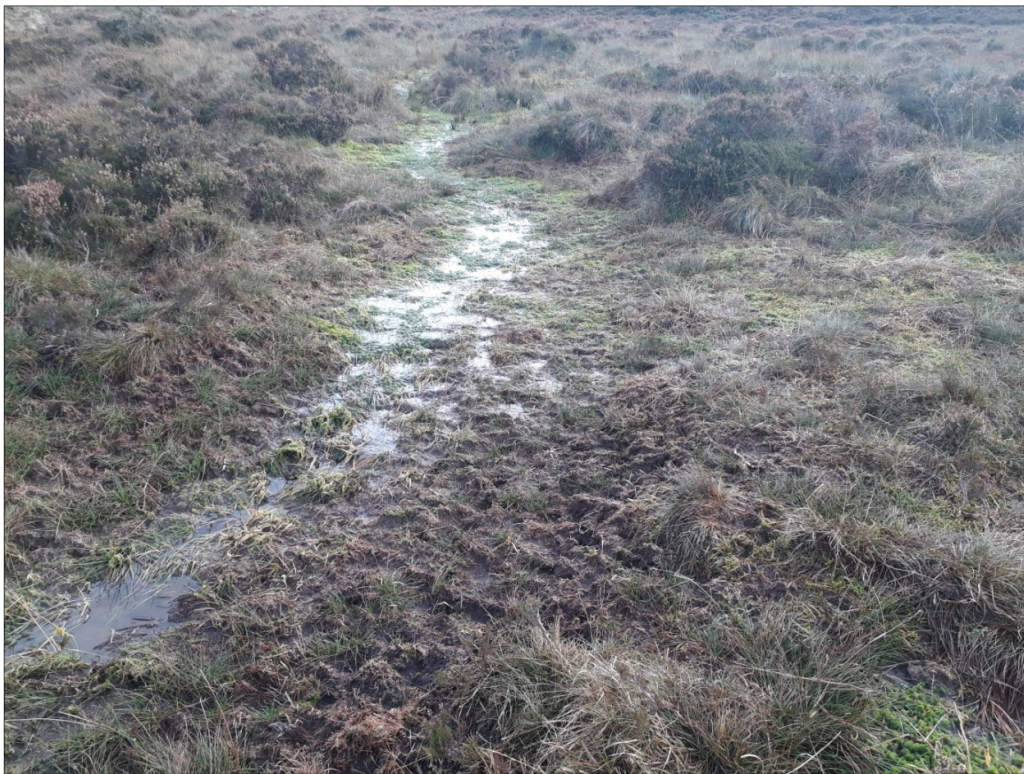
Plate 11. Poaching and trampling pressure leading to damage to areas of blanket bog at the base of the knolls burnt in 2019 indicating too much pressure from sheep in this area.

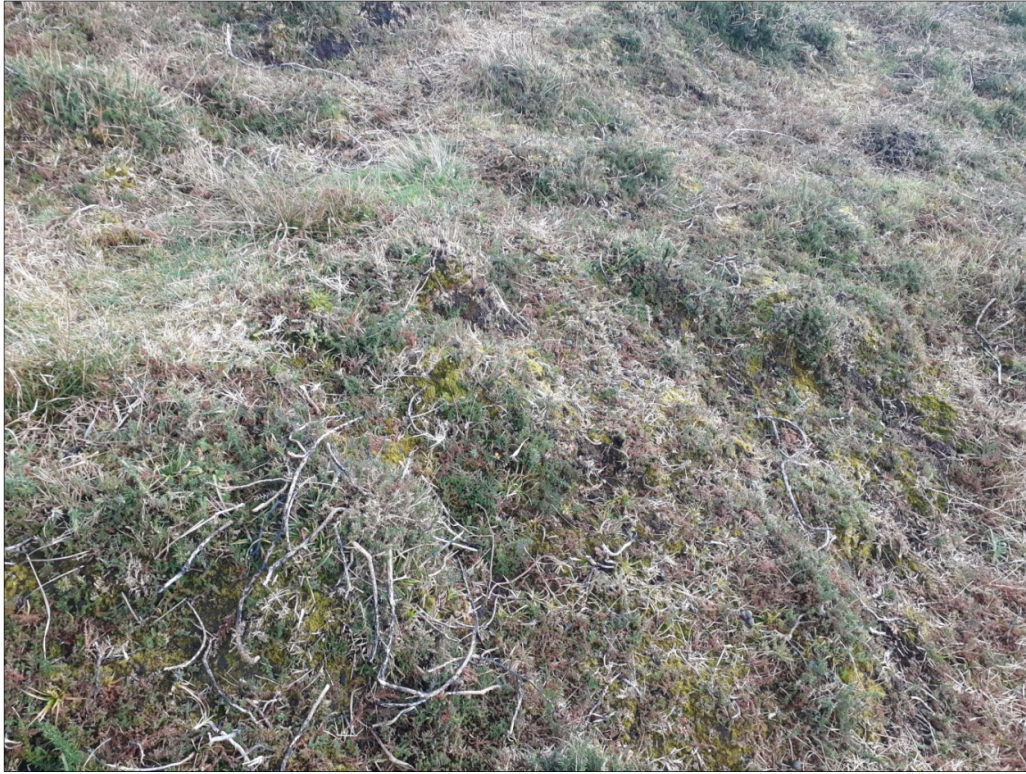
Plate 12. Heaving browsing pressure on the knolls burnt in 2019.

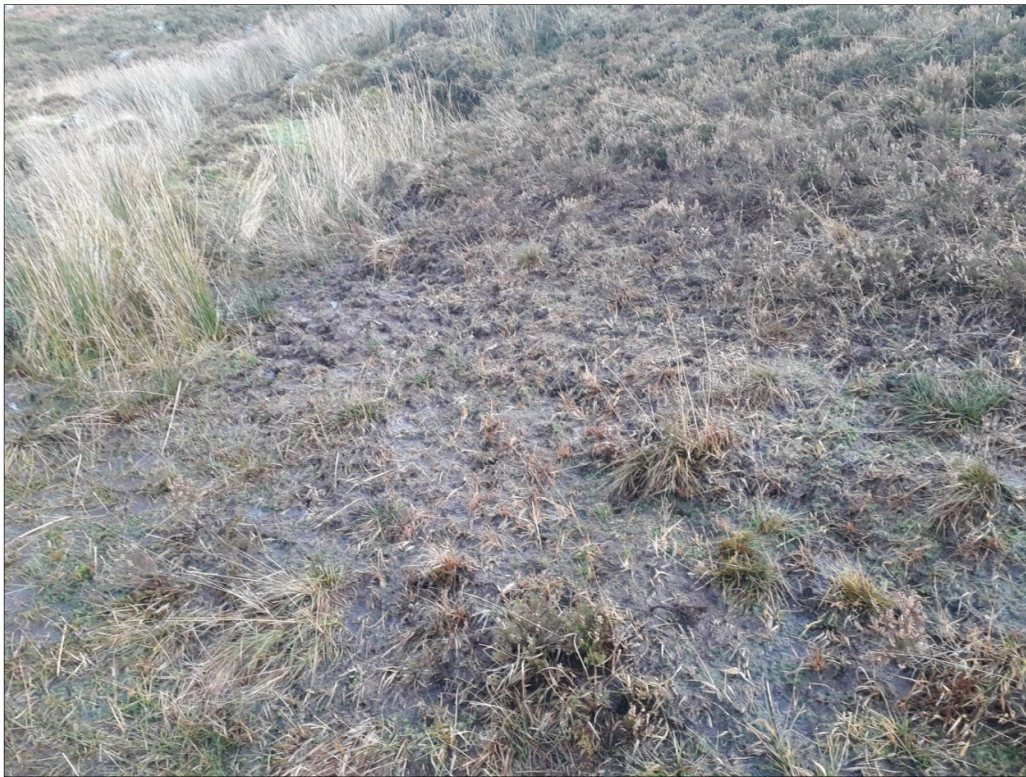
Plate 13. Extensive dunging, bare soil and poaching in the areas burnt in 2019.

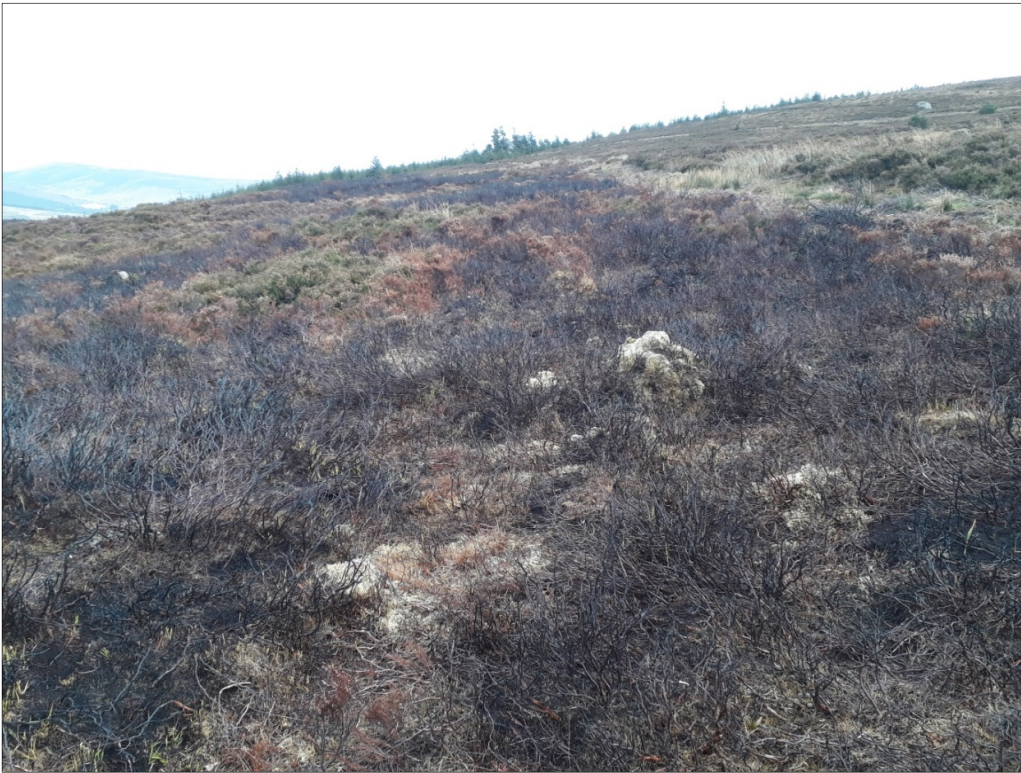
There was controlled burning conducted in several patches in Area 23 in 2020. This was carried out on the 17th September 2020 and initial assessments indicate that *Molinia* is regenerating in these areas. The results of this activity will be monitored in 2021 when some more vegetation has begun to recover.

Plate 14. Localised burning of tall heather in Area 23.

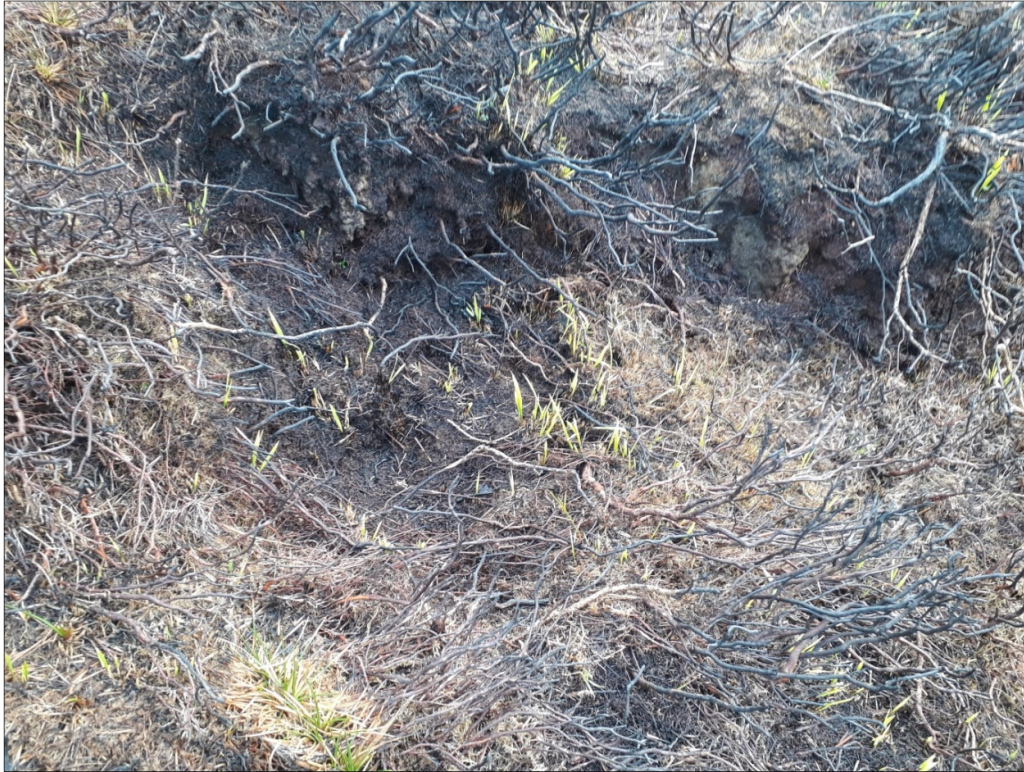
Plate 15. Regeneration of Purple Moor-grass (*Molinia caerulea*) following burning. There is a risk that heather could be lost following intensive burning events and *Molinia* could dominate.

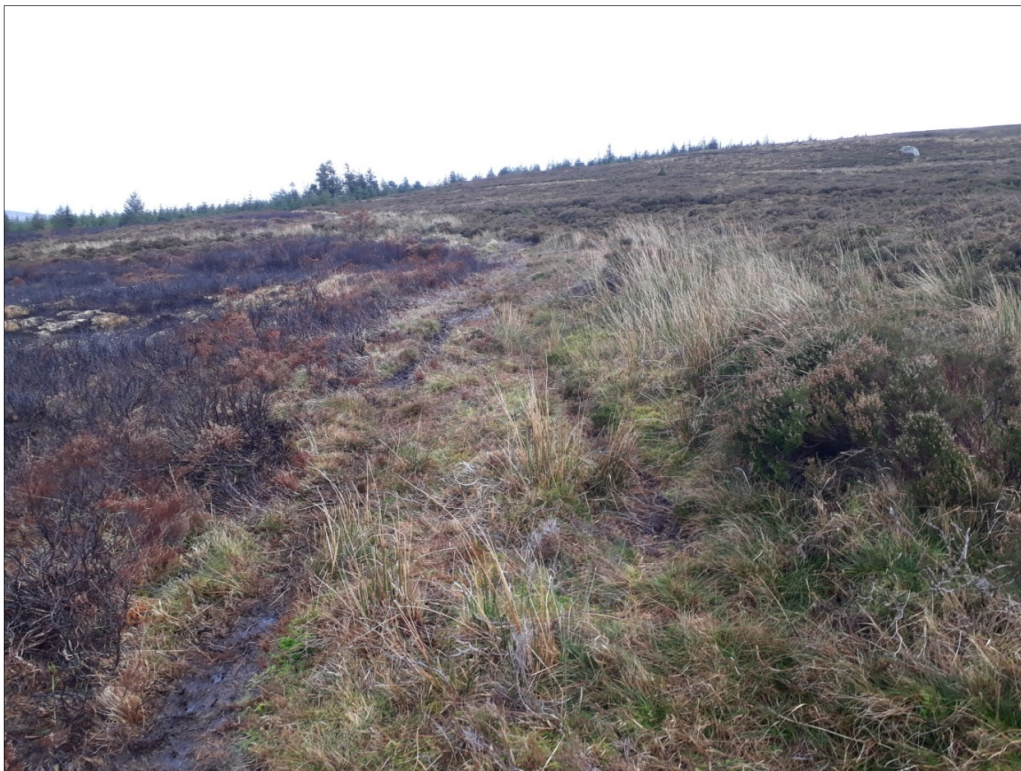
Plate 16. Track in Area 23 forming a firebreak. The ground between this track and the one visible in the upper part of the photograph and upslope in Area 22 should not be burnt as the bog vegetation here is recovering from previous burns.

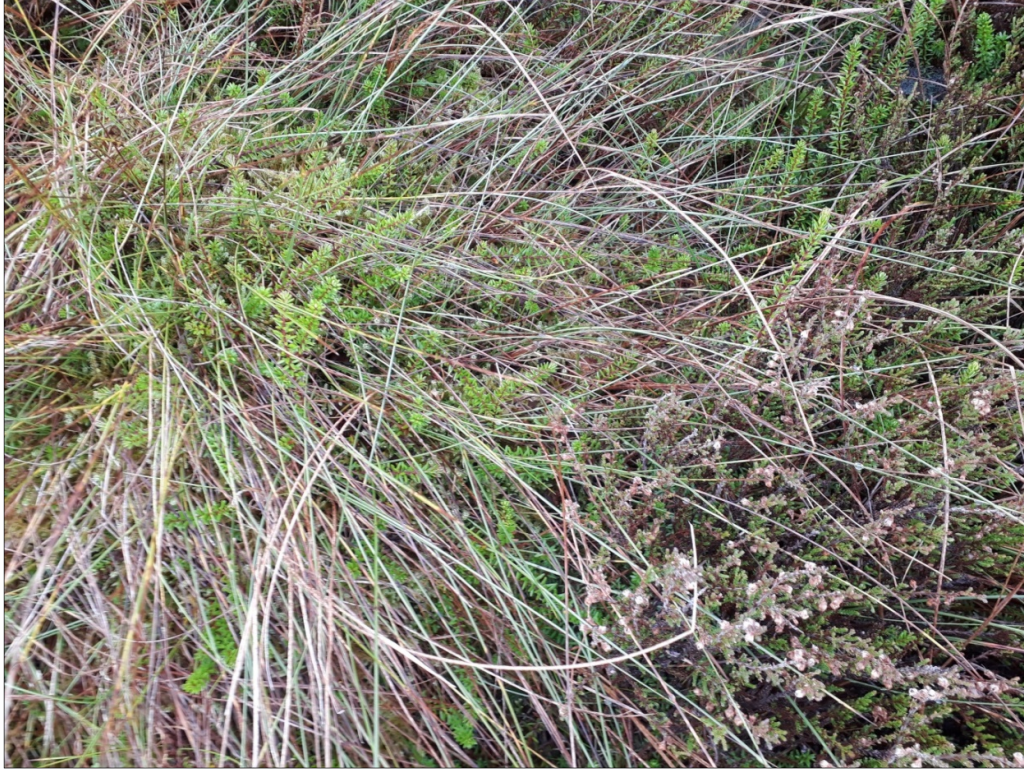
Plate 17. Recovering mountain blanket bog habitat in Area 23/22 with Crowberry (*Empetrum nigrum*).

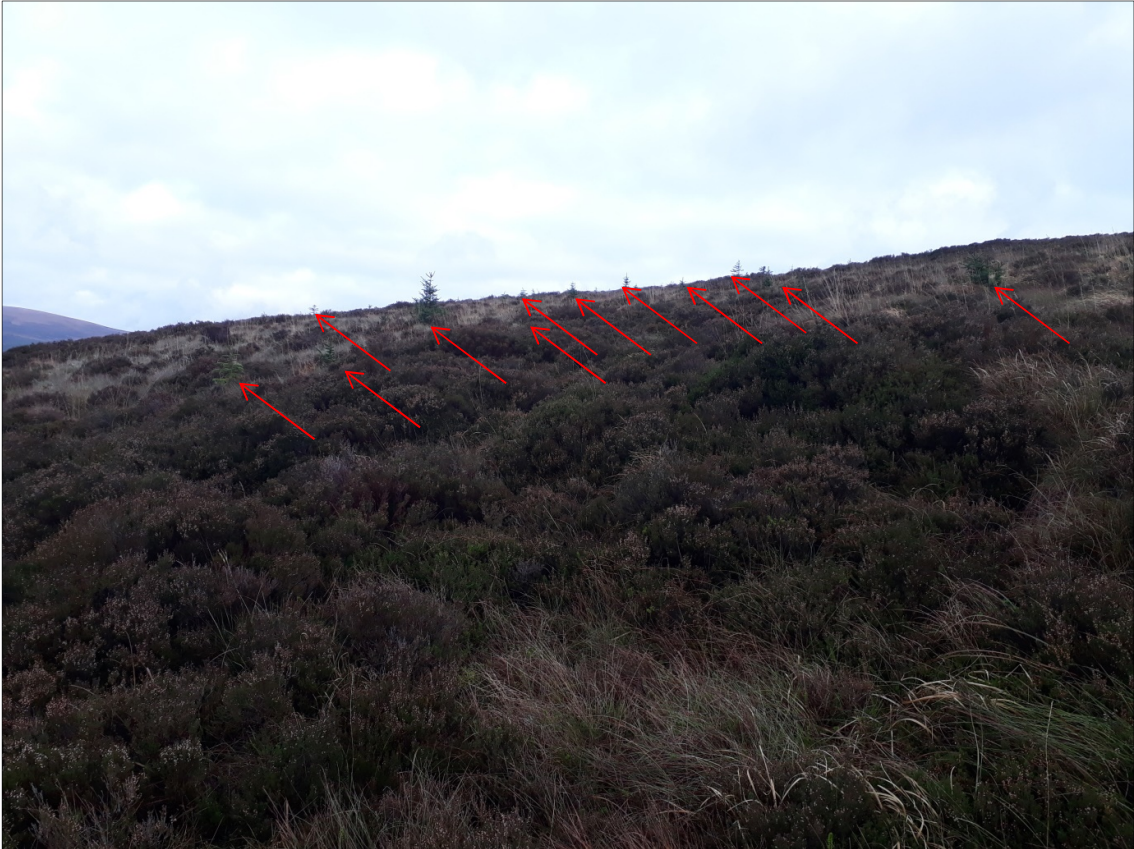
There are significant numbers of Sitka spruce seedlings and saplings in Areas 1, 22, 23, 24, 25, and on the ridge in Areas 3 and 4.

Plate 18. Sitka spruce regeneration in Area 22.

3. Cut/Pull self-seeded Sitka Spruce on the commonage.
4. Block drains over turf banks in areas 1, 18, 21 and 22, 16 (above the track) & coming from area 19.

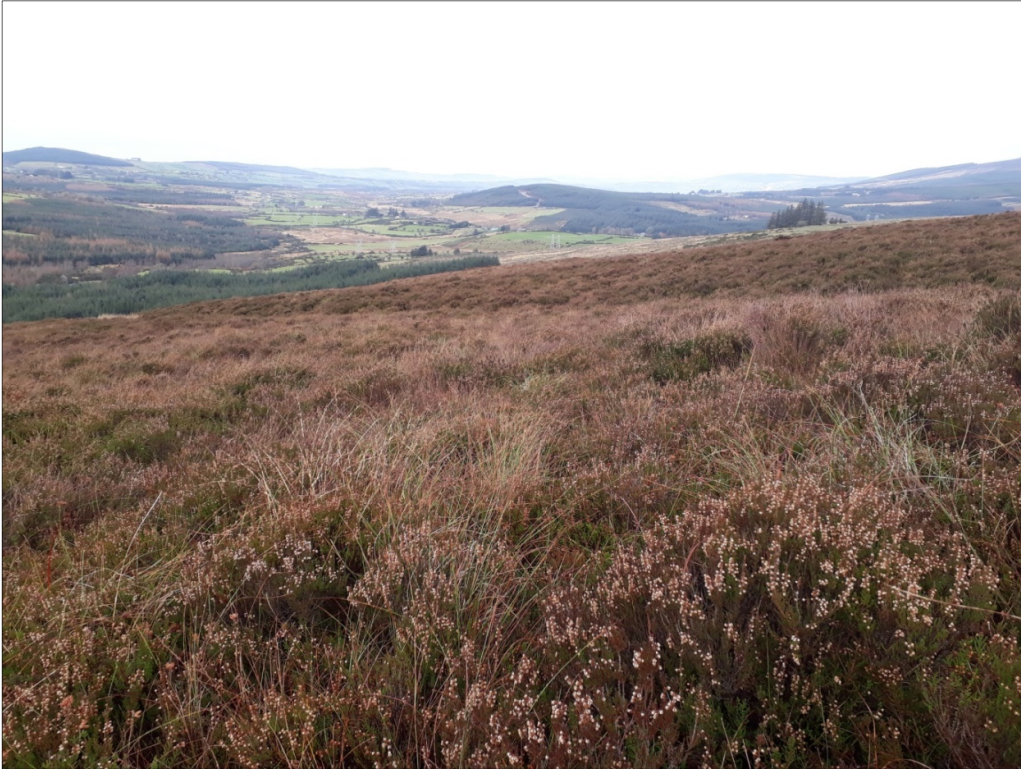
Plate 19. Areas of turf banks adjoining the cutover bog in Area 1/27 which have been impacted by drainage works associated with the turf cutting. Some of the drains here could be further investigated for their suitability for drain blocking to restore the hydrological function of the areas of cutover bog on the north slopes of Round Hill.

Drain blocking on the commonage will be completed in 2021.

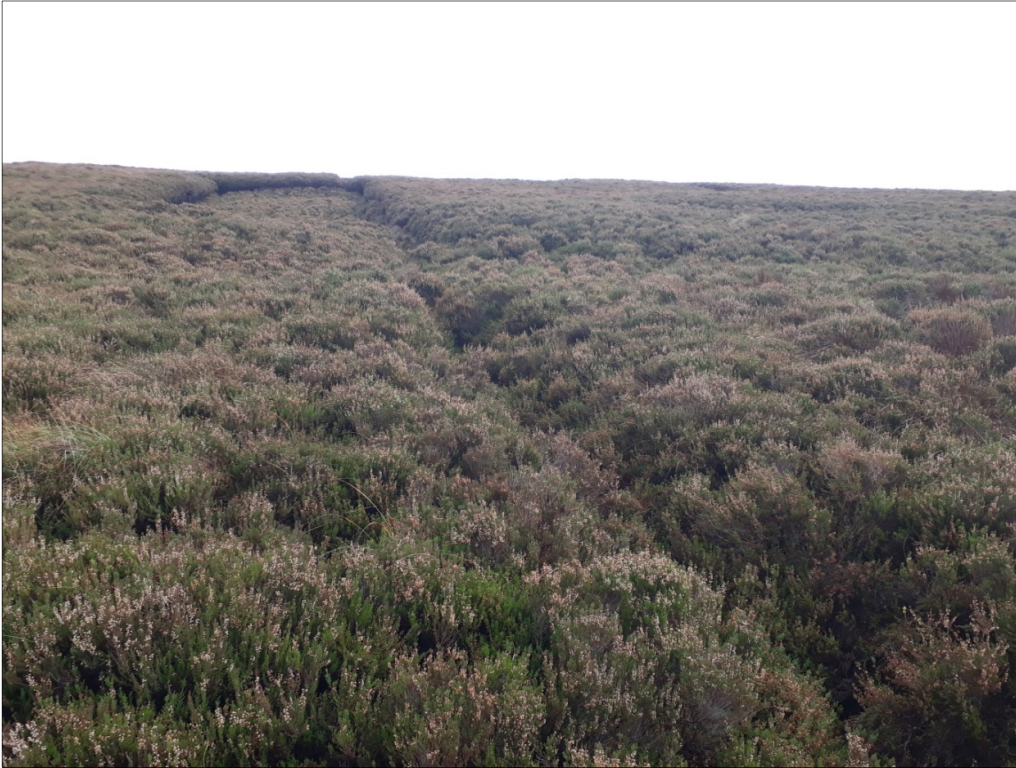
Plate 20. Some drains associated with the former turf cutting could be blocked in these areas.

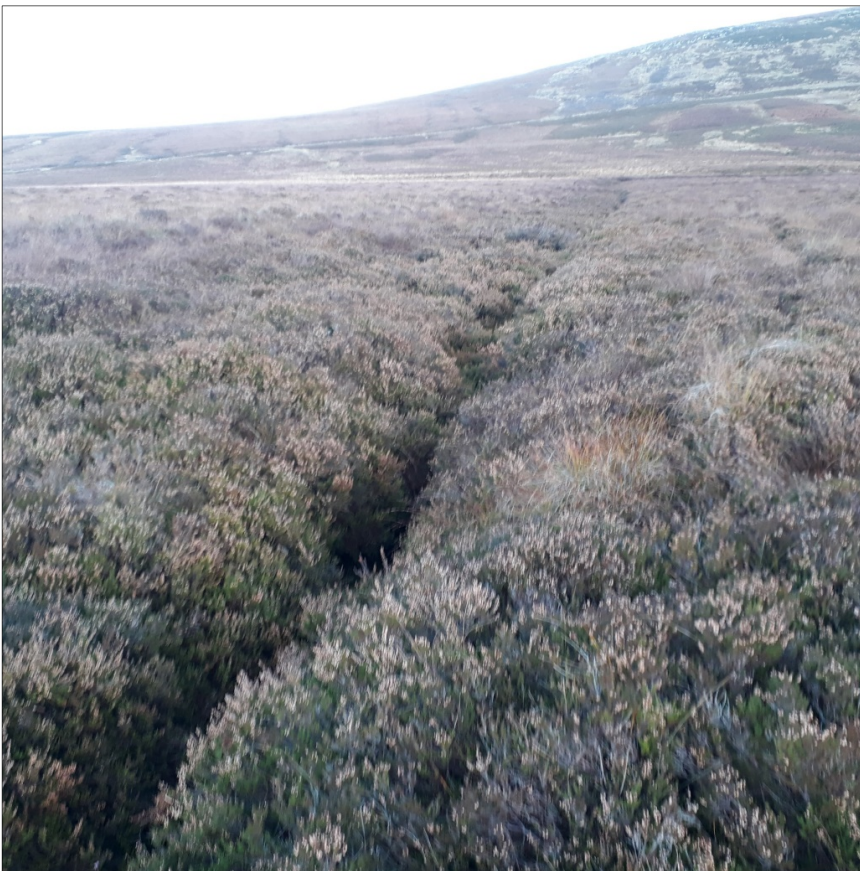
Plate 21. Drain along northern edge of Area 19 below the track awaits blocking.

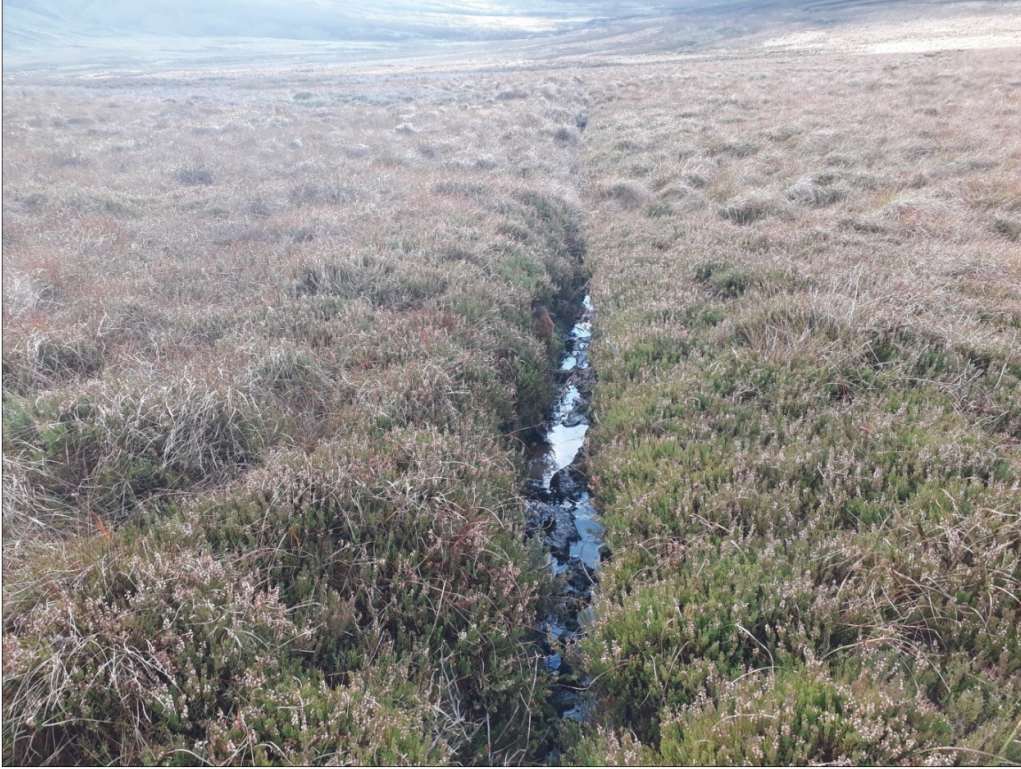
Plate 22. Drain along the northern edge of Area 19 above the track on the slopes below Granna Rock awaits blocking.

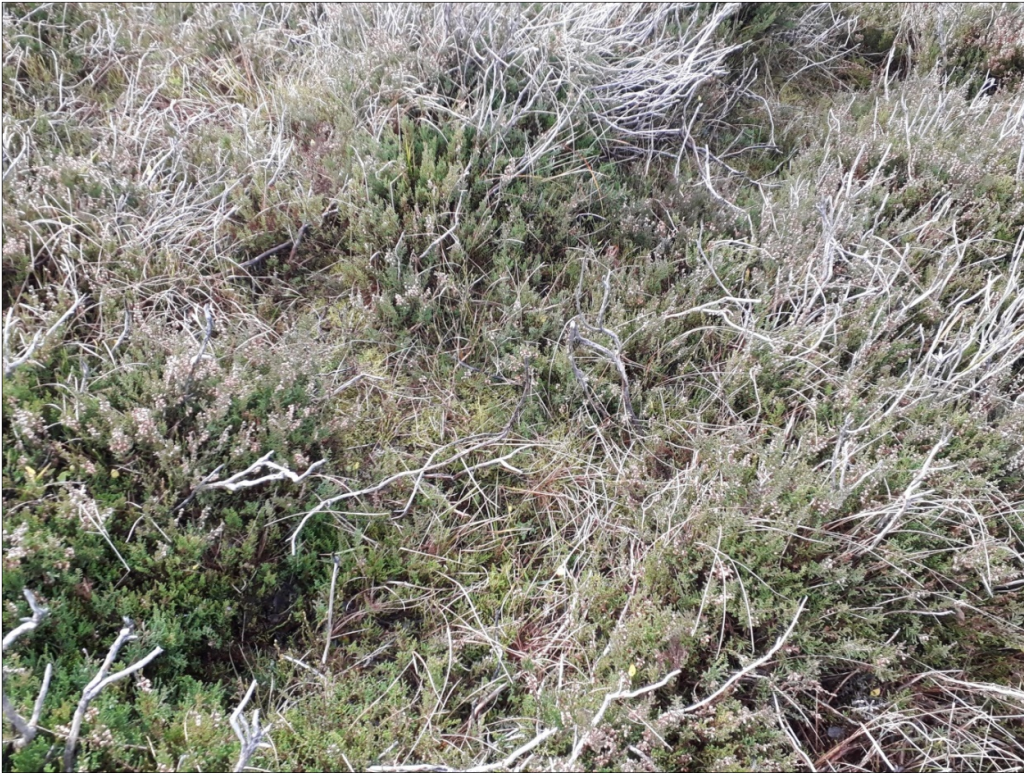
The areas of the hill which were previously intensively damaged by an uncontrolled burn were examined. Whilst there is some recovery of vegetation here the vegetation would remain in 'unfavourable inadequate condition' and some areas remain 'unfavourable bad' on account of large areas of exposed bare peat dominated mostly by ling.

Plate 23. Burnt slopes of Area 15, 16 and 31 below Granna rock are slow to recover from the burn from Knocknadruc.

It is imperative that no further burning occurs on the commonage outside of those agreed areas where a controlled burn can be implemented which needs to be done with the right intensity to ensure that the moss layer is not damaged during the burn.

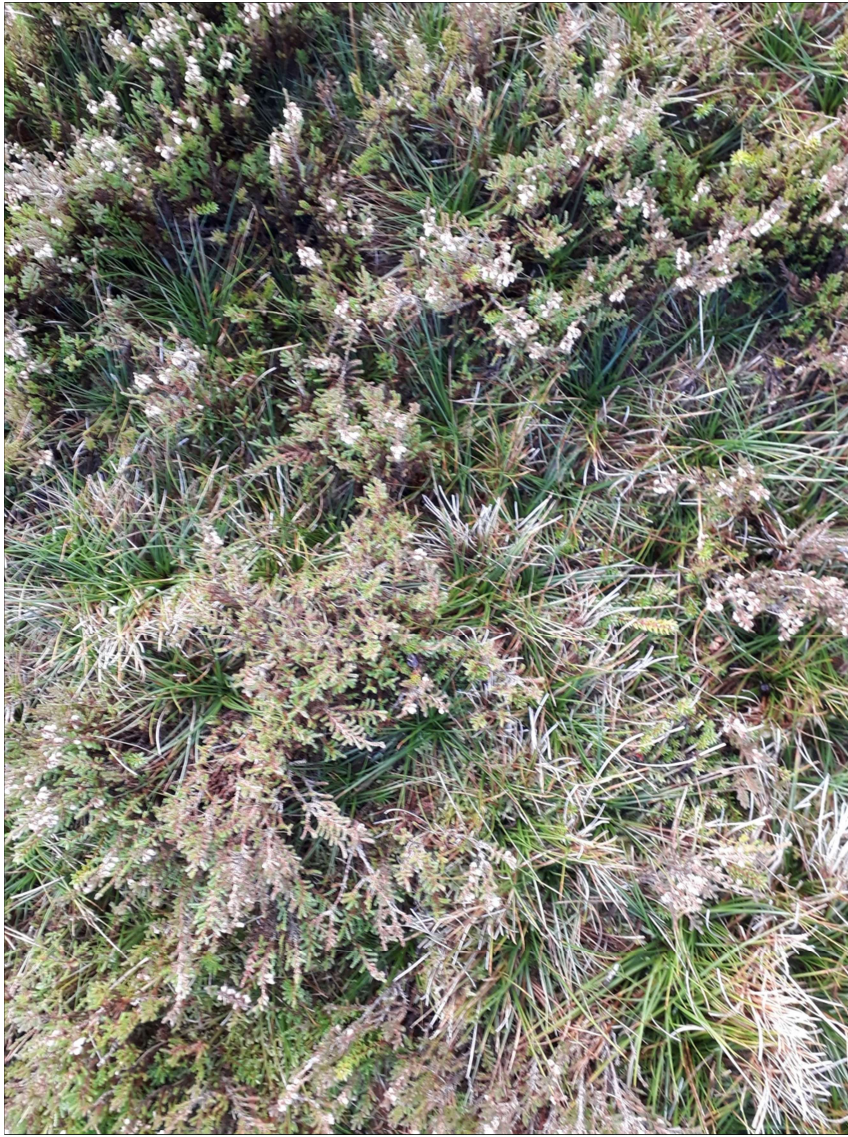
Plate 24. Heath rush dominating following burn from Knocknadruc in Area 15 and 31.

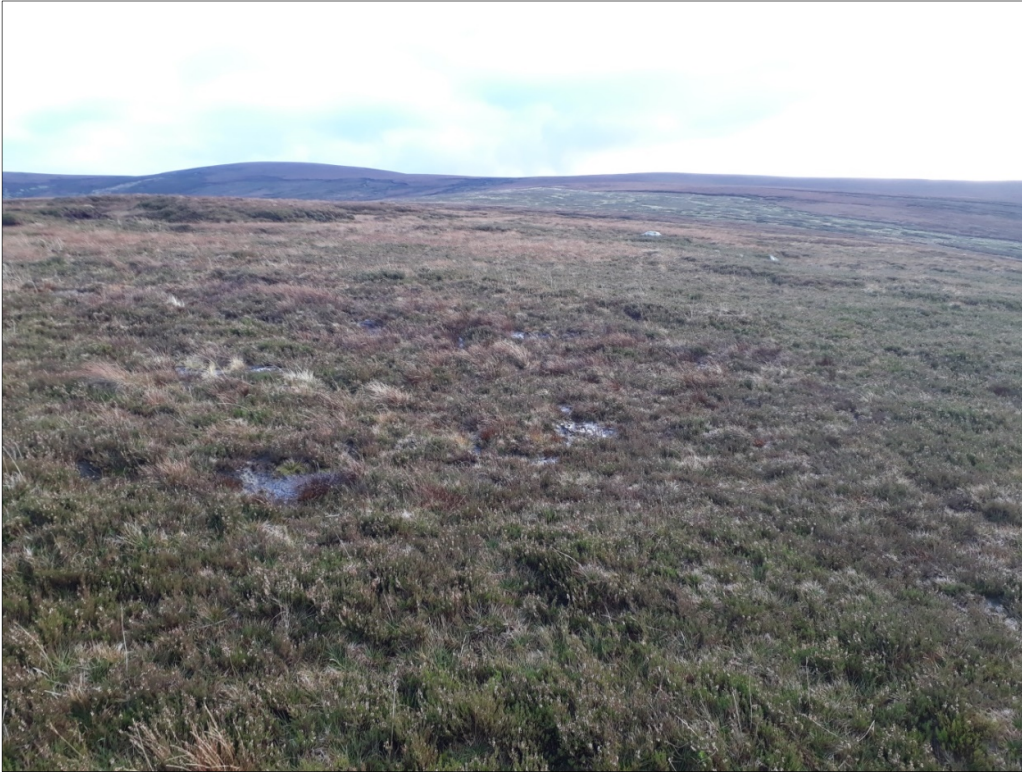
Plate 25. Slow recovery of heather with heath rush dominating following burn from Knocknadruce in Area 15 and 31.

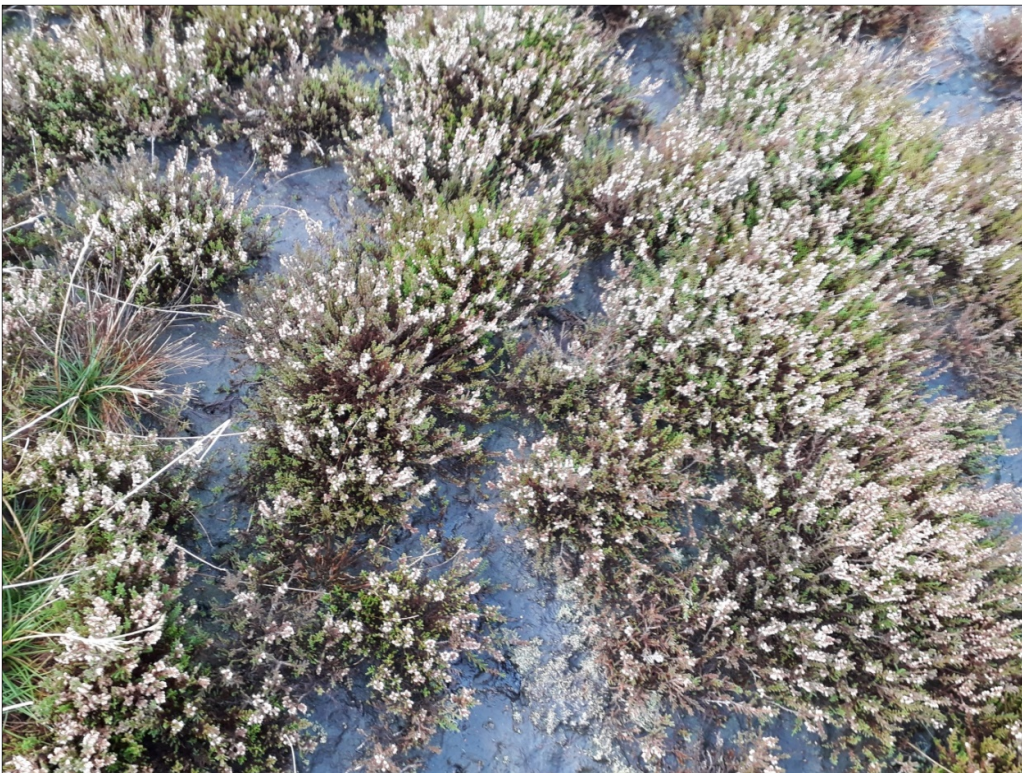
Plate 26. Large areas of bare peat are still present in Area 15 and 31.
