Granamore Commonage

2020 Ecological Survey

Final Report

20th April 2021

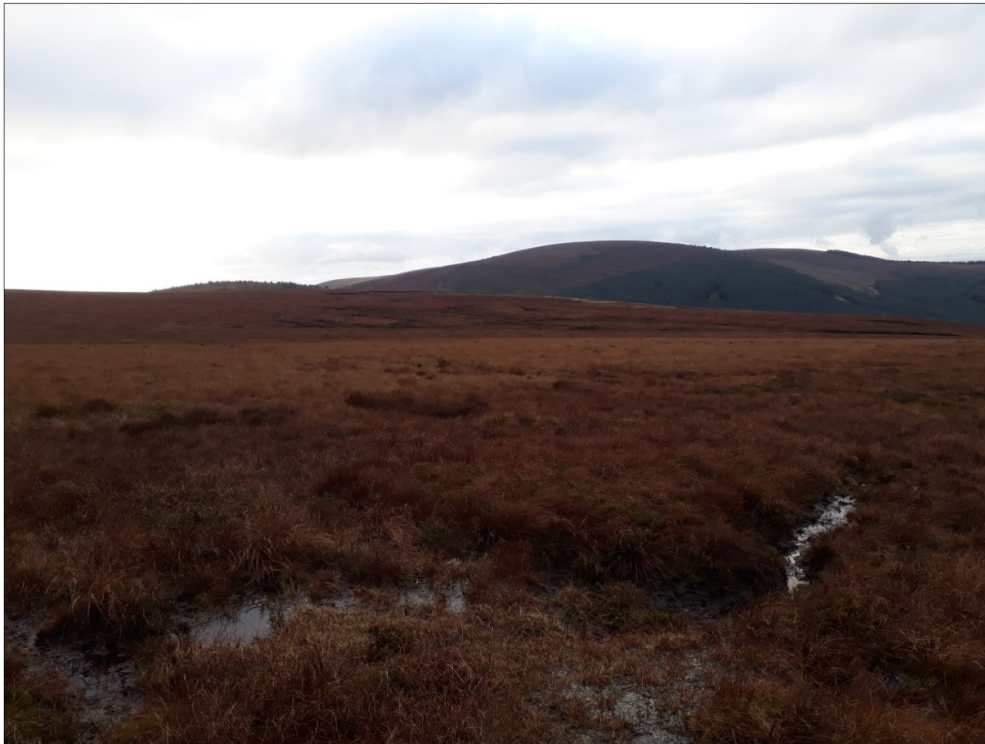
There was no noticeable improvement in the condition of erosion gullies in Area 3. This work needs to be prioritised in 2021.

Plate 27. Erosion gullies on the ridge in Area 3.

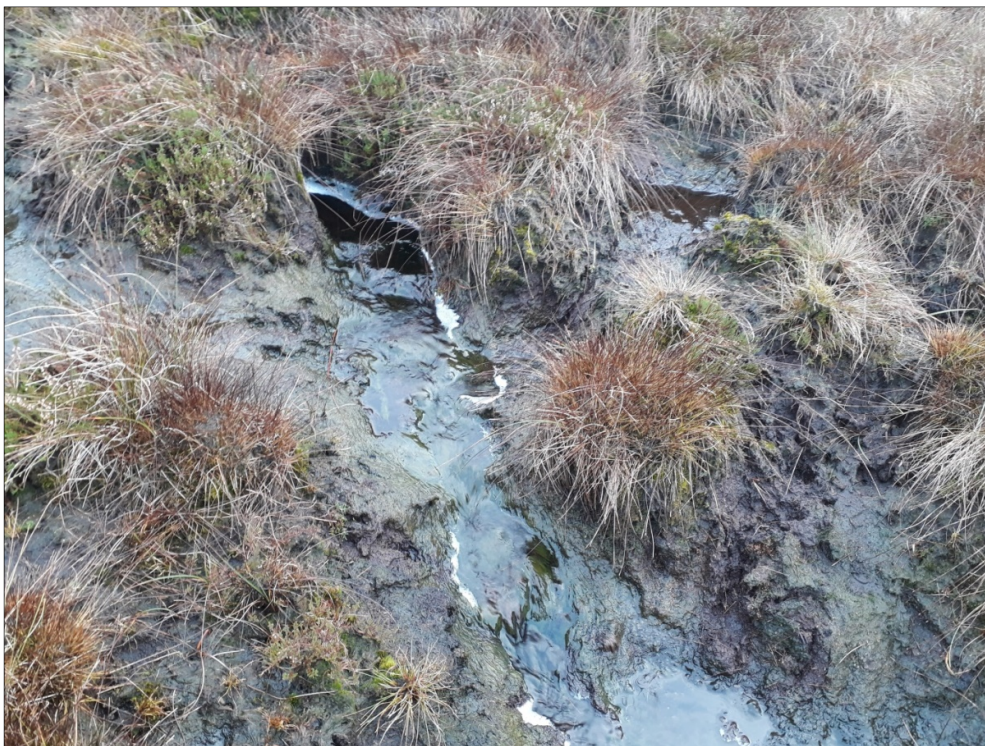
Plate 28. Algal filled eroding peat needs urgent attention on the ridge.

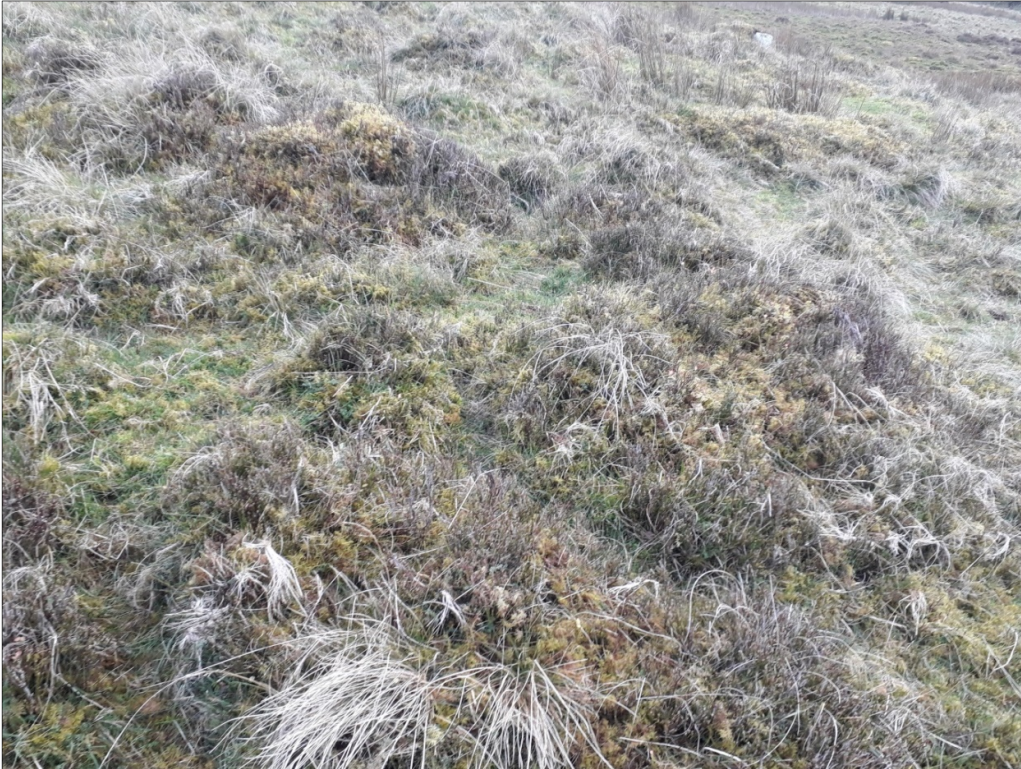
The condition of the acid grassland on the slopes in Area 16 were further examined in 2020. These are showing no sign of recovery from when they were looked at in 2019.

In many areas the grass has been all but browsed out with the sward dominated by mosses or in other instances by dense mat grass (*Nardus stricta*) which is unpalatable to sheep.

Any small pockets of heather in these areas are under intense browsing pressure.

Plate 29. Browsing pressure is clearly evident on remnant areas of heather in the acid grassland dominated slopes above the watercourse in Area 16.

The ongoing shepherding and movement of stock off the upper portions of the commonage above the track on the Round Hill must be implemented to allow these areas to recover.

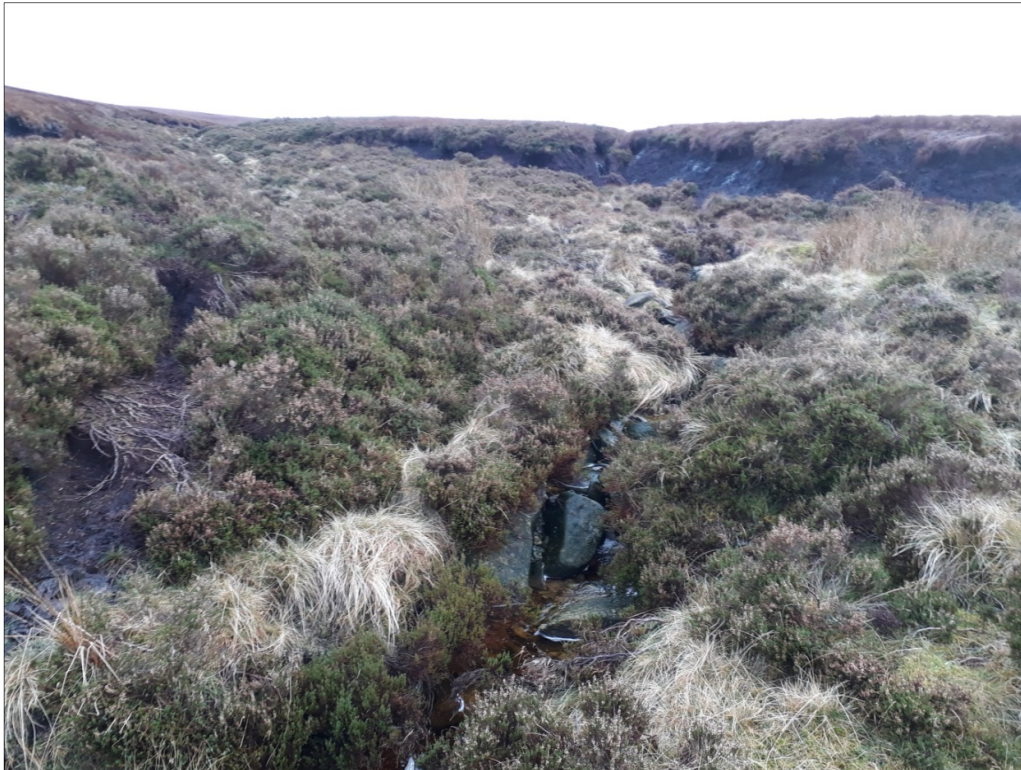
The eroding nature of the blanket bog on the ridge has developed gullies which will provide shelter for trees from exposure and wind but they will need significant protection from browsing pressure and deer.

Plate 30. The establishment of upland gully woodland needs to be prioritised in early 2021.

The establishment of gully woodland along the watercourses in the commonage through a variety of techniques is to be conducted in early 2021.

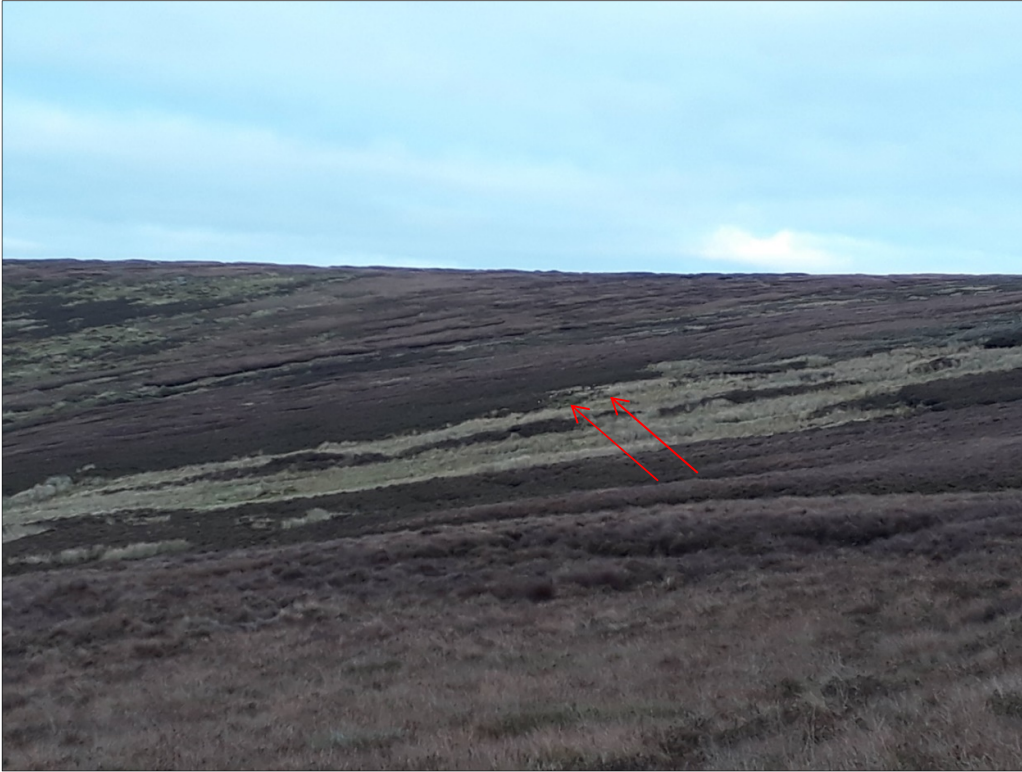
Forty invasive Sitka deer hybrids were recorded during the site visit.

Plate 30. Deer culling needs to take place within the commonage to allow the ridge vegetation to recover following sever burning damage and reduce erosion risks.

Deer populations on the commonage need to be addressed and culled in a collaborative programme with NPWS, Coillte, the Department of Defence and adjoining commonage shareholders.
