Granamore Commonage

2021 Ecological Survey

Final Report

2nd October 2021

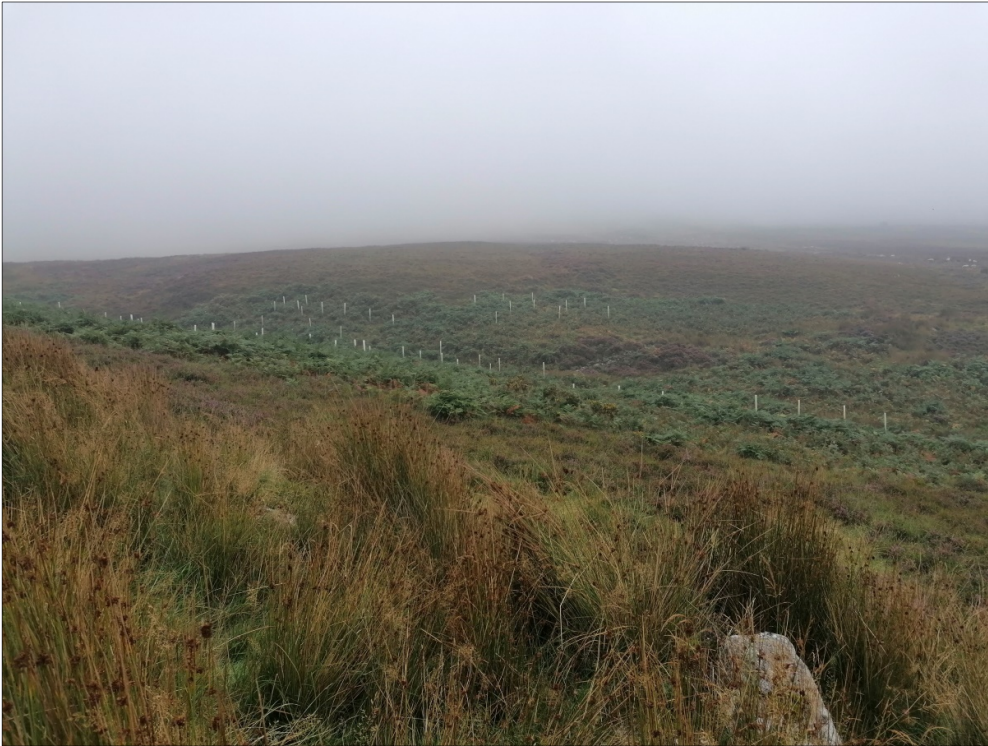
The tree planting on Granamore has been really well executed and has focused on the main channel as shown on **Plate 1** below.

Plate 1. Tree Planting along the main channel.

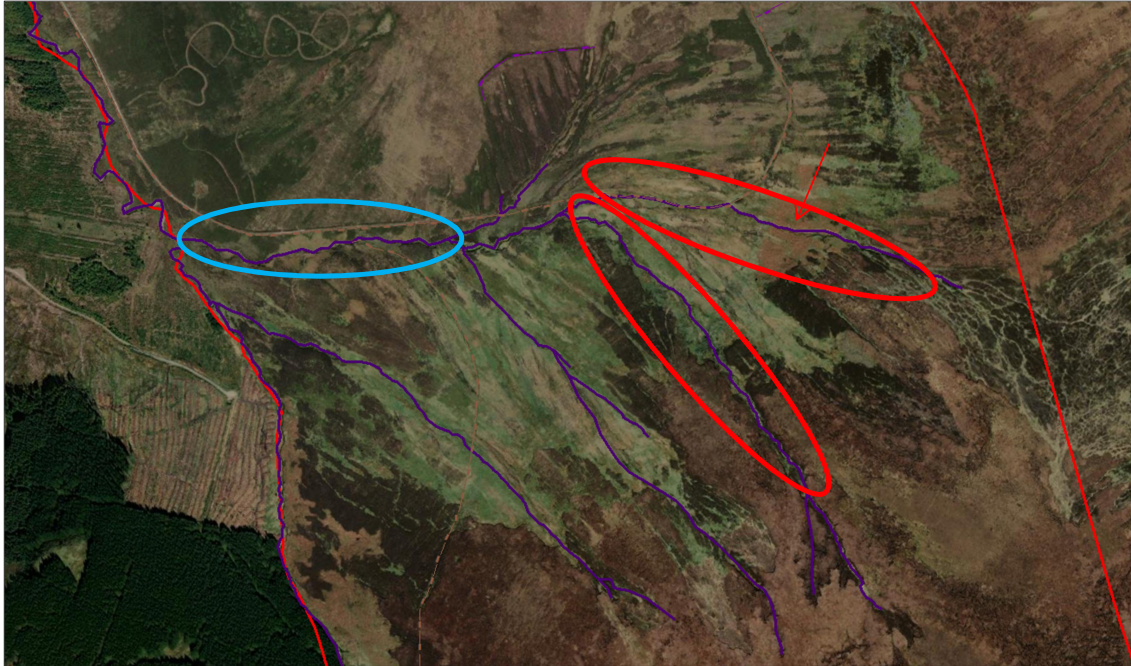
Figure 1. Tree planting at Granmore. Blue area planted in 2021. 2022 planting to focus on the two eastern watercourses shown in red, the area of bracken and the bowl where the erosion is occurring. Area of bracken shown by red arrow.

Following review and discussions on site with NPWS it was agreed that it would be preferable to continue the planting upstream to the two easternmost headwater streams and into those bowls on the slopes which are eroding and where the bracken is and on the drier slopes around the second stream to stabilise that as shown on **Figure 1** and **Plates 2** and **3** below.

Also, just to emphasise about planting the right trees in the right place in terms of oak, birch, mountain ash, holly, whitebeam, yew, and scots pine to go on the drier ground adjoining the watercourse whereas alder, willow and birch will do better on the wetter ground where the rushes are on the flushed slopes and closer to the river.

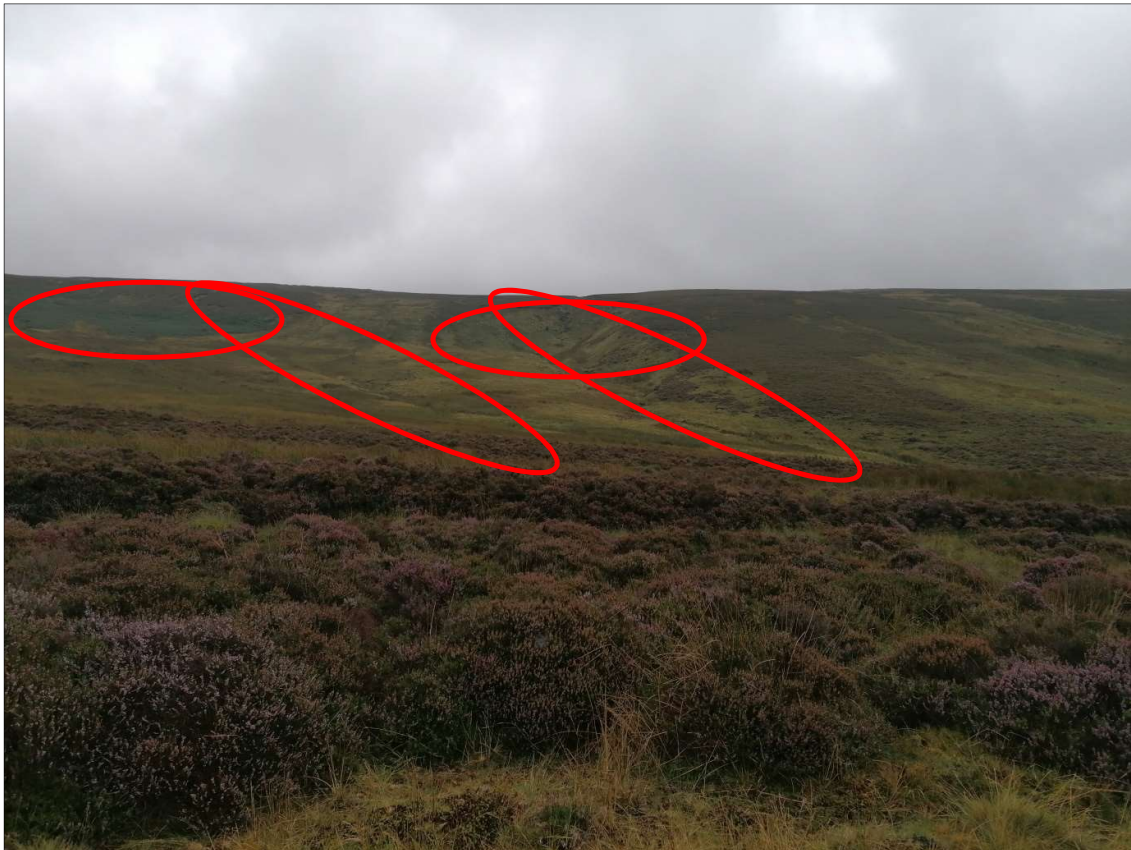
Plate 2. Areas for new planting - along the watercourses and in the bowl and the bracken dominated area.

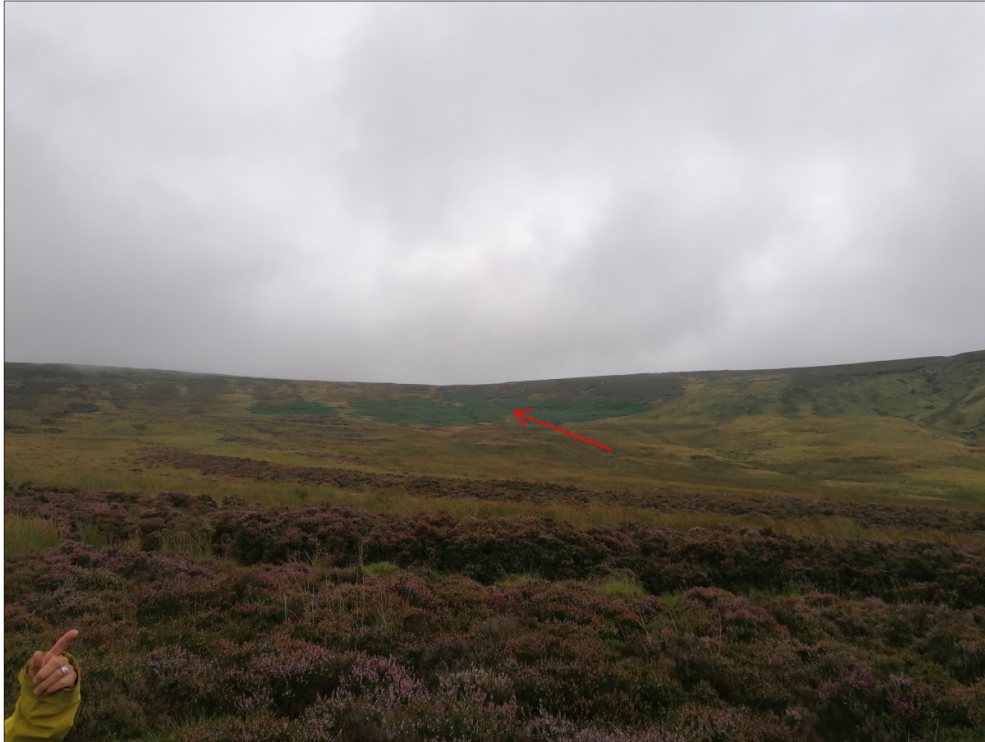
Plate 3. Bracken area to be planted with trees.

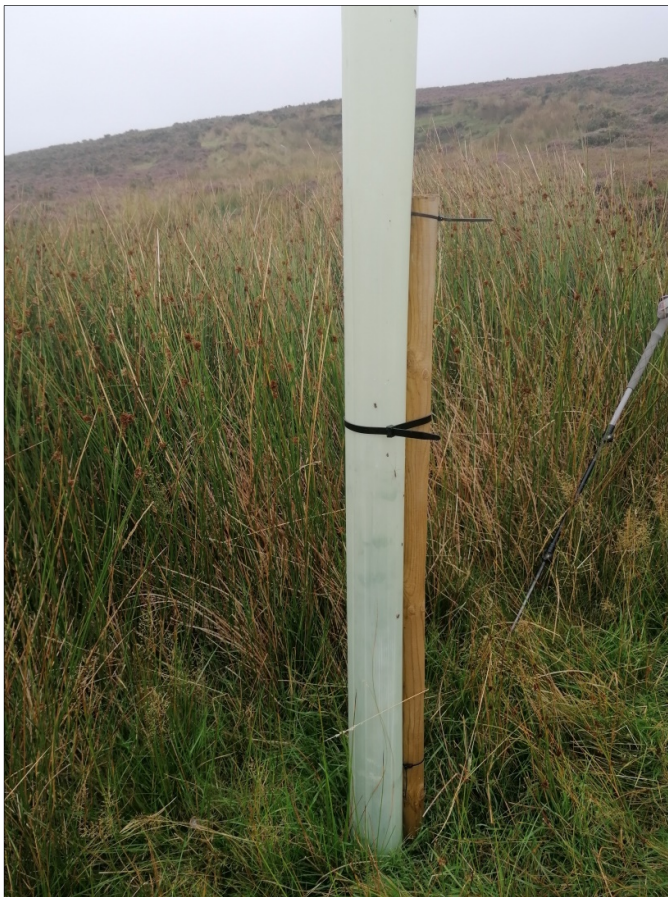
Some of the cable ties are slipping off at the top of the stake and Ann Fitzpatrick from NPWS had a larger reusable one that could simply go around the tube and stake as shown on **Plate 4** below. Heavier stakes are also recommended.

Plate 4. Additional cable ties and the use of heavier stakes are recommended.

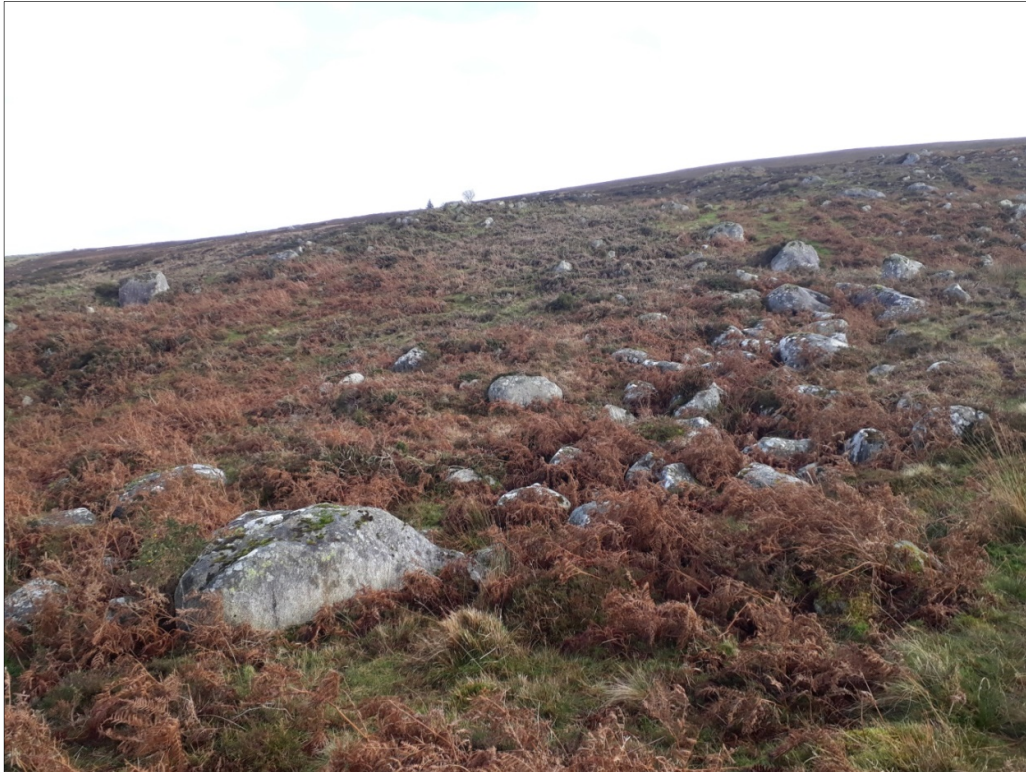
Brushcutting of European Gorse near the entrance to the commonage in Area 10 adjacent to the track was carried out on the 7th February 2020.

Other areas of European Gorse, Western Gorse and leggy Ling Heather in Area 2 have been manually cut and cleared by a crew of contractors using brush cutters in the rough and stony areas. Further areas were cut here with brushcutters on the 7th February 2020.

Plate 5. Flailing and cutting of gorse and heather was done manually on the rocky slopes in Areas 10, 2 and 24 in 2020.

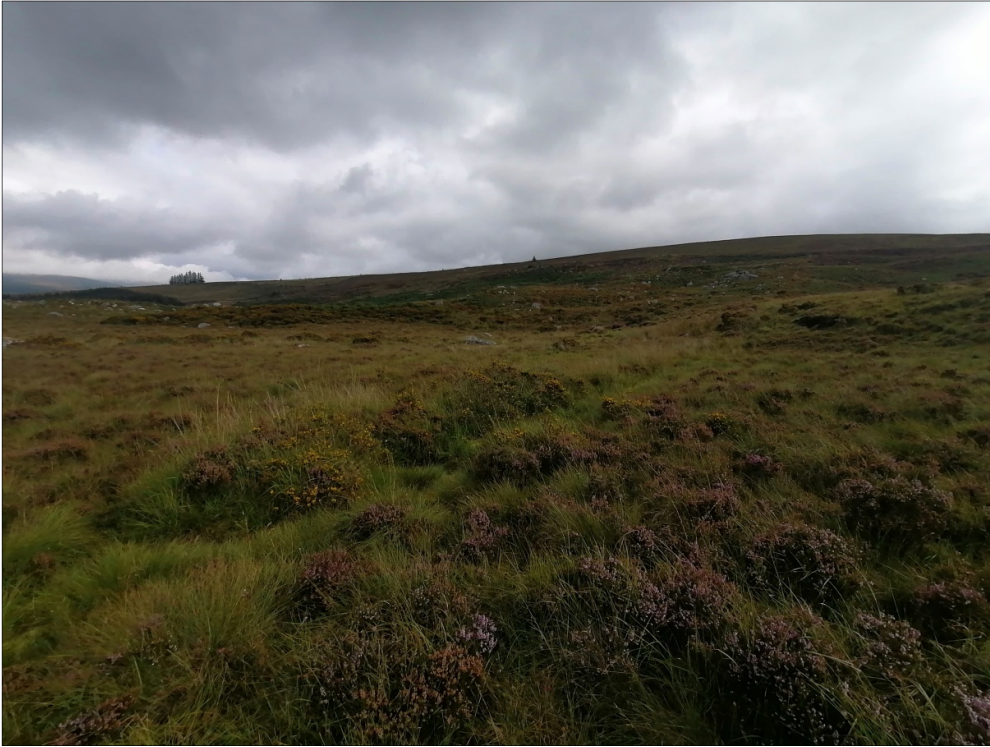
Plate 6. Looking up at the slopes where manual cutting took place.

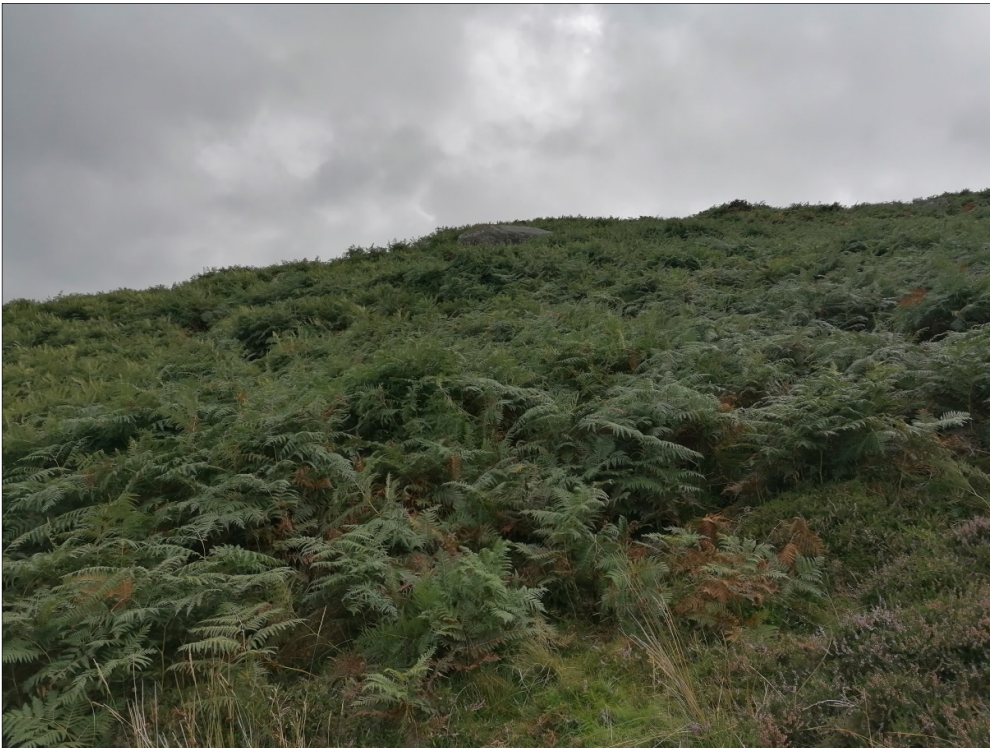
Plate 7. Large areas of bracken dominate these slopes.

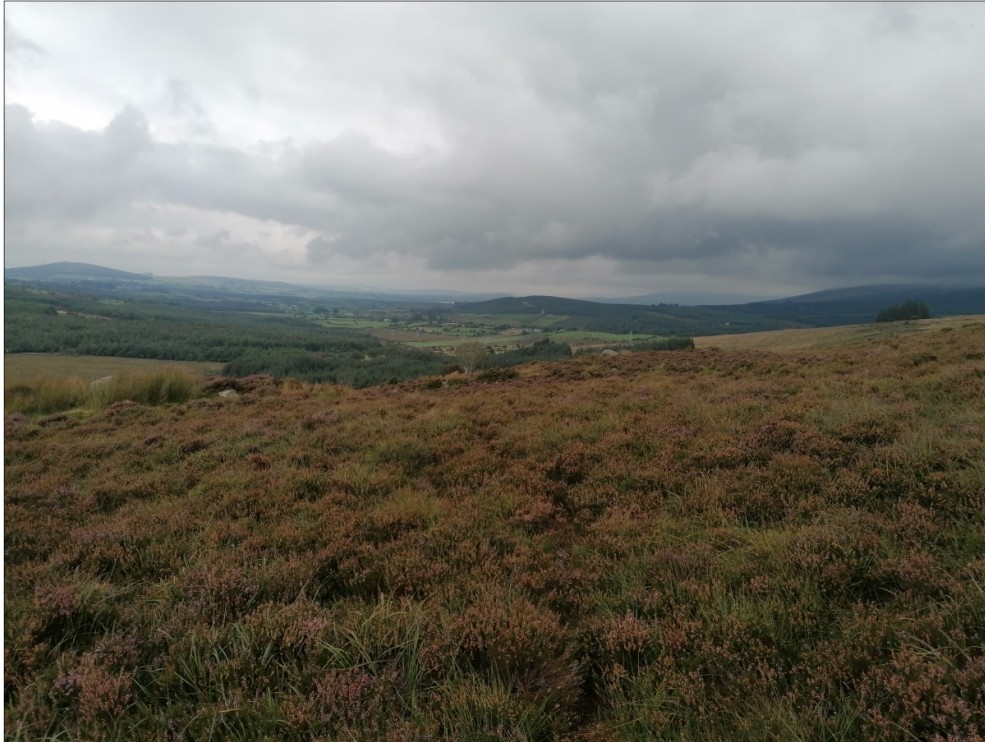
Plate 8. There should be no additional cutting or clearing within area 2 and 24 to allow native woodland to develop around existing trees here as agreed with NPWS.

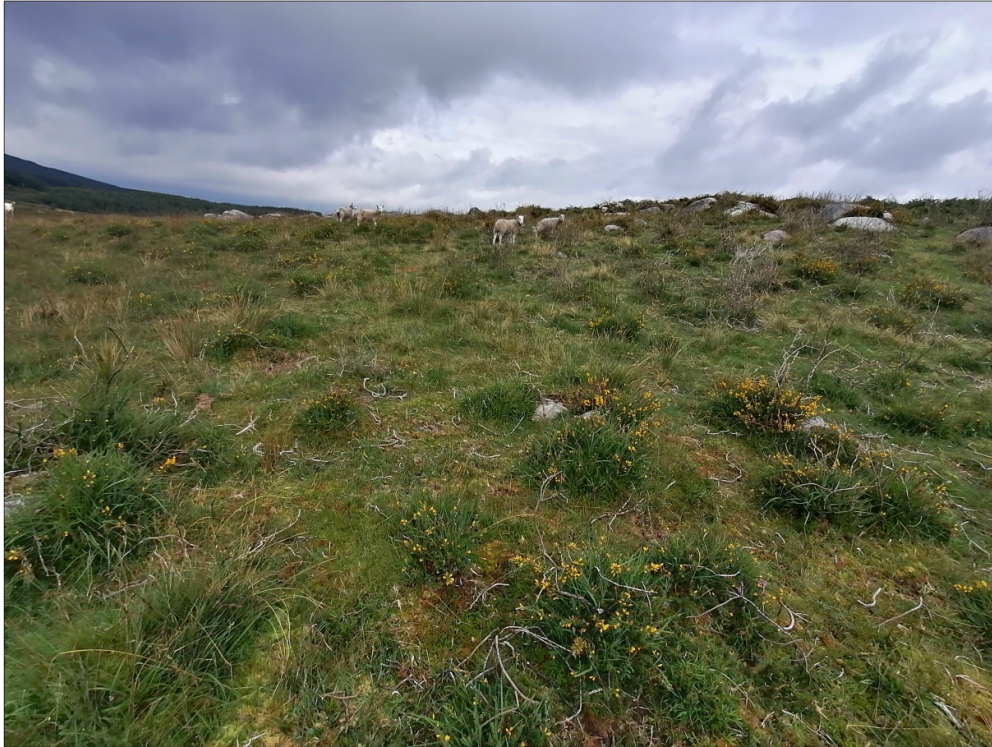
The knolls in Area which were burnt in 2019 were re-examined in 2020 and 2021. Sheep are congregating in this area post burning with extensive dunging and grazing pressure on the grasses underneath. This has resulted in areas of bare soil and poaching. The sheep need to be shepherded regularly out of this area to reduce browsing pressure on same.

Plate 9. Sheep continue to favour the knolls burnt in 2019.

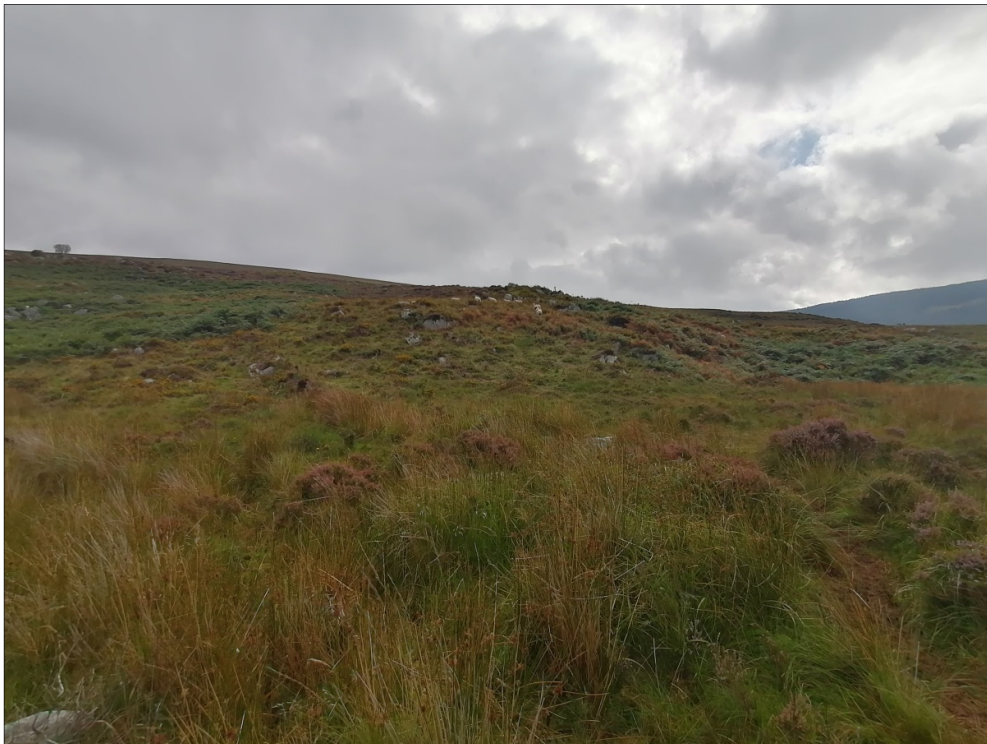
Plate 10. Bracken surrounding the knolls burnt in 2019 - trees would do well here as other methods to control the bracken here would be very difficult given the rough terrain.

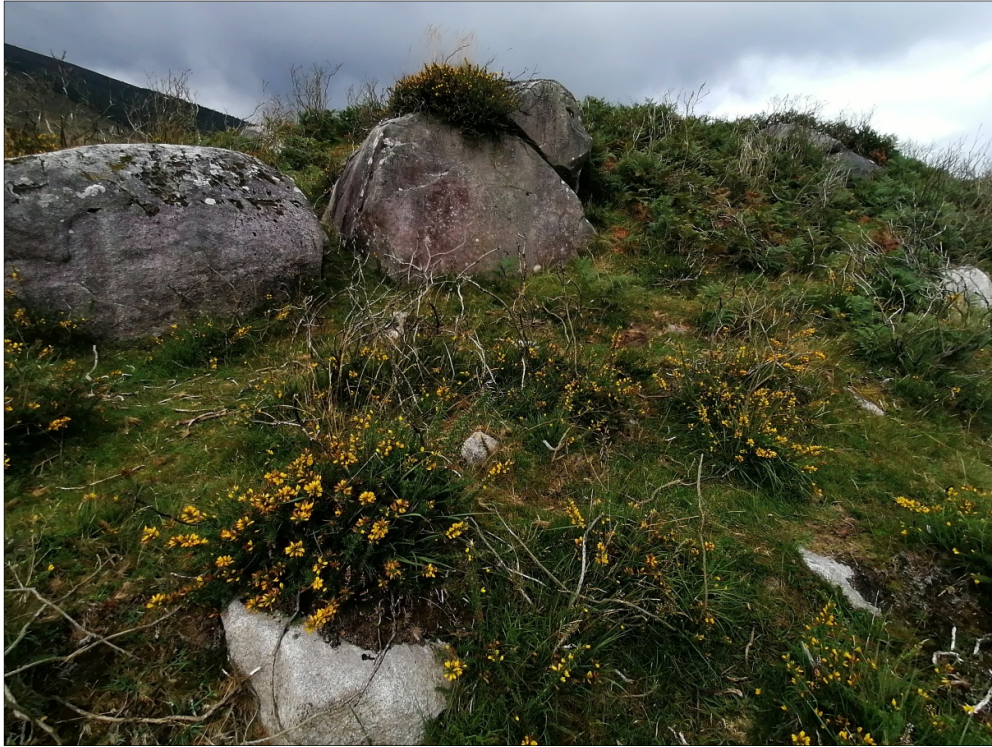
The hillocks are regenerating fairly well. They have a lot of regrowth of autumn gorse but there is also ling heather, tormentil, tufted hair grass, a bit of velvet bent grass, occasional common sedge, some mat grass and a lot of dunging by sheep so the sheep are very much hanging out here. There are also small bits of bilberry. In general the sward is ok, the burning and grazing is just moving it towards grassland and growing gorse really.

Plate 11. Regeneration of gorse on the knolls burnt in 2019.

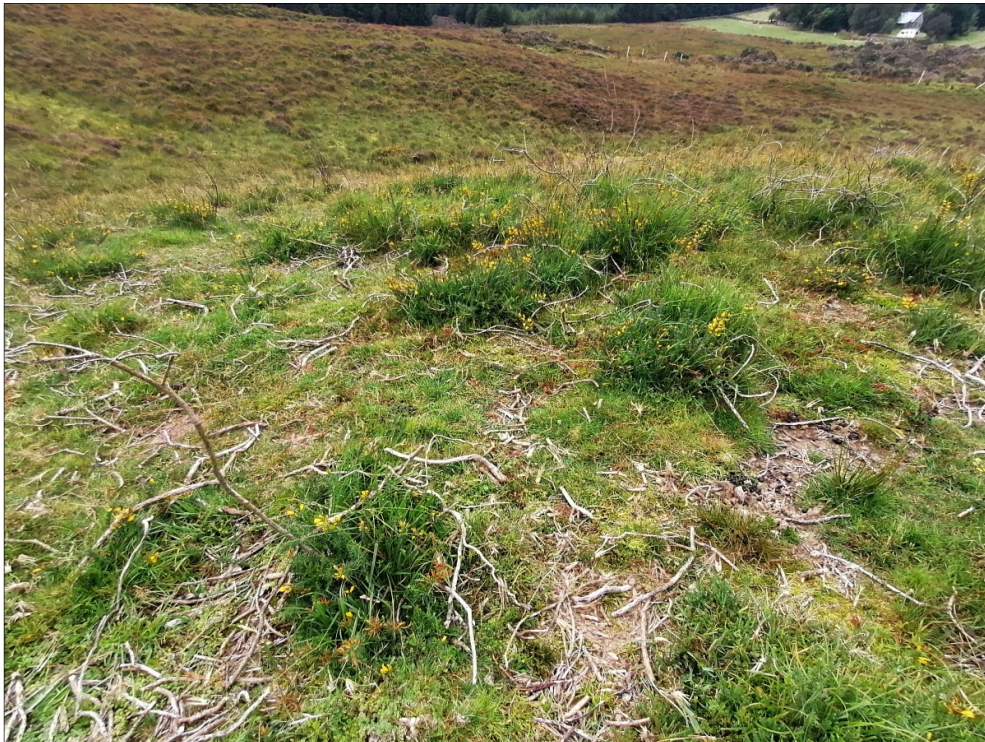
Plate 12. Dunging and some areas of bare soil on the areas burnt in 2019.

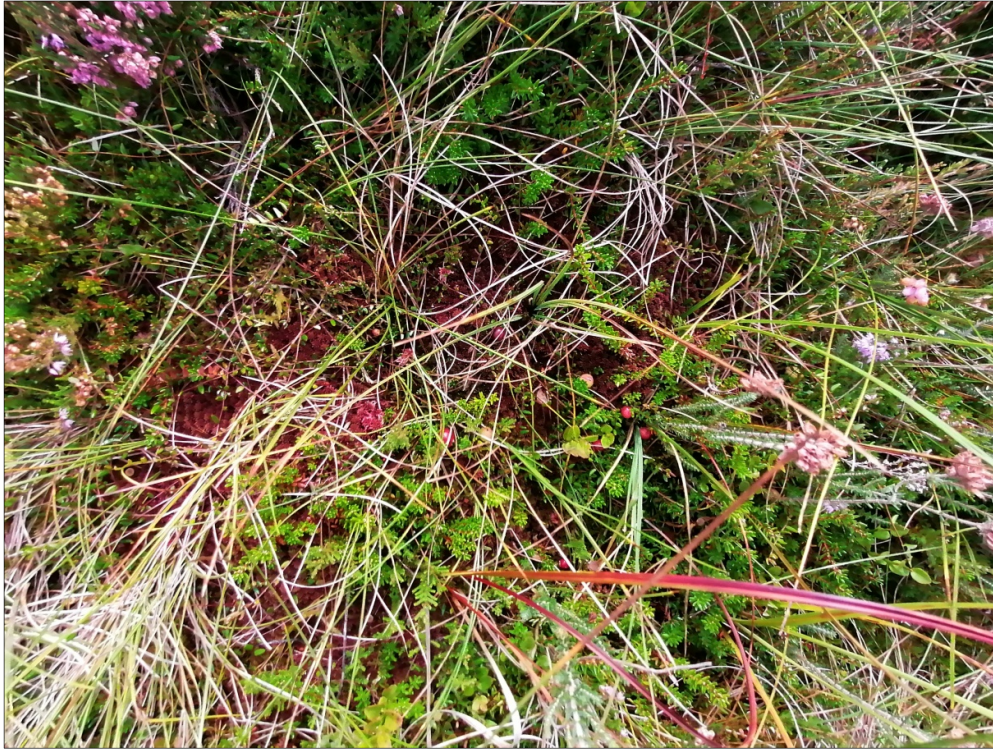
Plate 13. It is very important that areas of intact mountain blanket bog habitat are not burnt or damaged.

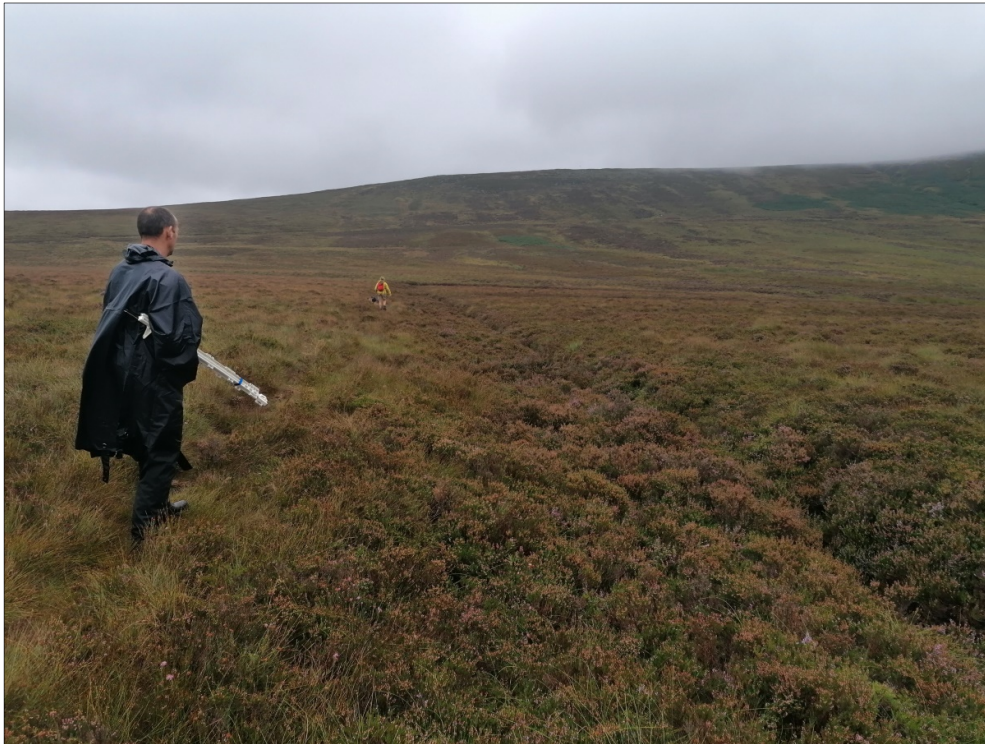
Plate 14. The main drain along the northern edge of the cutover bog on the southern side of Round Hill.

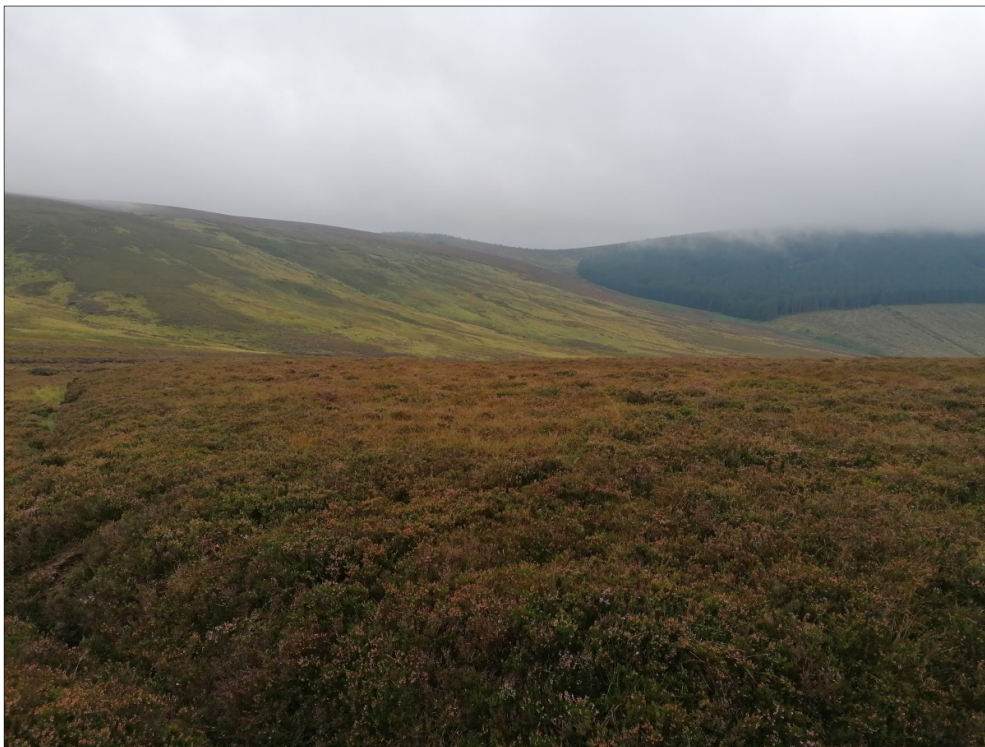
Plate 15. The eastern end of the drain.

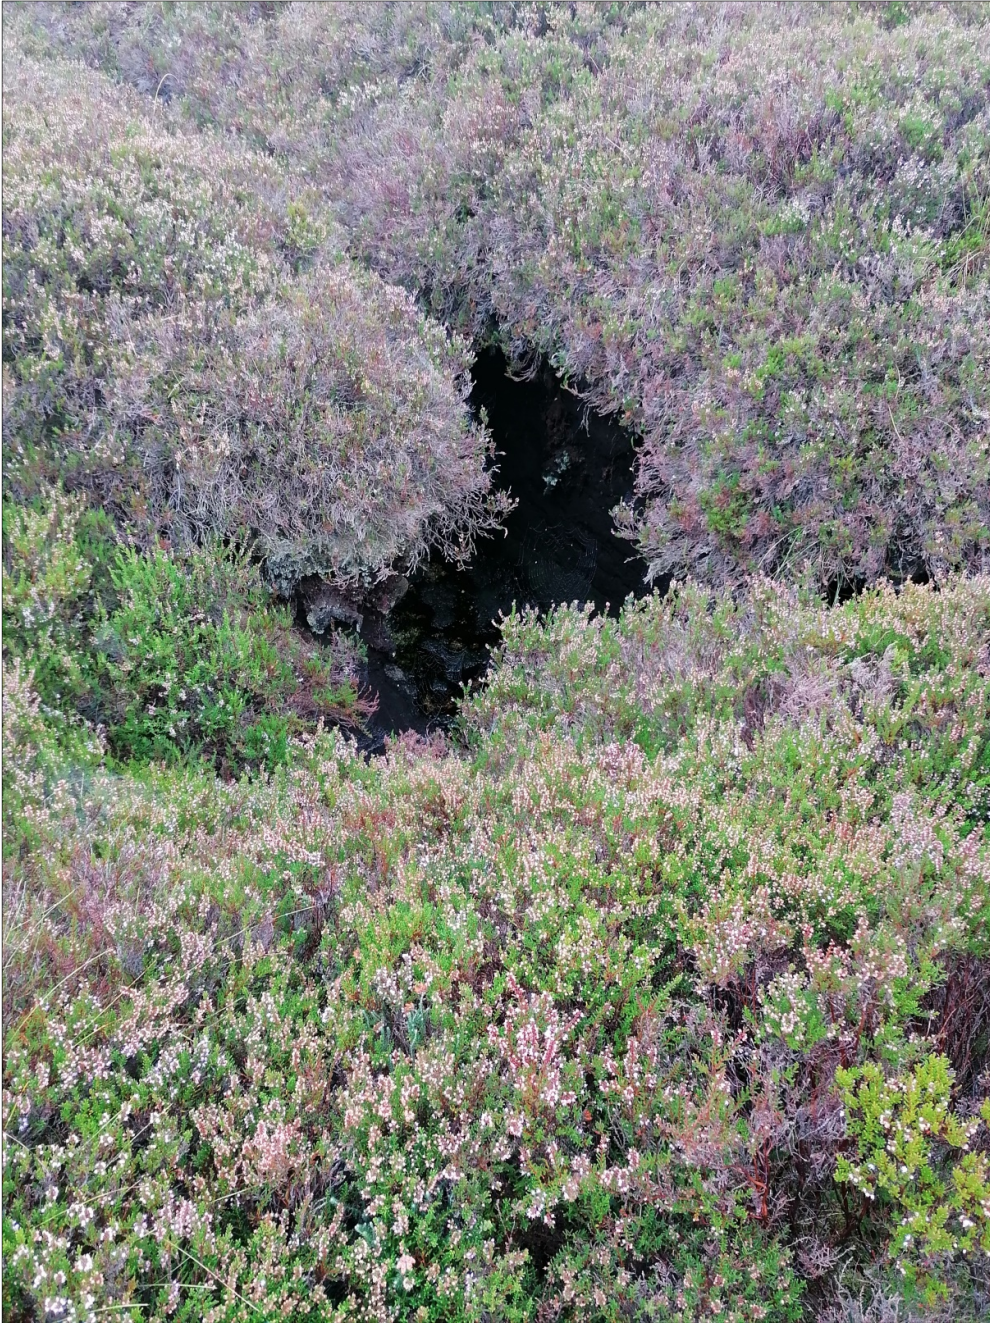
Plate 16. The drain is very deep with steep sides. Drains extend from here into the cutover.

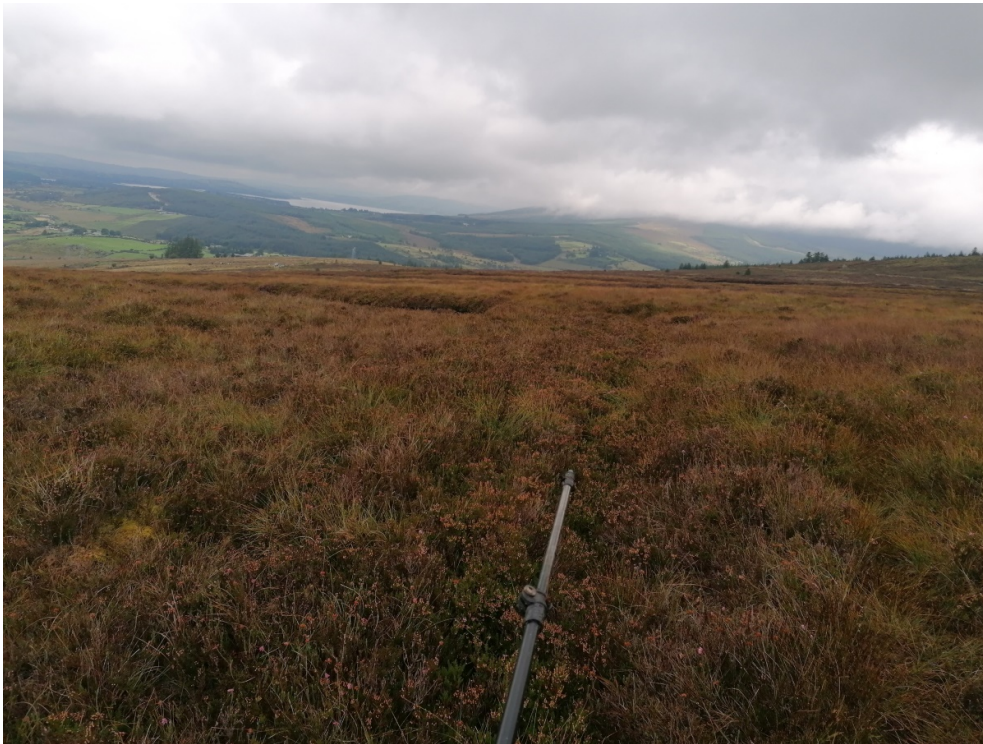
Plate 17. Drains such as this one could be further investigated for their suitability for drain blocking to restore the hydrological function of the areas of cutover bog on the north slopes of Round Hill.

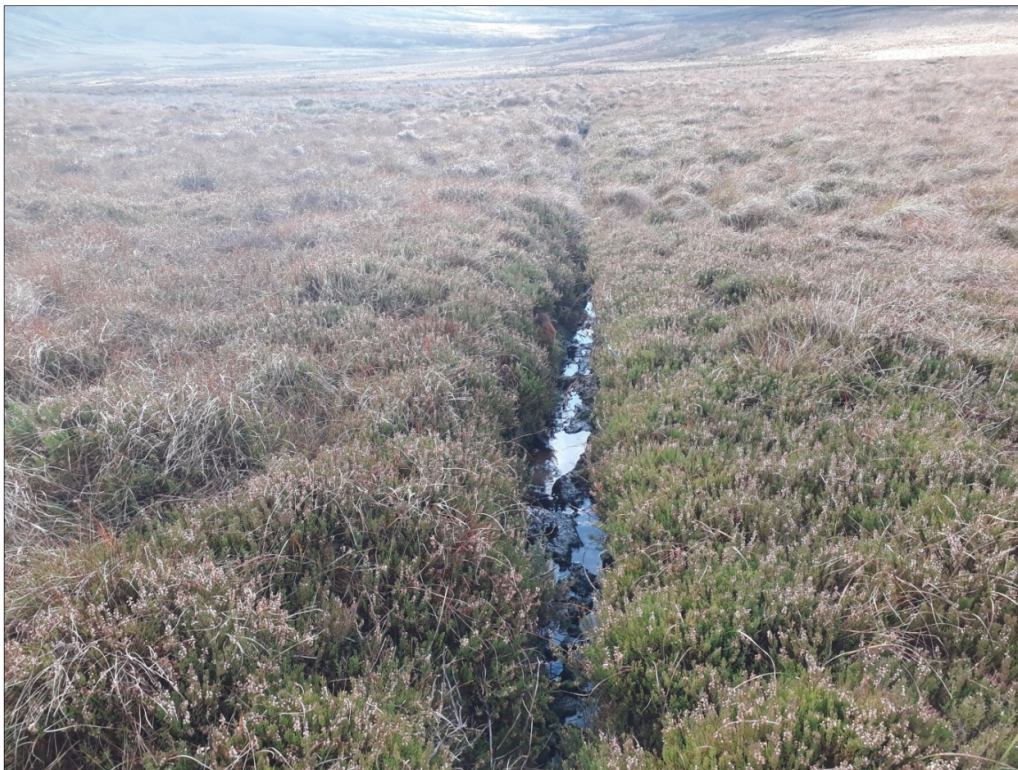
Plate 18. Drain along the northern edge of Area 19 above the track on the slopes below Granna Rock awaits blocking.

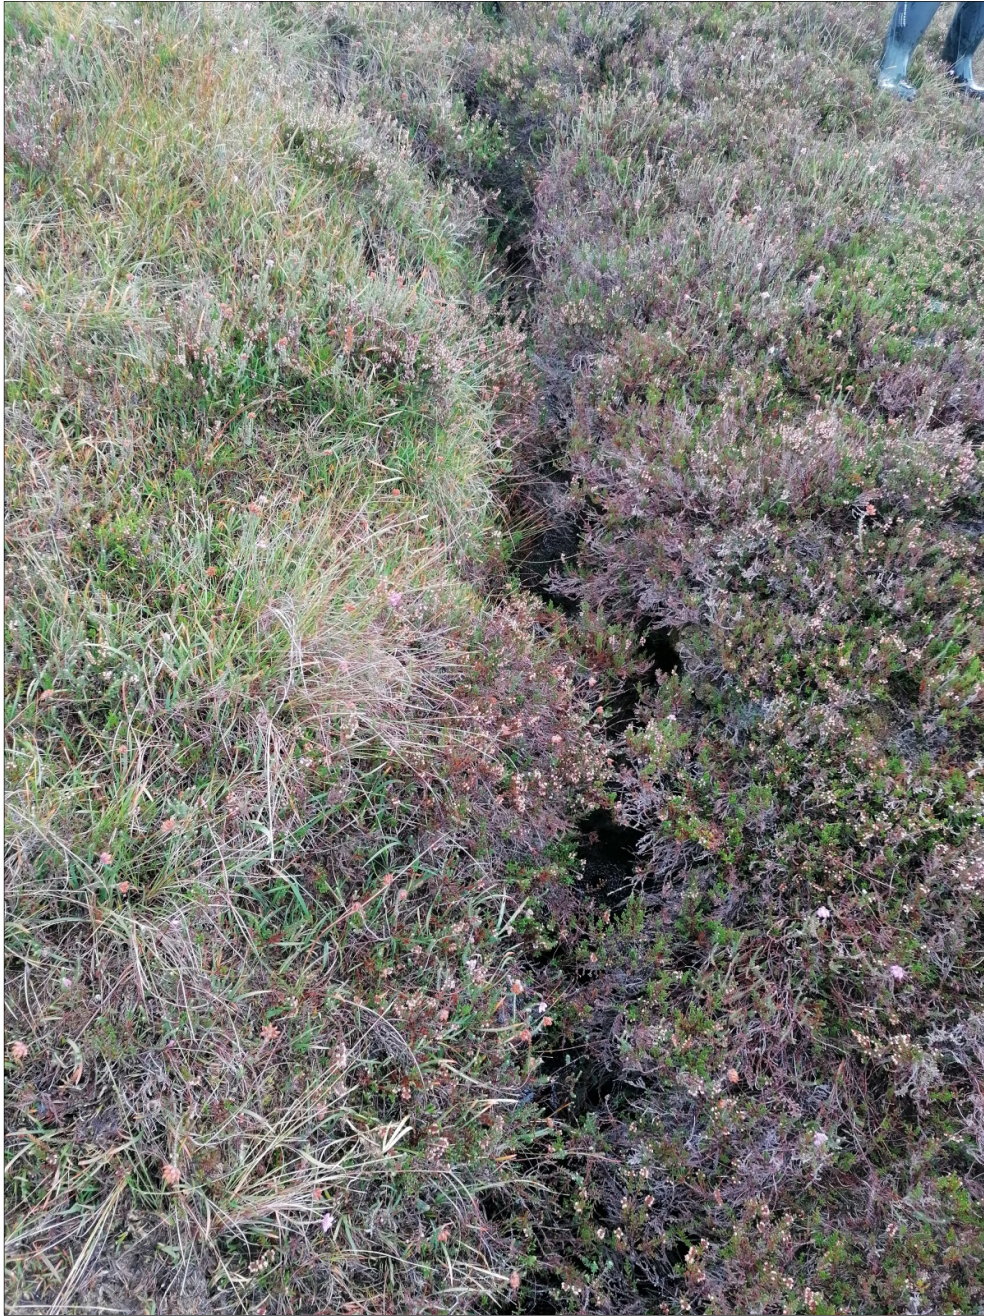
Plate 19. Some drains associated with the former turf cutting on the northern side of Round Hill could be blocked in these areas.

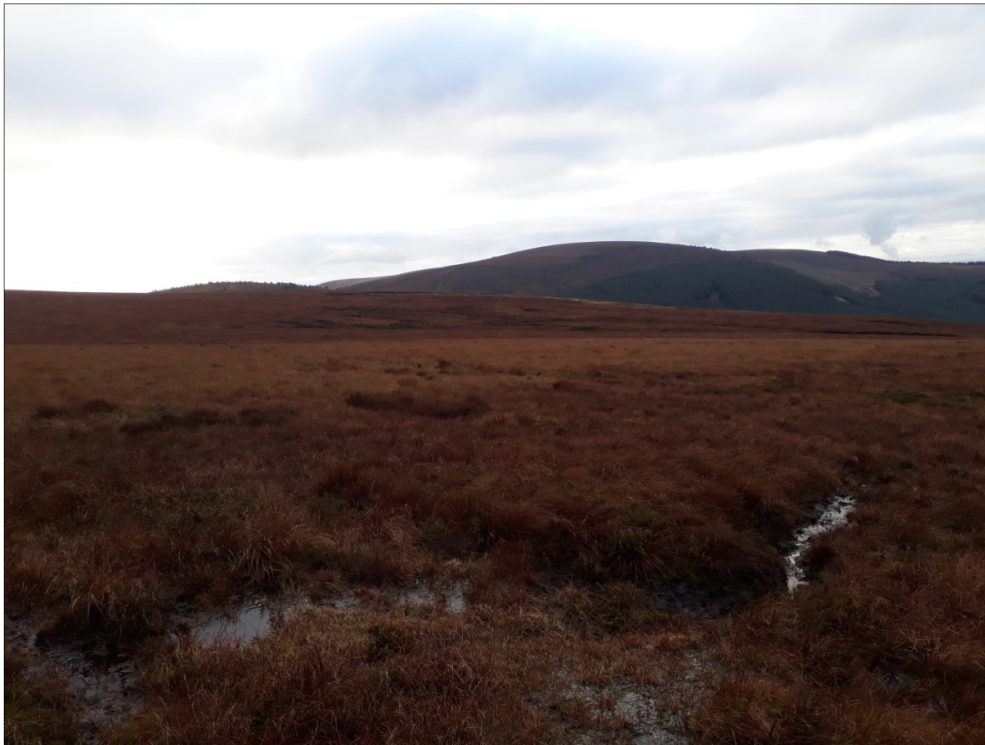
Plate 20. Erosion gullies on the ridge in Area 3.

This work needs to be prioritised in 2021/2022.

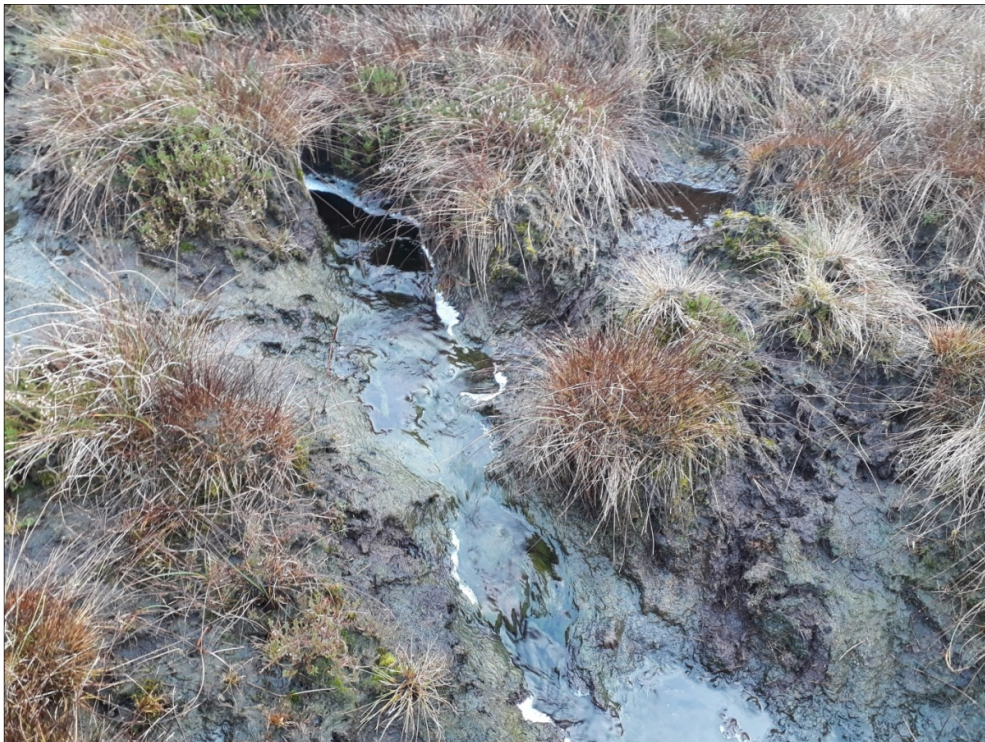
Plate 21. Algal filled eroding peat needs urgent attention on the ridge.

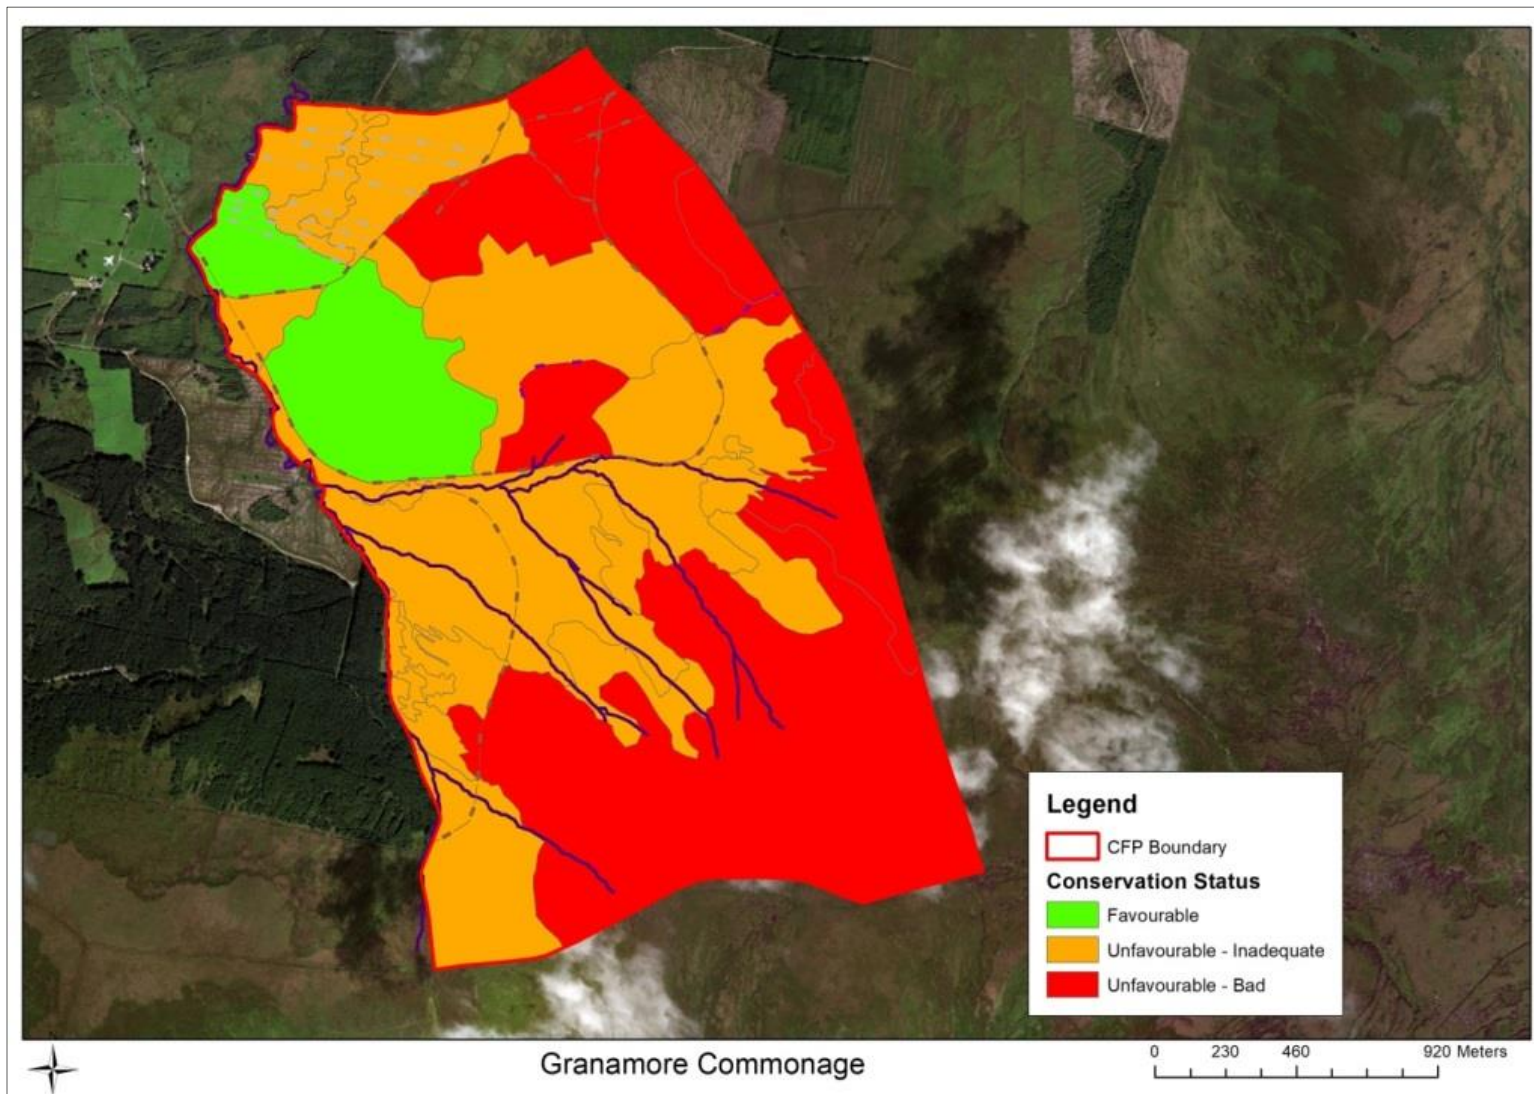
Figure 3. Habitat Condition Assessment for Granamore Commonage.

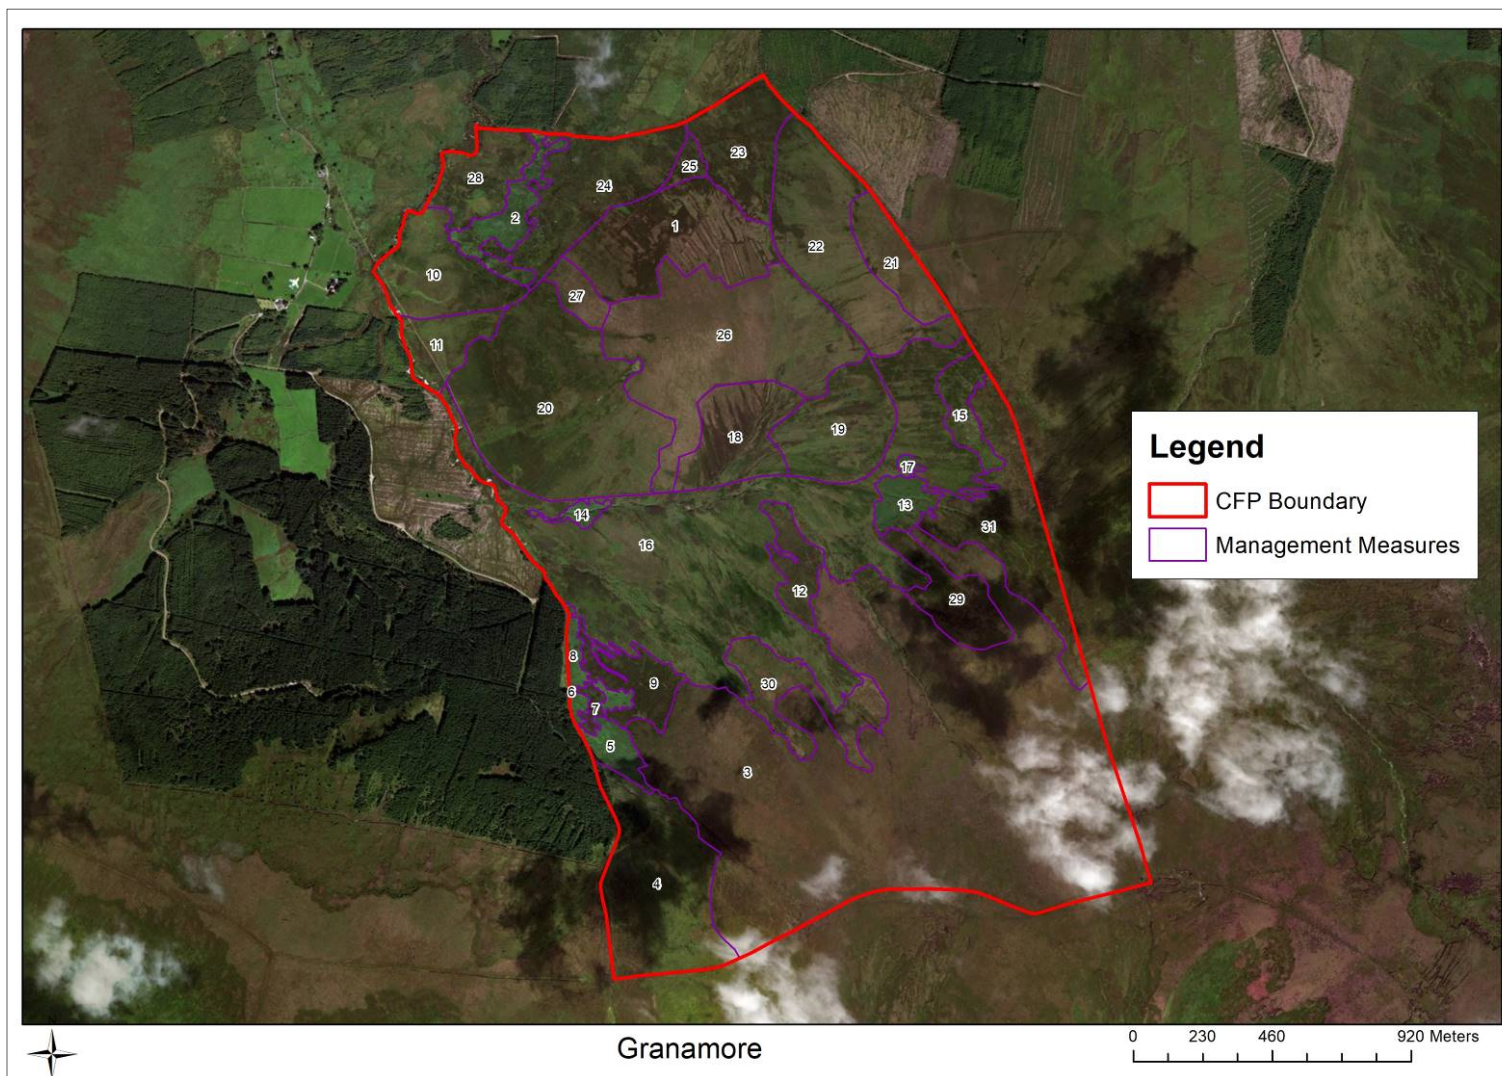
Figure 4. Management measures for Granamore.
