Great Sugarloaf

Great Sugarloaf (Section 1)

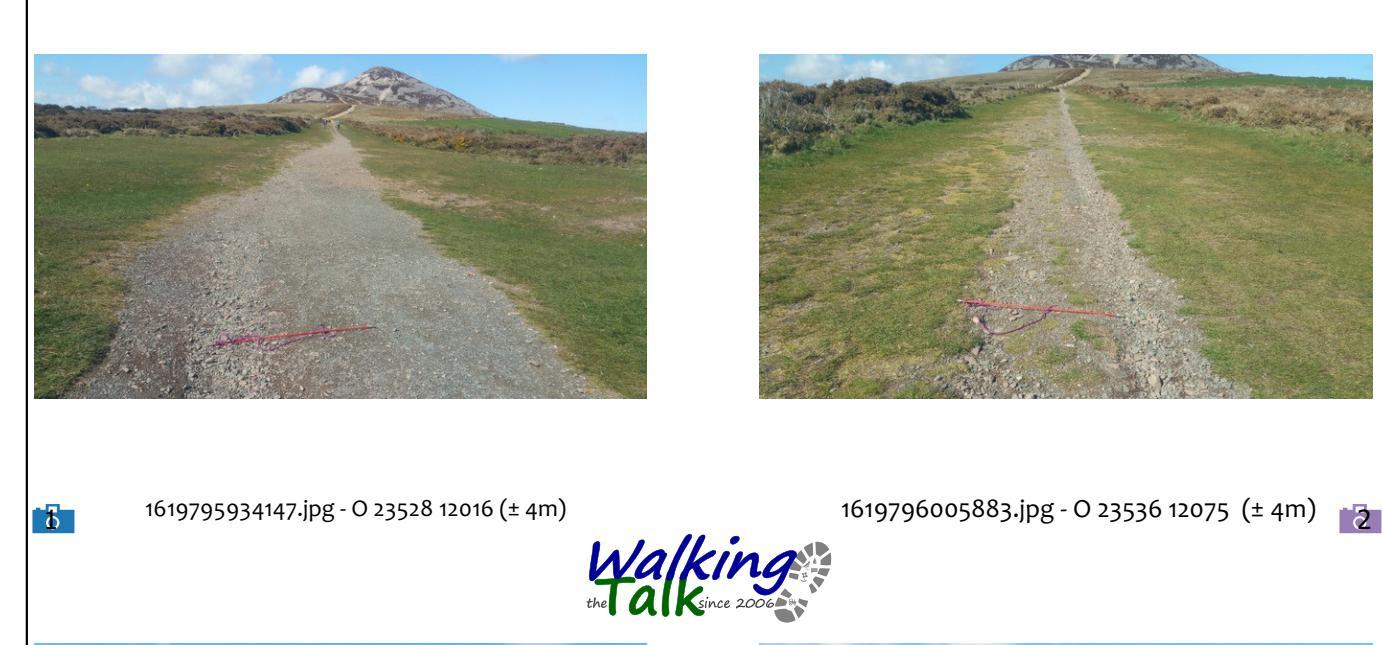
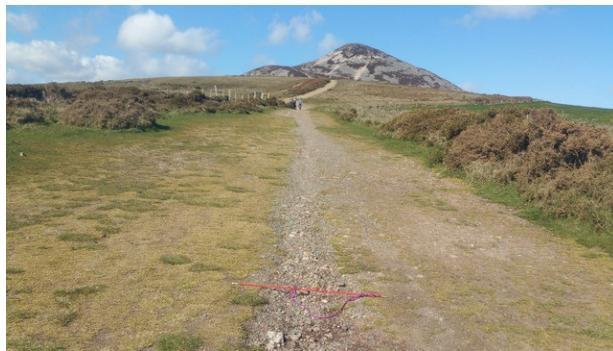
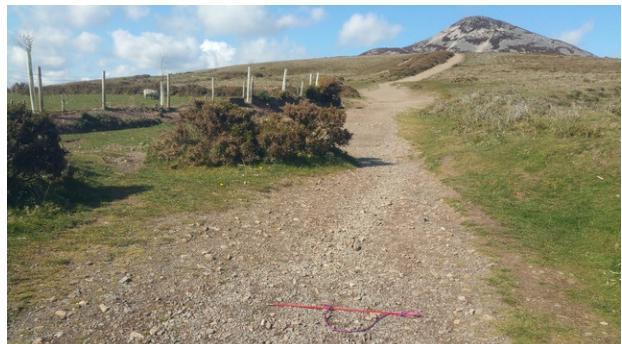
Section description: Start of path. Wide track with extensive trampling. Difficult to constrain people on open ground. Some signs of surface water erosion.

Substrate		Peat Depth ((cm)	Availability of Materials: None required
mineral_soil		0		
				Site Assessment: Easy access for machinery from
	Minimum	Maximum	Typical	car park - easiest completed with excatator
Trampled width (m)	2.5	8	8	(supervised) - 0.5 day's work
Bare width (m)	1.2	1.5	3	
Eroded depth (m)	0.1	0.1	0.2

Work type	Estimated input	Work Summary
minor_repair	20 days labour	Create three grade reversals across the track to intercept water with ditches to soakaways - could improve line definition (narrow to 2m if not used for agricultural access)

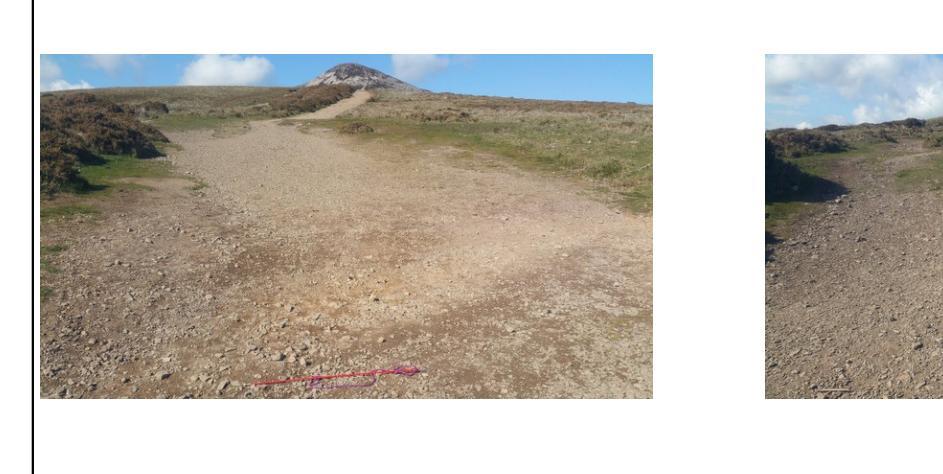
Section description: Section starts at fence corner, with increased gradient. More extensive erosion visible with widening and braiding to avoid loose stone on the main line.

Substrate		Peat Depth (cm)		Availability of Materials
mineral_soil		0		aggregate
	Minimum	Maximum	Typical	Site Assessment: Easy ma
Trampled width (m)	8	8	16	day's work with (supervis
Bare width (m)	6	6	7	grade reversals; 5 days w
Eroded depth (m)	0	0.1	0.2	excavator to resurface us

Work type	Estimated input	Work Summary
minor_repair	4 days labour	Install 3 grade reversals across surface to intercept water; could be resurfaced to reduce the roughness (encourage people to use the main line) - 2m wide unless used for agricultural access.

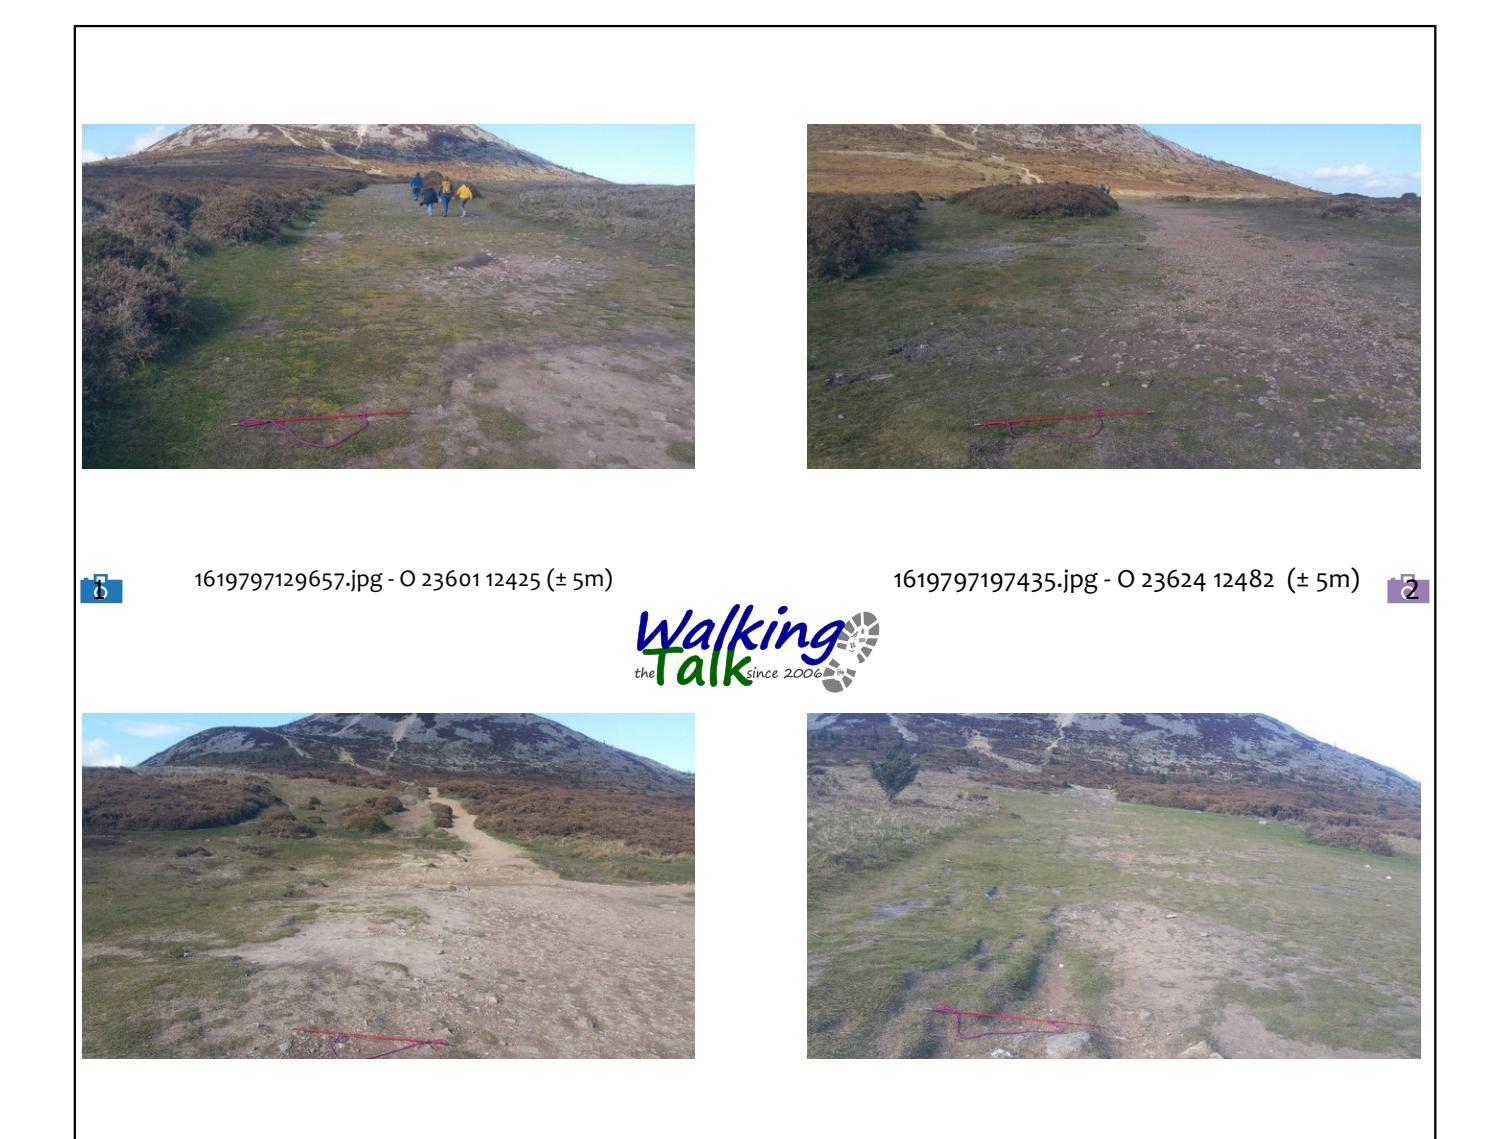
Section description: Section starts at break in slope (increased gradient). Very wide trampled zone with some signs of braiding (one main braid)

Substrate		Peat Depth ((cm)	Availability of Materials: Aggregate and block
mineral_soil		0		stone on site
	Minimum	Maximum	Typical	Site Assessment: Easy access for machinery from
Trampled width (m)	2	8	20	car park optional full upgrade 70 days labour or
Bare width (m)	0	5	6	10 days (with supervised excavator)
Eroded depth (m)	0	0.1	0.3

Work type	Estimated input	Work Summary
minor_repair	4 days labour	Install drainage to intercept water and close braids as minimum. Could be upgraded to fully repaired path up to 2m wide using locally won aggregate with anchor bars.

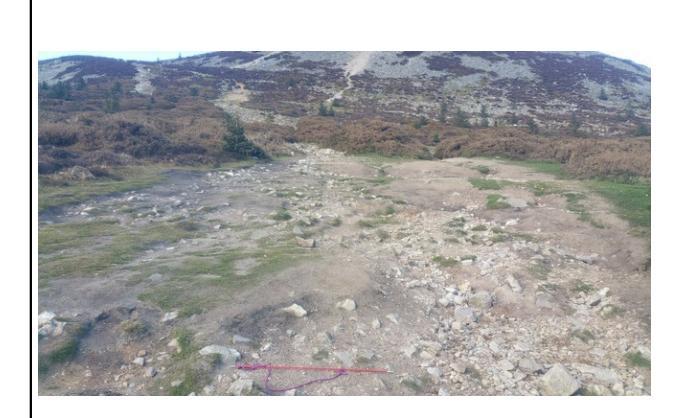
1619797944955.jpg - O 23709 12752 (± 5m)

Section description: Section starts at junction with way marked trail. Wide trample zone with multiple braids within this area. Damage is extensive with significant erosion with boulders exposed and some loose stone. Gorse works well to constrain further development.

Substrate		Peat Depth ((cm)	Availability of Materials: Aggegate and stone
mineral_soil		0		on site - (supervised) excavator could be used
				win materials for surfacing (which would red
	Minimum	Maximum	Typical	labour input)
Trampled width (m)	6	7	11	
Bare width (m)	6	7	11	Site Assessment:Could be used as a good
Eroded depth (m)	0.2	0.3	0.7	training site for path workers

Work type	Estimated input	Work Summary
major_repair	200 days labour	Needs to be fully restored with a mix of stone pitching, aggregate surfacing with anchor bars. Braids need closing and significant amounts of landscaping to help retain people on the preferred line. Path to be 1.5 to 2m wide.

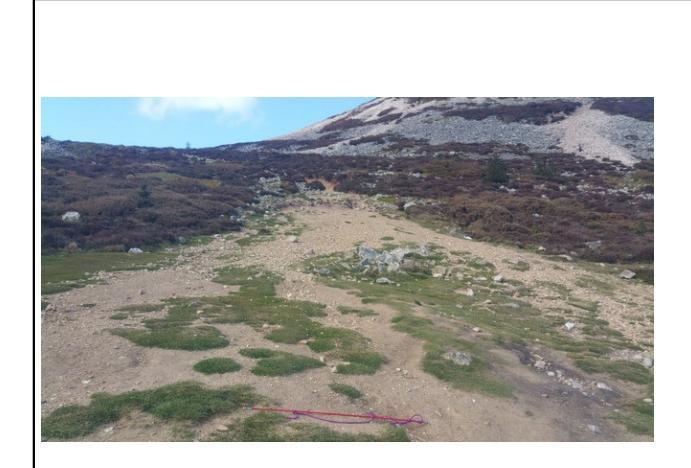
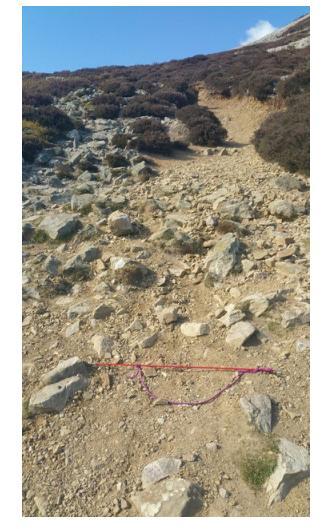
1619798684249.jpg - O 23712 12918 (± 5m)

Section description: Section starts where path splits. Extreme levels of damage with significant gullying due to surface water and footfall up 1.8m deep.

Availability of Materials: erosion has removed significant amounts of aggregate and block stone - stone available locallys

Work type	Estimated input	Work Summary
major_repair	300 days labour	This section could be used for a main line or section 9 - gully could be used to constrain the route Mix of stone pitching and aggregate surfacing with anchor bars. Path to be 1.5m wide (possibly with a few wider 'passing' places')

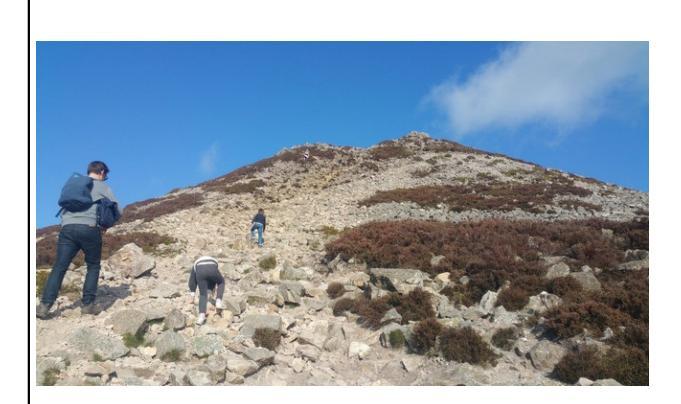
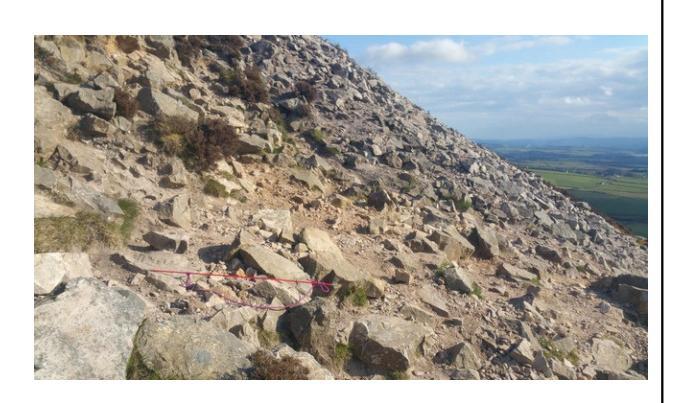
20210430_174626.jpg - O 23675 13099 (± 4m)

Section description: Top 'cone' of the hill and the main approach to the summit. There is a central gully which is heavily eroded but provides an 'adventure' option of scrambling (not easy on descent). There are multiple braids that intersect. Some braids have loose rock or traverse bedrock. Potential liability issues if renair / construction is done on the gully and it

Availability of Materials: Good availability of block stone. May need to winch materials up slope or may need helicopter to relocate stone if there is insufficient nearby (100 bags should be plenty)

Work type	Estimated input	Work Summary
major_repair	250 days labour	Major restoration required with boulder pitching and revetment - careful line selection is important. One option would be to define two routes (intended as ascent and descent - see section 8) and stabilise the gully to prevent boulder collapse. Path to be 1.2 - 1.5m wide

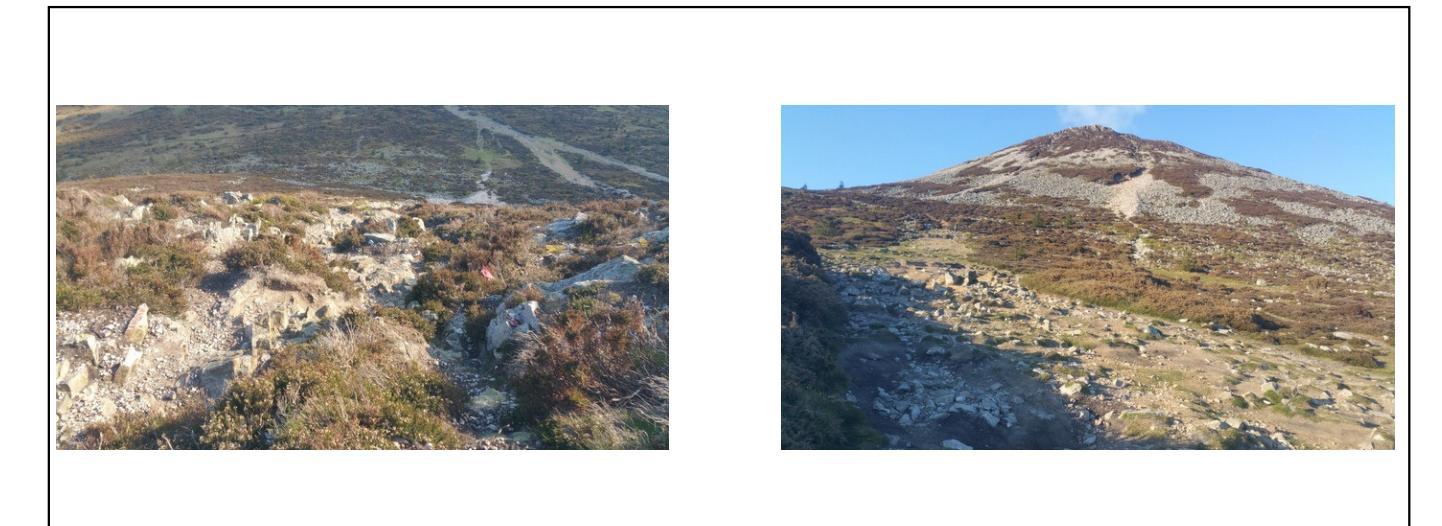
1619802110142.jpg - O 23798 13054 (± 5m)

Great Sugarloaf (Section 7)Start: O 23798 13054 (± 9m)End: (± m)Section description: This section is the south face direct route with loose scree and boulders. The scree slope is significantly eroded and this seciton is visible from a long distance.

Substrate		Peat Depth (cm)		Availability of Materials:
bedrock		0		
				Site Assessment: Unsustainable braids - steep
	Minimum	Maximum	Typical	ground with loose rock
Trampled width (m)	30	35	50	
Bare width (m)	1	3	10	
Eroded depth (m)	1	1	1

Work type	Estimated input	Work Summary
Light_touch	50 days labour	Landscaping is required to disguise the route and block easy access. Interpretive signs may be required in the short term to explain why this route is being closed.

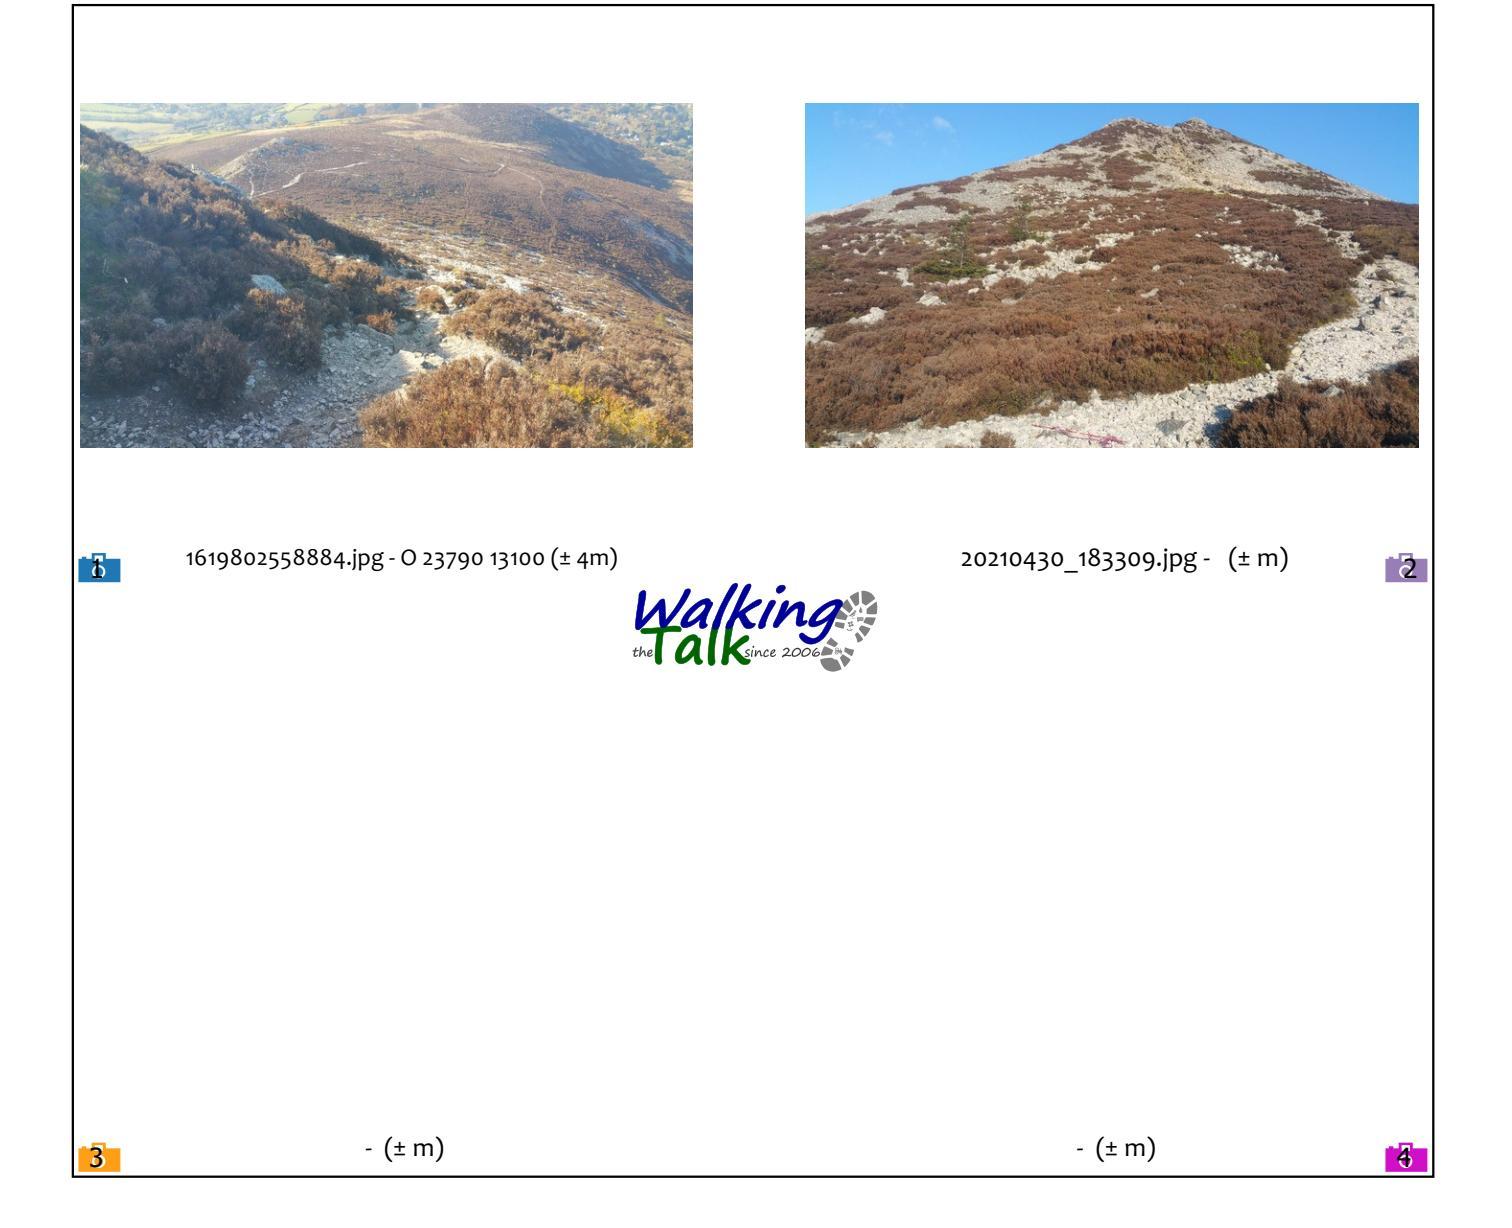
Section description: This section is the braid on the north side of the hill. Less steep gradient than the main route / gully but is not currently used heavily. It could be used as a return / descent route and could be used to allow repairs of the main route. However, it would be difficult to encourage people to use this on ascent in the long term (e.g. instead of the main

Substrate		Peat Depth (cm)		Availability of Materials: Moderately good
bedrock		0		availability; will need large stones winching or
				helicopter
	Minimum	Maximum	Typical	
Trampled width (m)	1	2	12	Site Assessment: Off the main path so could
Bare width (m)	0.5	1	3	potentially be repaired first allowing a diversior
Eroded depth (m)	0	0.3	0.5	when work on the main path is done

Work type	Estimated input	Work Summary
early_intervention	100 days labour	Could be alternative route to main route during the repair phase (do this section first); pitching and revetment needed. Path 1.2 - 1.5m wide

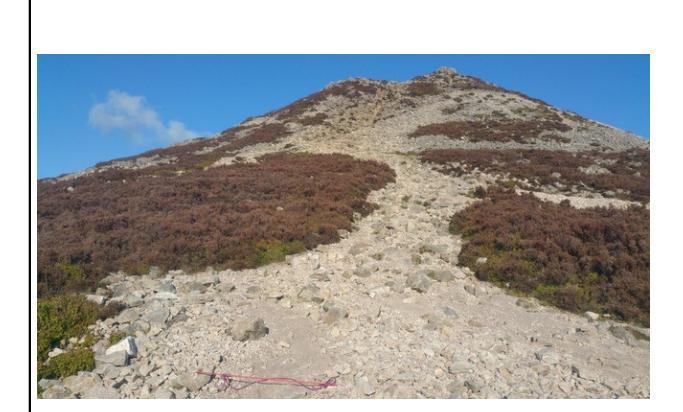
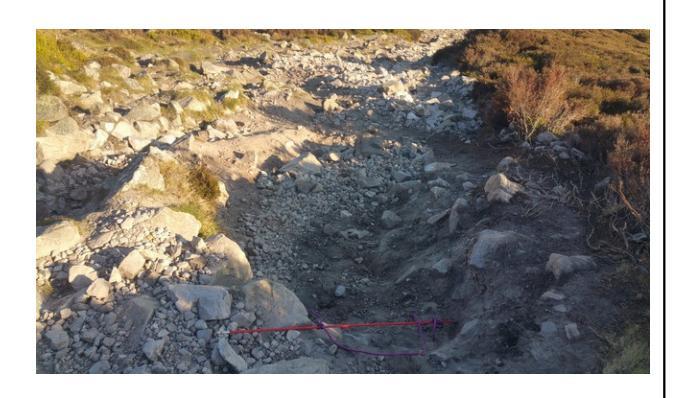
20210430_183028.jpg - (± m)

Great Sugarloaf (Section 9)Start: O 23684 13099 (± om)End: (± m)Section description: Alternative section with variable damage along the length. Parts could be used instead of section 5 and/or 6

Work type	Estimated input	Work Summary
Light_touch	50 days labour	Landscape restoration at key entry points to disguise the braids and help habitats to re-establish. Time allocated to sections 5 and 6 could be swapped if they are to be disguised instead - needs to be determined at the design stage. Total days allocated needs to be flexible between sections 5,6 and 9 to confirm the best route.
