Maulin loop

Maulin loop (Section 1)Start: O 19133 14101 (± 12m)End: O 19006 13876 (± 10m)Section description: Section starts at junction and is a constructed path leading up through forest. There is a short-cut braid part way up.

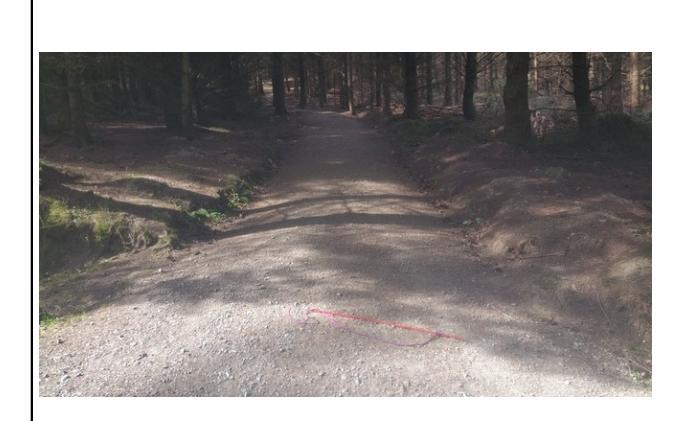
1619169232433.jpg - O 19132 14094 (± 10m)

Substrate		Peat Depth (cm)		Availability of Materials: Recently cut logs
mineral_soil		0		nearby which may be suitable
	Minimum	Maximum	Typical	Site Assessment: Easy access on forest road
Trampled width (m)	1.8	2	4	
Bare width (m)	1.8	2	2.5	
Eroded depth (m)	0	0	0.1

Work type	Estimated input	Work Summary
minor_repair	15 days labour	Logs used as water bars and steps are rotten and need replacing.

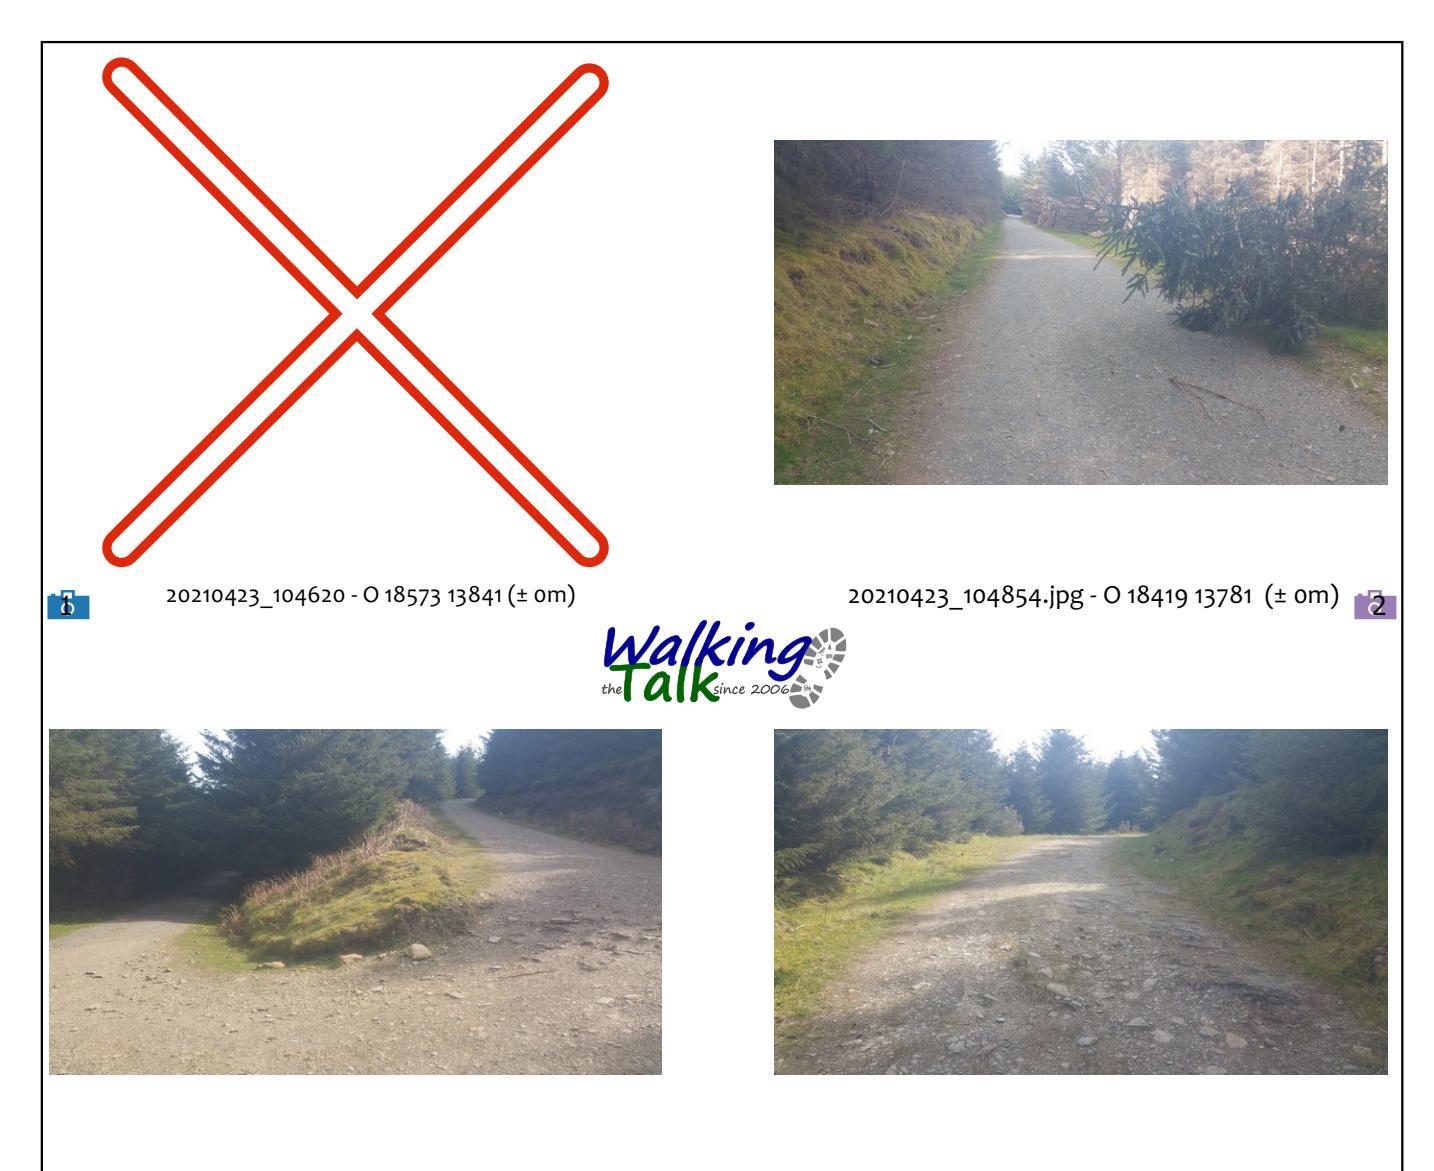
Maulin loop (Section 5)Start: O 18427 13596 (± 9m)End: O 18186 13285 (± 4m)Section description: Section starts at junction with forest road and follows a minor constructed track through plantation woodland.

Substrate		Peat Depth (cm)		Availability of Materials: Logs would be
mineral_soil		0		available
	Minimum	Maximum	Typical	Site Assessment: access for small vehicles
Trampled width (m)	1.5	1.8	2.5	
Bare width (m)	1.5	1.8	2.2	
Eroded depth (m)	0	0	0.2

Work type	Estimated input	Work Summary
minor_repair	5 days labour	Water bars near the top of the section need to be replaced
