Survey date: Apr 20, 2021

**Overall description:** Path leads through agricultural land up to broad ridge which extends towards Tonelagee

**Overall assessment:** Mostly drainage issues that need to be addressed but sections of deep and damaged peat would need full construction (not recommended)

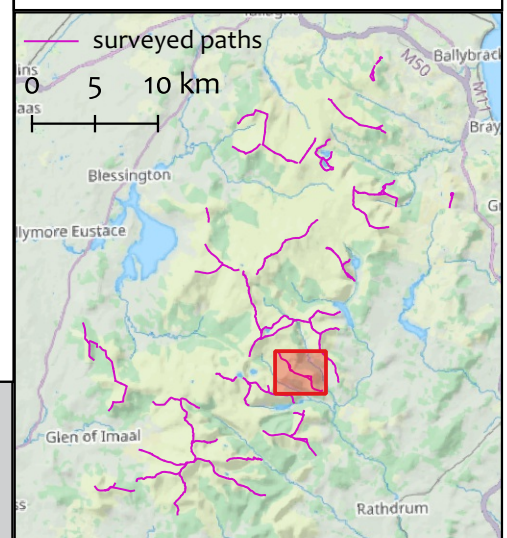
Site Assessment:Work is rough but functional

| minor_repair | 6 days labour | Drainage: 2 water bars; 10m ditch; 4 anchors |

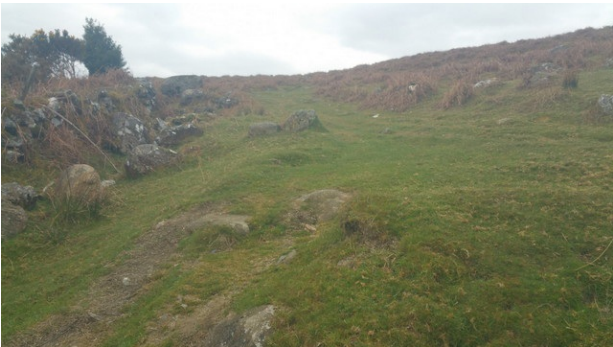
5

**Site Assessment:**Used by agricultural vehicles

| none | | None |

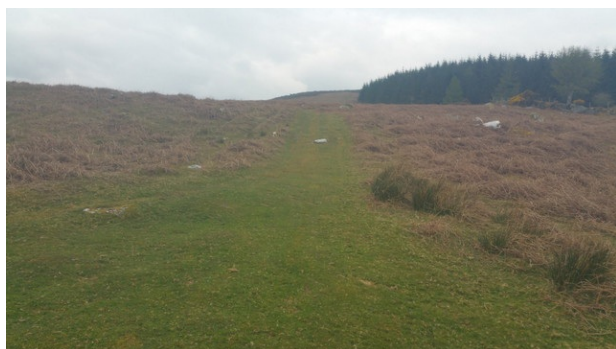
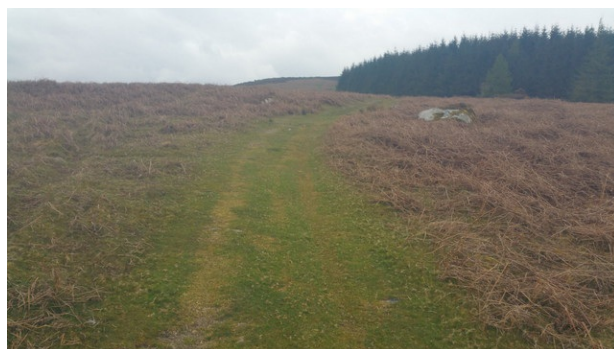
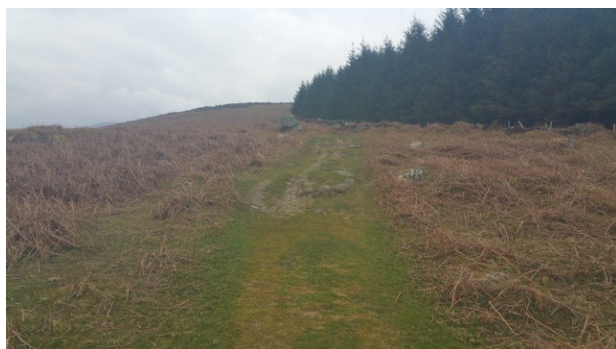
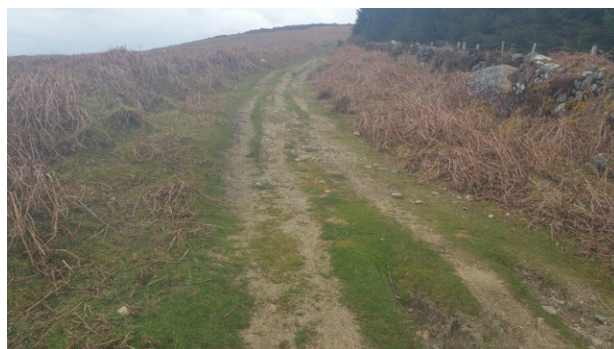
## Brockagh (Section 3)

Section description: Junction with track - path runs up the field

**Site Assessment:** Used by vehicles

| Work type | Estimated input | Work Summary |
|---|---|---|
| none | | |

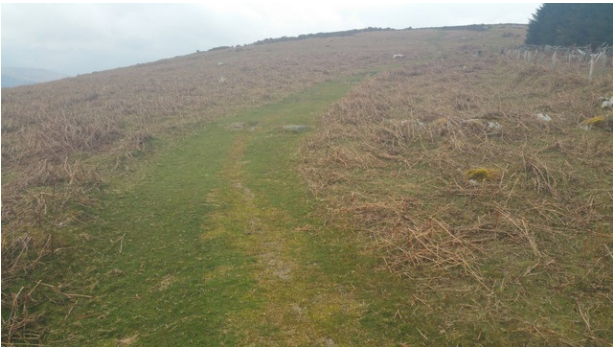
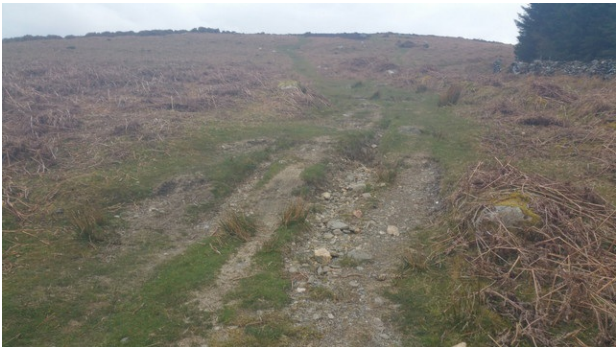
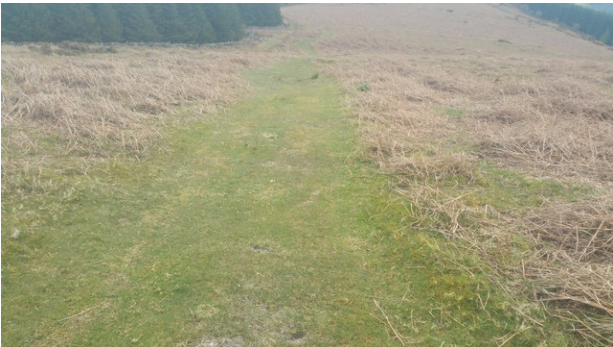
# Brockagh (Section 4)

Section description: Path split into two branches

**Site Assessment:**This branch probably more used by walkers

| Work type | Estimated input | Work Summary |
|---|---|---|
| early_intervention | | Drainage: 5 Water bars |

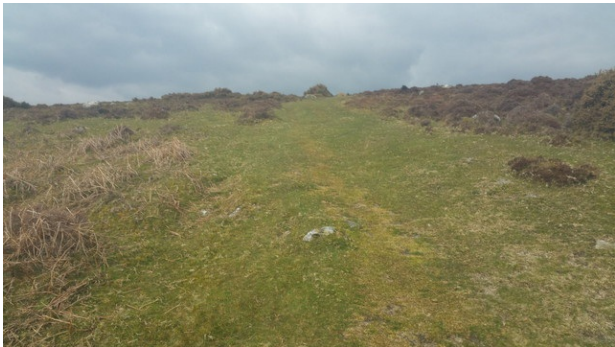
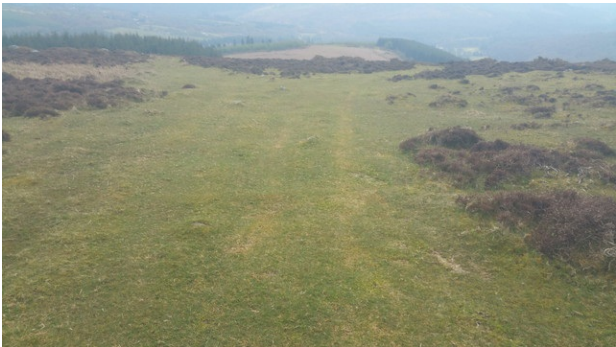
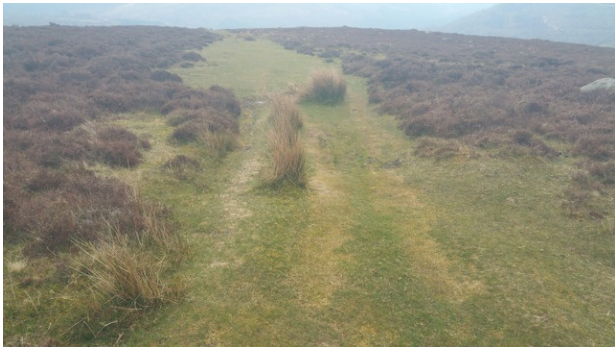
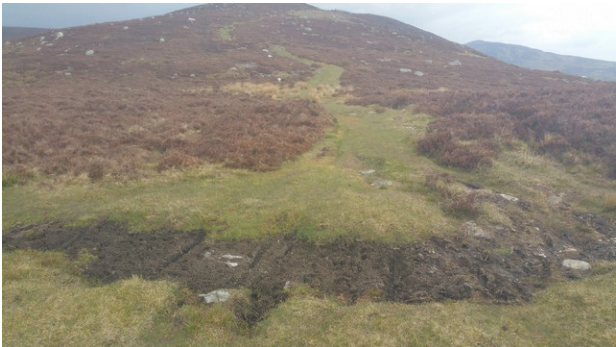
# Brockagh (Section 5)

Section description: Change of slope. Boulder by path

**Site Assessment:**Easy access (grade reversals by excavator?)

| early_intervention | 5 days labour | Drainage: 2 grade reversals 3 cross drains; 20m exit ditches - Isolated flat spots that need draining near p4 |

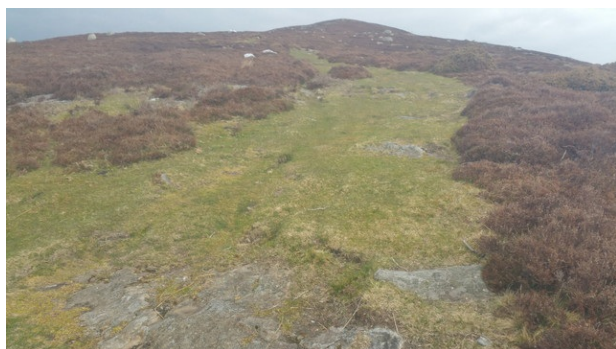
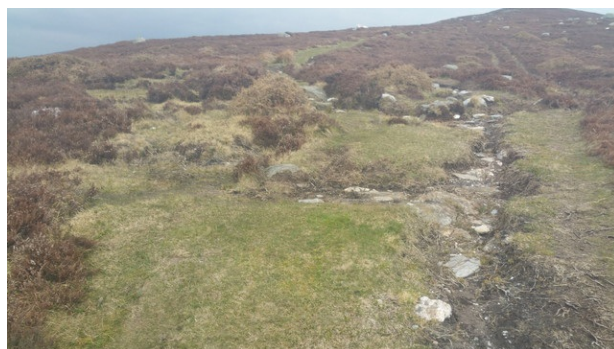
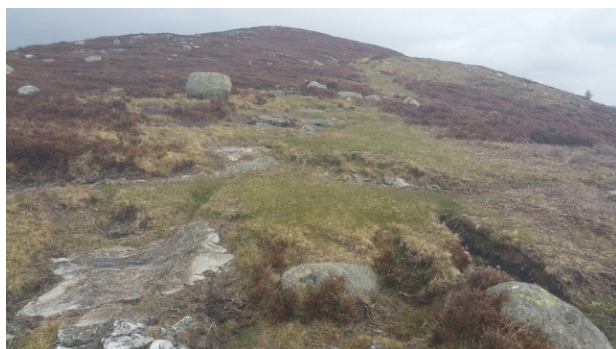
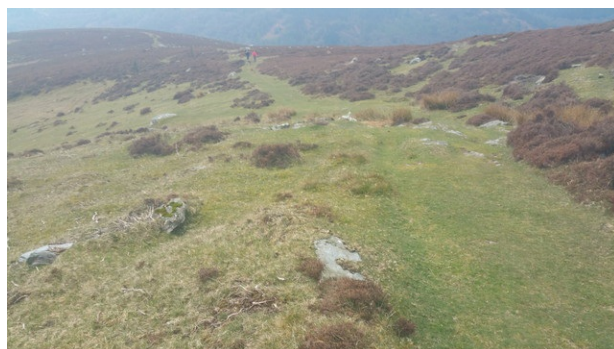
## Brockagh (Section 6)

**Section description:** Steeper slope and low outcrop of rock across path

**Site Assessment:** Depends on vehicle use as to whether repair is viable

| Work type | Estimated input | Work Summary |
|---|---|---|
| early_intervention | 12 days labour | Drainage: 2m pitch by p2; 8 water bars and 1 cross drain with ditch |

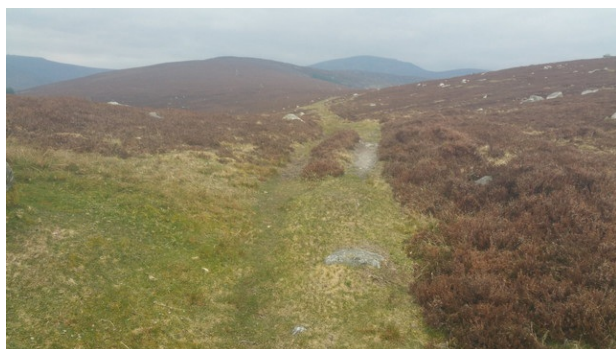
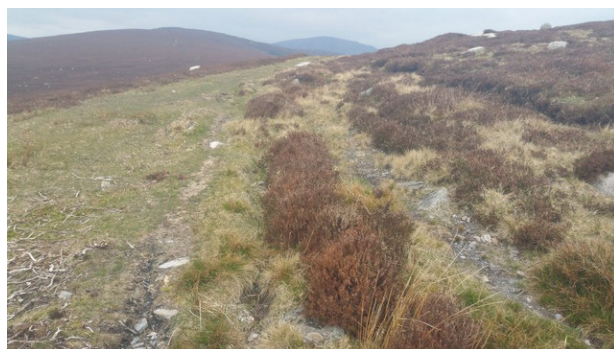
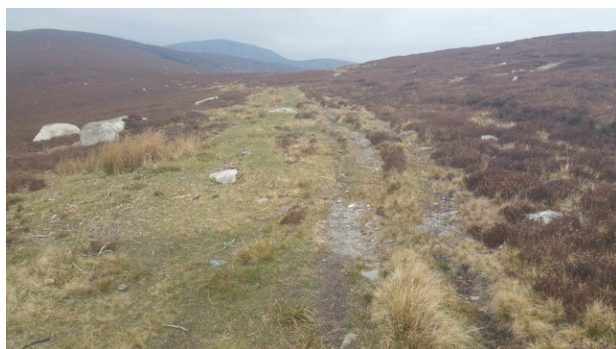
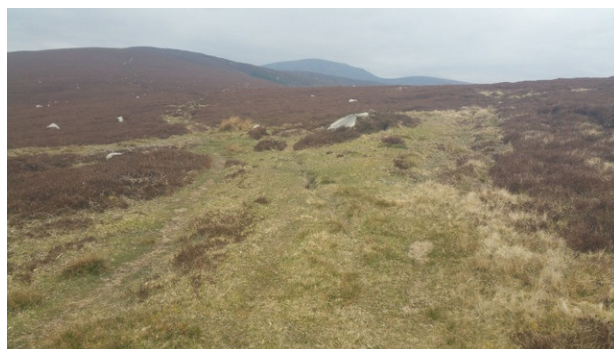
## Brockagh (Section 7)

**Section description:** Junction with large erratic boulder - cross slope helps contain people

**Site Assessment:** Stable path with short wet sections

| Work type | Estimated input | Work Summary |
|---|---|---|
| early_intervention | 15 days labour | Drainage: 10 cross drains; side ditch on hag line |

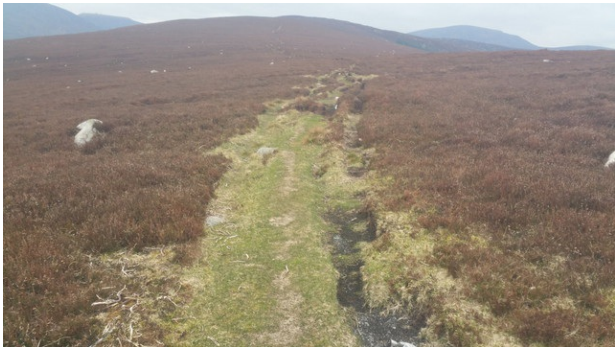
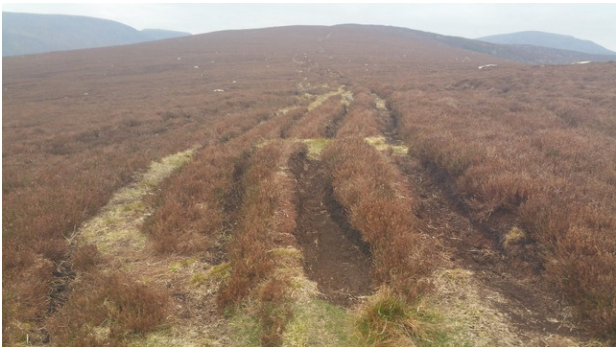
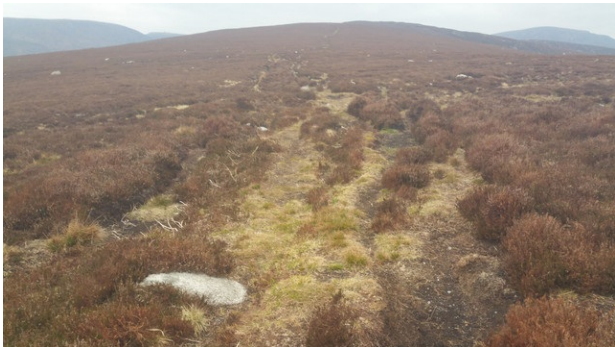
**Site Assessment:**Option to Machine build 1m wide path as hag management

| none | | Peat too deep to do minor works: High and dry path (200m aggregate with 5 cross drains) and hag restoration. |

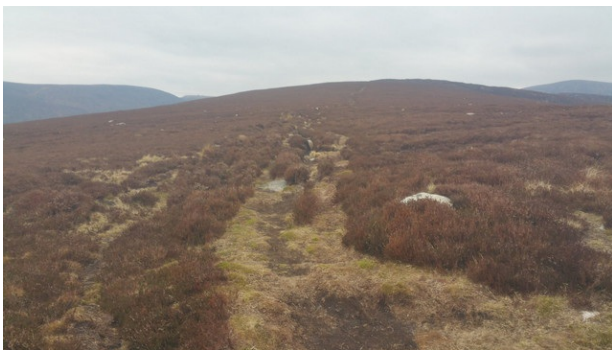
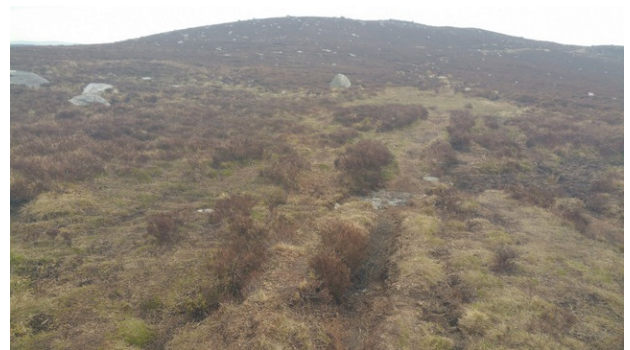
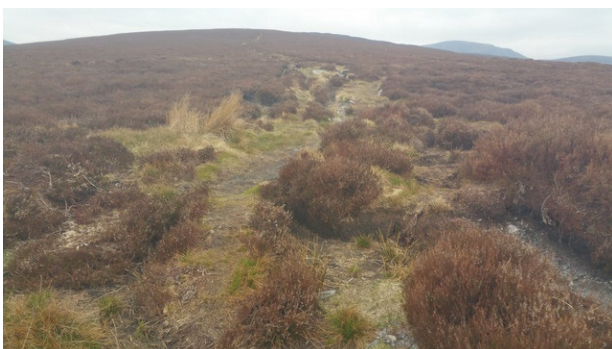
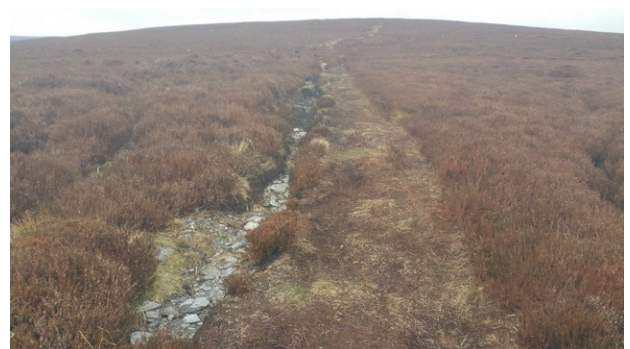
## Brockagh (Section 9)

Section description: Junction with SE Top path

**Site Assessment:** Easy machine build but might not be appropriate

| Work type | Estimated input | Work Summary |
|---|---|---|
| none | | Would need to be a full construction High and dry with hag restoration and drainage |

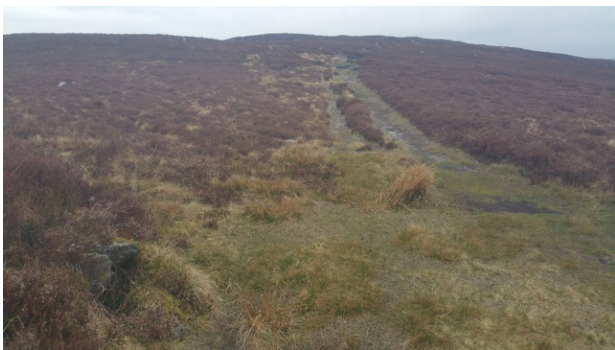
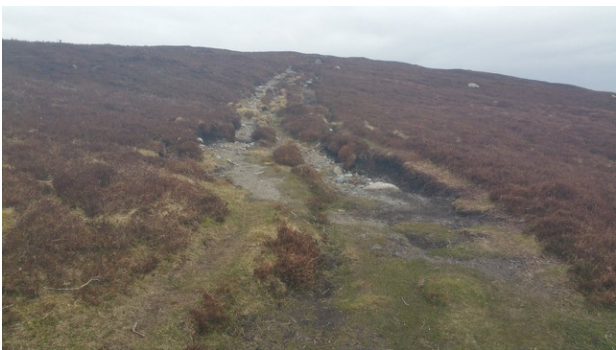
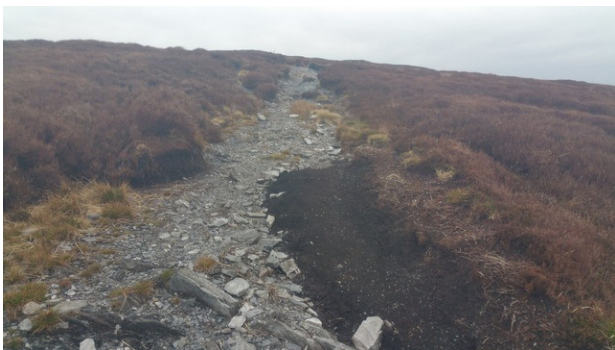
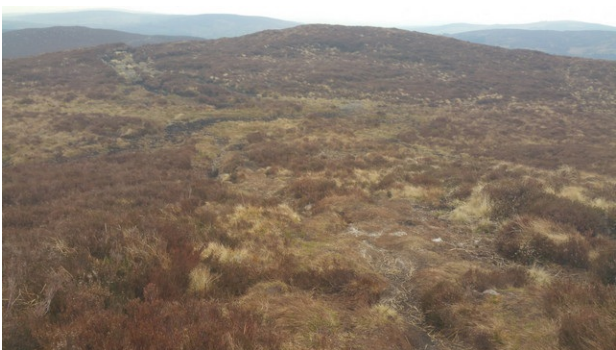
# Brockagh (Section 10)

Section description: Section starts at earth wall

**Site Assessment:**Long walk in

| Work type | Estimated input | Work Summary |
|---|---|---|
| early_intervention | 15 days labour | Drainage and hag restoration: 10 water bars; Float 15m of path in deeper peat 'pocket' by p4 |

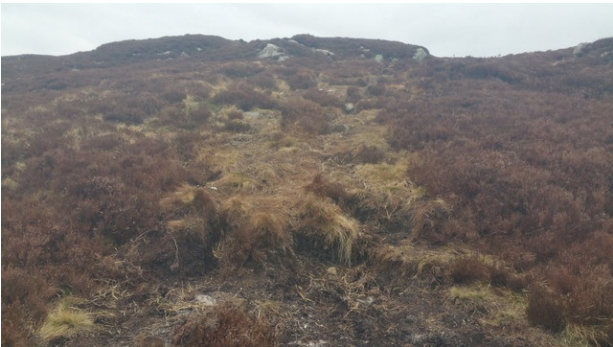
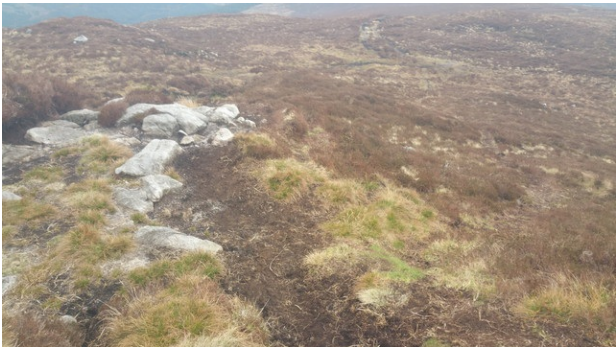
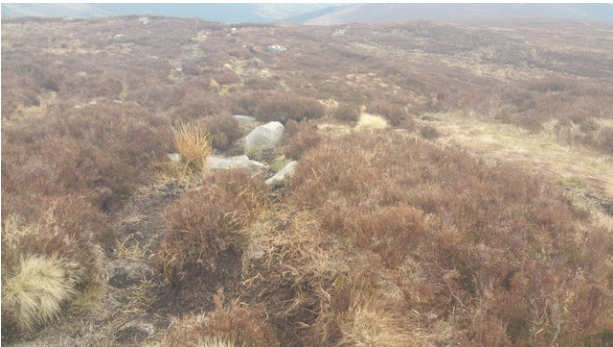
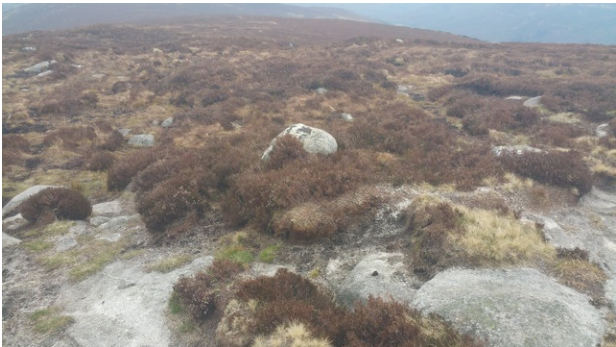
# Brockagh (Section 11)

Section description: Granite bedrock after flat boggy area

**Site Assessment:**Change of rock type so needs granite to be used only

| Light_touch | 20 days labour | Line definition |

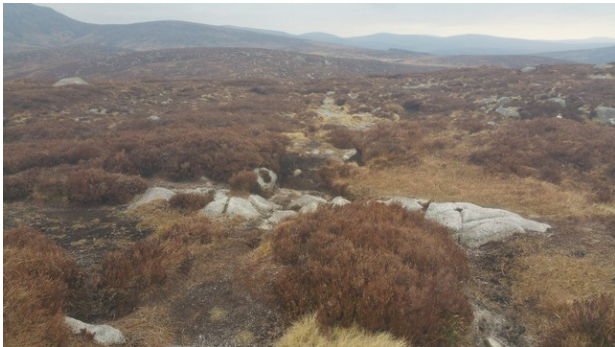
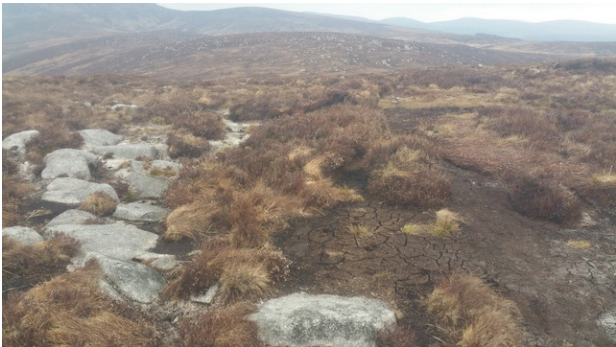
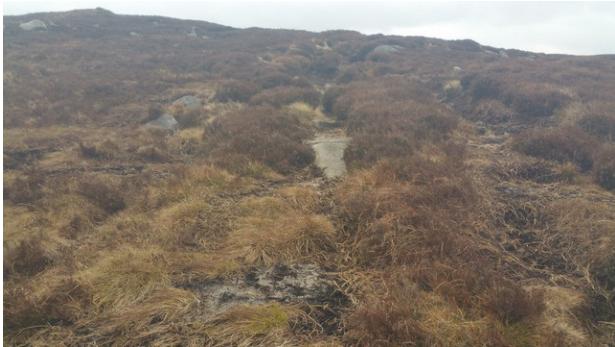
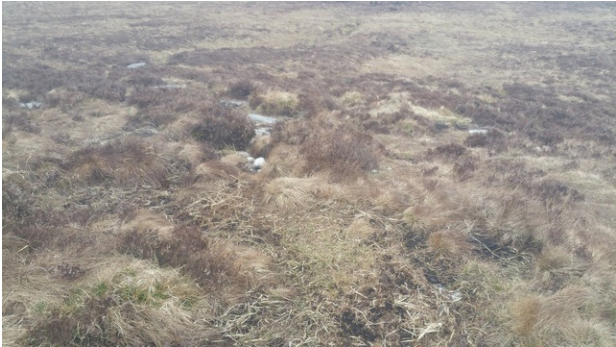
**Brockagh (Section 12)**  
**Section description:** Summit

**Site Assessment:**Remote site

| early_intervention | 20 days labour | 200m line definiton ; 5 water bars |

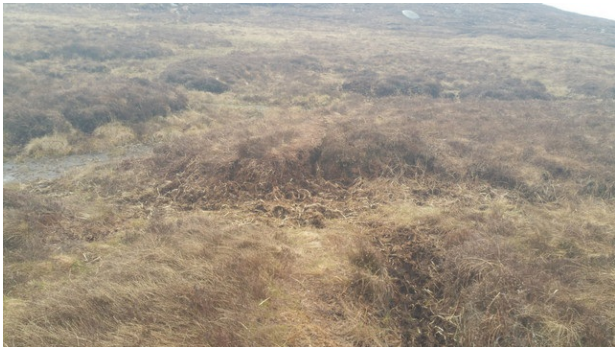
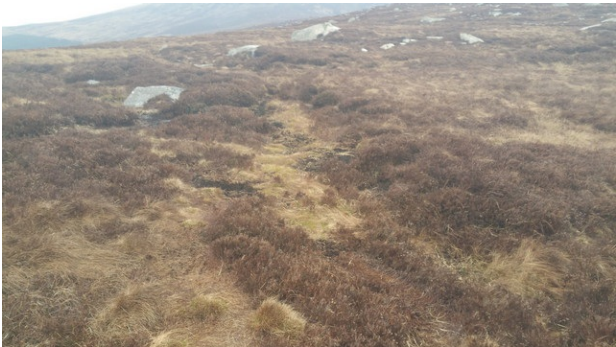
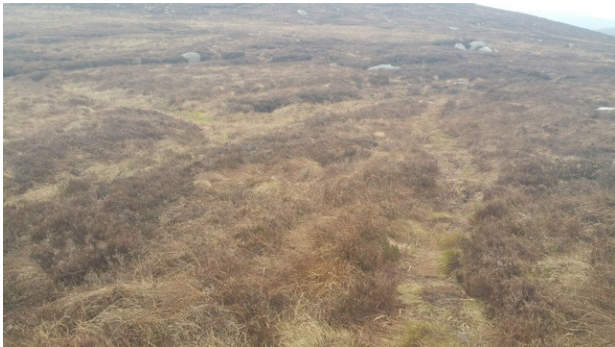
**Site Assessment:**Higher ground might be better route

| none | | No work viable |

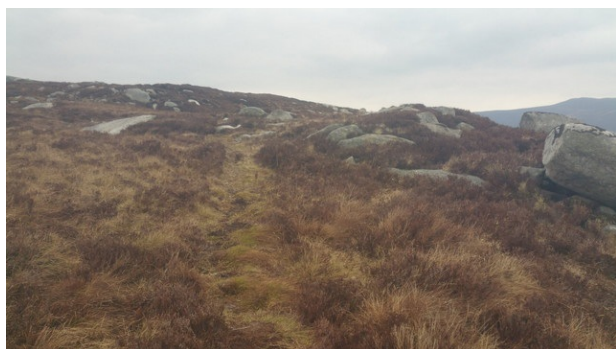
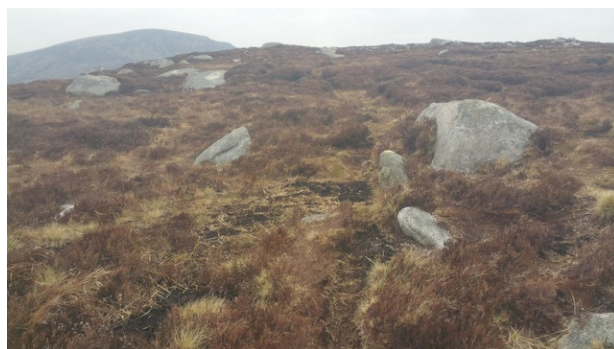
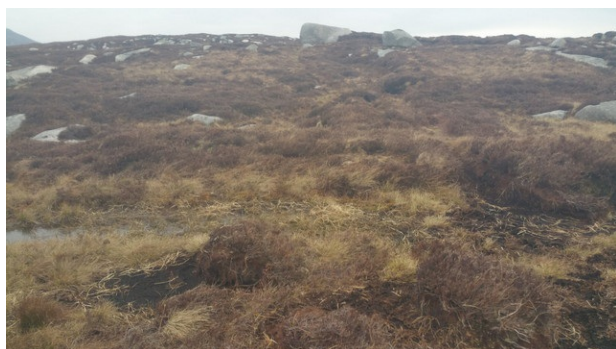
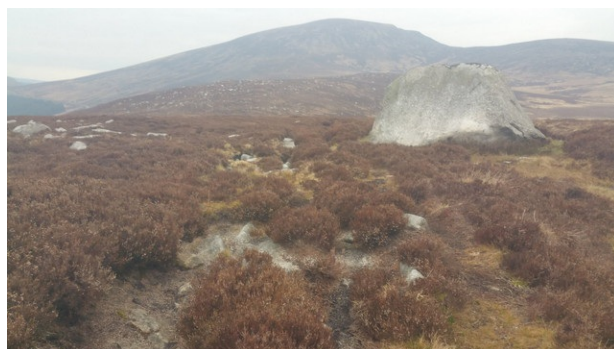
## Brockagh (Section 14)

**Section description:** Boulder on slope away from bog

**Site Assessment:** Hard to justify doing this work

| Work type | Estimated input | Work Summary |
|---|---|---|
| none | 10 days labour | 200m Line definition and peat hag restoration |

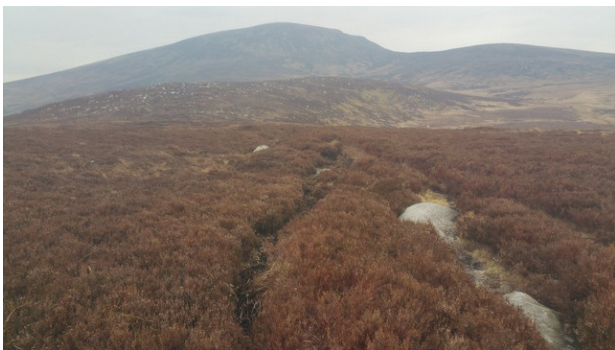
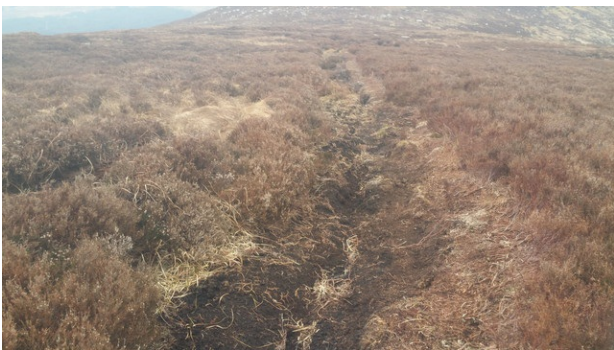
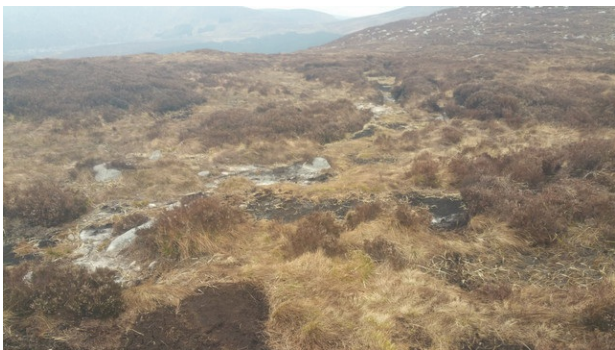
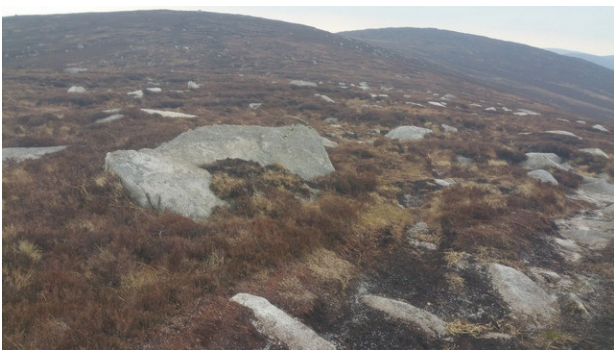
**Brockagh (Section 15)**  
**Section description:** Very large boulder

**Site Assessment:**remote site

| none | | No feasible work |

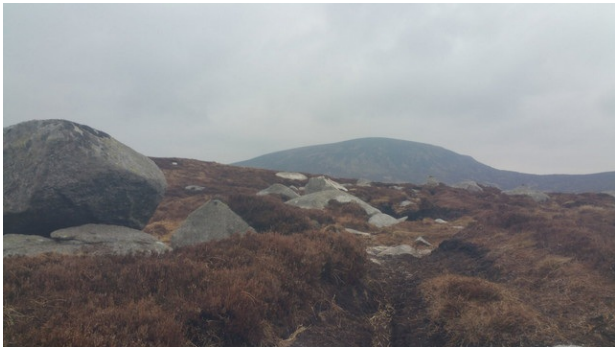
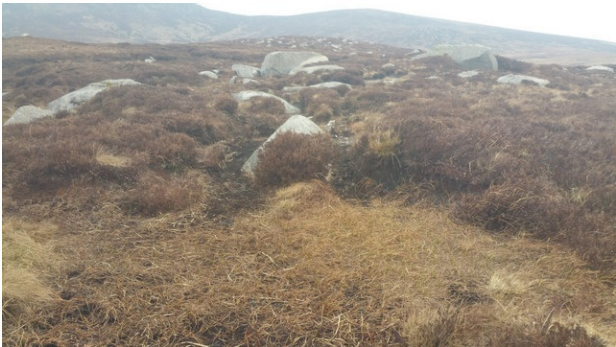
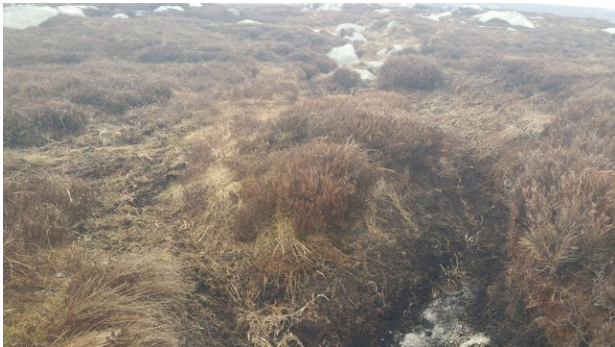
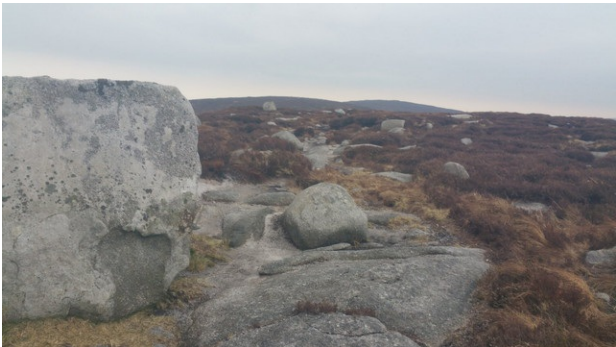
# Brockagh (Section 16)

Section description: Large perched boulder

**Site Assessment:**Remote site. Path continues across deep peat.

| none | | Not viable |

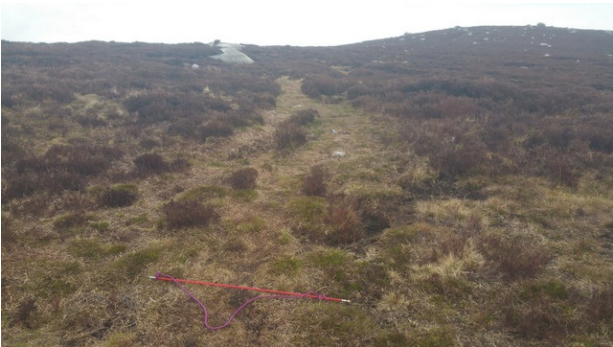
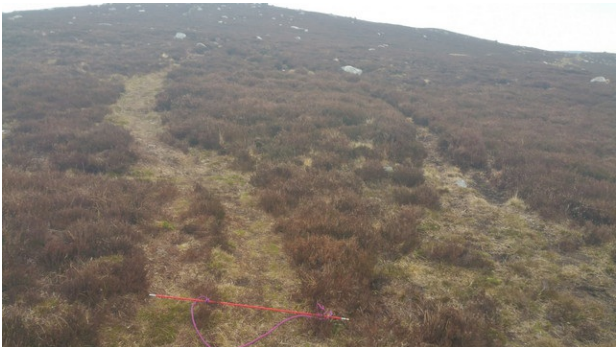
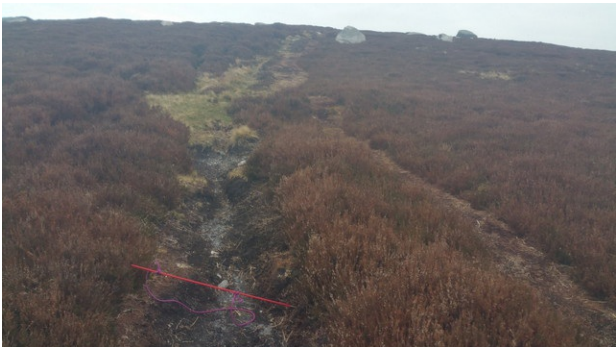
**Brockagh (Section 18)**  
**Section description:** Summit path

**Site Assessment:**On fall line but not changing rapidly

| early_intervention | 15 days labour | Drainage 15 water bars on first 300m |
