**Overall description:** The path is a safe route through the firing range to Lugnaquilla

**Overall assessment:** Sensitive repair would be possible using light touch techniques giving a broadly sustainable route up to the summit of Lugnaquilla. Potential for military to assist?

**Work summary:** Line definition and improvements to drainage

## Camerahill (Section 1)

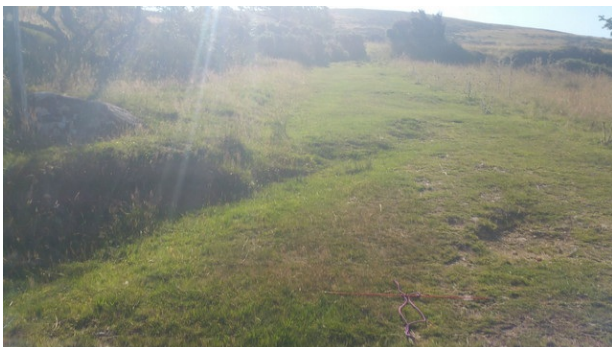
1626769709136.jpg - S 98908 92755 ( $\pm 5\text{m}$ )

**Site Assessment:** Vehicles use the route

| Work type | Estimated input | Work Summary |
|---|---|---|
| none | | Grass sward appears to be robust for current use |

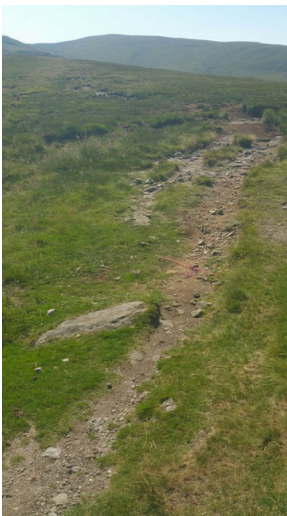
1626773591969.jpg - S 99889 92406 (± 3m)

**Site Assessment:**Variable peat depth 70cm down to 20cm

| Light_touch | 30 days labour | 400m Line Definition: 20m dig out peat bank to fill erosion gullies . 5 water bars |

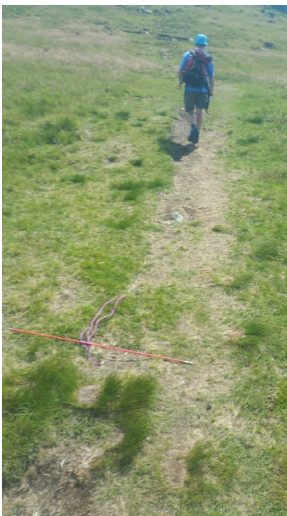
1626778242697.jpg - T 00907 91879 (± 3m)

**Availability of Materials:** Good enough for line Definition but additional stone requird for pitching

| Light_touch | 8o days labour | 300m line Definition water management at top of section; 60m pitching |

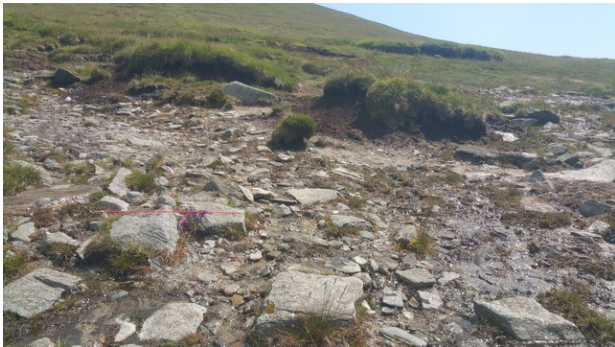
**1** 1626780964569.jpg - T 02139 91586 (± 3m)

**Site Assessment:**Scree

| Work type | Estimated input | Work Summary |
|---|---|---|
| Light_touch | 20 days labour | Minor line definition |
