Survey date: Jul 14, 2021

**Overall description:** Path runs through forestry plantation to a peaty summit

**Overall assessment:** work within the forestry plantation at the start of the path is feasible. On areas of deep peat work is not recommended.

**Church mountain (Section 1)**  
**Section description:** Start at forestry track junction

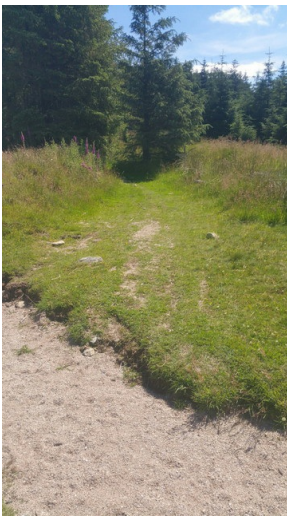
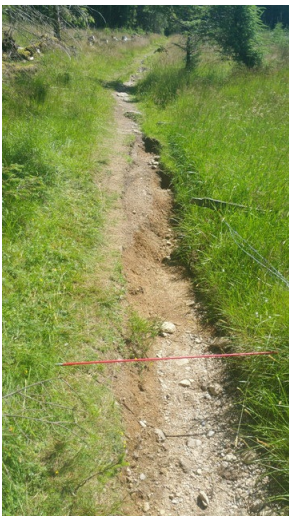
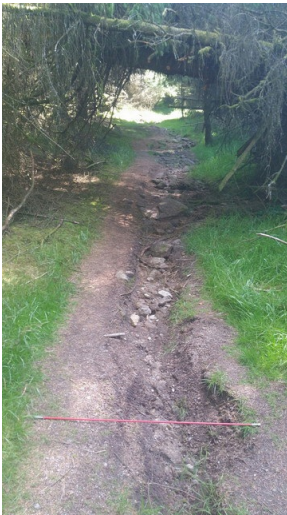
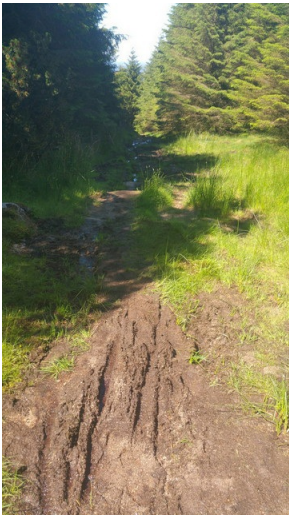
**Availability of Materials:** Block stone is small and scarce

**Site Assessment:**Materials could be carried in on a power barrow

| Work type | Estimated input | Work Summary |
|---|---|---|
| early_intervention | 12 days labour | Drainage: 2 water bar with 5m outlet ditches near start; water bar at end of cleared area; clear 3 windthrown trees; 5 water bars on steeper area; 2 water bars by wet area; |

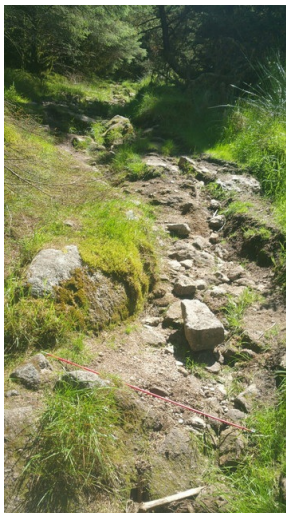
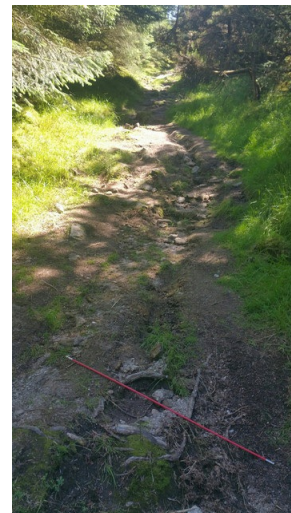
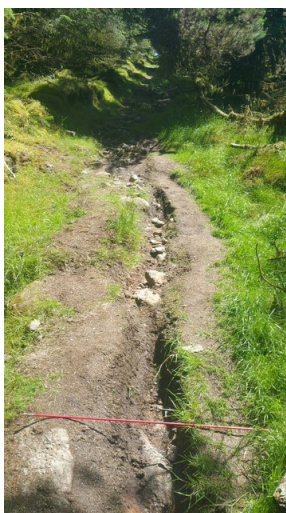
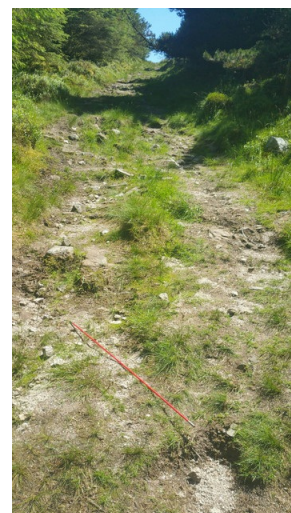
**Section description:** Big boulders above wet area. Increase in gradient

**Availability of Materials:** Better than previous section but marginal

**Site Assessment:** Long drive in for power barrow

| Work type | Estimated input | Work Summary |
|---|---|---|
| early_intervention | 15 days labour | Drainage: water bars every 30m |

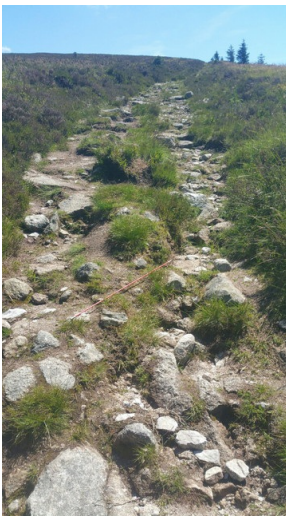
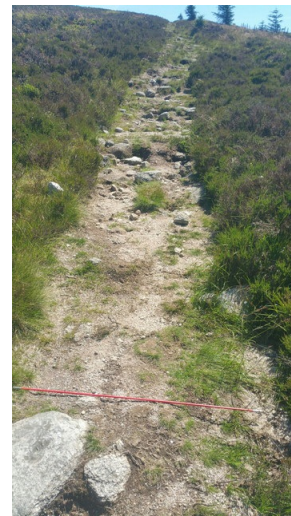
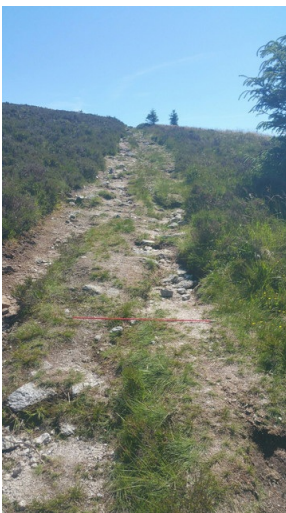
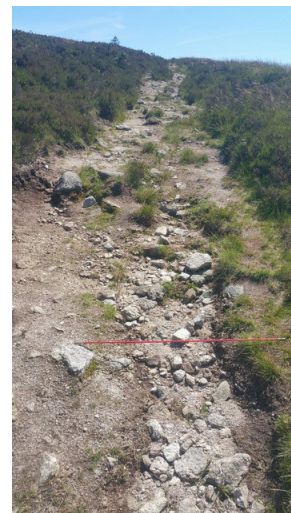
Section description: Edge of plantation

**Availability of Materials:** Block stone available

**Site Assessment:** Possible to reach with excavator

| Work type | Estimated input | Work Summary |
|---|---|---|
| early_intervention | 10 days labour | Drainage: water bars every 30m; de-roughening of surface |

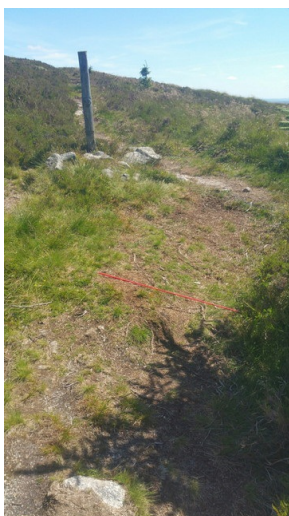
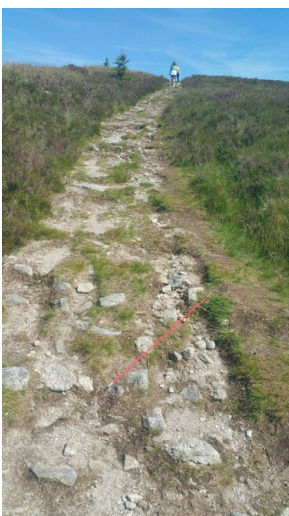
Section description: Fence and braid

Availability of Materials: Minimal block stone

| Work type | Estimated input | Work Summary |
|---|---|---|
| none | | Nothing urgent |

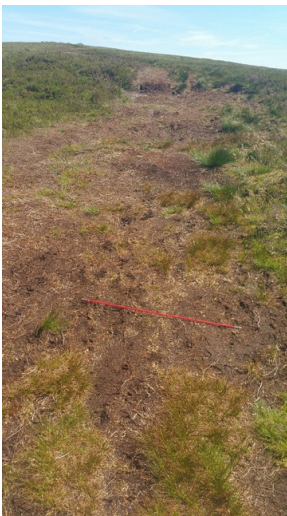
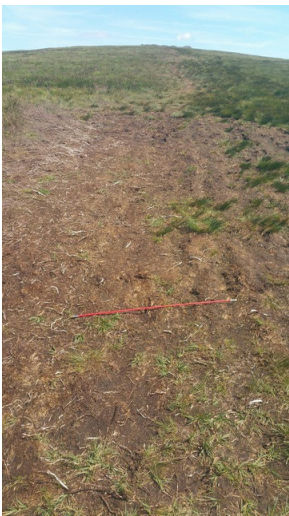
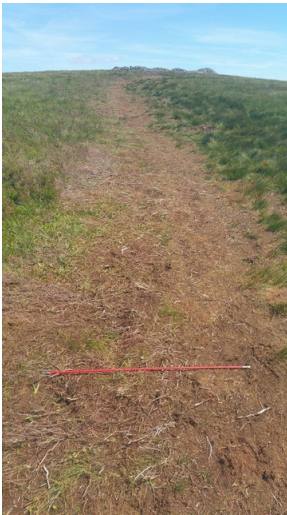
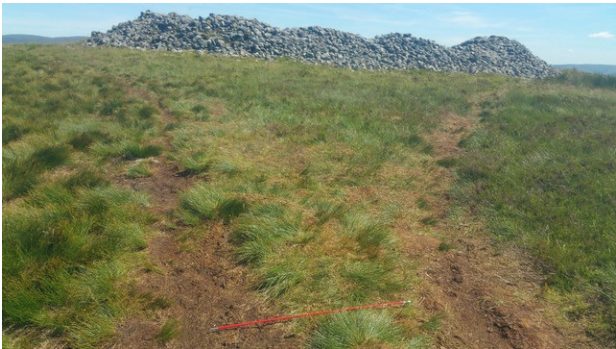
**Church mountain (Section 5)**  
**Section description:** Junction with desire line

**Availability of Materials:** None  
**Site Assessment:**No machine access

| Work type | Estimated input | Work Summary |
|---|---|---|
| none | | Deep peat. No intervention advised - floated aggregate or bog bridge would be an option |

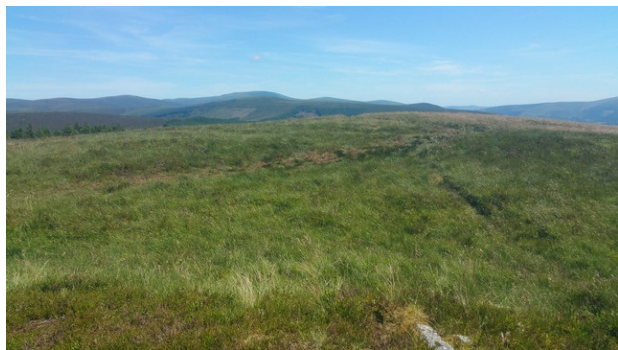
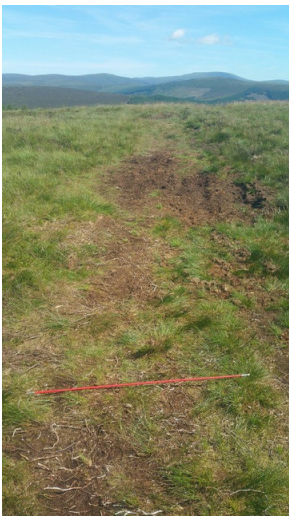
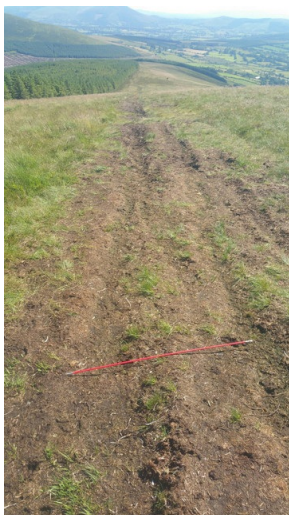
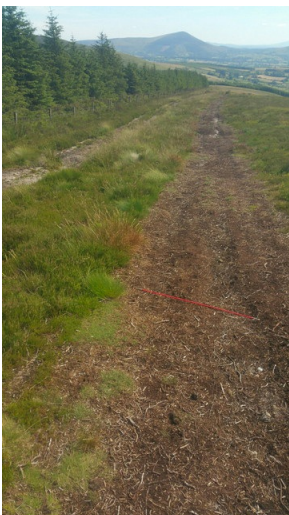
Section description: Summit

**Availability of Materials:** Limited. Some aggregate

**Site Assessment:** Quad bikes using route

| Work type | Estimated input | Work Summary |
|---|---|---|
| none | 5 days labour | Some drainage on the braid nearest the fence could help - as grade reversals |

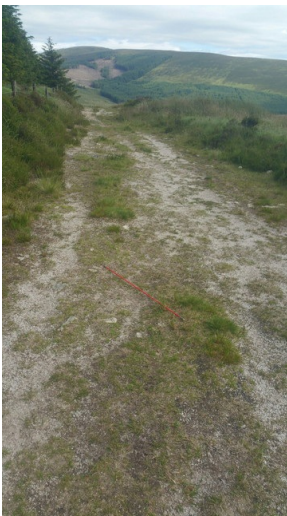
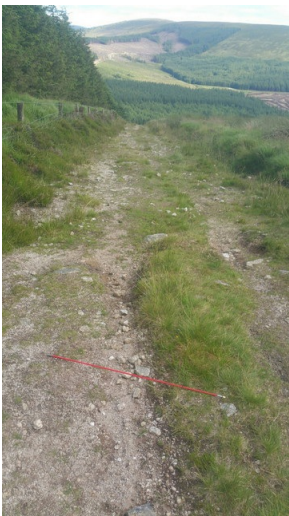
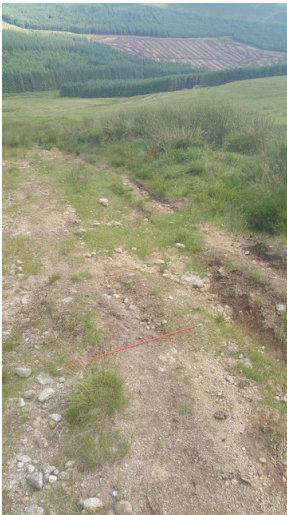
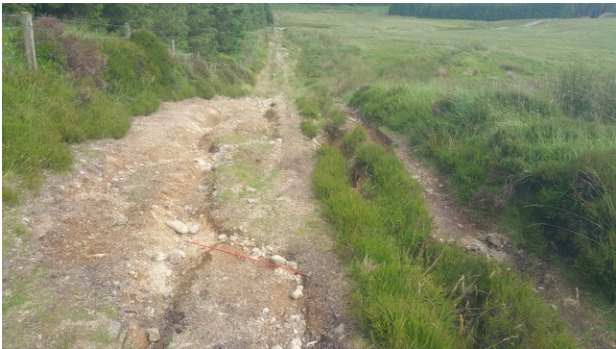
**Church mountain (Section 7)**  
**Section description:** Corner of forestry

Availability of Materials: Aggregate available

| Work type | Estimated input | Work Summary |
|---|---|---|
| none | | No recreation damage but grade reversals need fixing to prevent further damage to track |

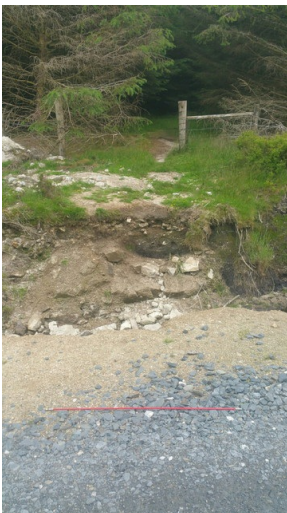
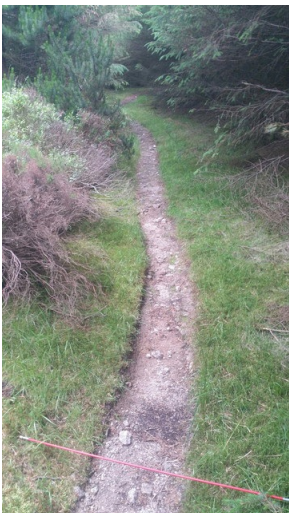
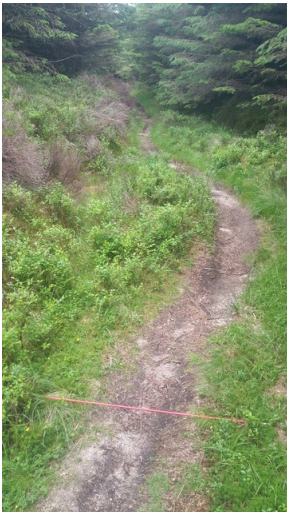
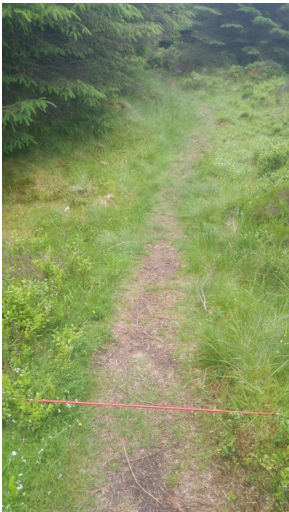
**Church mountain (Section 8)**  
**Section description:** Forest road

**Availability of Materials:** Aggregate beneath surface

**Site Assessment:**Woodland ride

| Work type | Estimated input | Work Summary |
|---|---|---|
| none | | Leave alone |

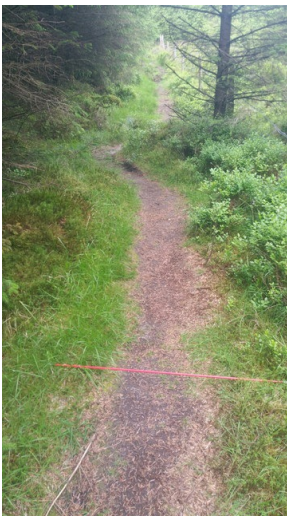
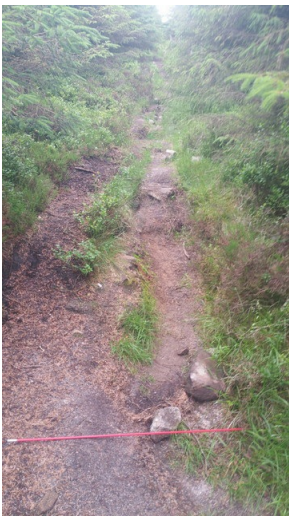
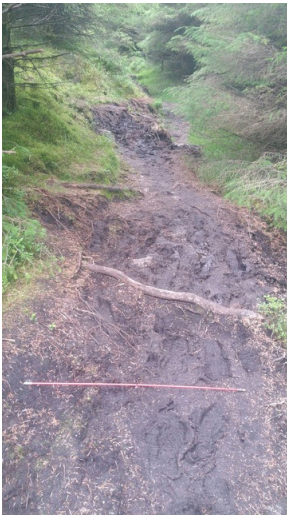
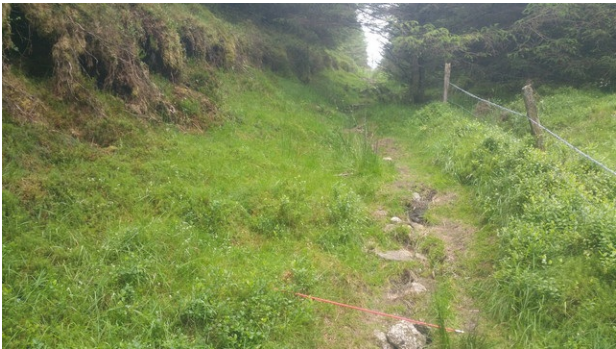
**Church mountain (Section 9)**  
**Section description:** Forest boundary fence

**Availability of Materials:** Very little block stone

**Site Assessment:**Difficult machine access

| Work type | Estimated input | Work Summary |
|---|---|---|
| none | | Any work would be access development rather than conservation.<br>Drains across to fence side would reduce water flow |

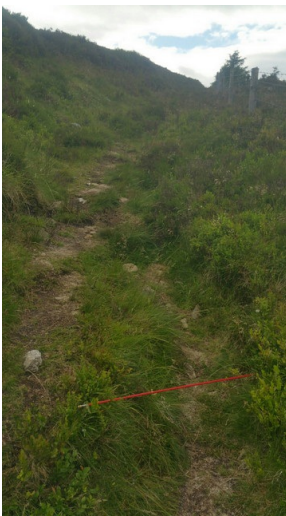
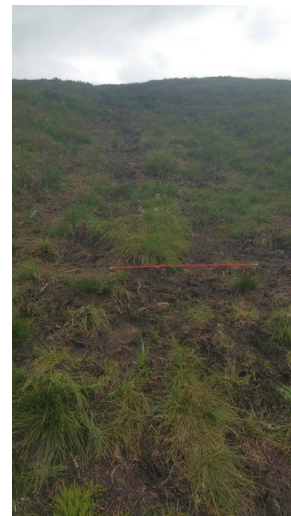
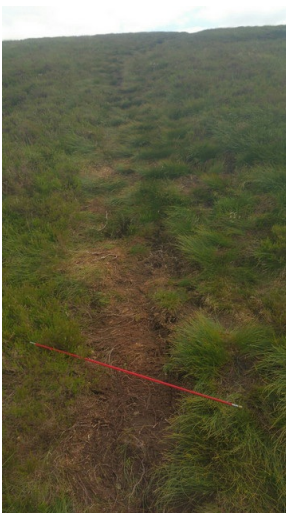
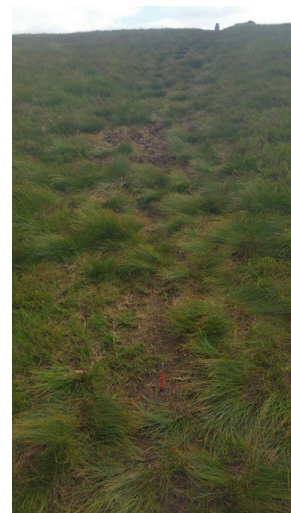
Section description: Fence at top of forestry

**Availability of Materials:** None

**Site Assessment:** No options

| Work type | Estimated input | Work Summary |
|---|---|---|
| none | | Deep peat. No work viable - better to close down than attempt to develop / "repair" |
