Survey date: Apr 22, 2021

Overall description: Path leads from a farm yard up an old pony track and on to the open hill

Overall assessment: Could be a good demonstration site for management of paths through eroded peat

Claughenagh (Section 1)

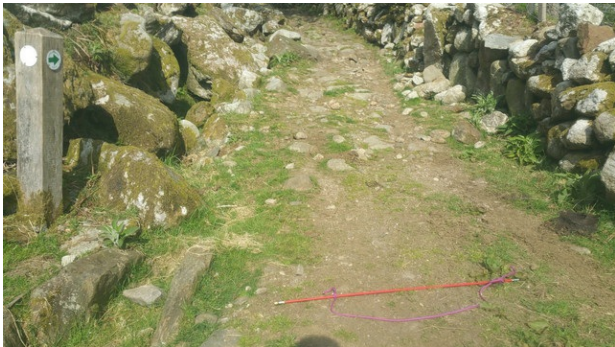
1619083348931.jpg - T 08600 91974 (± 9m)

Section description: Path starts at farm yard - this section is an old pony track but not part of the survey

Work type	Estimated input	Work Summary
minor_repair		one cross drain needs to be repaired

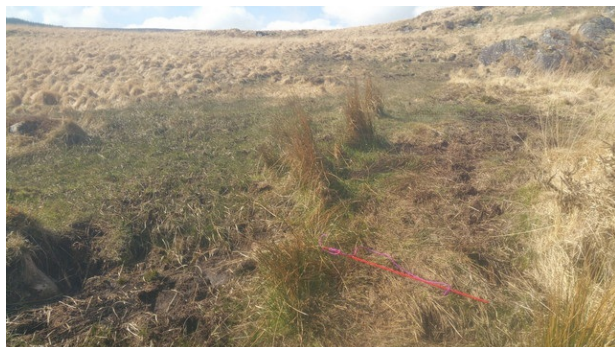
1619085353163.jpg - T 07988 92014 (\pm 3m)

Section description: Section starts at the end of the pony track

Minimum	Maximum	Typical
Trampled width (m)	4	5	10
Bare width (m)	0	0	0.5
Eroded depth (m)	0	0	0.2

Work type	Estimated input	Work Summary
early_intervention	15 days labour	Spot repairs amounting to 5m of stone pitching and 1 cross drain at start; 15m mixed pitching / aggregate (30/70). Full upgrade of this section is not recommended at present as it is likely to encourage increased use. Some areas of deep peat (>50cm) will be difficult to manage if use increases significantly - floated path would be required.

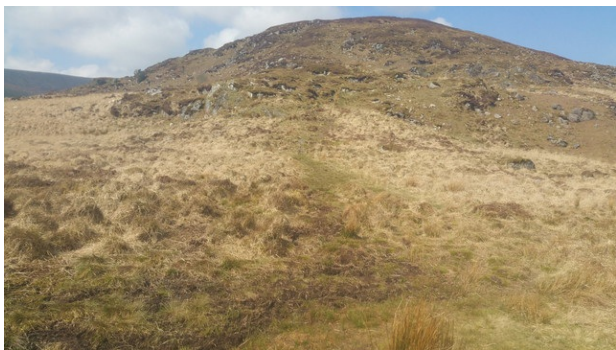
1619086485554.jpg - T 07855 91990 (± 3m)

Section description: This section begins at the stile. Desire line with sufficient trampling to leave bare ground in places. The line is braided and poorly drained

Minimum	Maximum	Typical
Trampled width (m)	1	1.5	4
Bare width (m)	0	0.5	2
Eroded depth (m)	0	0.1	0.2

Work type	Estimated input	Work Summary
early_intervention	10 days labour	Drainage could be installed to help reduce the impact of trampling - 10 water bars. Another option would be to fully construct a path (not currently recommended) - this would be a mix of aggregate and stone pitching

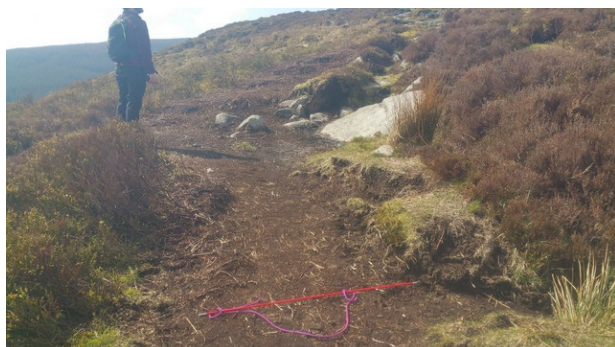
1619088071577.jpg - T 07481 92015 ($\pm 3m$)

Section description: Section starts at an obvious grassy spot on granite outcrop. Vegetation has been trampled to expose peat and in places the peat has eroded to bedrock

Minimum	Maximum	Typical
Trampled width (m)	1.5	2	4.5
Bare width (m)	0.5	1.5	3
Eroded depth (m)	0	0.3	0.4

Work type	Estimated input	Work Summary
Light_touch	40 days labour	Where the bedrock is exposed the path would benefit from line definition work (250m) and peat hag restoration (reducing the active erosion of the peat)

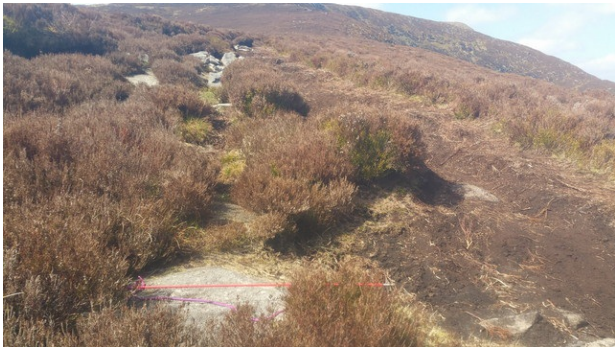
1619091023442.jpg - T 07015 92067 (± 3m)

Minimum	Maximum	Typical
Trampled width (m)	1.5	2	3.5
Bare width (m)	0.8	1.5	2.5
Eroded depth (m)	0.3	0.3	0.6

Work type	Estimated input	Work Summary
Light_touch	40 days labour	Hag restoration and blocking braids 200m; 300m deroughen; 5 water bars

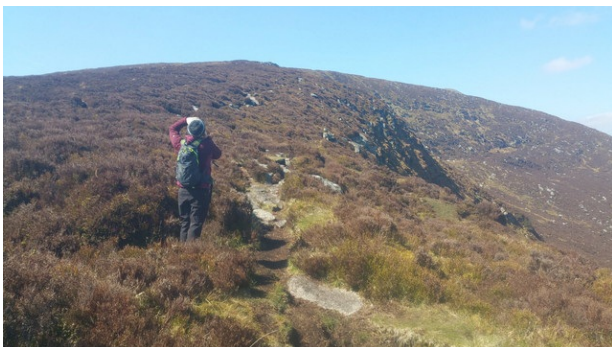
1619092215589.jpg - T 06850 92098 (\pm 3m)

Section description: Low outcrop next to path

Minimum	Maximum	Typical
Trampled width (m)	2	2.5	6
Bare width (m)	0.8	1.5	2.5
Eroded depth (m)	0	0.5	0.6

Work type	Estimated input	Work Summary
Light_touch	25 days labour	300m line definition; Peat restoration would be beneficial - reprofile hags

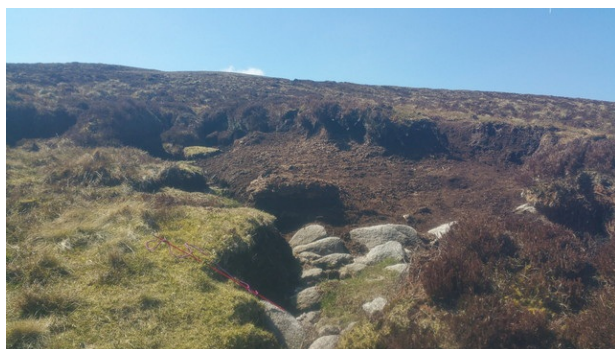
1619096616180.jpg - T 06381 92081 ($\pm 3m$)

Section description: Section starts where the path moves away from cliff edge and runs to summit of Cloghernaugh

Minimum	Maximum	Typical
Trampled width (m)	2	2.5	25
Bare width (m)	0	1.5	25
Eroded depth (m)	0	0.3	1

Site Assessment: Variable peat depth

Work type	Estimated input	Work Summary
Light_touch	60 days labour	Pitch 30m; 50m line definition and possible jute net at bare peat; 15m deep cut peat to link sections at bedrock level - needs vegetation work to prevent peat erosion.
