Survey date: May 1, 2021

Length: 5804m

# Corriegasleggaun and Carrawaystick

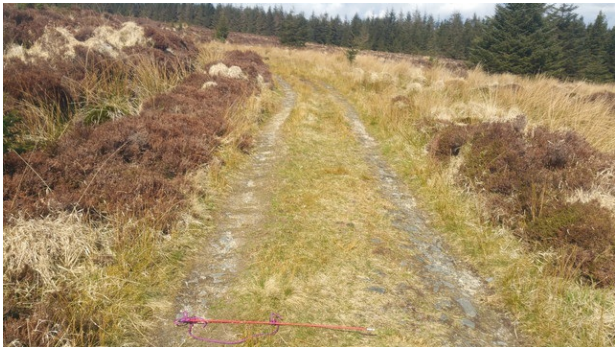
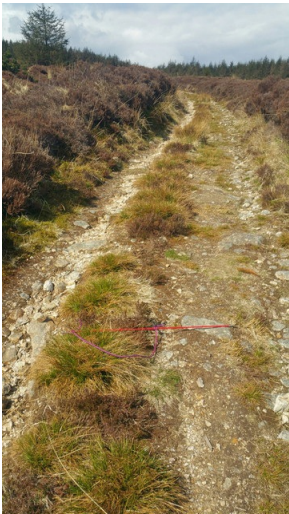
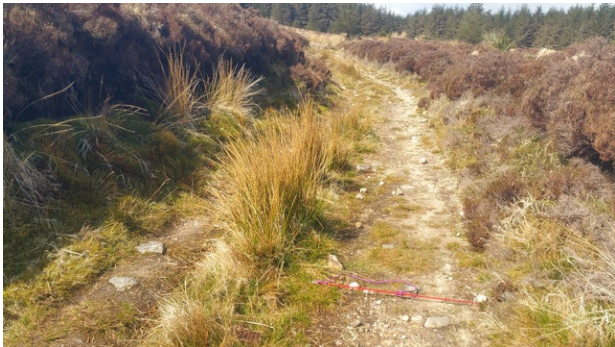
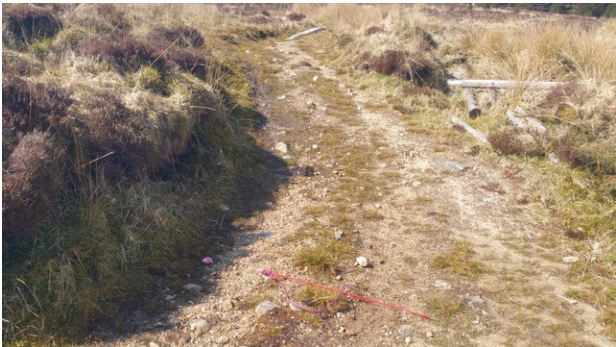
Section description: Track junction

**Site Assessment:**Track with limited vehicle use

| Work type | Estimated input | Work Summary |
|---|---|---|
| none | | |

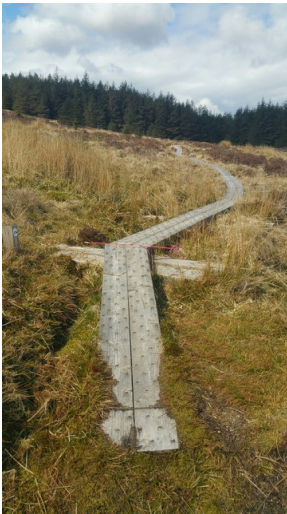
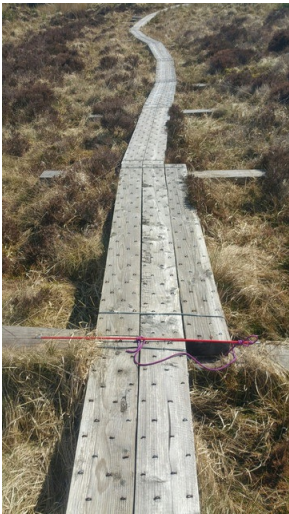
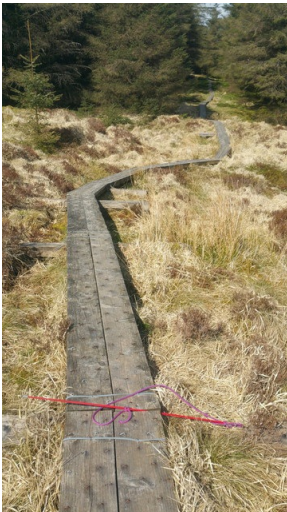
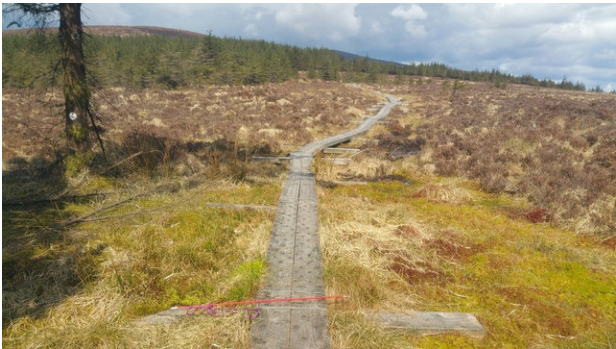
Section description: Bog bridge

**Site Assessment:**Structure in good condition.  
 Repair or replacement will be difficult.  
 Plantation woodland on 1m+ peat

| none | | |

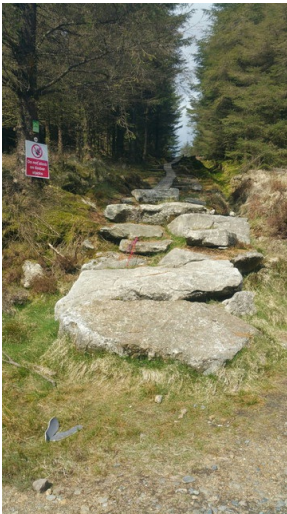
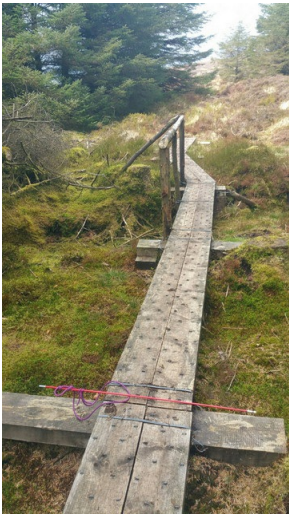
Site Assessment:As section 2

| none | | |

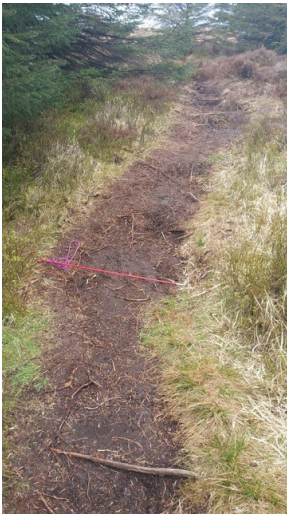
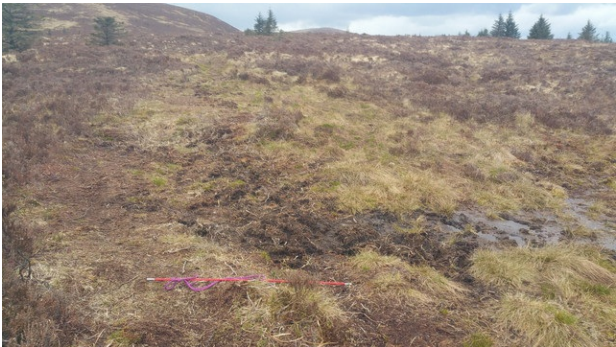
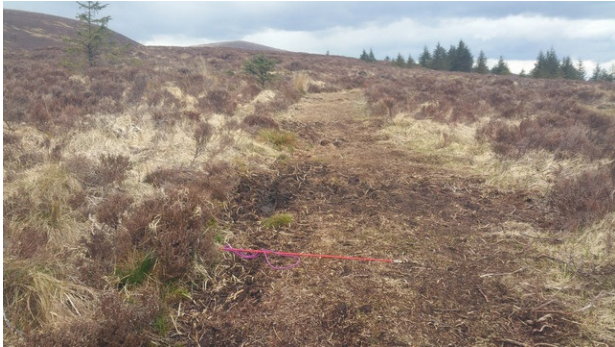
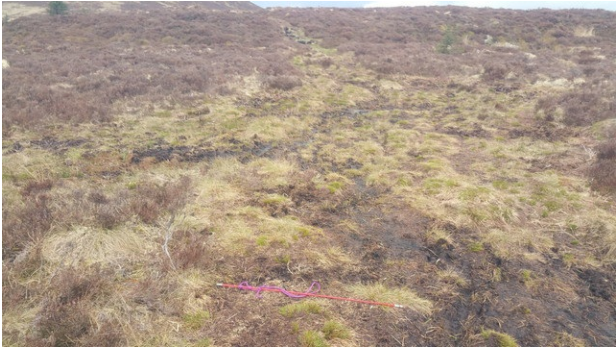
**Corriegasleggaun and Carrawaystick**  
**Section description:** End of bog bridge

**Site Assessment:**Open hill with deep peat.  
 Scrambler tracks visible

| Work type | Estimated input | Work Summary |
|---|---|---|
| none | | Nothing viable except floated path or bog bridge |

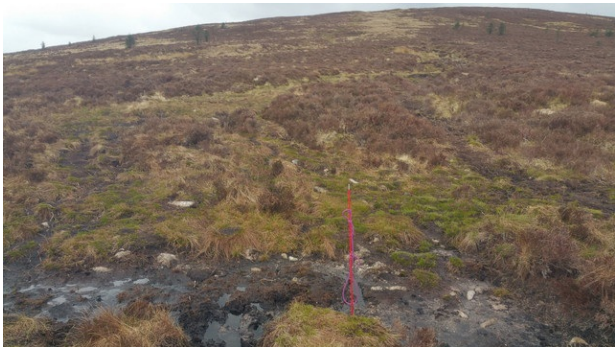
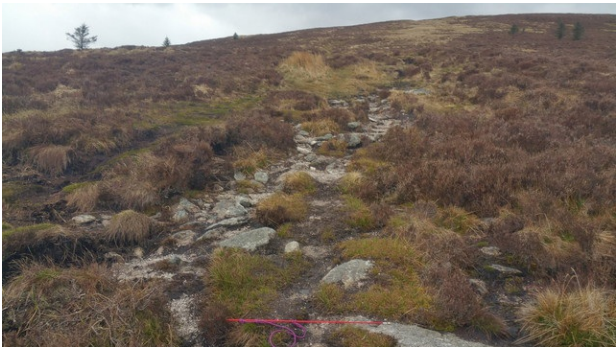
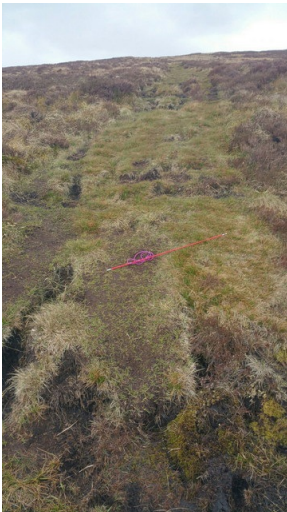
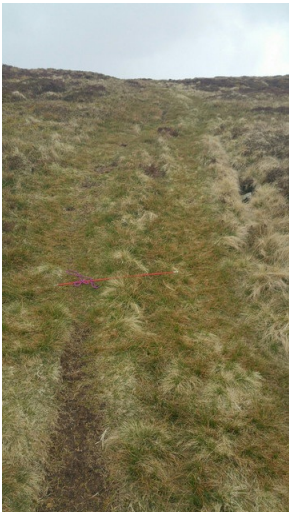
Section description: Stone at surface at change in gradient and bog pool

Site Assessment: Poor access - previous section is deep peat

| early_intervention | 5 days labour | Some minor drainage possible where peat has eroded |

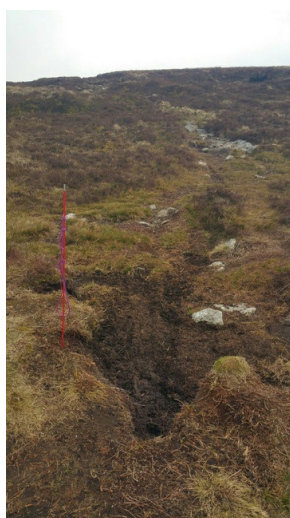
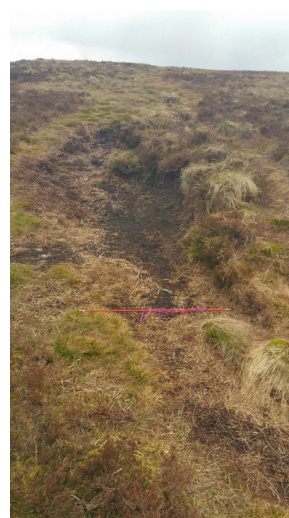
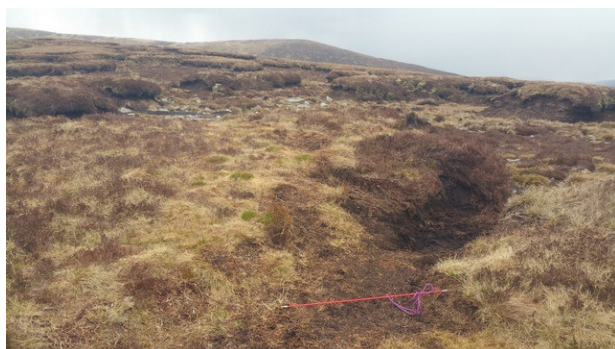
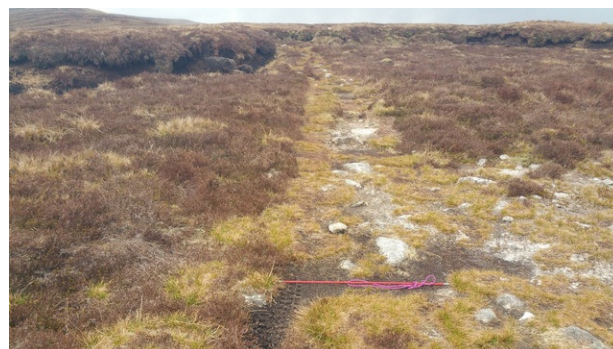
Section description: Decrease gradient and hag

Site Assessment: Dying bog

| Work type | Estimated input | Work Summary |
|---|---|---|
| Light_touch | 70 days labour | Peat restoration techniques and selection of a line across depleted peat |

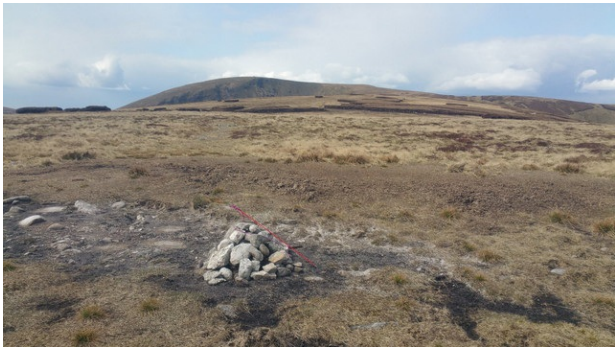
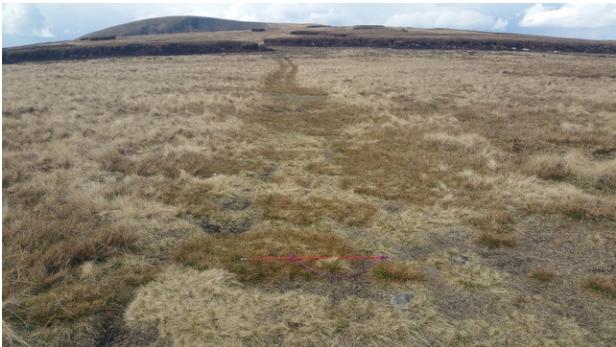
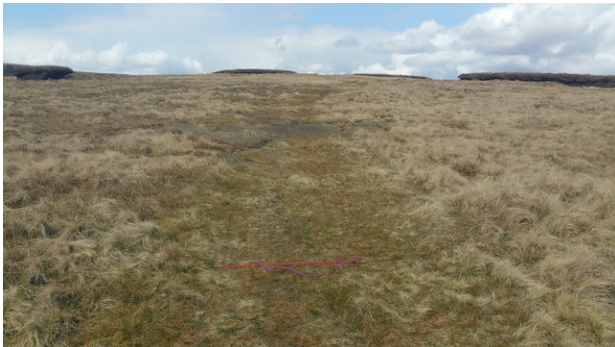
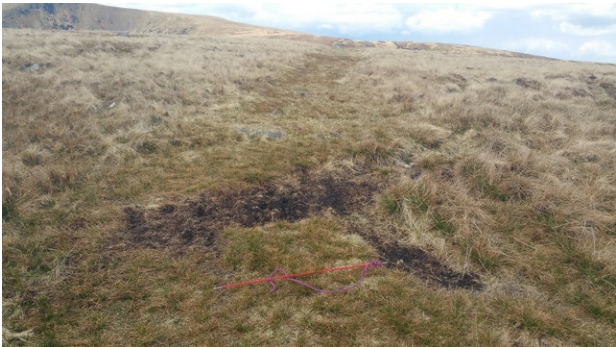
**Corriegasleggaun and Carrawaystick**  
**Section description:** Cairn on minor summit

**Site Assessment:**Access difficult

| Light_touch | 25 days labour | Peat restoration techniques to find a way through depleted peat |

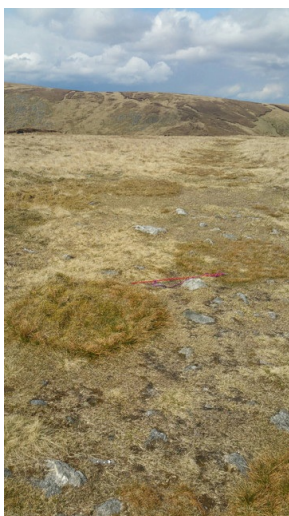
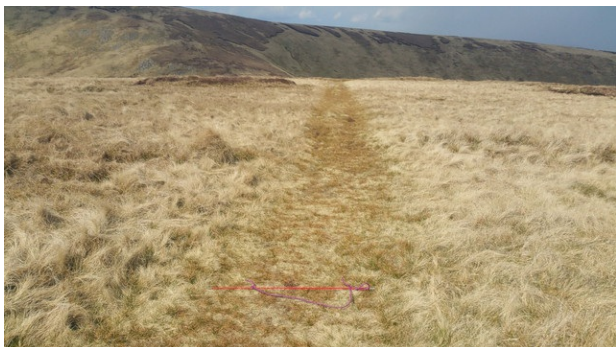
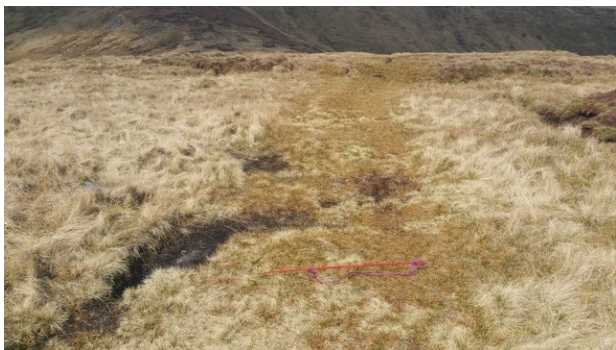
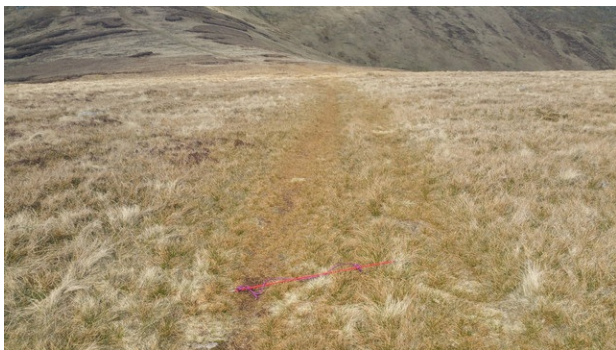
Section description: Summit

Site Assessment:Remote

| Work type | Estimated input | Work Summary |
|---|---|---|
| none | | no work recommended |

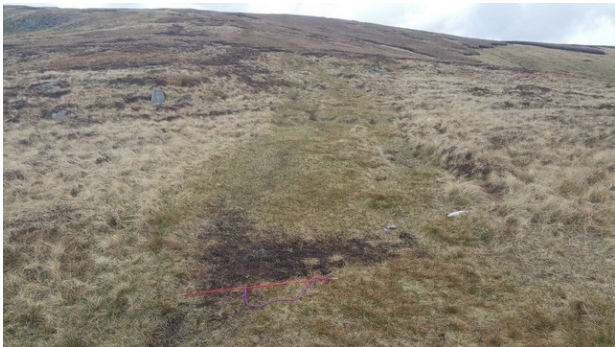
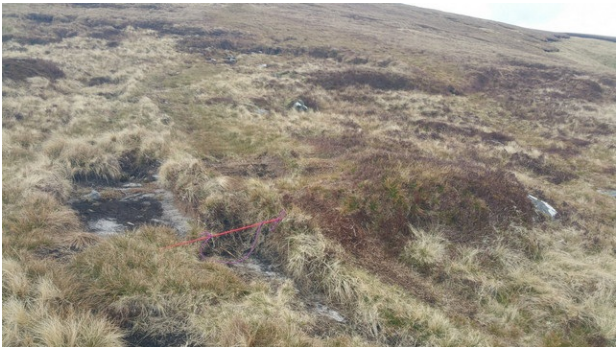
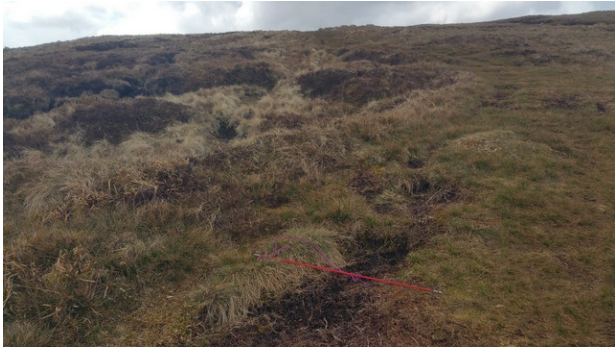
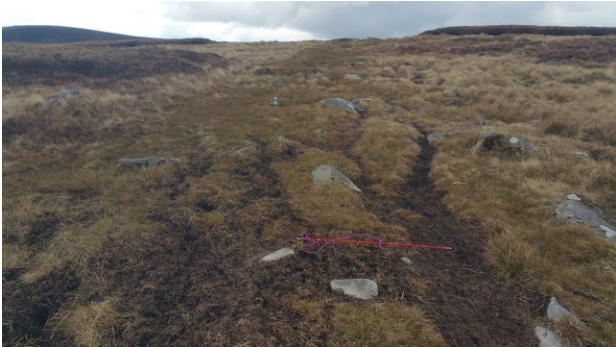
Section description: Boulders on col

Site Assessment:Remote

| Work type | Estimated input | Work Summary |
|---|---|---|
| Light_touch | 5 days labour | Minor drainage but deep peat makes additional work less viable |
