Survey date: Apr 29, 2021

**Overall description:** Direct ascent through forestry from Glendalough gives access to the ridge of Derrybawn

## Derrybawn (Section 2)

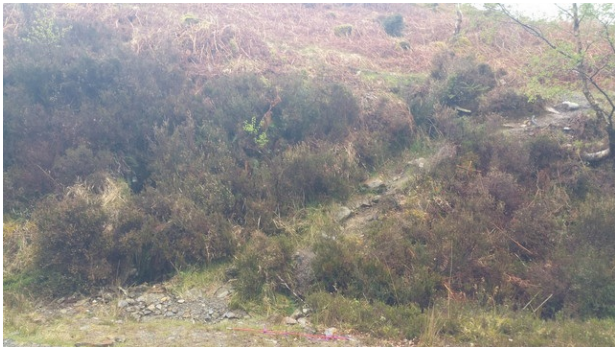
1619695878247.jpg - T 11164 95691 (± 10m)

**Site Assessment:**Culvert under track is inadequate. Easy access on track at top

| early_intervention | 5 days labour | 1 Water bar to prevent washout at braid; 15m large ditch at top to collect runoff and disperse along old wall with cross drain |

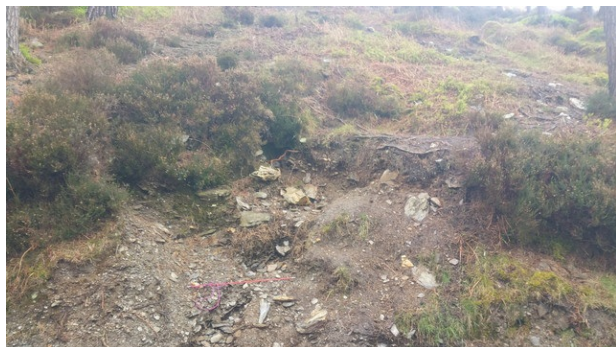
1619697270878.jpg - T 11336 95682 (± 9m)

Section description: Track crossing - direct route up slope

**Site Assessment:** No machine access

| Work type | Estimated input | Work Summary |
|---|---|---|
| early_intervention | | Remove water from path line; cross drain plus 10m ditch; stabilise 30m surface |

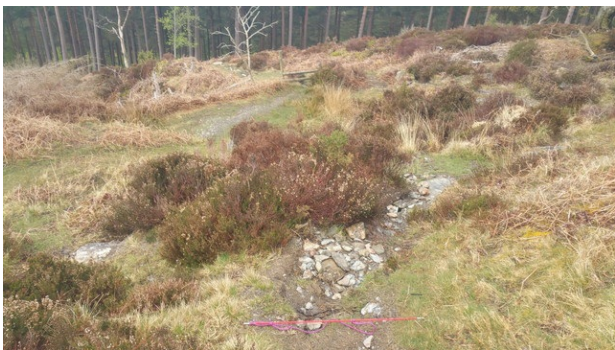
1619698649363.jpg - T 11472 95674 (± 5m)

**Site Assessment:**Steep ground

| Work type | Estimated input | Work Summary |
|---|---|---|
| early_intervention | 8 days labour | Drainage: 5 water bars; 1 cross drain and 10m ditch at top |

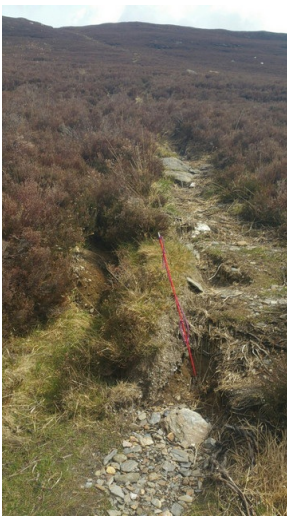
1619702198426.jpg - T 11545 95646 (± 9m)

**Derrybawn (Section 4)**  
**Section description:** Track crossing

**Site Assessment:**Good access for hand work

| early_intervention | 20 days labour | Drainage: water bars every 20m with curved drain out (to slow watr dispersal |

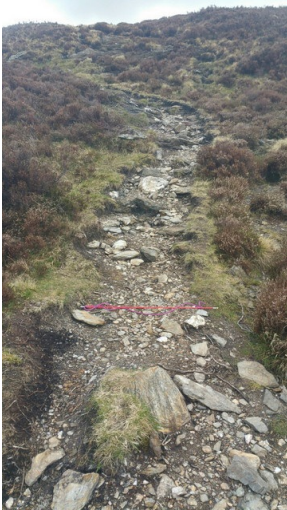
1619703396494.jpg - T 11892 95567 (± 4m)

**Site Assessment:**Open slope

| Light_touch | 5 days labour | Drainage (water bar every 20m) and landscaping |

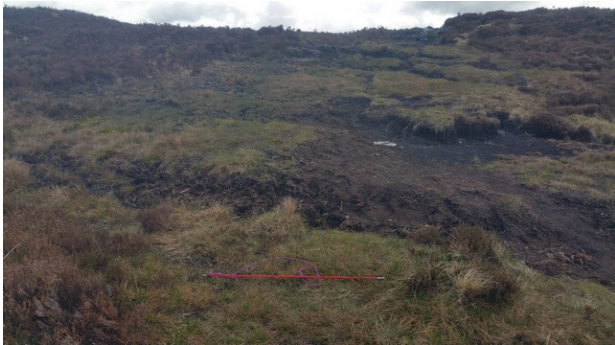
1619704031101.jpg - T 11922 95500 (± 5m)

**Site Assessment:**Bedrock difficult to work with

| Light_touch | 10 days labour | Line definition |

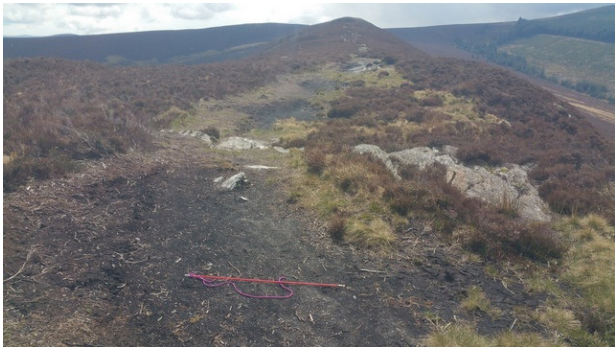
**1** 1619704849244.jpg - T 11806 95136 (± 5m)

**Derrybawn (Section 7)**  
**Section description:** Col

**Site Assessment:**Ridge with easy access

| Work type | Estimated input | Work Summary |
|---|---|---|
| none | | difficult to work due to peat depth unless full construction - not recommended |

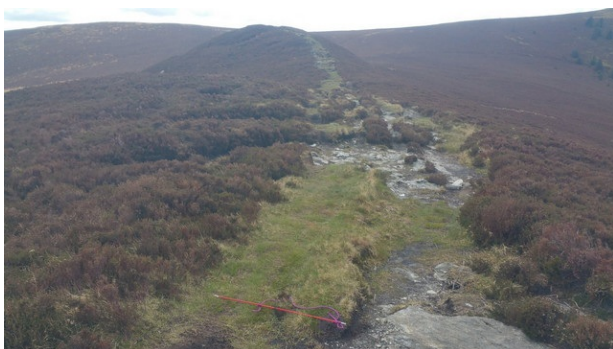
1619705987971.jpg - T 11408 94372 ( $\pm 4\text{m}$ )

Section description: Minor summit and width change

| Work type | Estimated input | Work Summary |
|---|---|---|
| none | | would need full construction or nothing |

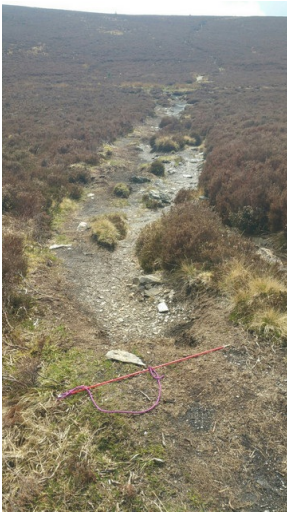
1619706633495.jpg - T 11231 94060 (± 4m)

**Site Assessment:**Easy machine access from adjacent forest road

| early_intervention | | Drainage: 10 water bars with drains to disperse |

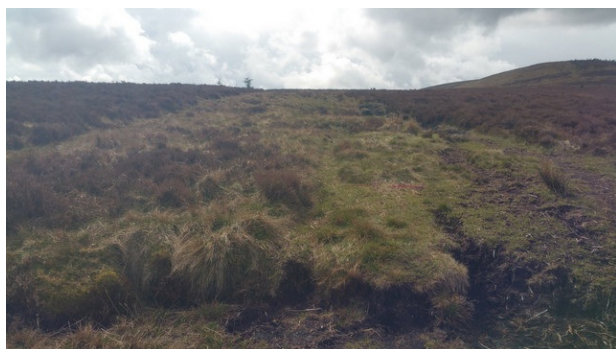
1619707446872.jpg - T 11016 93905 (± 3m)

**Section description:** Change slope and widen damage zone on peat

**Site Assessment:** Easy machine access

| Work type | Estimated input | Work Summary |
|---|---|---|
| none | | Monitor only |

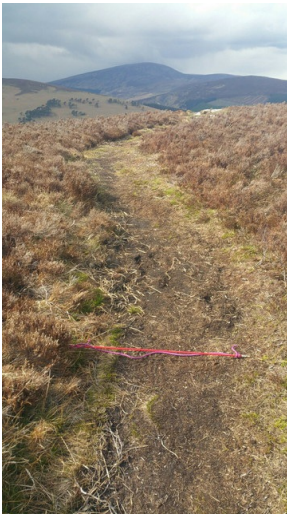
1619711176901.jpg - T 11884 95588 (± 4m)

Section description: Junction with main path

Site Assessment:Alternative route to forestry track

| Work type | Estimated input | Work Summary |
|---|---|---|
| none | | No work on this spur |

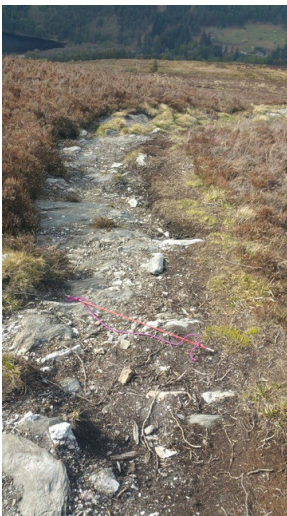
1619711417010.jpg - T 11875 95617 (± 5m)

**Derrybawn (Section 12)**  
**Section description:** Slope increases

**Availability of Materials:** Schist  
**Site Assessment:**Good alternative

| early_intervention | 5 days labour | Minor drainage |
