Wicklow Mountains Path Survey

Client: Wicklow Uplands Council

Version: 2.1 - release

Date: 5 July 2022

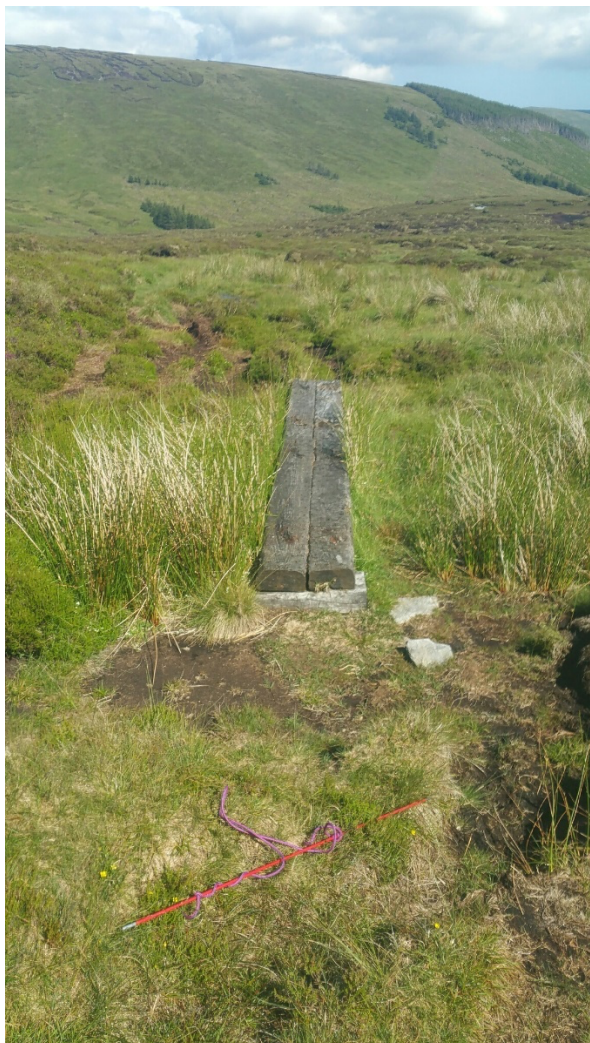
Figure 1: discontinuous bog bridge with braiding at the ends

‘Spot repairs’ (treating localised erosion) also become less viable with deeper peat because trampling pressure is concentrated on a single line to the repair point, leading to extension of the trampled / damaged area at the ends of the treated segment – this usually results in an ongoing ‘positive feedback loop’ of extending the repair zone, or in some cases abandonment.

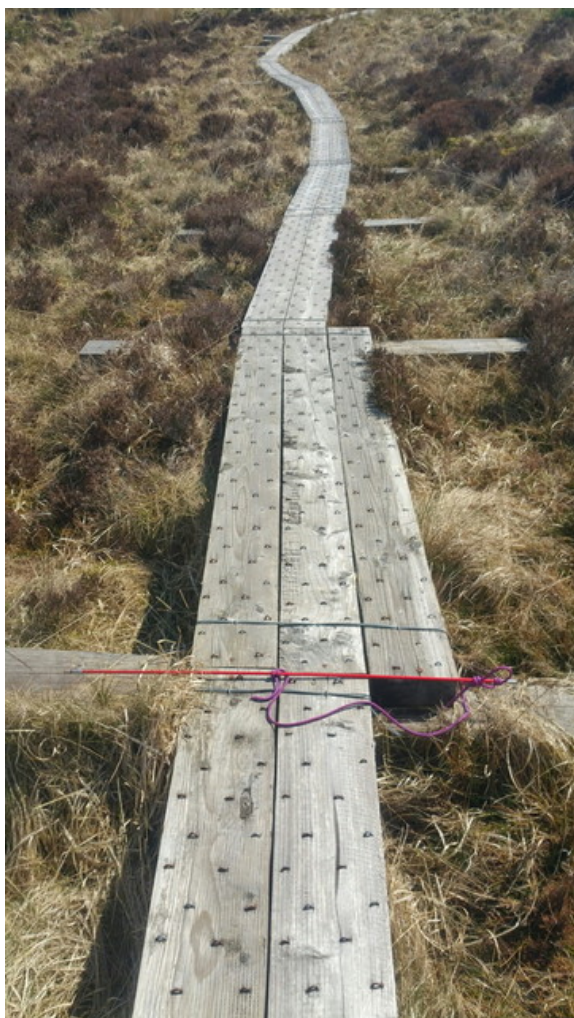
Figure 2: Bog bridge with 'passing place'

On gradients up to 30% (1 in 3 or 16°), floating aggregate paths or bog bridge / boardwalks are an option, but as the gradient increases above 10% (1 in 10 or approx. 5°) aggregate tends to need more frequent ongoing maintenance. In areas with high water tables, paths and structures are susceptible to movement, especially as the weight of the path / structure and gradient can cause the peat to ‘flow’ over time exacerbating any effects of gravity within the peat mass itself. Flagstone / slab paths have working in other areas (such as the Pennines) on low gradients, but there is no obvious source of flagstone locally.

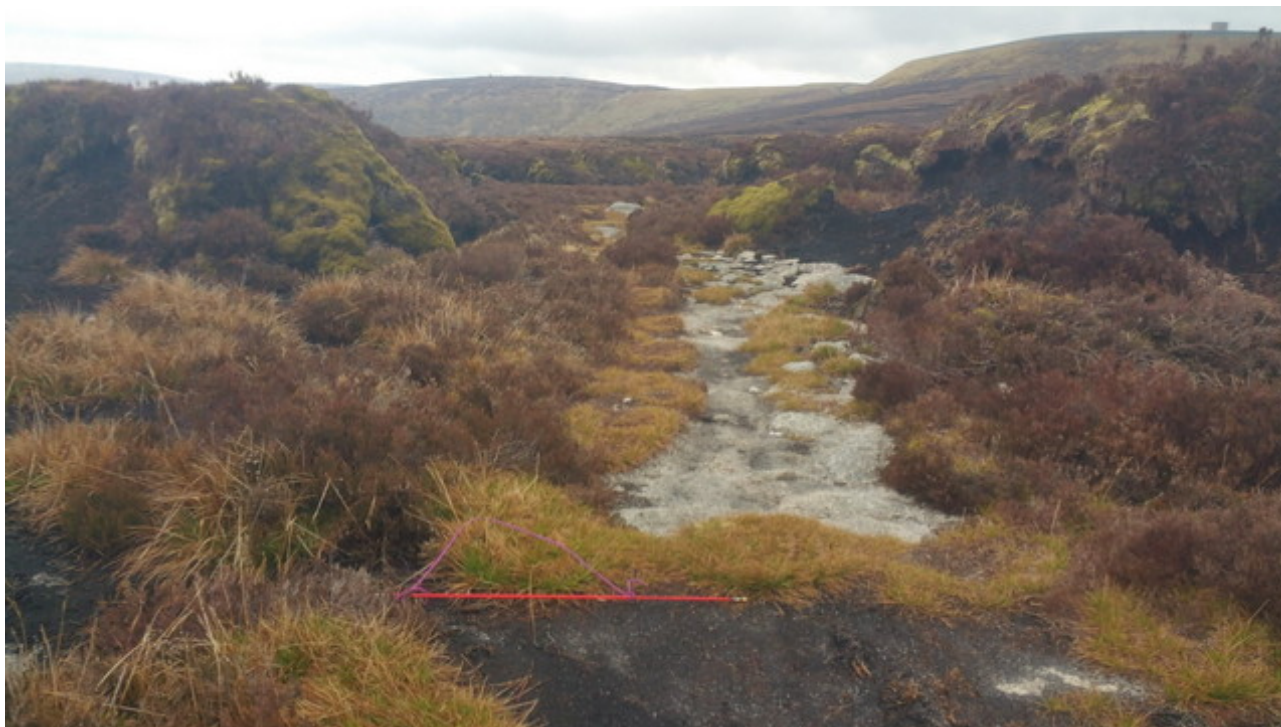
Figure 3: Desire line through area of eroded peat (Camaderry)

Some routes cross areas of peat that have eroded down as far as the underlying substrate either as a result of long-term recreation on a particular line, or wider peat degradation and erosion resulting from other pressures (e.g. grazing). Perhaps counter-intuitively, these damaged areas may provide opportunities to develop more sustainable routes without needing to float paths for extended lengths. By careful selection of a route through eroded peat it may be possible to find hard base close to the surface – this may at times be a less direct option than that usually taken by walkers. However, it would be necessary to consider the path as a whole rather than as individual sections to ensure that it is viable to repair the whole path without significant traverse(s) of deep peat.

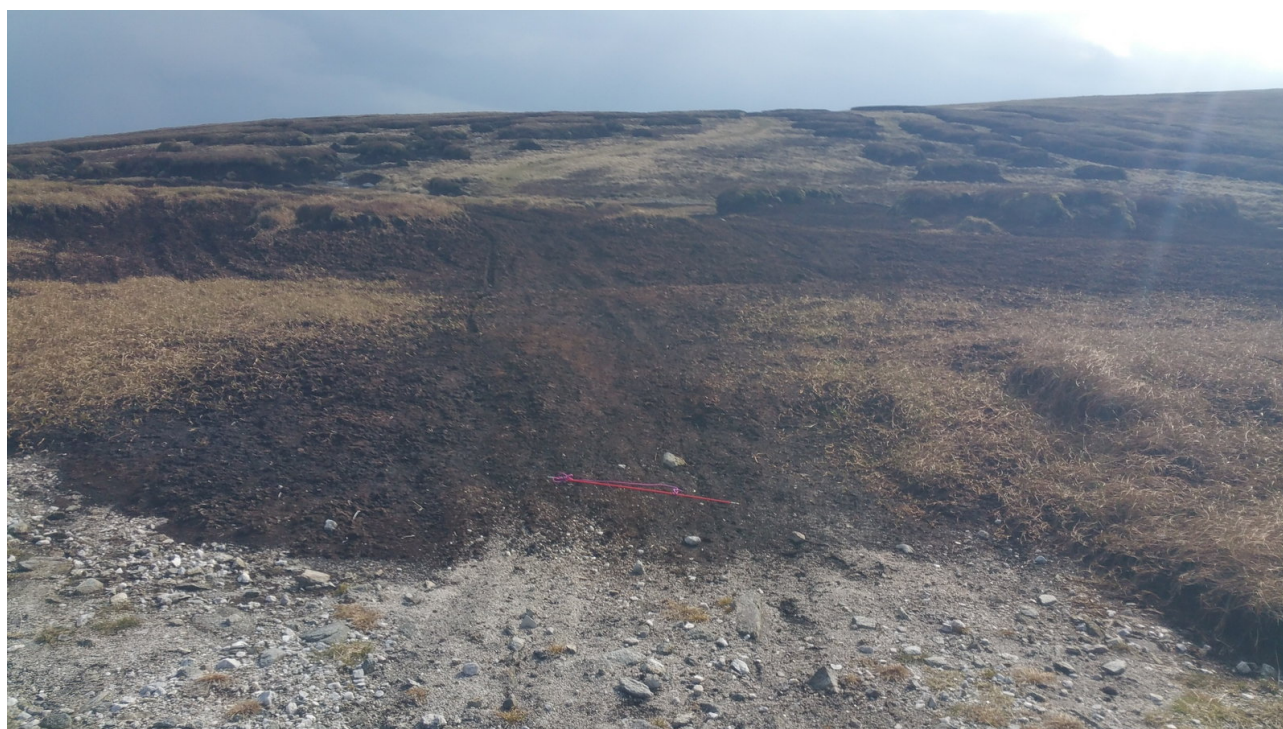
Figure 4: Extensive damage caused by quad bikers and scramblers

Parts of the Wicklow Mountains are used by quad bikes and scramblers, most of which is not related to land management. The routes used by these vehicles show significant levels of damage – far outweighing impacts of walkers, especially in areas of deep peat. ‘Recreational’ use of off-road vehicles is acknowledged to be a policing issue requiring ongoing enforcement, but there are difficulties in gathering evidence that can be used in court. Even though it is probably a small number of individuals engaging in illegal activity, additional resources including CCTV may be necessary in order to overcome current inadequacies in rates of prosecution, to discourage others from participating.
