Survey date: Jul 15, 2021

**Overall description:** Steep ascent up towards Lugnaquilla with some sections on deep peat

# Fraughan Rock Glen (Section 1)

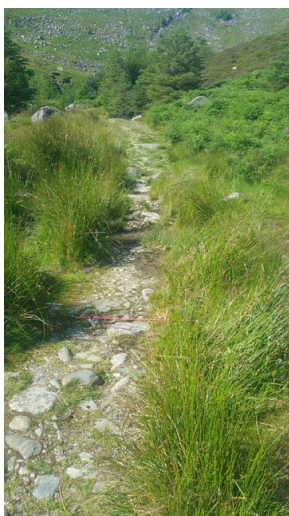
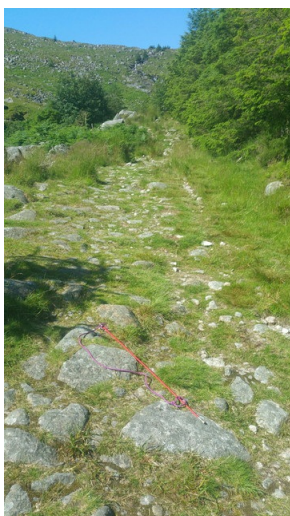
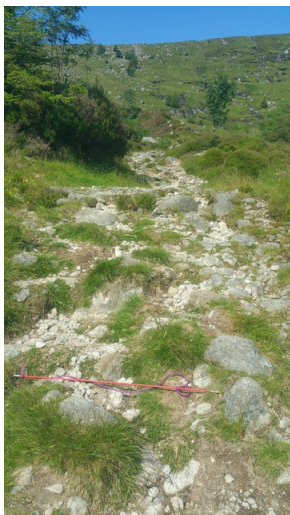
Section description: End of forestry track

**Availability of Materials:** Good block stone

**Site Assessment:**Can drive to site

| Work type | Estimated input | Work Summary |
|---|---|---|
| minor_repair | 5 days labour | Drainage: 5 water bars |

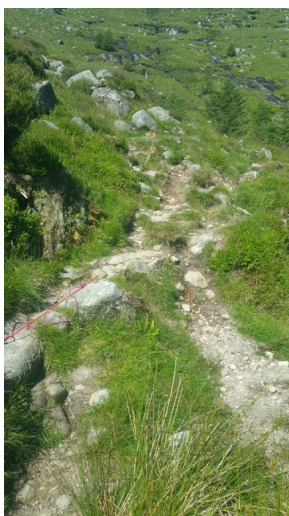
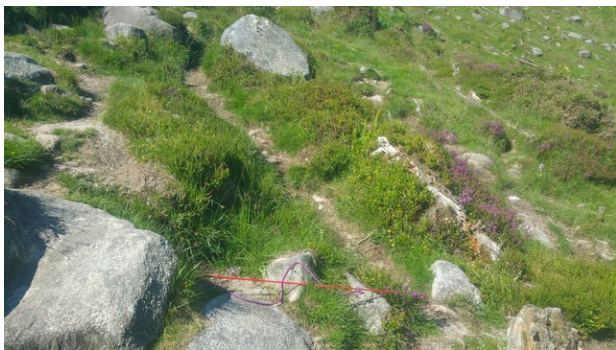
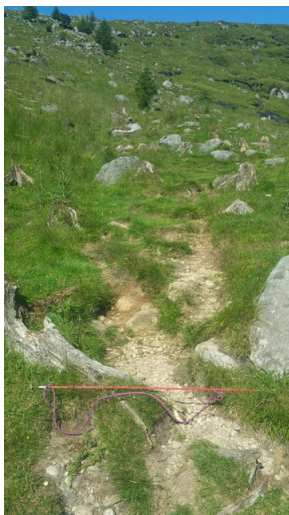
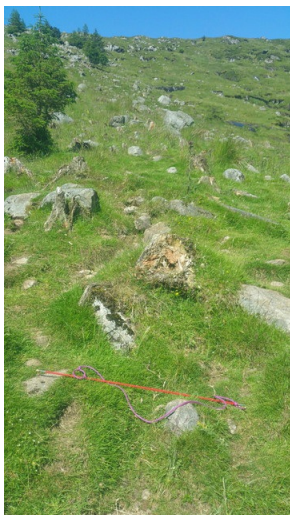
Section description: Moraine

**Availability of Materials:** Good in moraine

**Site Assessment:** Easy access

| Work type | Estimated input | Work Summary |
|---|---|---|
| early_intervention | 5 days labour | Drainage: 5 water bars. Could upgrade in future but would need 90% pitched |

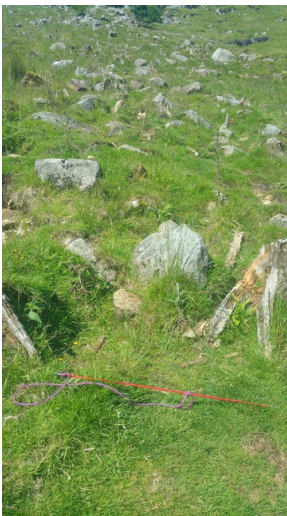
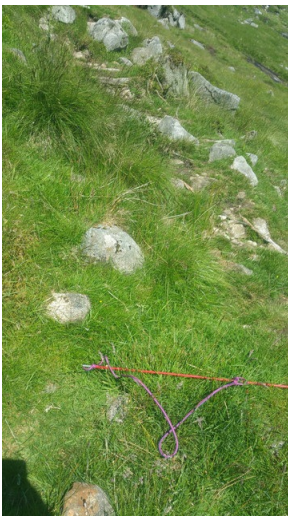
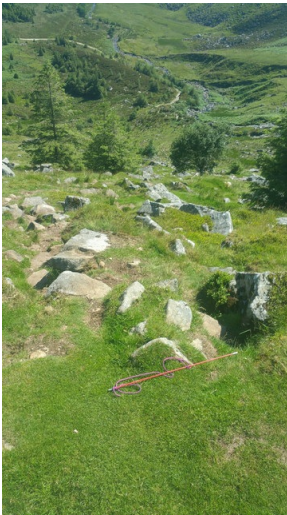
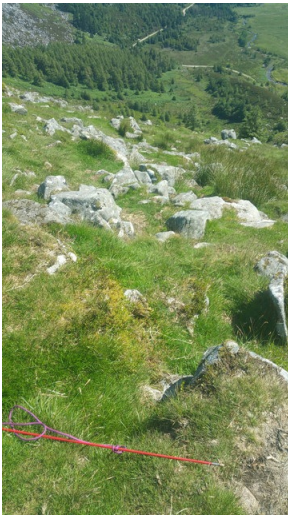
Section description: Large boulder at top of moraine. Increase in slope

Site Assessment:Winch required due to large boulders

| Work type | Estimated input | Work Summary |
|---|---|---|
| early_intervention | 50 days labour | Line definition and drainage - may not be worthwhile given the peat depth on higher sections) |

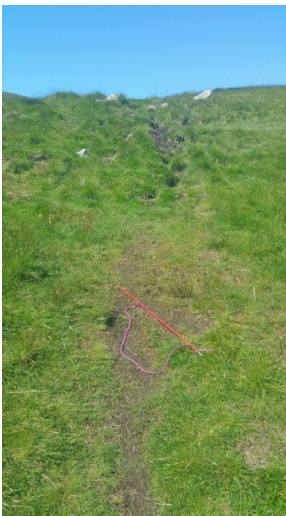
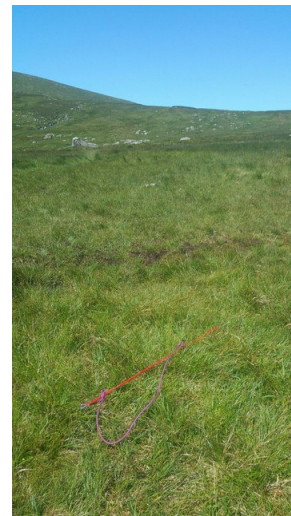
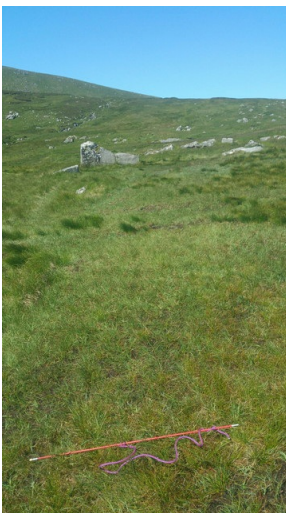
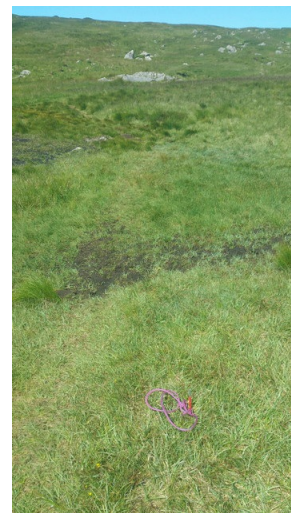
**Section description:** End of boulder field. Decrease in slope

**Availability of Materials:** Minimal probably exists below peat

| Work type | Estimated input | Work Summary |
|---|---|---|
| none | | Would need import of materials or deep excavation. No intermediate interventions due to peat depth |

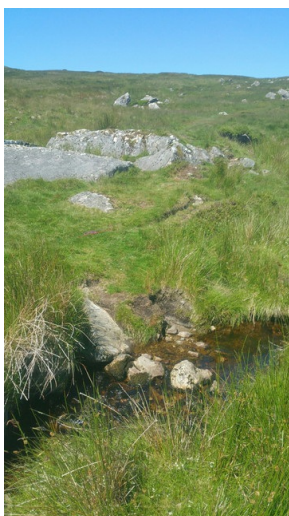
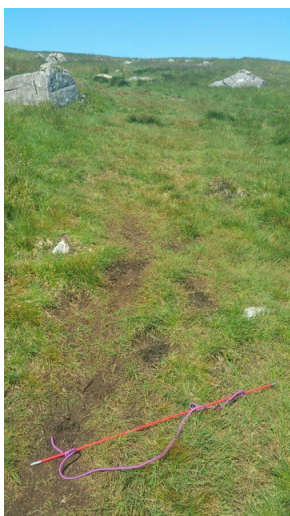
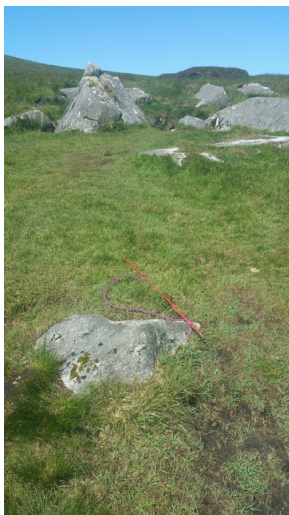
Section description: Stream crossing

**Site Assessment:** Easy helicopter access

| Work type | Estimated input | Work Summary |
|---|---|---|
| none | | No intermediate interventions possible due to peat depth |

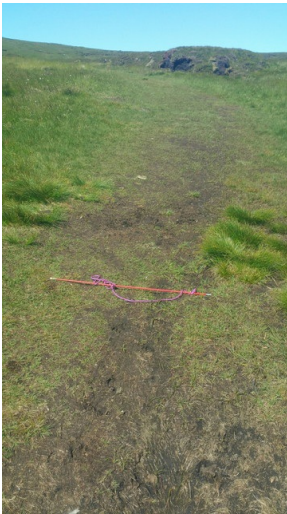
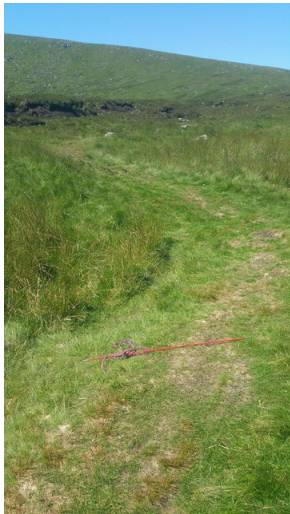
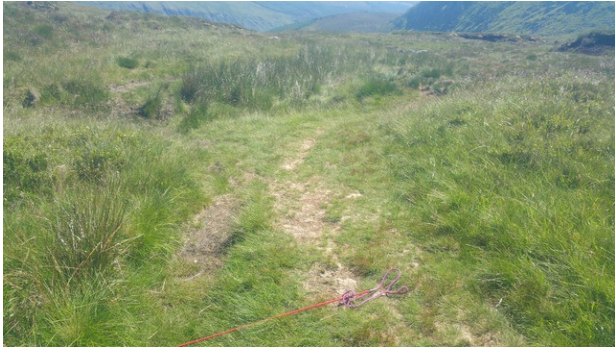
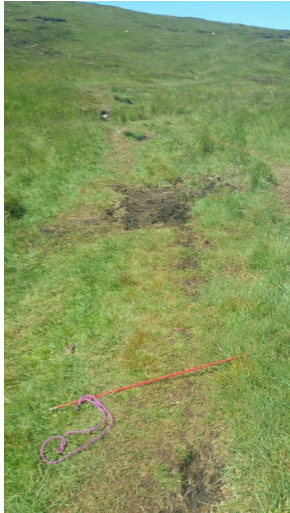
Section description: Boulders at start of hag field

Availability of Materials: Some near steam crossings

| Work type | Estimated input | Work Summary |
|---|---|---|
| none | | Deep peat even next to hags anything would need to be floated |

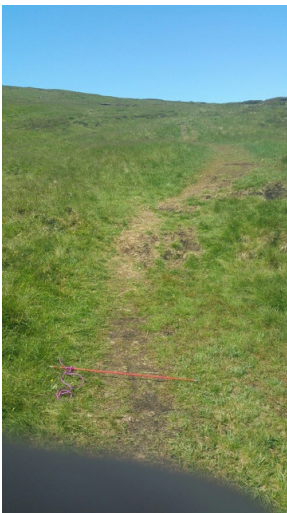
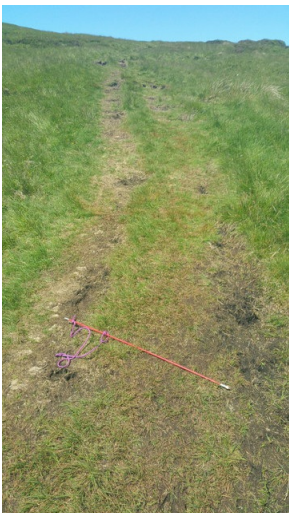
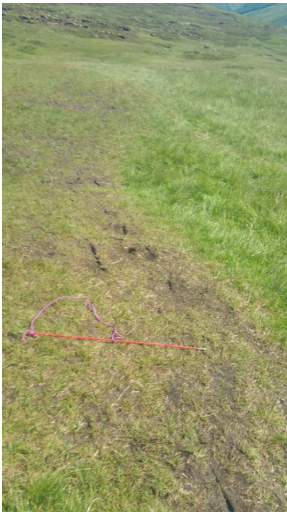
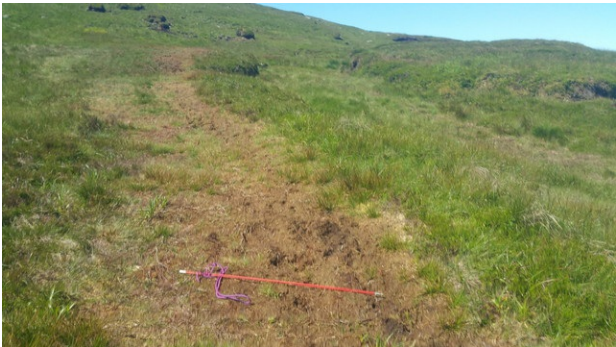
Section description: Stream crossing. Increase slope

Site Assessment:Large hag field

| none | | Deep peat - no work viable |

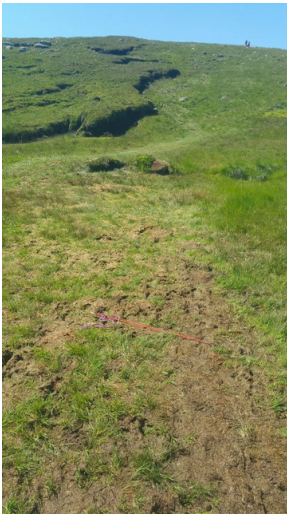
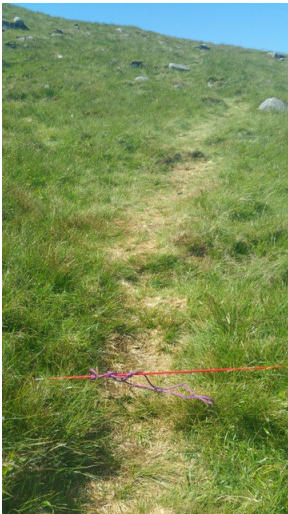
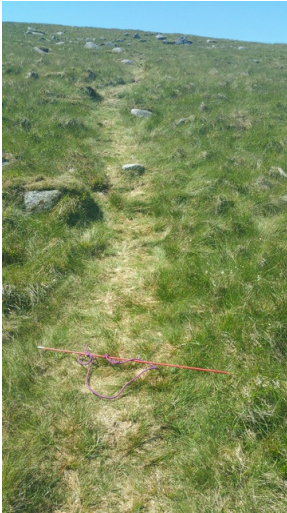
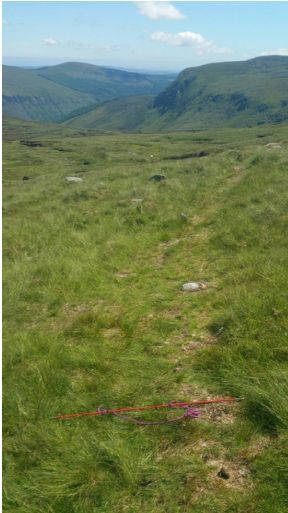
Section description: Bog pool. Sheep grave!

**Site Assessment:**Variable depth of peat

| Work type | Estimated input | Work Summary |
|---|---|---|
| none | | Deep peat on steep slope - no work is viable |
