Survey date: Apr 30, 2021

Length: 4628m

Sections: 8

**Glendoo-Cloghnagun-Prince William's** Start: O 14119 20498 (± 4m) End: O 14400 20099 (± 4m)

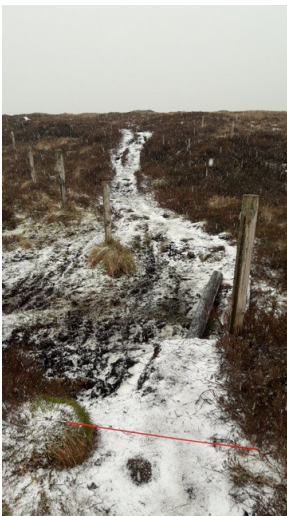
**1** 1619779616025.jpg - F 093555 5680400 (± 0m)

**Section description:** Section starts at a fence line and traverses the 'plateau' of Glendoo Mountain. Parts of this section have wide trample / bare zones.

Minimum	Maximum	Typical
Trampled width (m)	0.5	1	10
Bare width (m)	0.3	0.5	10
Eroded depth (m)	0.1	0.2	0.6

Work type	Estimated input	Work Summary
none		Due to peat depth, there are limited opportunities for localised repair.

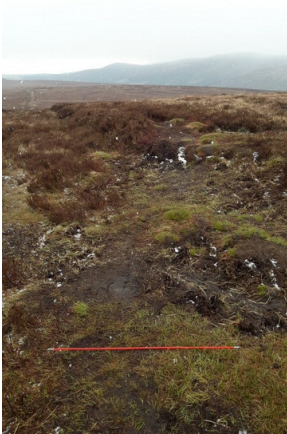
1619781994900.jpg - O 14402 20102 (± 5m)

**Section description:** Section start marks a change of gradient / upland grasses and sedges patch. Reduced trample width compared with section 2

Minimum	Maximum	Typical
Trampled width (m)	0.5	1	2
Bare width (m)	0.1	0.3	1
Eroded depth (m)	0	0.1	0.3

Work type	Estimated input	Work Summary
none		Vegetation restoration in some deeply eroded patches would be beneficial but hampered by deep peat

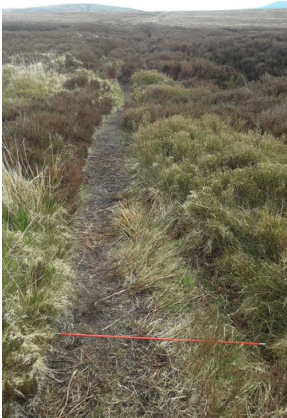
1619784965295.jpg - O 14578 19872 (± 4m)

**Section description:** Section is on a flat area with characteristic billberry bush at start. Path widening is occurring around bog pools

Minimum	Maximum	Typical
Trampled width (m)	0.3	1	3
Bare width (m)	0	0.5	2
Eroded depth (m)	0	0.1	0.4

Work type	Estimated input	Work Summary
none		Site restoration not viable due to deep peat.

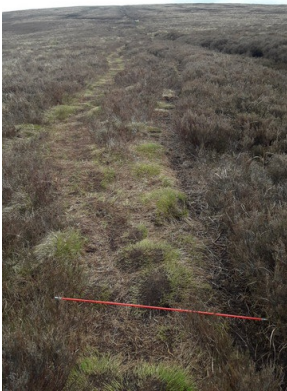
1619788526098.jpg - O 15718 19048 (± 5m)

**Section description:** Section marks a change of gradient / eroded peat step. A few sphagnum pools occur where trampling has spread.

Minimum	Maximum	Typical
Trampled width (m)	0.3	1.5	10
Bare width (m)	0.3	0.6	3
Eroded depth (m)	0	0.1	0.3

Work type	Estimated input	Work Summary
early_intervention	2 days labour	Blocking some braids. Deep peat hampers any other options

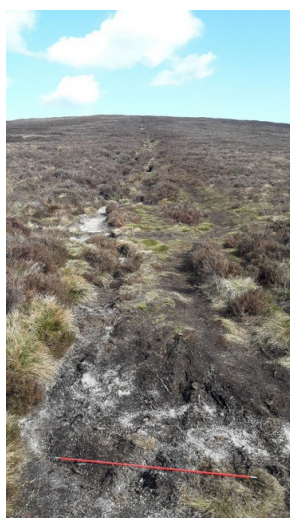
1619793822029.jpg - O 17287 18356 ( $\pm 4m$ )

**Section description:** Change of gradient / mineral soil appearing. Water is washing out mineral material in the first half of the section.

Minimum	Maximum	Typical
Trampled width (m)	0.5	1.5	2
Bare width (m)	0.3	0.6	1
Eroded depth (m)	0	0.1	0.2

Work type	Estimated input	Work Summary
Light_touch	5 days labour	Install water bar to divert water flowing from natural side ditch. Minor line definition work.
