Survey date: Jul 17, 2021

**Overall description:** Route from Sally Gap to Mullacleevaugh East Top

**Overall assessment:** Extensive areas of deep peat and eroded / degraded peatlands - a higher priority than path repair

## Gravale (Section 1)

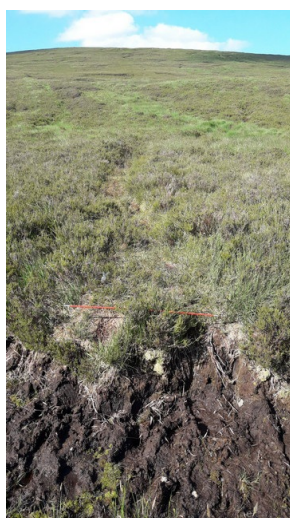
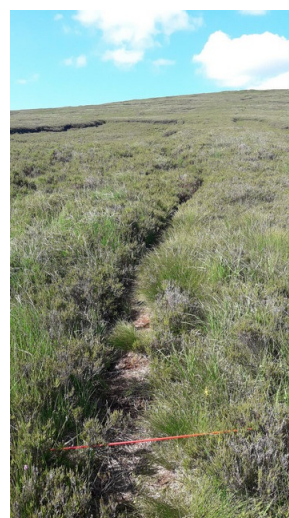
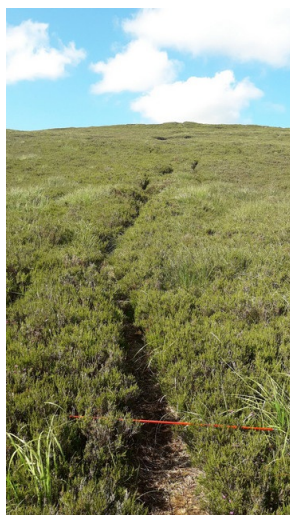
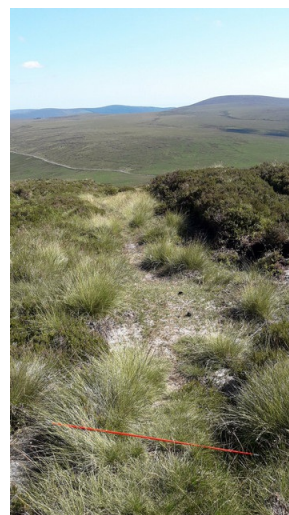
Section description: Start of route at Sally's gap

**Site Assessment:** Access to Sally gap crossroad

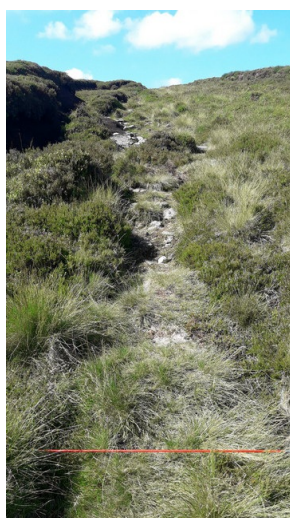
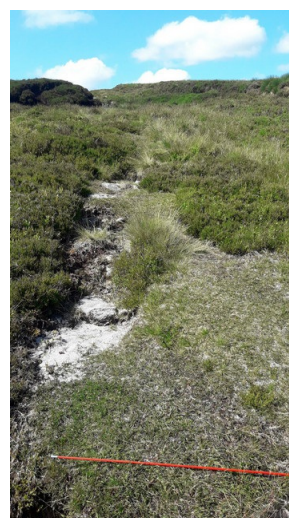
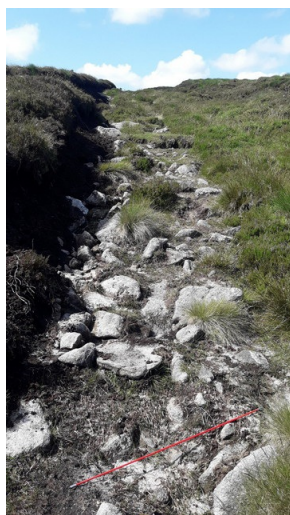
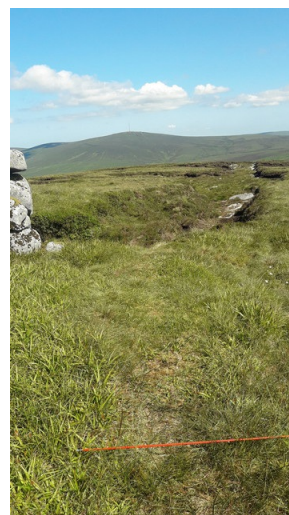
**Section description:** Mineral soil exposed, area of wide peat erosion overgrazed

**Site Assessment:** Summit area. Power barrow could be driven up. Huge area of peat erosion close to summit area. Peat restoration techniques needed edge of route corridor

| Work type | Estimated input | Work Summary |
|---|---|---|
| early_intervention | 5 days labour | 5 water bars |

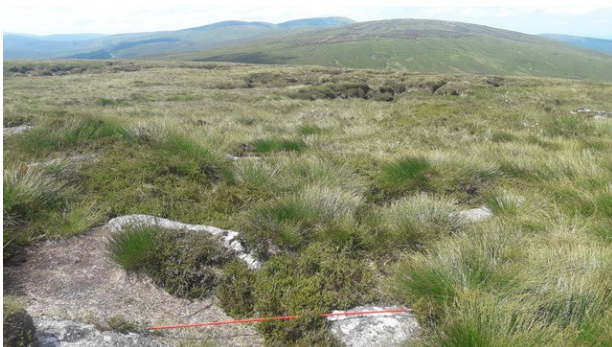
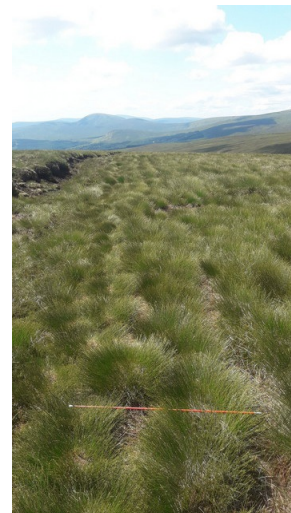
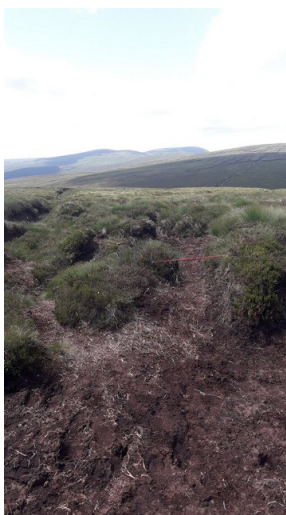
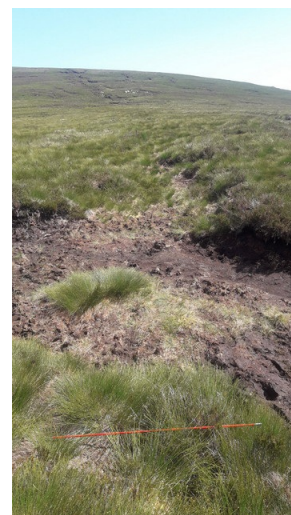
Section description: Carrigvoher summit

**Site Assessment:** Remote.

| Work type | Estimated input | Work Summary |
|---|---|---|
| none | | Peatland restoration techniques at summit and end of section. |

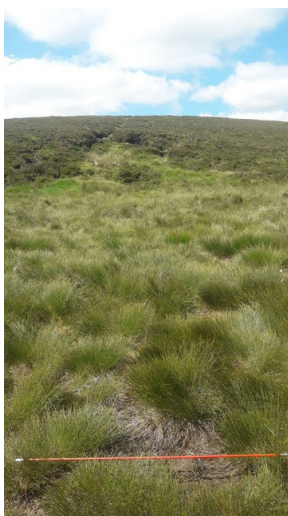
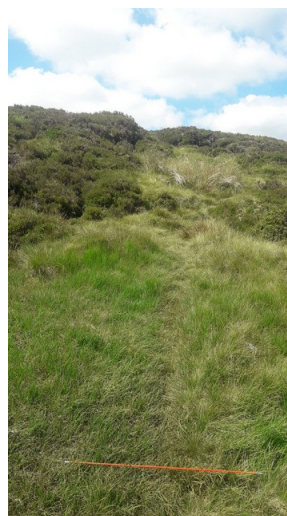
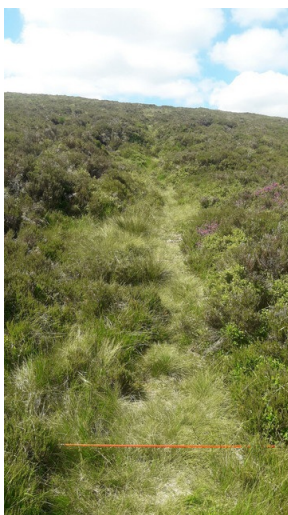
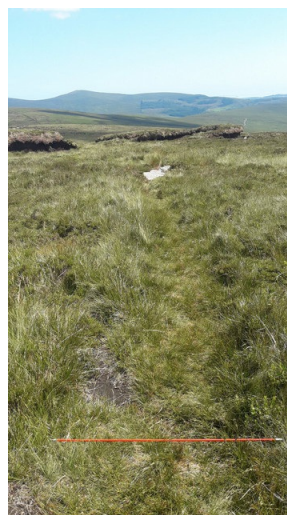
**Section description:** Change of gradient. Ascent to Gravale summit. Flat area where path line difuses, navigation through meandering deep peat erosion.

| Work type | Estimated input | Work Summary |
|---|---|---|
| none | | Peatland restoration techniques. |

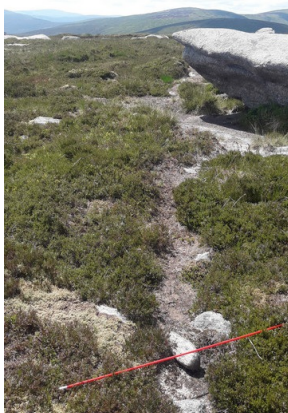
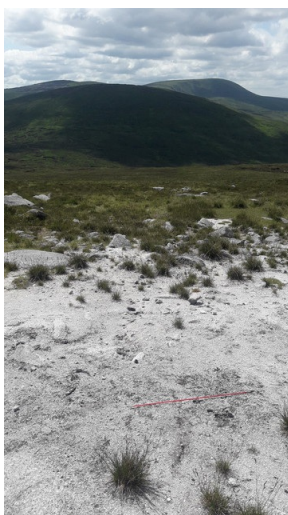
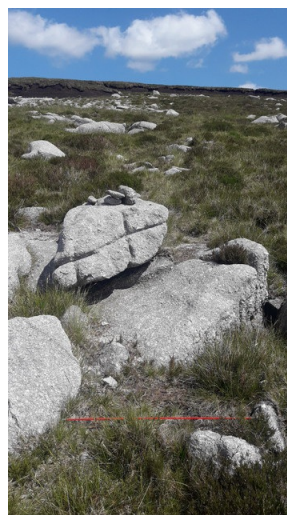
**Section description:** Gravale summit. Path line middle of summit eroded area with mineral soil and bedrock exposed, following route signpost by some small stone cairns along the mineral soil-bedrock exposed areas

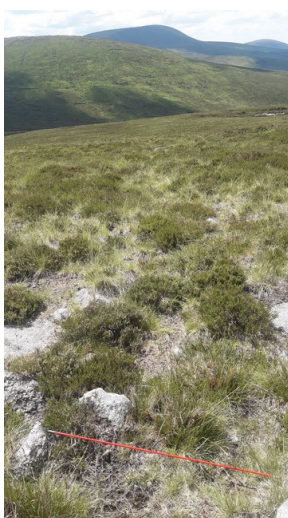
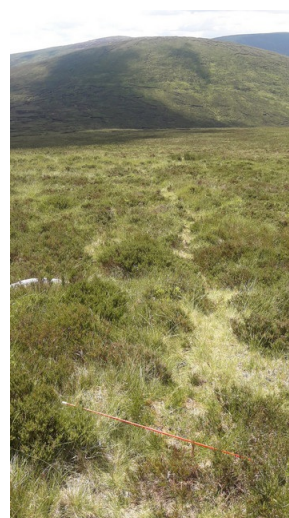
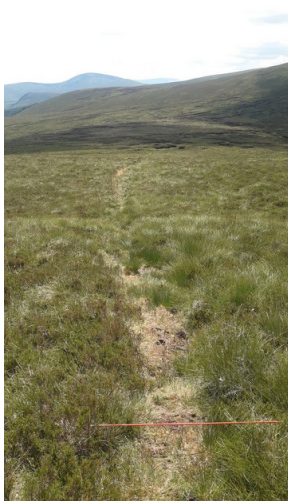
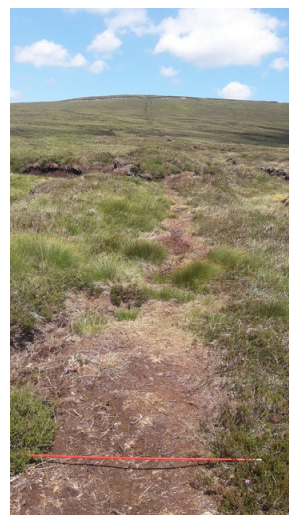
**Section description:** No obvious path line descending towards Duffy Hill ascent area

**Site Assessment:** Single scar over vegetation with a few bare soil areas and several areas where path line difuses within regenerating vegetation

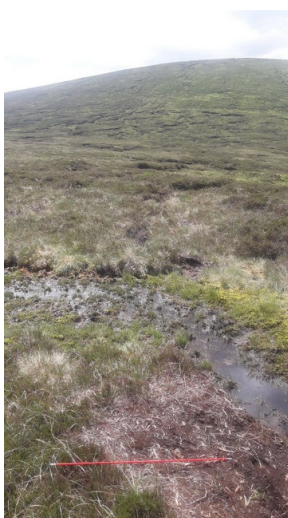
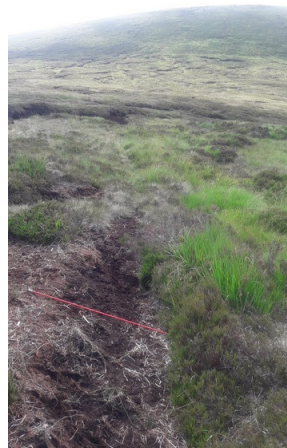
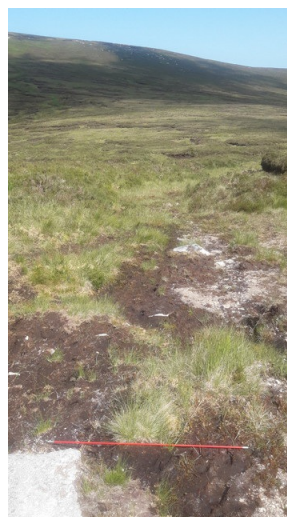
**Section description:** Start of bog pools and meandering peat erosion that difficults navigation

**Site Assessment:** Difficult navigation through eroded peat areas and bog pools cutting path line

| Work type | Estimated input | Work Summary |
|---|---|---|
| none | 5 days labour | Peatland restoration techniques and re-routing of some areas going straight to bog pools |

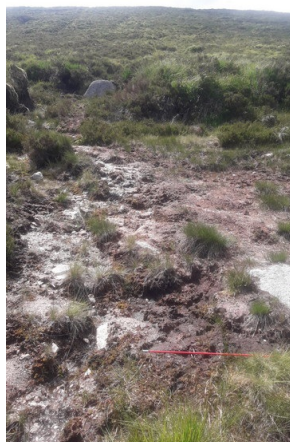
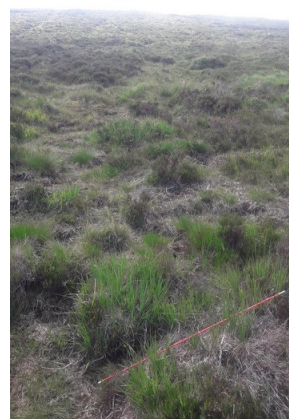
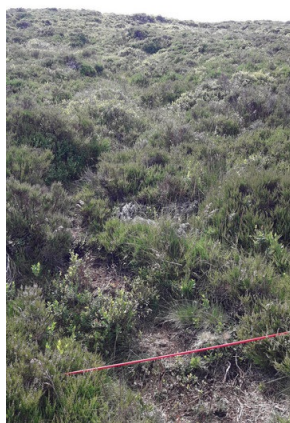
**Section description:** Gradient increases, mineral soil exposed

**Site Assessment:** Very defined line with few erosion when section towards summit steeper. Mineral soil and bedrock exposed close to the summit, but stable.

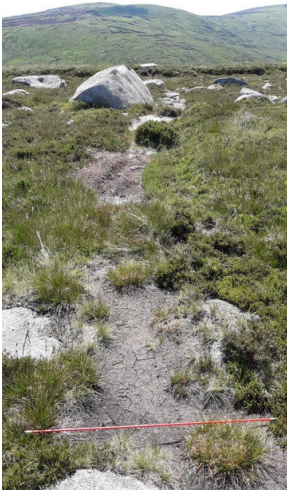
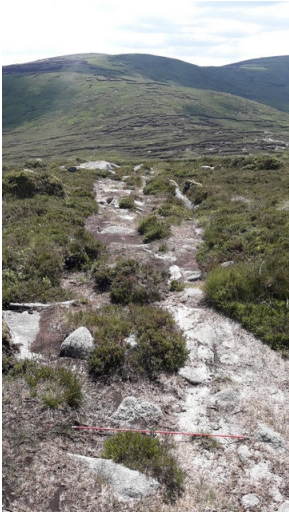
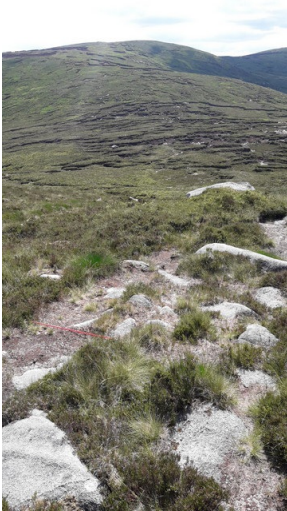
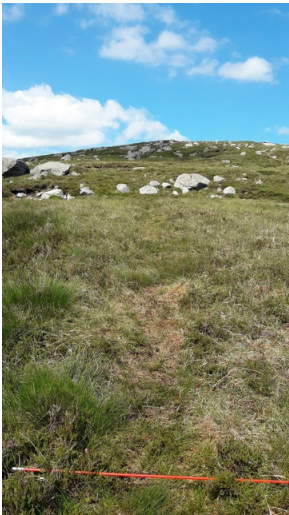
**Site Assessment:**Defined line over trampled vegetation. Very stable except for a few areas beside the wide peat trampled areas.

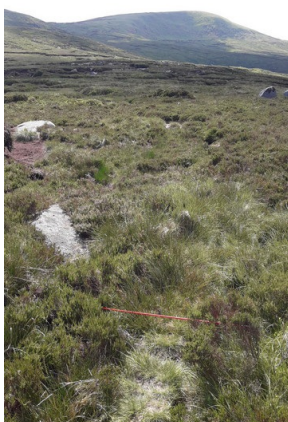
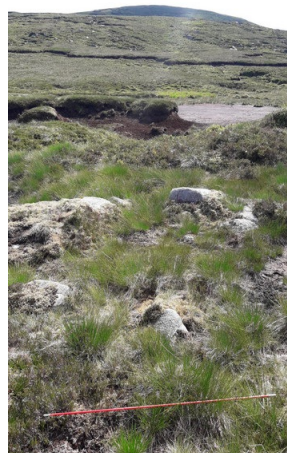
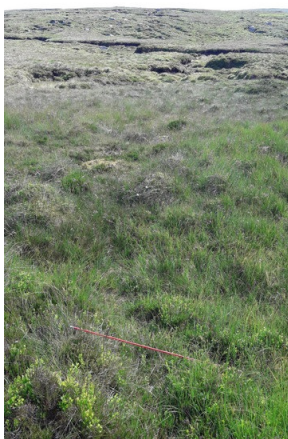
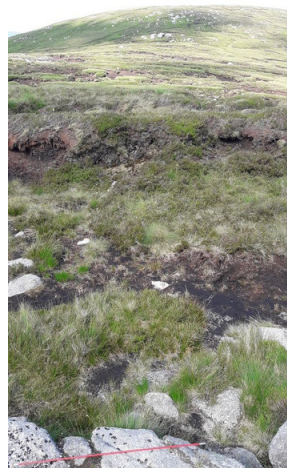
**Section description:** Change of gradient (flattening) start of boggy areas and wide peat erosion. 1 braid each side of central pool areas. Path line undefined at the end of section. Stranded navigation.

| Work type | Estimated input | Work Summary |
|---|---|---|
| none | | Peatland restoration techniques. |

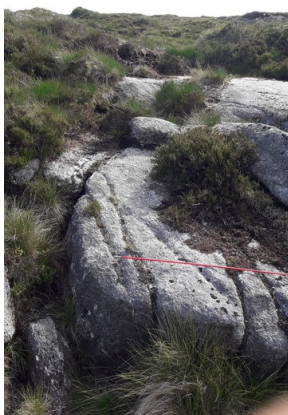
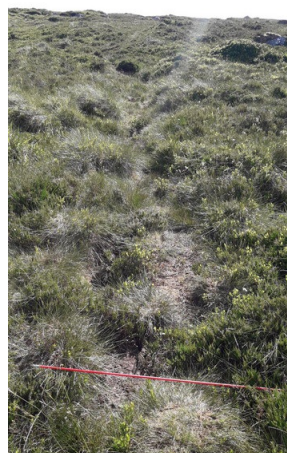
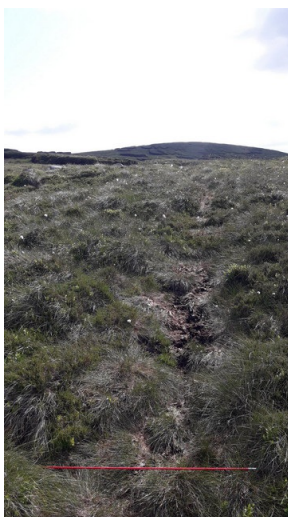
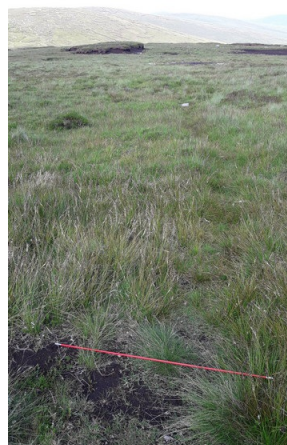
**Section description:** Change of gradient, bedrock large slab step

**Site Assessment:** The path line dilutes at the end of section closer to the summit area

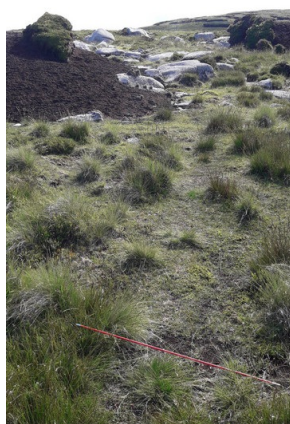
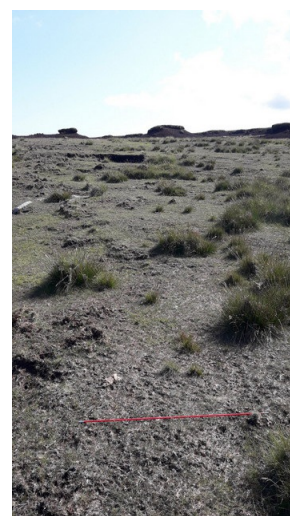
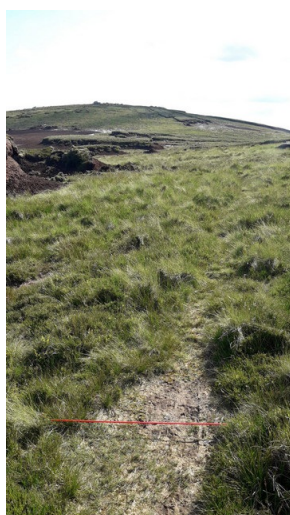
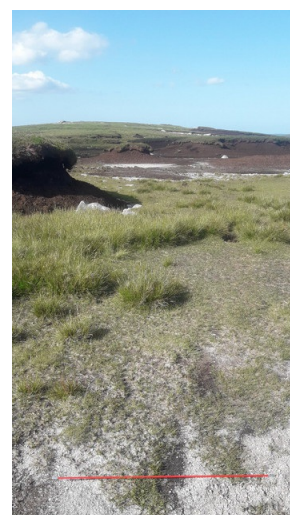
**Section description:** Bedrock reappearing, open upper slopes plateau without defined path line

**Site Assessment:** No path line obvious if gps track not followed

| Work type | Estimated input | Work Summary |
|---|---|---|
| none | | Path line difuses over a very wide peat eroded area |

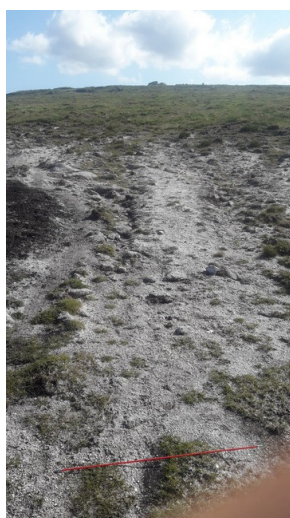
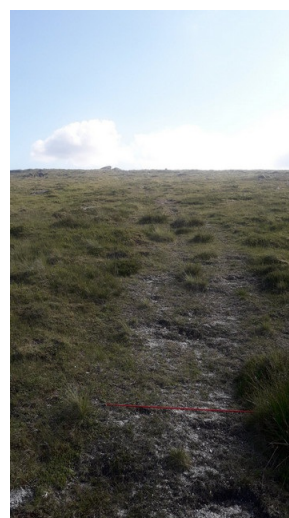
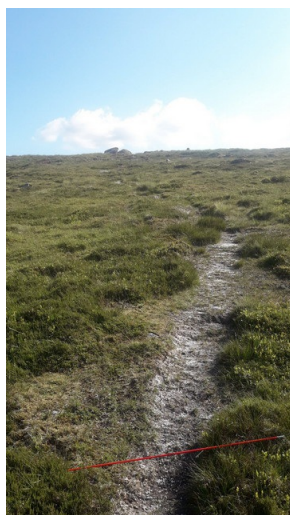
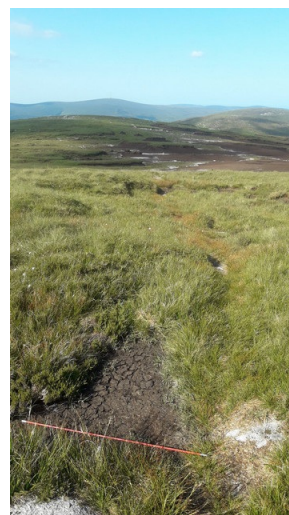
Section description: Mineral soil exposed and change of gradient and habitat

**Site Assessment:** Final summit ascent, mineral soil exposed at first stretch, surface stable
