**Overall description:** Path on edge of broad plateau

**Overall assessment:** Deep peat makes work unviable - major bare peat expanses with potential for large scale peatland restoration (good site access)

**Kippure to Seefingan (Section 7)**  
**Section description:** Kippure summit

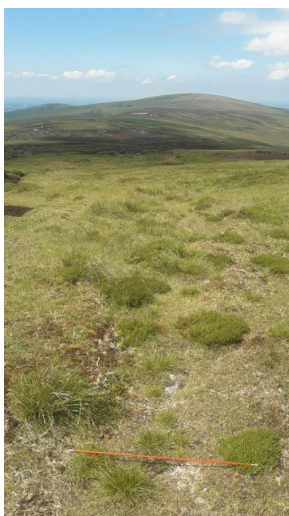
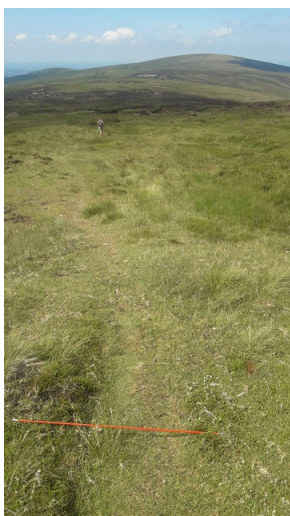
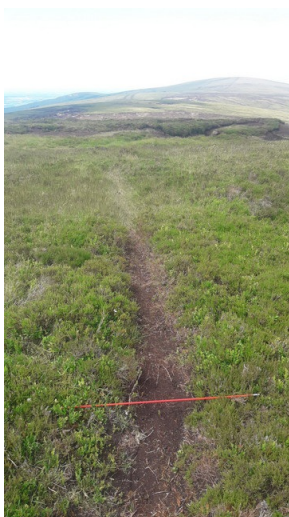
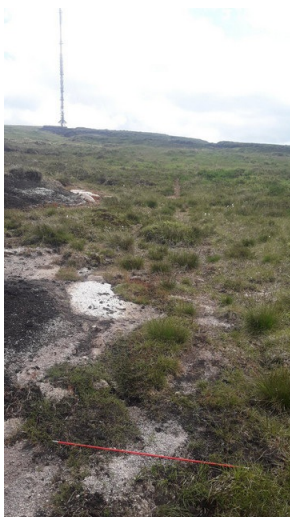
**Site Assessment:**Access track summit

| Work type | Estimated input | Work Summary |
|---|---|---|
| none | | |

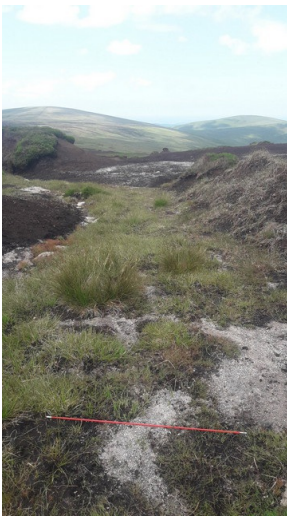
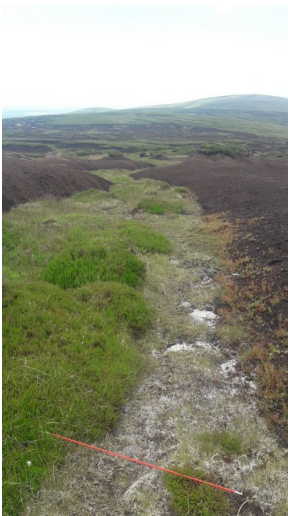
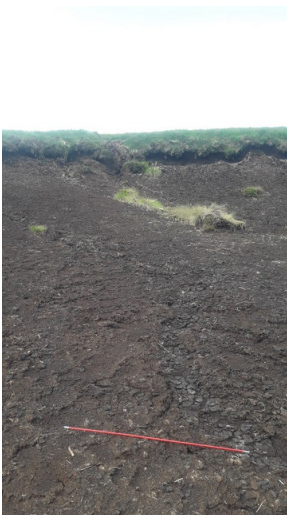
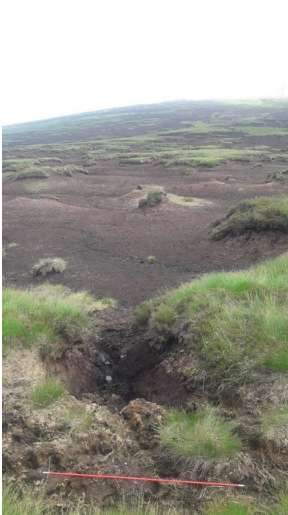
Section description: Path difuses into wide peat eroded area

Site Assessment:Remote but close to summit access for machinery

| Work type | Estimated input | Work Summary |
|---|---|---|
| none | | Peatland restoration techniques |

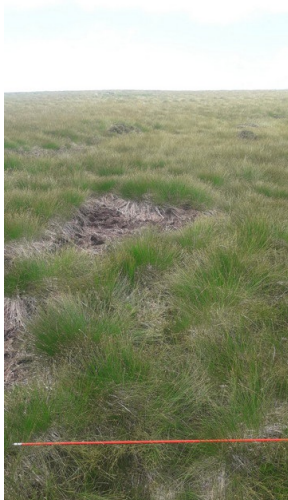
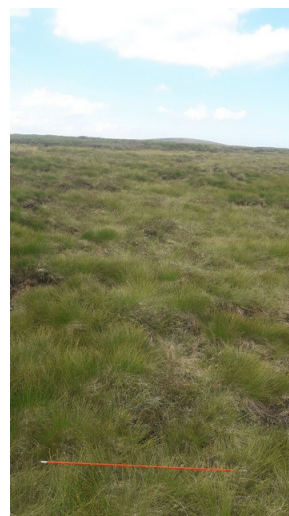
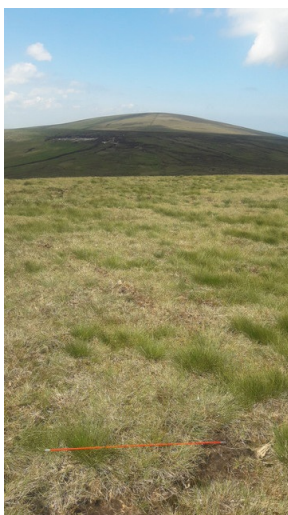
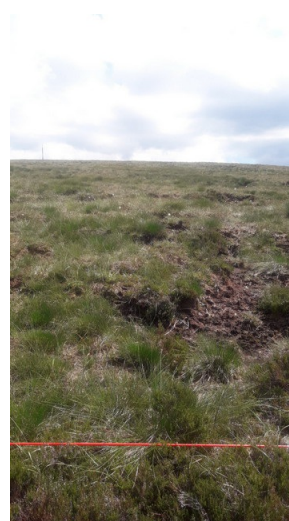
**Section description:** End of wide bare peat area, continous cover of deer grass with not defined path line. No significant trampling pressure

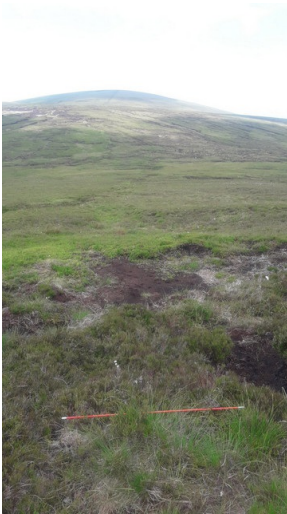
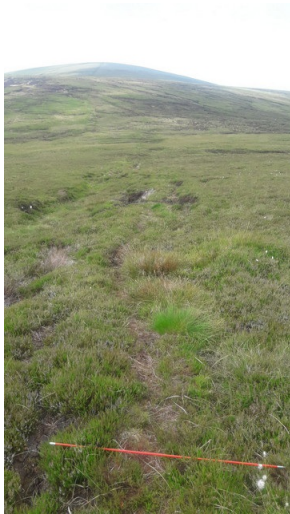
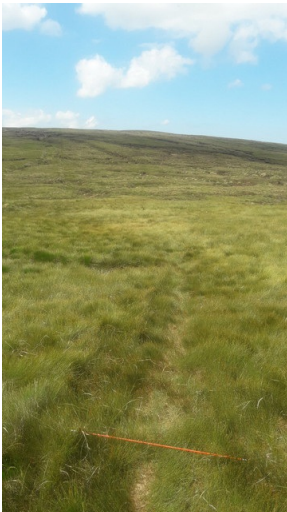
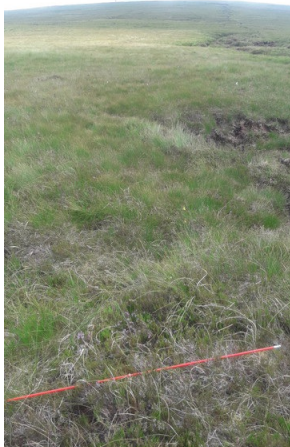
**Section description:** Change of vegetation to heathland, peat step 0.5 m. Path line defines briefly when vegetation dominated by heather. When deer grass dominates the path line disappears

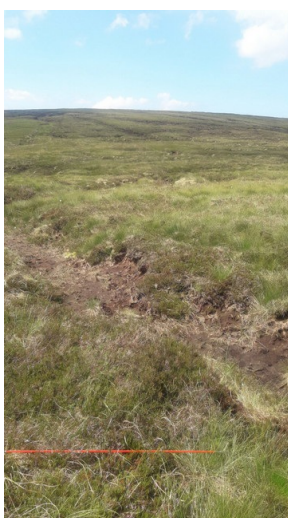
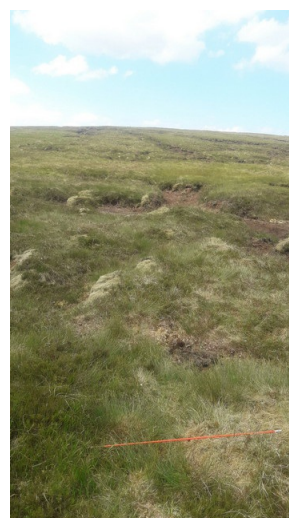
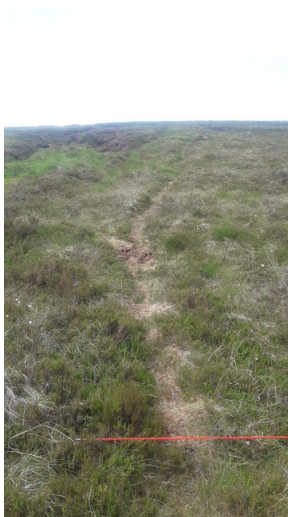
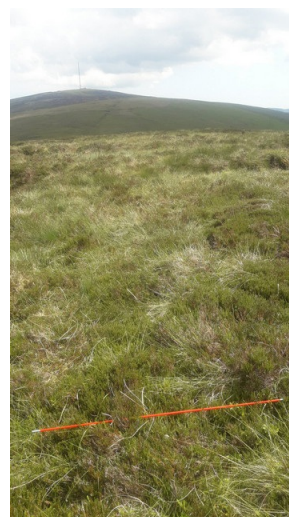
**Section description:** Change of gradient ascending and broken peat landscape starting. Navigation difficult. Path line just defined at times, trampling pressure very spread because of broken peat landscape surroundings

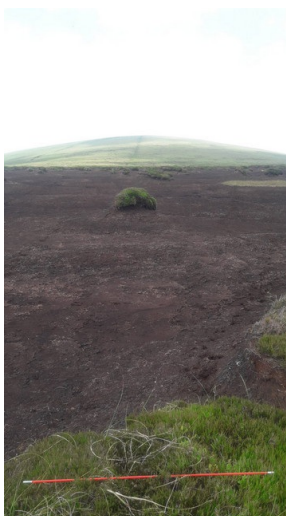
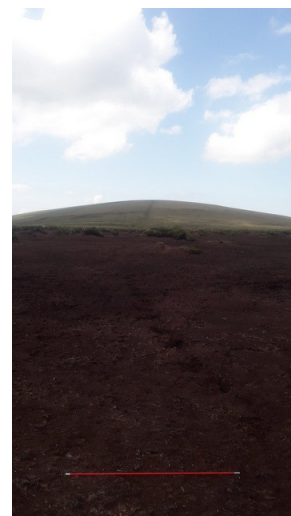
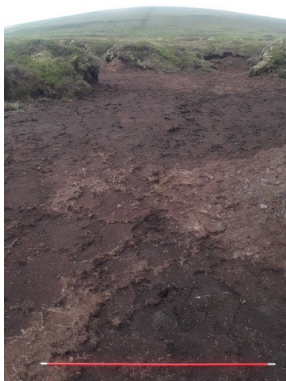
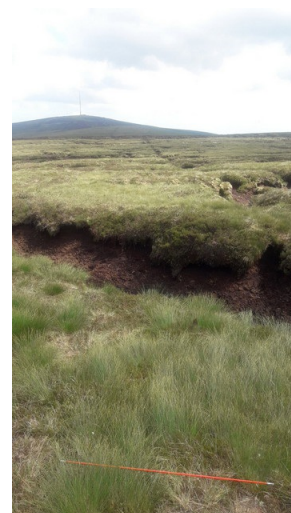
Section description: Start of very wide bare peat area

| Work type | Estimated input | Work Summary |
|---|---|---|
| none | | Peatland restoration techniques |

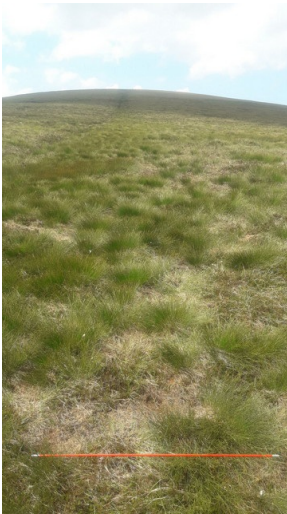
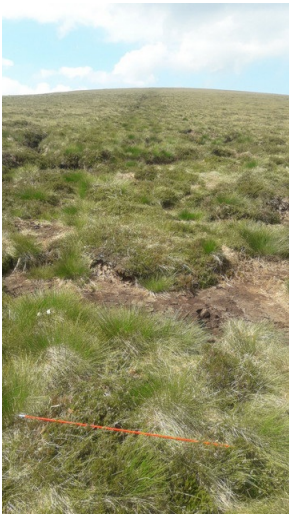
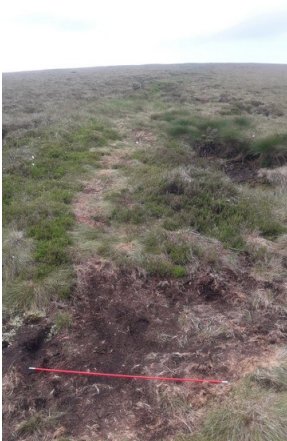
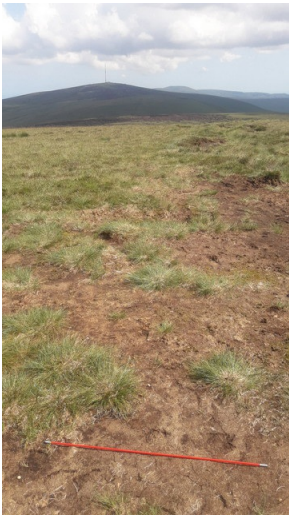
**Section description:** End of wide bare peat broken landscape. Very difuse path lines at times that gradually defines on the upper section area close to the summit

**Site Assessment:**Remote site
