Survey date: Apr 27, 2021

Overall description: Path traverses above the cliffs round both Loughs

Overall assessment: Areas of deep peat some of which is on moderate gradient. Proximity to the road (and car park) means that repairs are likely to lead to increase in use

Lough bray upper (Section 1)

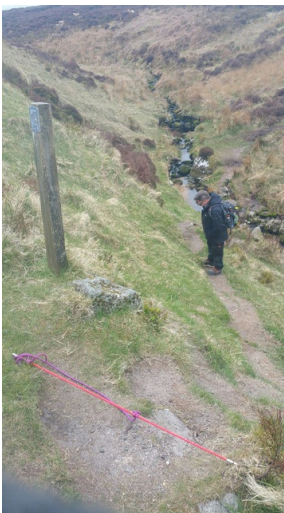
1619513531621.jpg - O 14271 15010 (\pm 9m)

Section description: Section starts at roadside and drops to crossing of the stream

Length (m)	Max gradient (%)	Min gradient (%)	Crossfall (%)
61	30	0	0

Substrate	Peat Depth (cm)
peat	90

Minimum	Maximum	Typical
Trampled width (m)	0.3	0.5	2
Bare width (m)	0.3	0.3	0.8
Eroded depth (m)	0	0.2	0.3

Work type	Estimated input	Work Summary
none		Any work would need to be floated on the peat, which combined with the slope down to the watercourse would make this a complex task. There are no intermediate repair options.

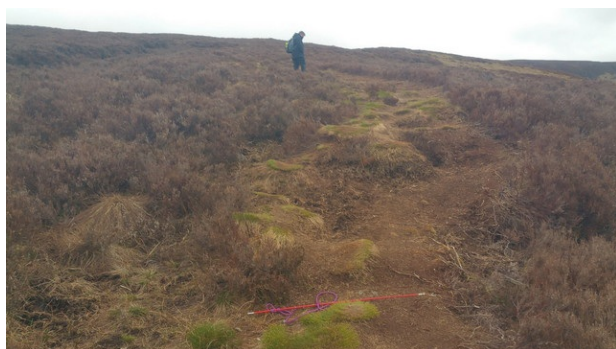
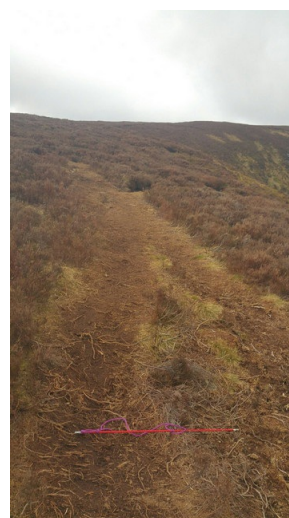
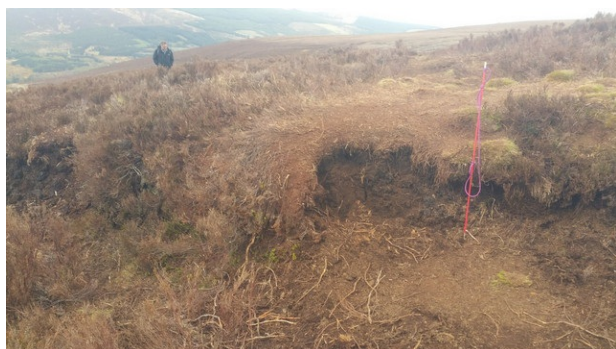
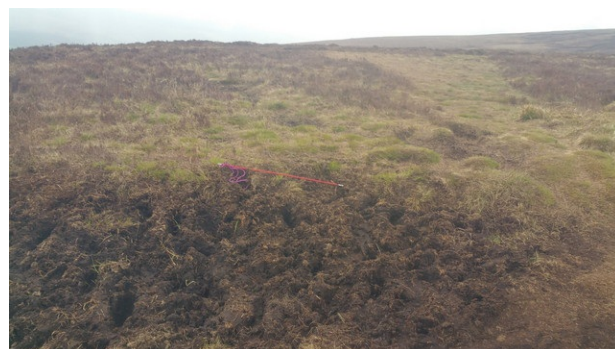
Section description: Section starts at a change slope beyond the stream and runs across deep blanket bog at the top of the corrie.

Length (m)	Max gradient (%)	Min gradient (%)	Crossfall (%)
575	20	5	0

Substrate	Peat Depth (cm)
peat	100

Minimum	Maximum	Typical
Trampled width (m)	2	3	35
Bare width (m)	0.5	0.8	11
Eroded depth (m)	0	0.3	0.6

Work type	Estimated input	Work Summary
none		Bog bridges would be an option to reduce erosion of bare peat, but these are likely to focus trampling pressure so may exacerbate the problem.

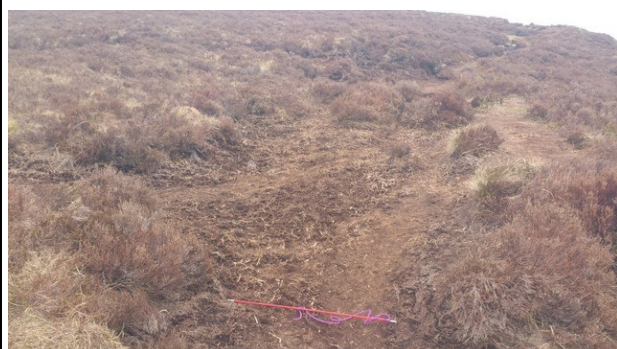
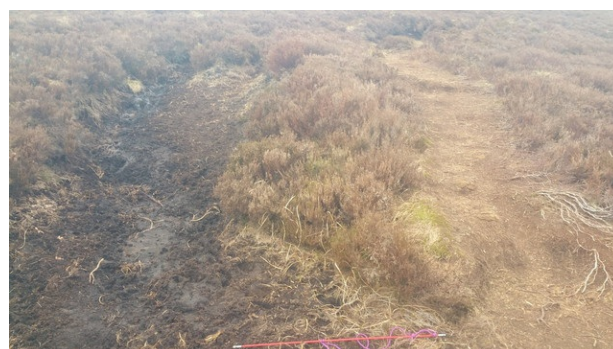
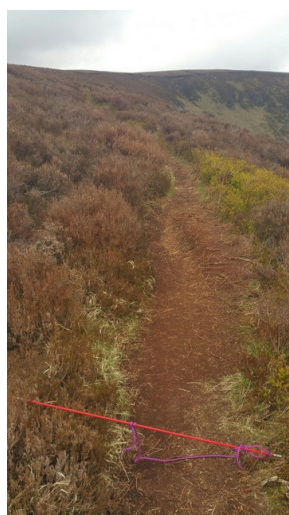
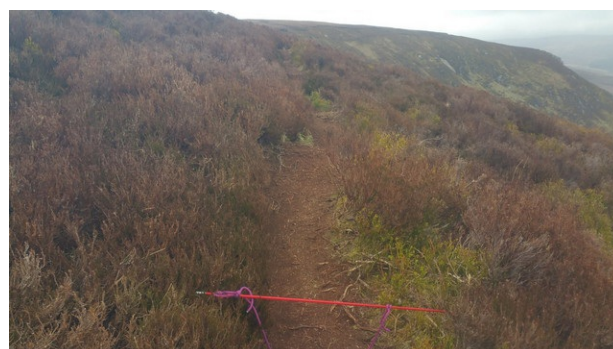
Section description: Section starts where the route narrows and follows the corrie rim. Mostly stable where the cross slope means that peat is drier.

Length (m)	Max gradient (%)	Min gradient (%)	Crossfall (%)
814	15	0	25

Substrate	Peat Depth (cm)
peat	100

Minimum	Maximum	Typical
Trampled width (m)	0.5	1	5
Bare width (m)	0.3	0.5	3
Eroded depth (m)	0.2	0.2	0.8

Work type	Estimated input	Work Summary
none	7 days labour	A series of spring lines could be managed by the installation of cross drains. Any other work would require a floating construction due to peat depth

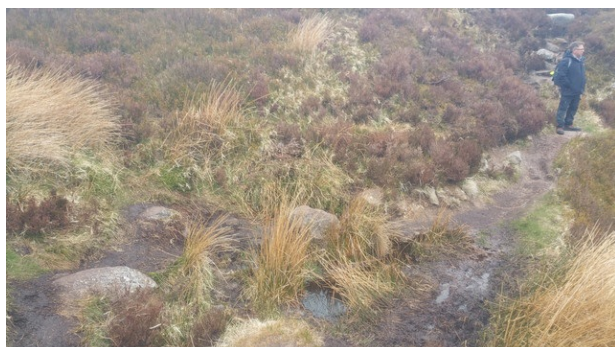
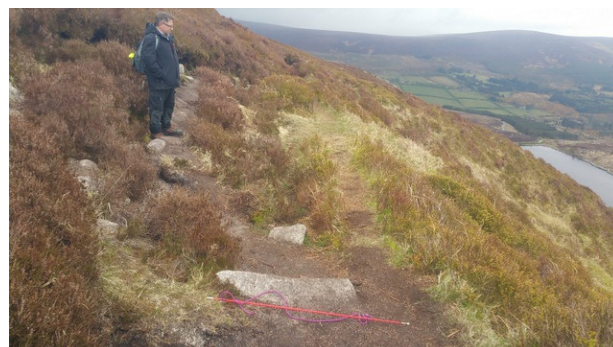
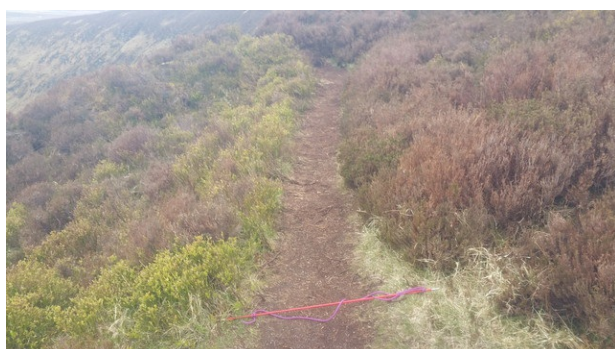
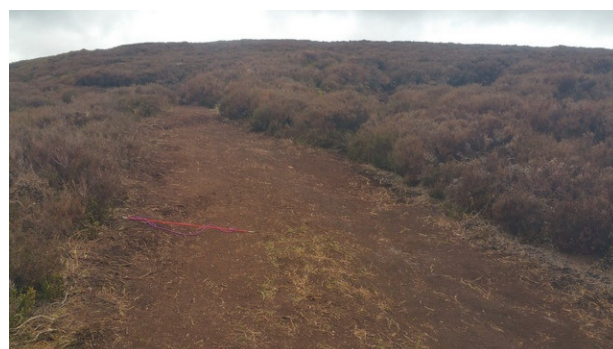
Section description: Section starts at a stream on cliff edge and continues to the end of the corrie with a marked cross slope, which constrains the desire line (for most of the way)

Length (m)	Max gradient (%)	Min gradient (%)	Crossfall (%)
495	15	0	40

Substrate	Peat Depth (cm)
peat	100

Minimum	Maximum	Typical
Trampled width (m)	0.5	0.8	7
Bare width (m)	0.5	1	3
Eroded depth (m)	0.2	0.3	1

Work type	Estimated input	Work Summary
none		No work is urgently required or recommended

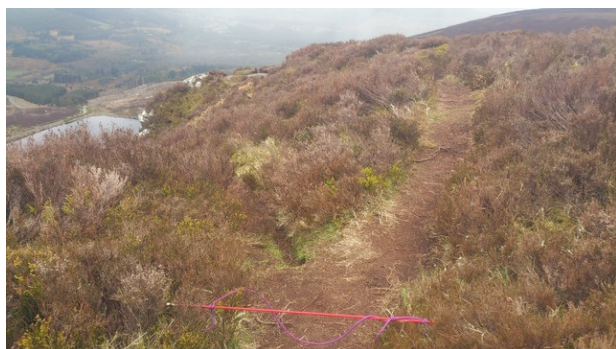
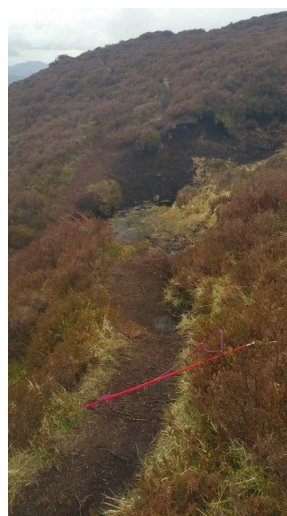
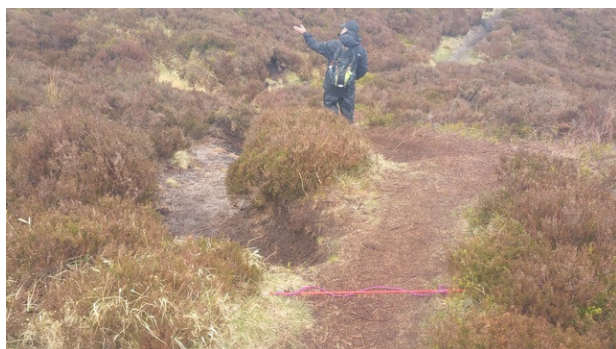
Section description: Section starts at junction with route up the head-wall of the corrie. It continues round the corrie rim of Lower Lough Bray

Length (m)	Max gradient (%)	Min gradient (%)	Crossfall (%)
337	30	0	30

Substrate	Peat Depth (cm)
peat	100

Minimum	Maximum	Typical
Trampled width (m)	1	1	6
Bare width (m)	0.3	0.5	4
Eroded depth (m)	0.2	0.3	1.2

Work type	Estimated input	Work Summary
none		None recommended due to peat depth

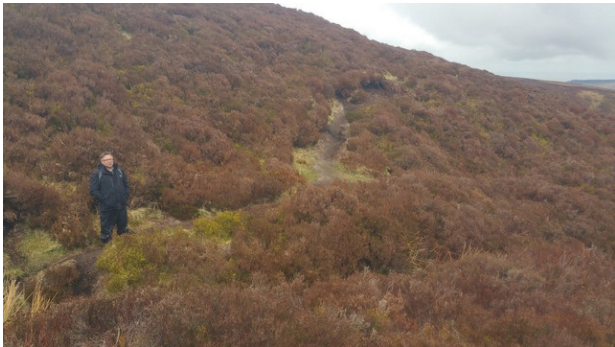
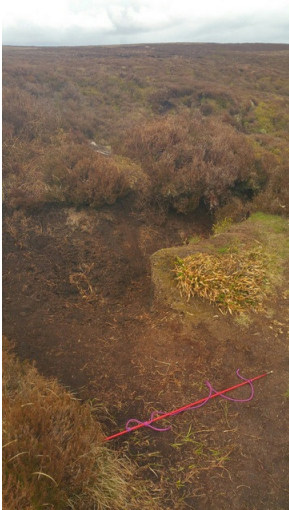
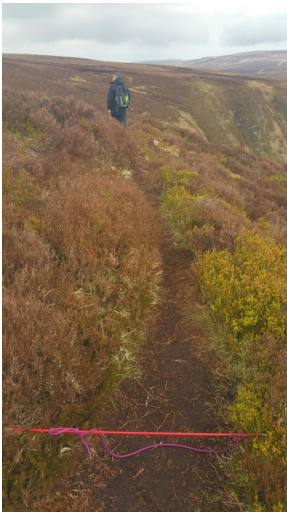
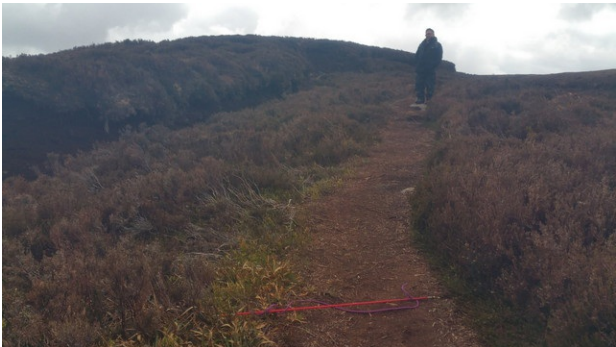
Section description: Section starts at a stream gully and continues to travers the corrie rim. Two minor braids

Length (m)	Max gradient (%)	Min gradient (%)	Crossfall (%)
339	15	0	35

Substrate	Peat Depth (cm)
peat	100

Minimum	Maximum	Typical
Trampled width (m)	0.5	1	6
Bare width (m)	0.5	0.5	2
Eroded depth (m)	0.2	0.3	1

Work type	Estimated input	Work Summary
none		No work recommended due to peat depth

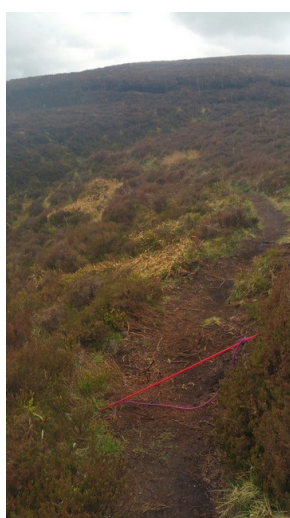
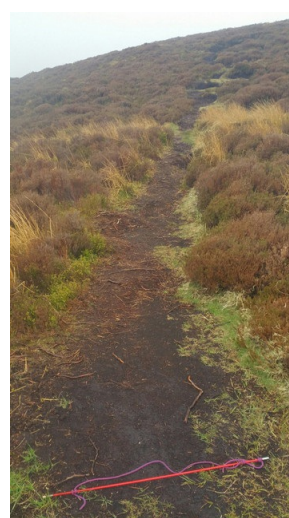
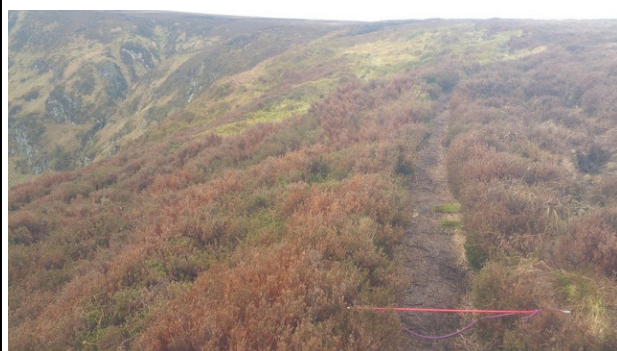
Section description: Section starts at a gully and continues on the rim of the corrie - some parts are on flatter ground away from the steep edge

Length (m)	Max gradient (%)	Min gradient (%)	Crossfall (%)
1159	25	5	25

Substrate	Peat Depth (cm)
peat	100

Minimum	Maximum	Typical
Trampled width (m)	1	1.5	8
Bare width (m)	0.3	0.5	1.5
Eroded depth (m)	0.2	0.3	0.8

Work type	Estimated input	Work Summary
none	3 days labour	Drainage could be installed on eroded aggregate areas (water bars) - not recommended independently of other sections

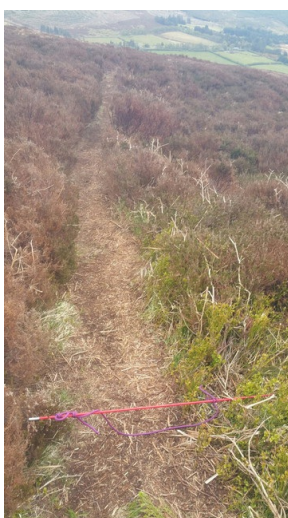
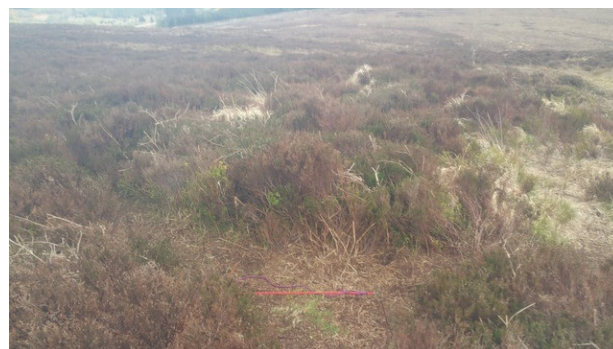
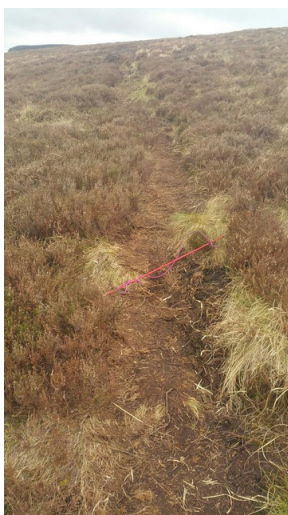
Section description: Section starts at the junction with a more direct route that passes behind the house on Lower Lough Bray. Route passes through deep heather

Length (m)	Max gradient (%)	Min gradient (%)	Crossfall (%)
450	25	5	20

Substrate	Peat Depth (cm)
peat	70

Minimum	Maximum	Typical
Trampled width (m)	0.5	0.8	2.5
Bare width (m)	0.3	0.5	2.5
Eroded depth (m)	0	0.1	0.5

Work type	Estimated input	Work Summary
none		No work recommended due to peat depths

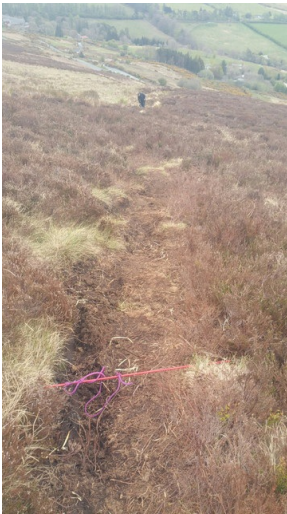
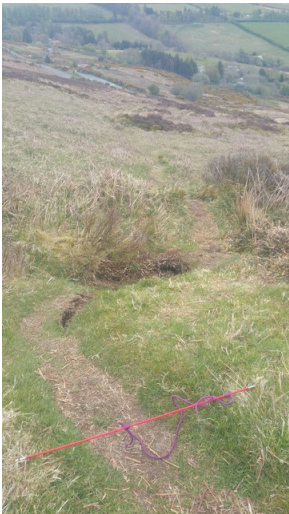
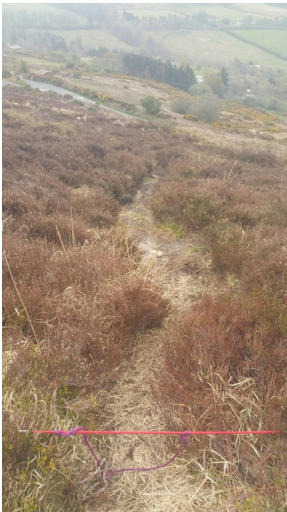
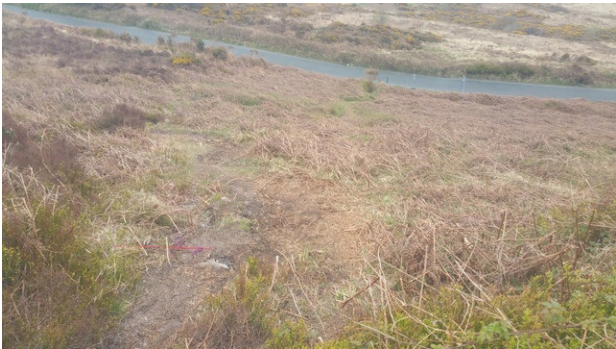
Section description: Section starts at a change of slope and runs steeply down to the road through areas of bracken.

Length (m)	Max gradient (%)	Min gradient (%)	Crossfall (%)
290	43	40	0

Substrate	Peat Depth (cm)
peat	30

Minimum	Maximum	Typical
Trampled width (m)	0.3	0.5	1
Bare width (m)	0.3	0.3	0.3
Eroded depth (m)	0.1	0.2	0.6

Work type	Estimated input	Work Summary
none	3 days labour	Minor drainage on the steepest ground could help to slow the development of a scar
