Lough bray lower

Survey date: Apr 27, 2021

Overall description: Old peat road that continues to Upper Lough Bray

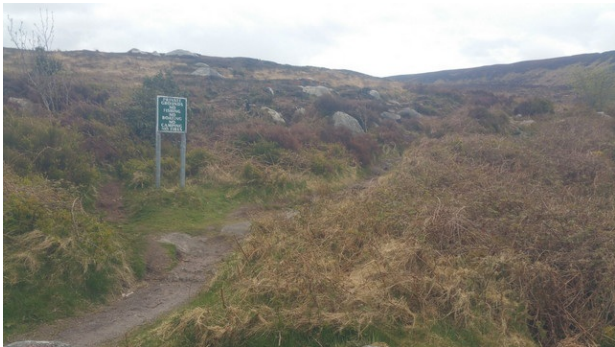
1619531160918.jpg - O 14164 16384 (± 4m)

Section description: Section starts at roadside - this appears to be a popular route to reach the Lough.

Work type	Estimated input	Work Summary
major_repair	25 days labour	If treated independently (i.e. not as a means to promote all paths on the site) this section could be fully upgraded. It would require a mix of aggregate surfacing and approximately 10m of pitching in short bursts between the aggregate

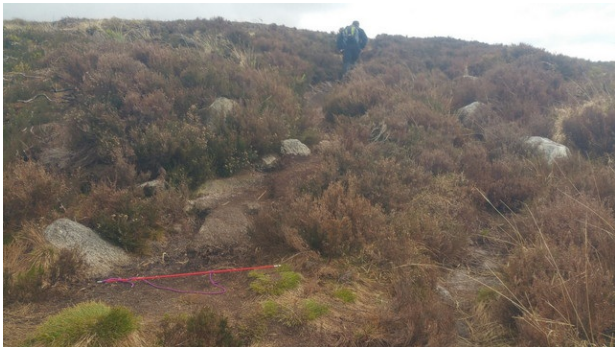
1619531735582.jpg - O 14117 16314 (± 4m)

Section description: Section begins at the Lough and climbs parallel to the shore. There are a number of braids around boulders

Work type	Estimated input	Work Summary
early_intervention	5 days labour	If any work is done on site the moste beneficial would be to close down braids to reduce the visual impact of the route.

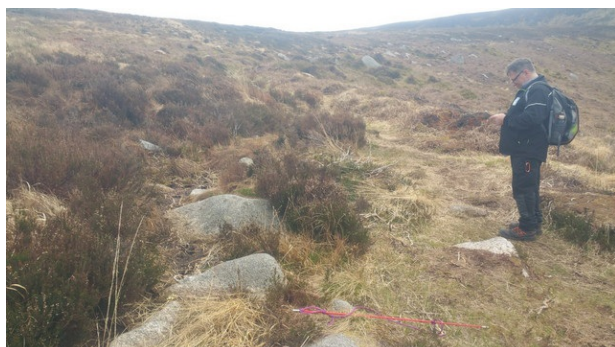
1619532892192.jpg - O 14100 16028 ($\pm 4m$)

Section description: Section starts at a large boulder across path. Possibly an old peat road giving access to the cuttings further up the hill

Site Assessment: Old peat road so may have hard base in places

Work type	Estimated input	Work Summary
minor_repair	14 days labour	Deep peat means that full upgrade is not recommended. Drainage work could be undertaken to intercept surface water - side ditch and 5 cross drains

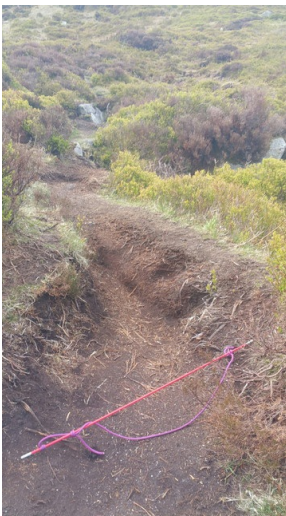
1619535364977.jpg - O 13594 15807 ($\pm 4\text{m}$)

Section description: Steep ground by pointy boulder

Work type	Estimated input	Work Summary
none		Highly technical section for repair due to gradient - not recommended
