# Lough bray moraine

Survey date: Apr 27, 2021

**Overall description:** Path from old quarry / car park to Upper Lough Bray and along moraine

**Overall assessment:** Don't upgrade - Potential to cause recreation hot spot if significantly upgraded and very difficult to manage

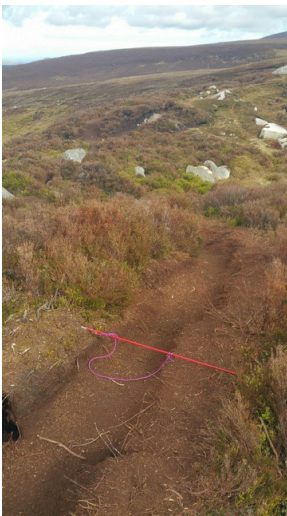
1619537535168.jpg - O 13622 15768 (± 4m)

**Section description:** Section starts at junction between the two loughs and runs along the moraine. It is a very wide trample zone on deep peat

Minimum	Maximum	Typical
Trampled width (m)	2	4	7
Bare width (m)	1	1.8	3
Eroded depth (m)	0.1	0.1	0.4

Work type	Estimated input	Work Summary
none		The deep peat means that it would be necessary to float a path but the broad top of the moraine means that it will be difficult to keep visitors on the path - so a narrow path would be ineffective. Work is not recommended.

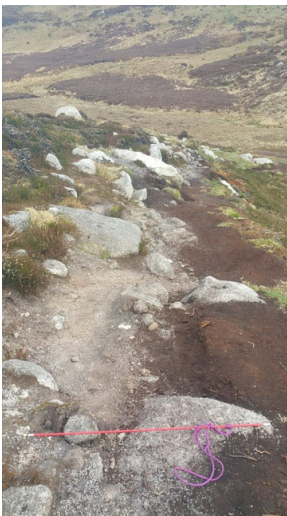
1619538676558.jpg - O 13928 15299 (± 5m)

Section description: Section starts at the very large boulders at end of moraine and runs down to the stream crossing

Minimum	Maximum	Typical
Trampled width (m)	3	5	8
Bare width (m)	2	4	5
Eroded depth (m)	0	0.2	0.5

Work type	Estimated input	Work Summary
none		Given the sensitivity of the moraine (deep peat) no work is recommended. In principle a path could be built with a mix of aggregate (70m) and boulder pitching (50m). This would need to be floated on deep peat, which may lead to long term management problems

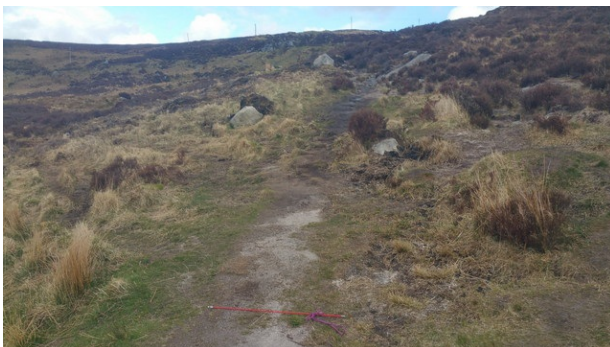
1619539144392.jpg - O 14010 15232 (± 5m)

Minimum	Maximum	Typical
Trampled width (m)	5	25	40
Bare width (m)	1	2.5	6
Eroded depth (m)	0	0.2	1

**Site Assessment:** Deep peat

Work type	Estimated input	Work Summary
none	15 days labour	Minor drainage (side ditch and 4 cross drains) and landscaping would help to reduce the current impact but upgrade of the path is not recommended

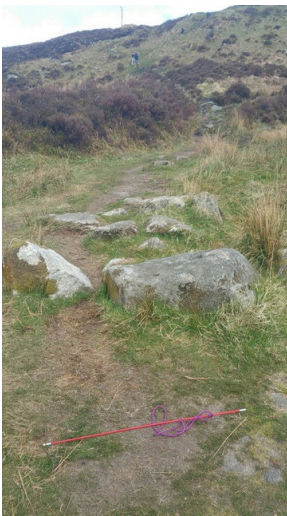
1619539591914.jpg - O 14166 15175 (± 5m)

Section description: This section runs between a stream crossing and the road

Site Assessment:Steep start by road

Work type	Estimated input	Work Summary
none	10 days labour	Minor works to drain and deroughen the surface could be beneficial but could provide encouragement for additional use. Not recommended
