Lugnaquilla spur

Survey date: May 1, 2021

**Overall description:** Broad plateau area with poorly define route (signs of trampling across wide areas)

**Overall assessment:** This a remote location at high altitude. Very difficult to constrain walkers on the open ground so path development is challenging

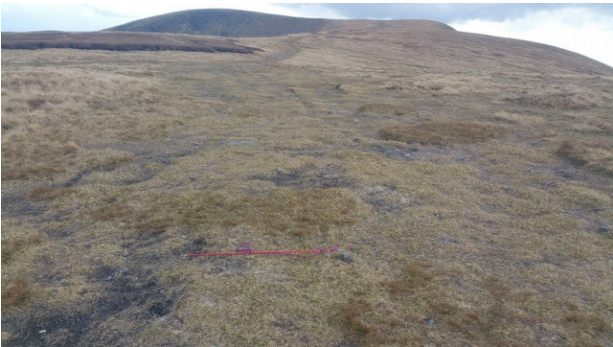
1619879128298.jpg - T 04410 91857 (± 9m)

**Lugnaquilla spur (Section 1)**  
**Section description:** Junction - route up shoulder

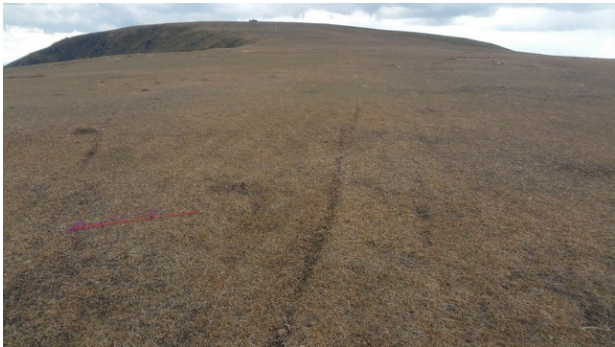
1619880525818.jpg - T 03483 92054 (± 5m)

**Lugnaquilla spur (Section 2)**  
**Section description:** Boulders on shoulder

**Site Assessment:**Scrambler bikes

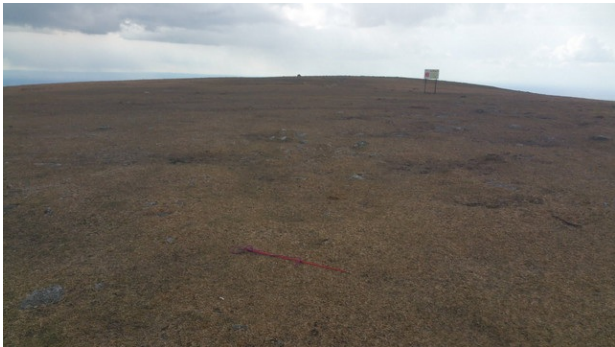
1619881084475.jpg - T 03197 91780 (± 4m)

**Lugnaquilla spur (Section 3)**  
**Section description:** Summit
