# Lugnaquilla to Table

Survey date: Jul 20, 2021

Length: 5780m

Sections: 9

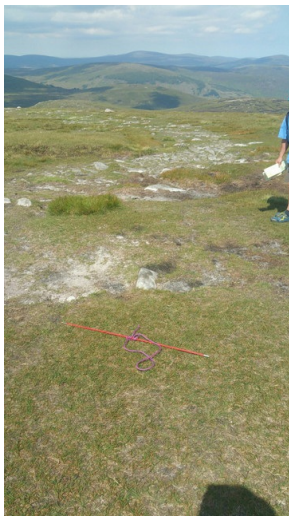
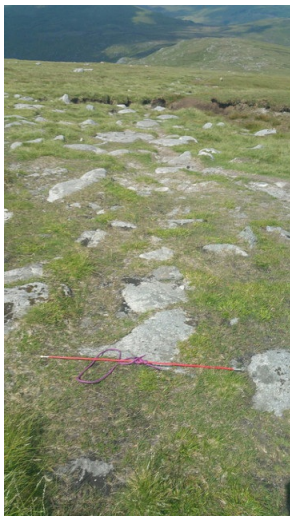
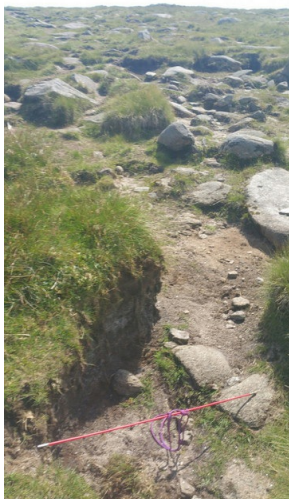
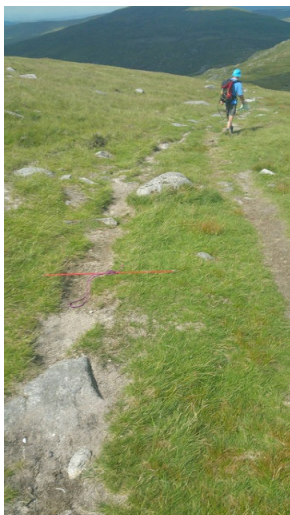
Section description: Minor summit cairn

Site Assessment:Remote work site

| Work type | Estimated input | Work Summary |
|---|---|---|
| none | 10 days labour | Could define line to reduce spread of people |

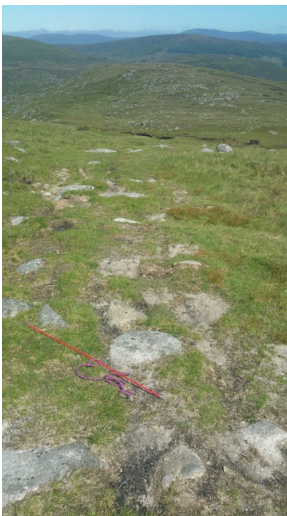
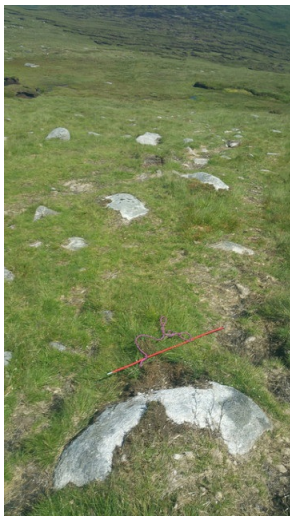
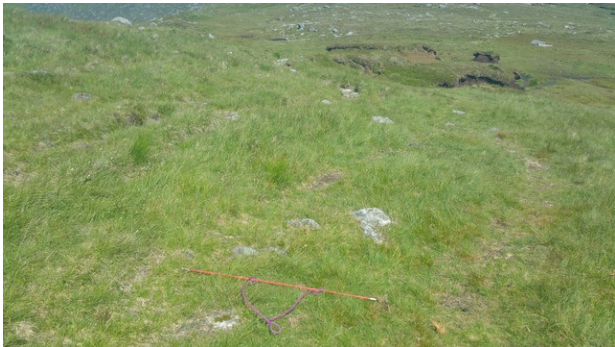
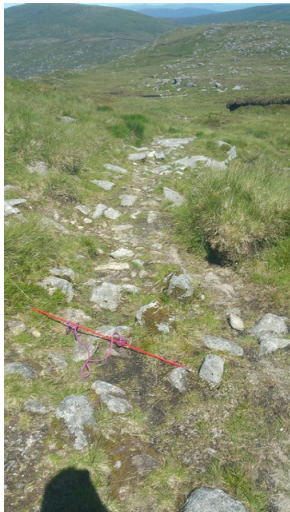
Section description: Path junction

**Site Assessment:**Degraded peat

| Work type | Estimated input | Work Summary |
|---|---|---|
| early_intervention | 5 days labour | Minor drainage to reduce surface water flow on the route |

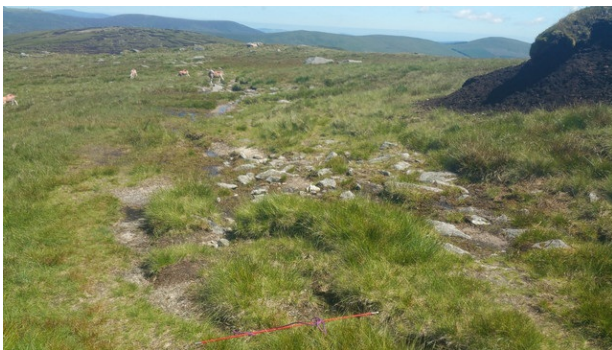
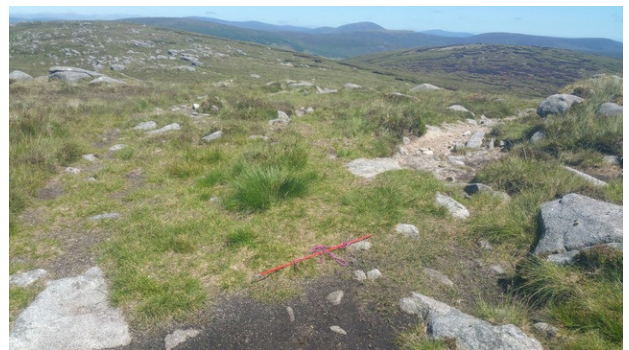
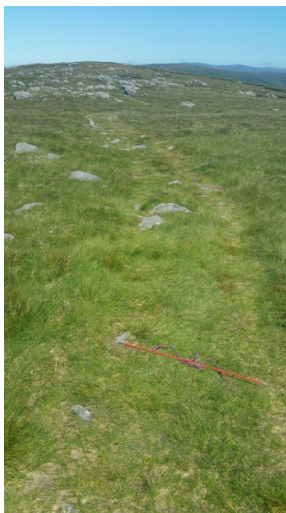
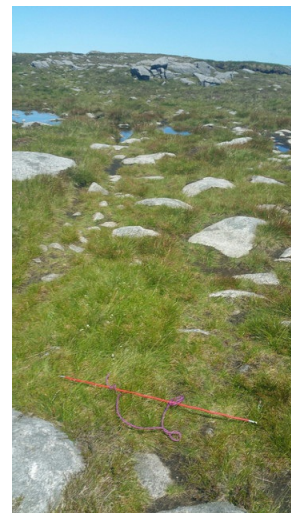
Section description: By large hags. Decrease gradient

**Site Assessment:** Degraded peat exposing boulders

| Work type | Estimated input | Work Summary |
|---|---|---|
| Light_touch | 10 days labour | Line definition ; 5m stepping stones |

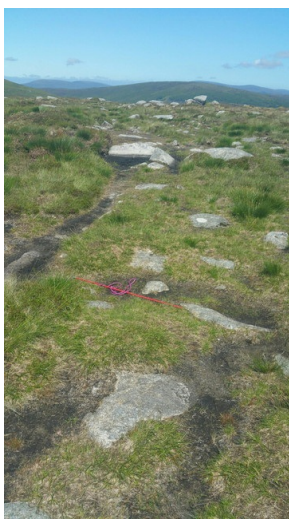
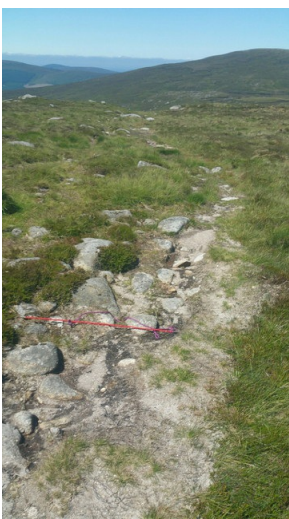
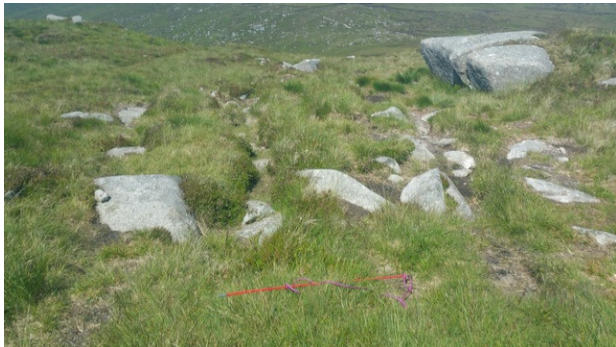
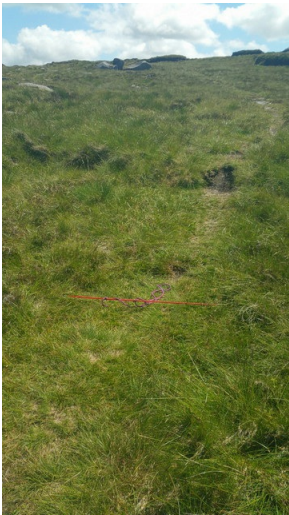
Section description: Split boulder on knoll

Site Assessment: Degraded peat

| Work type | Estimated input | Work Summary |
|---|---|---|
| Light_touch | 20 days labour | Line definition |

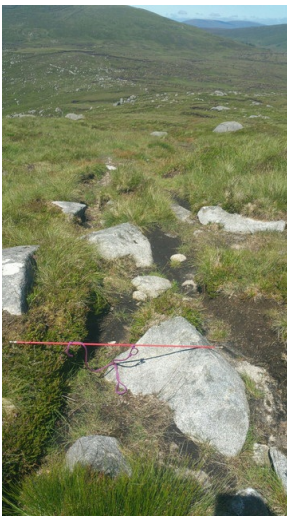
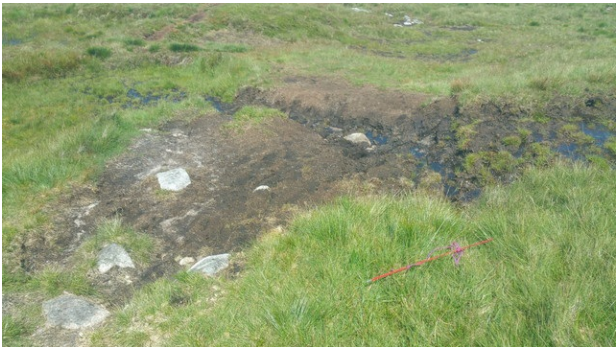
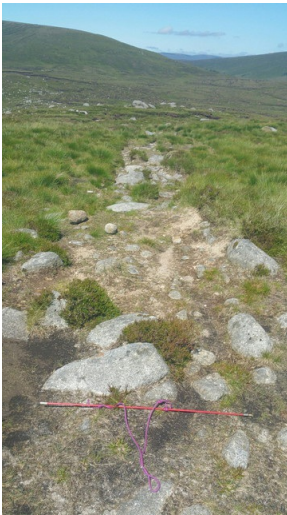
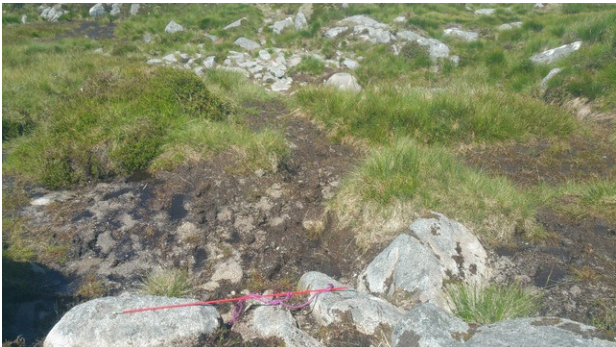
Section description: Large boulders at top of slope

**Site Assessment:**Lots of hags. Some recreation induced

| Work type | Estimated input | Work Summary |
|---|---|---|
| Light_touch | 50 days labour | Line definition |

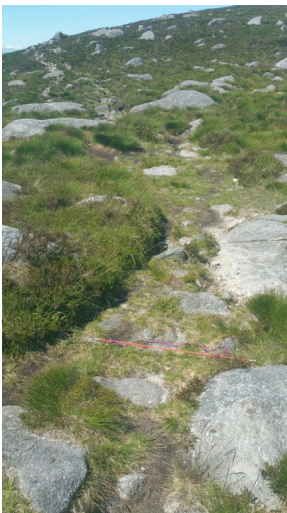
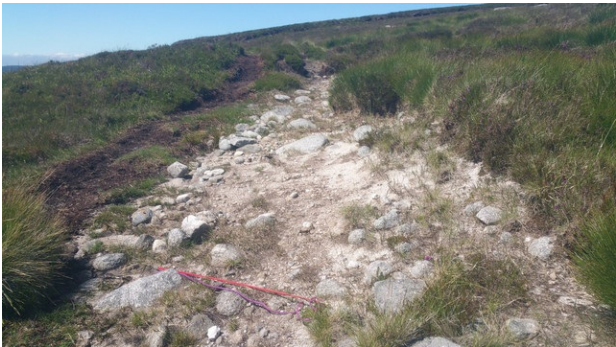
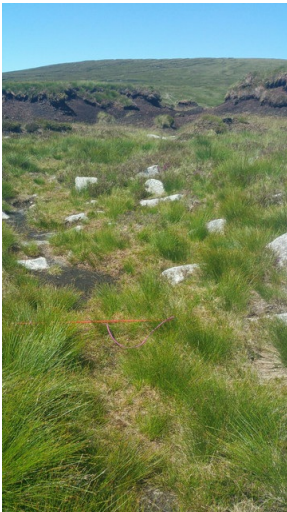
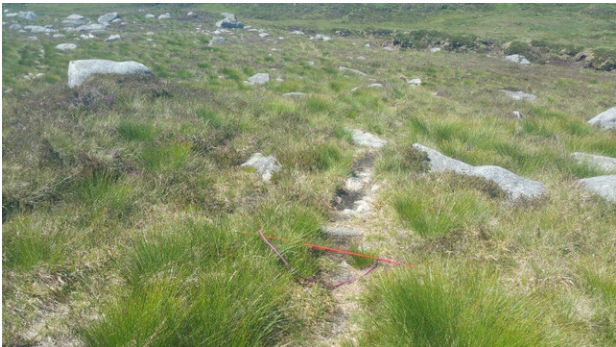
Section description: Large boulders at col

**Site Assessment:**Remote site

| Work type | Estimated input | Work Summary |
|---|---|---|
| Light_touch | 50 days labour | Peat hag reprofiling; line definition across areas with already removed peat |

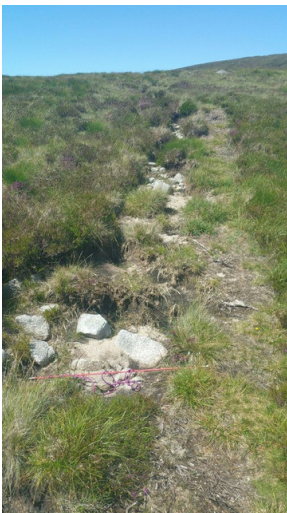
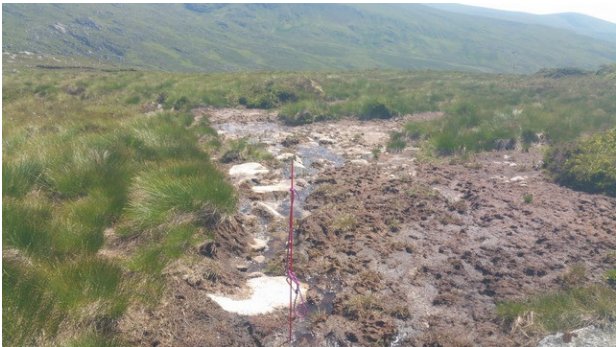
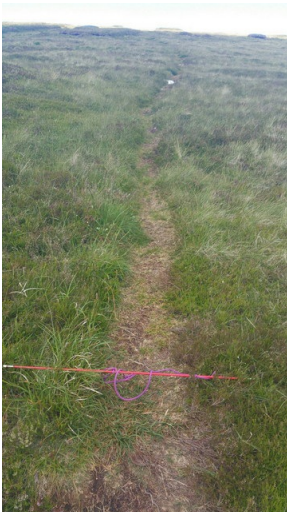
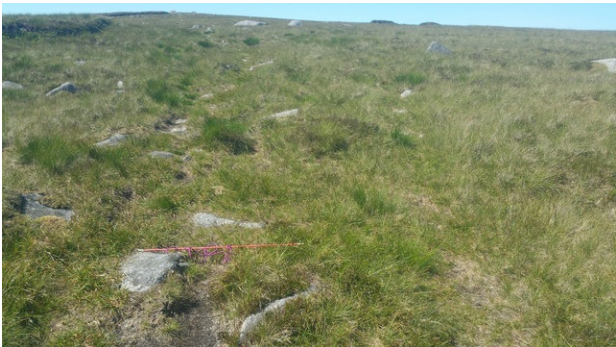
**Lugnaquilla to Table (Section 8)**  
**Section description:** Base of slope. Two parallel paths

**Site Assessment:**Remote work site

| Light_touch | 50 days labour | Line definition |
