Survey date: Jul 19, 2021

Length: 4288m

**Overall description:** Approach route to Lugnaquilla but most damage is from quad bikes

## Lybagh (Section 2)

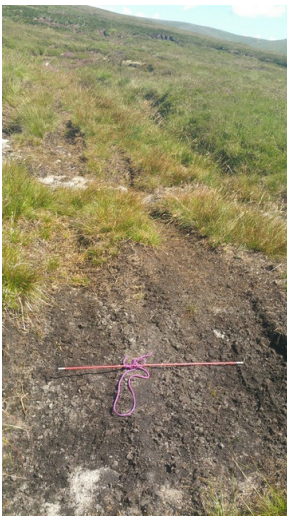
1626692185134.jpg - T 02497 89401 (± 3m)

Current Condtion

| Length (m) | Max gradient (%) | Min gradient (%) | Crossfall (%) |
|---|---|---|---|
| 266 | 15 | 10 | 0 |

| Substrate | Peat Depth (cm) |
|---|---|
| peat | 100 |

| | Minimum | Maximum | Typical |
|---|---|---|---|
| Trampled width (m) | 5 | 12 | 25 |
| Bare width (m) | 2 | 2 | 4 |
| Eroded depth (m) | 0 | 0.1 | 0.6 |

Availability of Materials: None  
Site Assessment:Open hill no access

| Work type | Estimated input | Work Summary |
|---|---|---|
| none | | Deep peat. Remove quads |

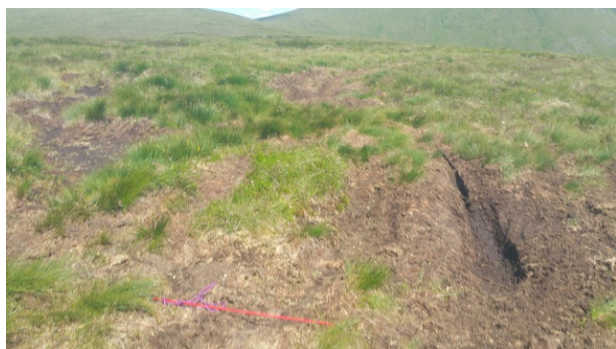
1626694254754.jpg - T 02542 89668 (± 3m)

**Section description:** Minor summit. Quad tracks converge

**Site Assessment:** Variable peat depth mostly degraded from 1.5m to 0.2

| Work type | Estimated input | Work Summary |
|---|---|---|
| none | | Could block some peat erosion gullies |

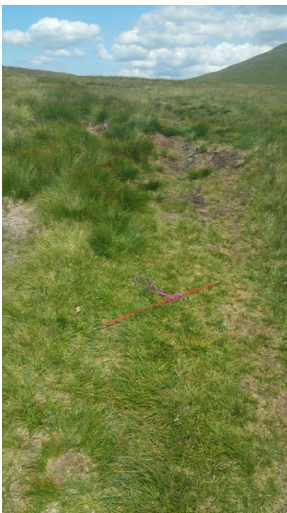
1626697165204.jpg - T 02099 90731 (± 3m)

Section description: Corner by hags near summit

Site Assessment:Joins other quad task

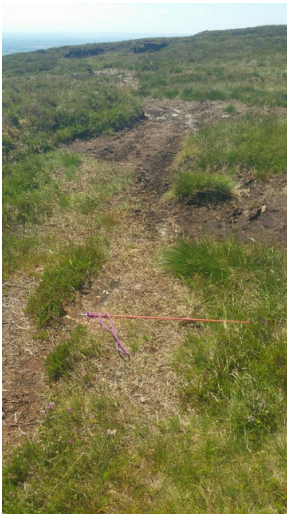
1626701368557.jpg - T 02439 89389 (± 3m)

| Trampled width (m) | 2 | 4 | 16 |
| Bare width (m) | 0 | 2 | 5 |
| Eroded depth (m) | 0.1 | 0.5 | 1.2 |

Site Assessment:Needs intervention

| early_intervention | 10 days labour | Remove quads and cut ditches to redirect water - will not stabilise on its own |

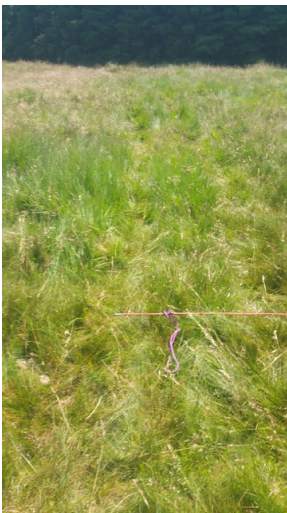
1626703183739.jpg - T 01674 88515 (± 3m)

Site Assessment: Agricultural use of quad?
