Survey date: Apr 23, 2021

**Overall description:** Route from forestry at Maulin along the ridge

**Overall assessment:** Significant areas of deep peat on moderate slopes

## Maulin to tonduff (Section 1)

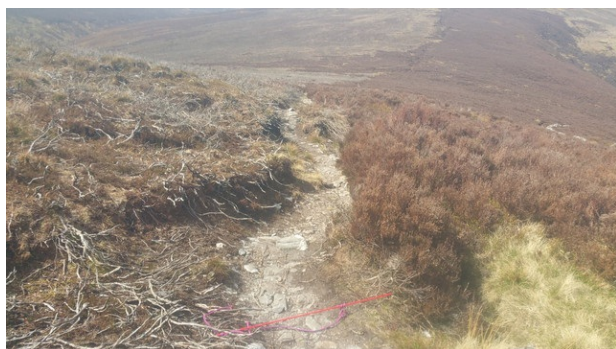
1619177897859.jpg - O 18080 13036 ( $\pm$  4m)

**Section description:** Section starts at the junction with Maulin path and runs to the col between Maulin and Tonduff. Cross slope and long heather are effective at keeping people on a defined line.

Length (m)	Max gradient (%)	Min gradient (%)	Crossfall (%)
232	35	5	20

Substrate	Peat Depth (cm)
peat	30

Minimum	Maximum	Typical
Trampled width (m)	0.8	1	2
Bare width (m)	0.5	1	1.8
Eroded depth (m)	0.2	0.2	0.5

Work type	Estimated input	Work Summary
none	5 days labour	Improving the drainage (5 water bars) could help reduce erosion. Not recommended as further sections are not sustainable

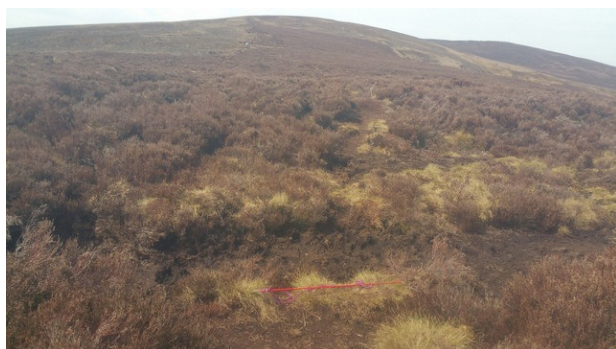
1619178524127.jpg - O 17856 13014 ( $\pm 4m$ )

**Section description:** Section runs from the col between Maulin and Tonduff up to East Top. The route quickly disperses and crosses deep peat on a slope

Substrate	Peat Depth (cm)
peat	100

Minimum	Maximum	Typical
Trampled width (m)	6	8	25
Bare width (m)	1	2	10
Eroded depth (m)	0.2	0.3	1

**Site Assessment:** Very deep peat on slope.

Work type	Estimated input	Work Summary
none		Deep peat would make this route difficult to manage for large numbers of people - no work recommended

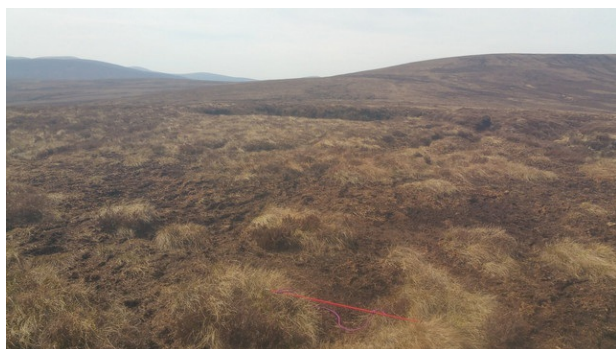
1619182437129.jpg - O 16938 13115 (± 5m)

**Section description:** Section starts from East Top and runs towards the main summit across a broad col. It cross deep peat, some of which is degraded (hags). The route is dispersed with some wide trampling around wet peat.

**Site Assessment:** Deep peat >2m

Work type	Estimated input	Work Summary
none		Path work is not viable on this depth of peat.

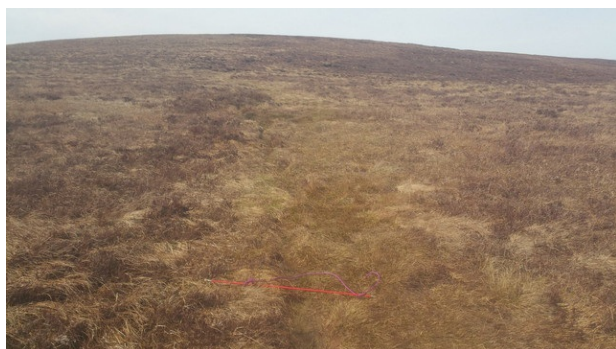
1619183657402.jpg - O 16268 13160 ( $\pm 4m$ )

**Section description:** Section starts at a change of slope and heads up to the main summit of Tonduff crossing very deep peat

**Site Assessment:** Remote site. Heli lift materials for peat restoration if necessary

Work type	Estimated input	Work Summary
none		Peat restoration is more necessary than path repair - depth of peat means path work is not viable

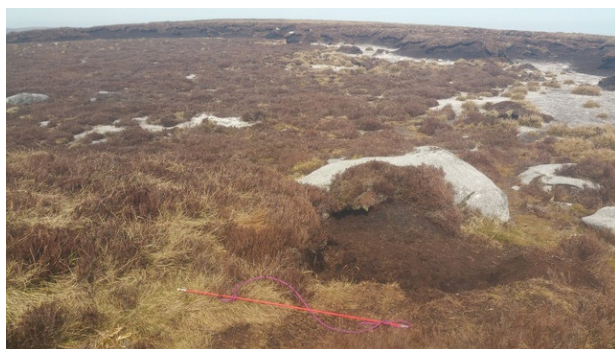
1619184669431.jpg - O 15908 13427 ( $\pm 5\text{m}$ )

**Section description:** Section begins at summit of Tonduff South and crosses flat area to the main summit. Large area of bare peat and steep hags.

**Site Assessment:**Hags

Work type	Estimated input	Work Summary
none		Peat restoration only - bare peat and hag reprofiling
