**Overall description:** Route leads across from Mullaghcleevaun route to summit of Moanbane - not a continuous path on the ground

**Overall assessment:** Degraded peat on the slopes of Moanbane and deep peat across the col

# Moanbane (Section 1)

## Moanbane (Section 2)

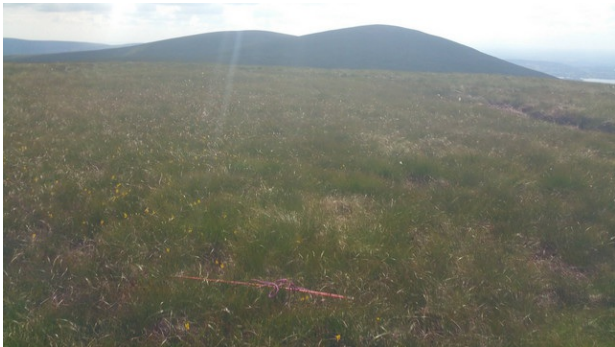
1626537271721.jpg - O 05439 07417 (± 5m)

Section description: Junction with main path - no clearly visible on the ground

| Work type | Estimated input | Work Summary |
|---|---|---|
| none | | No path |

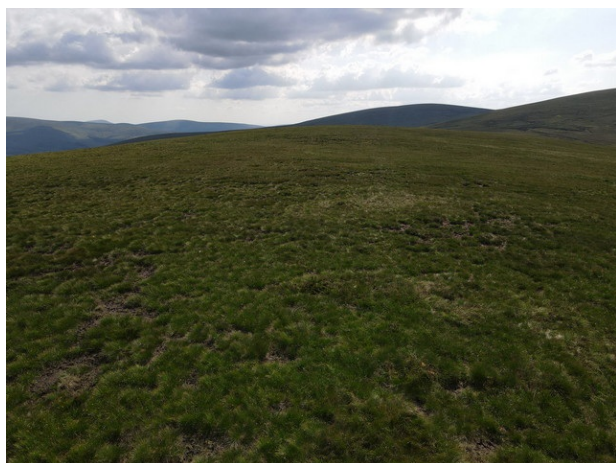
DJI\_0102.jpg - (± m)

**Section description:** Section flown by drone - no path visible. Peat erosion evident

| Work type | Estimated input | Work Summary |
|---|---|---|
| none | | No path |
