Survey date: Jul 17, 2021

**Overall description:** Route from Black Hill to summit of Mullaghcleevaun which crosses broad open slopes

**Mullaghcleevaun (Section 1)**  
**Section description:** End of vehicle track

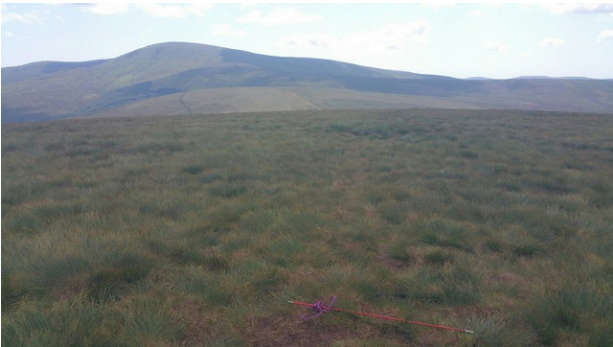
1626521322595.jpg - O 04139 09030 (± 4m)

**Site Assessment:**Deep peat

| early_intervention | 10 days labour | Peat dams across emerging gullies |

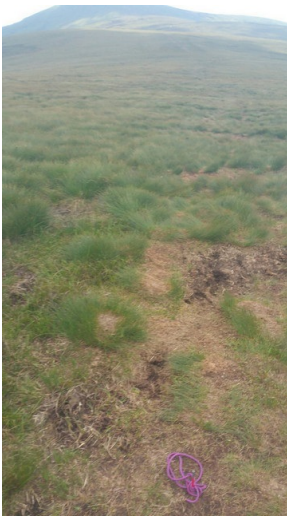
1626522332425.jpg - O 04406 08556 (± 4m)

**Mullaghcleevaun (Section 2)**  
**Section description:** Col change in slope

**Site Assessment:**Don't touch

| none | | Deep peat |

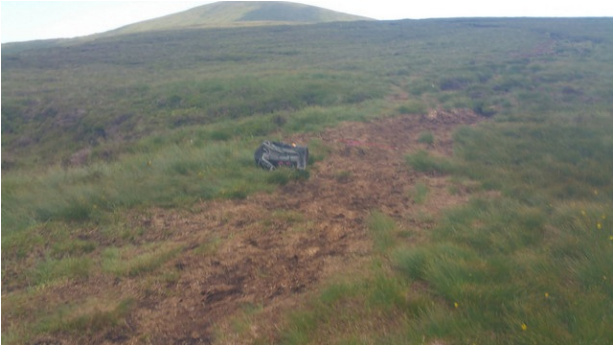
1626524069289.jpg - O 05236 07735 (± 5m)

**Mullaghcleevaun (Section 3)**  
**Section description:** Deep gully and increase slope

**Site Assessment:**Bedrock exposed near top of section

| early_intervention | 20 days labour | Peat dams to slow water. Path works not viable due to peat depth |

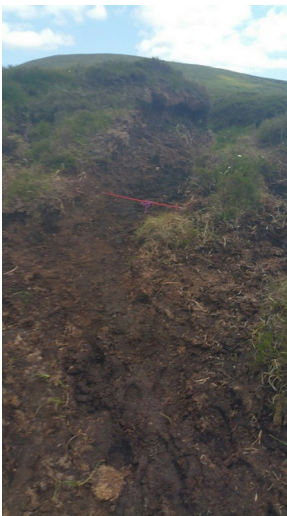
1626528704351.jpg - O 05542 07431 (± 4m)

**Mullaghcleevaun (Section 4)**  
**Section description:** Gully at top of slope

**Site Assessment:**Not all exposed peat is from recreation

| Work type | Estimated input | Work Summary |
|---|---|---|
| early_intervention | | Peat restoration |

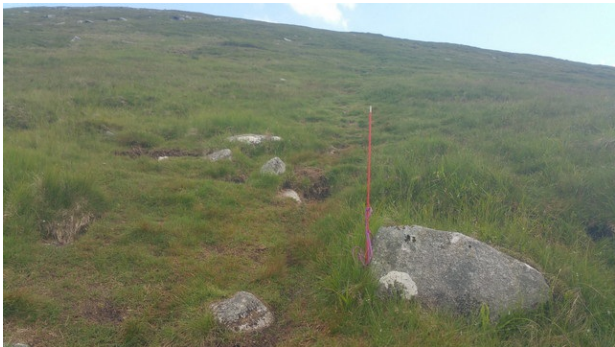
1626530399773.jpg - O 06232 07126 (± 4m)

Section description: Steep slope. Angular boulder near base of slope

Site Assessment:Remote site

| Work type | Estimated input | Work Summary |
|---|---|---|
| none | 10 days labour | 10 water bars - but access to the site is poor across deep peat |
