# Prince William's Seat loop

Survey date: Apr 30, 2021

**Overall description:** Loop path that connects the summit of Prince William's Chair and the Wicklow Way

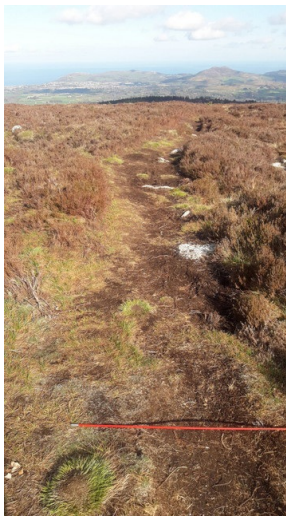
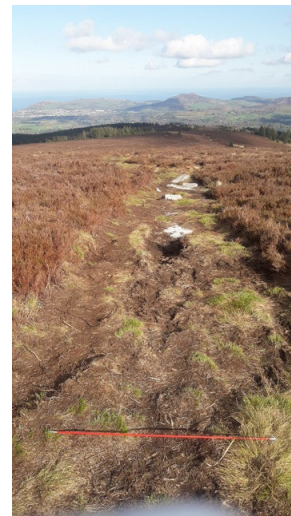
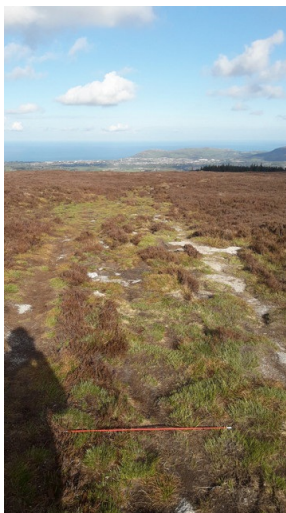
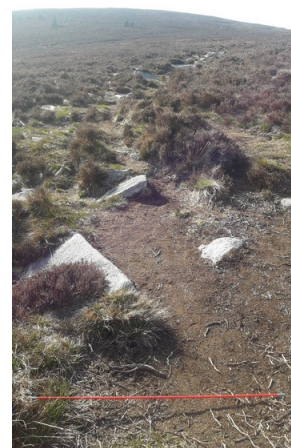
**Section description:** Path junction at summit. Some signs of mineral soil being washed by rainfall but no gullies present.

| Length (m) | Max gradient (%) | Min gradient (%) | Crossfall (%) |
|---|---|---|---|
| 559 | 8 | 0 | 3 |

| | Minimum | Maximum | Typical |
|---|---|---|---|
| Eroded depth (m) | 0 | 0.1 | 0.1 |

| Work type | Estimated input | Work Summary |
|---|---|---|
| early_intervention | 2 days labour | A few anchor bars would be beneficial, blending with the current stony stretches. |

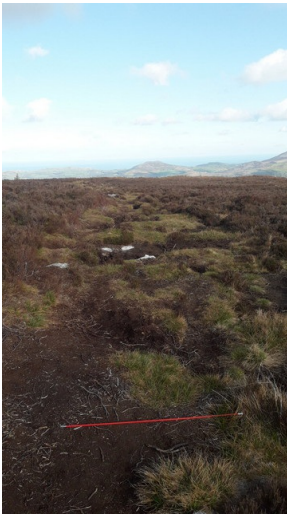
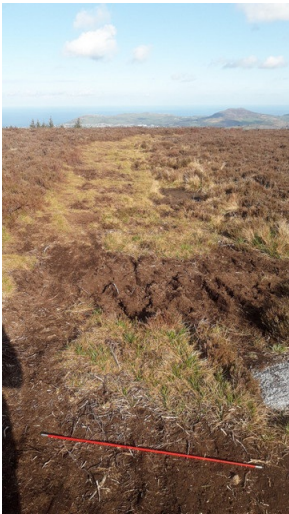
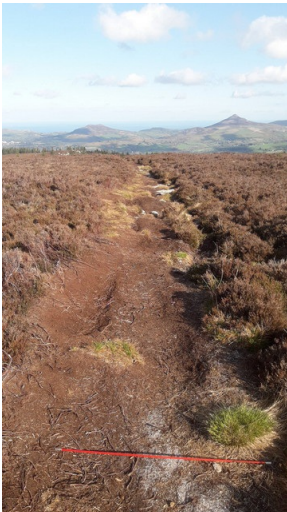
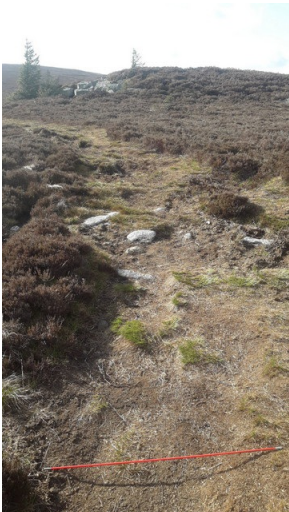
**Prince William's Seat loop (Section 2)** Start: O 18170 18066 (± 4m)  
**Section description:** Change gradient / end of mineral soil and raised boulders surface

| 60 | 2 | 0 | 2 |

| none | | |

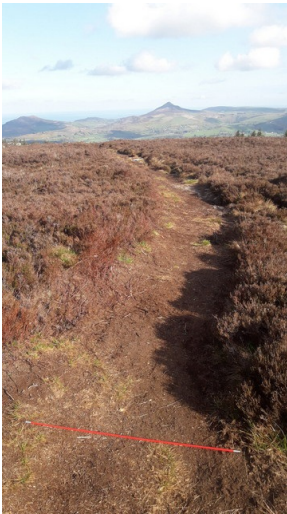
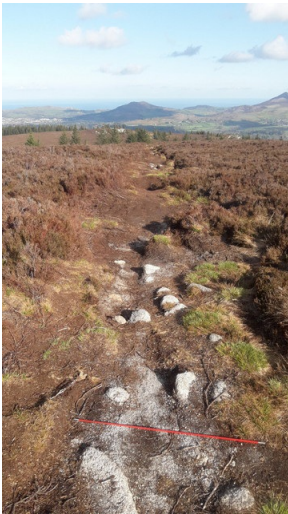
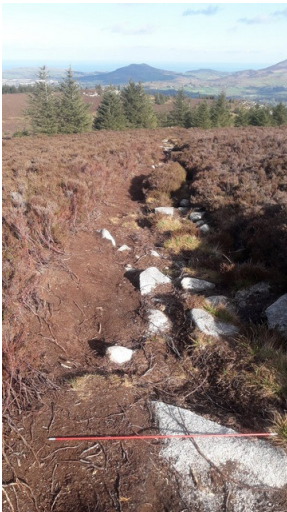
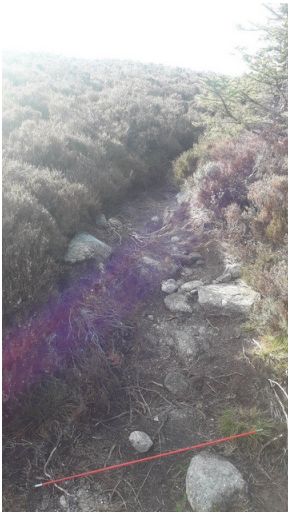
**Section description:** Change of gradient / mineral soil appearing - some scouring of path surface

| | Minimum | Maximum | Typical |
|---|---|---|---|
| Eroded depth (m) | 0.1 | 0.1 | 0.3 |

| Work type | Estimated input | Work Summary |
|---|---|---|
| early_intervention | 3 days labour | Anchor bars to reduce gradient and water bar to address washing of path materials. |

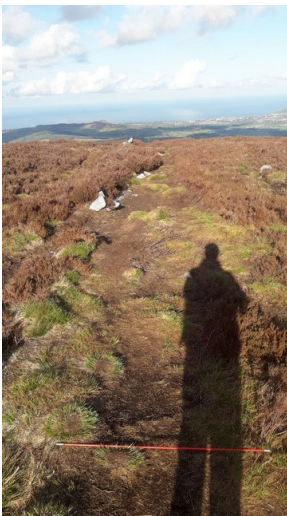
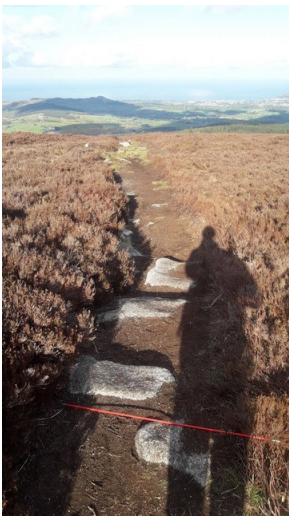
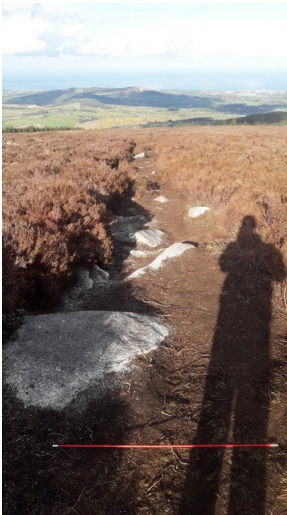
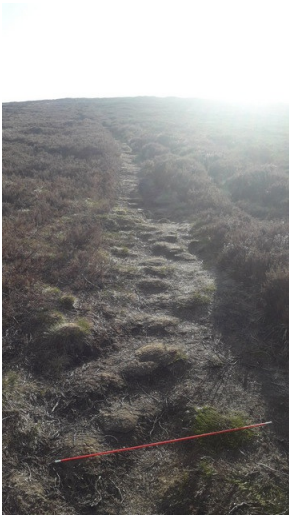
| Eroded depth (m) | 0 | 0.1 | 0.2 |

| early_intervention | 1 days labour | Water bar on eroded gully with raised stones. |

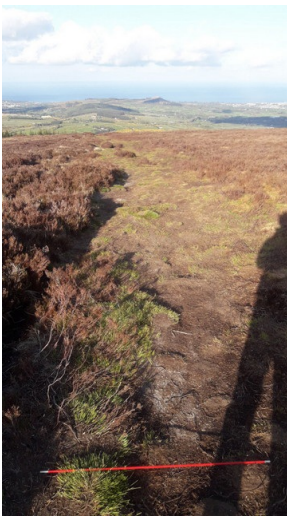
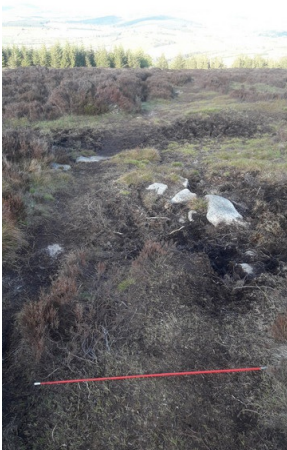
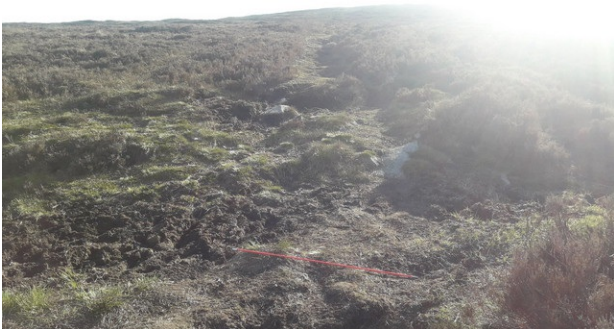
| | Minimum | Maximum | Typical |
|---|---|---|---|
| Eroded depth (m) | 0 | 0.1 | 0.2 |

| Work type | Estimated input | Work Summary |
|---|---|---|
| none | | |

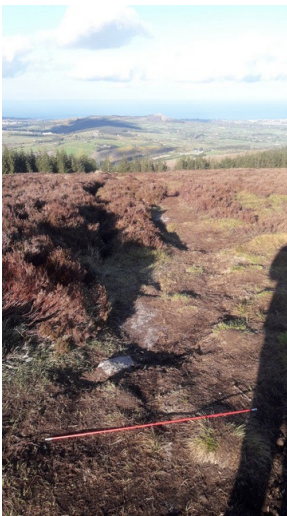
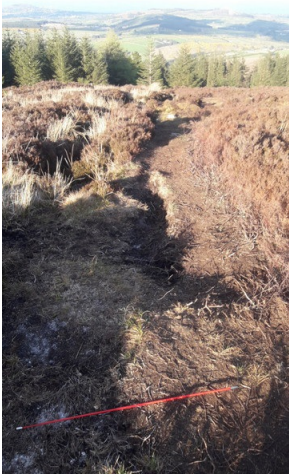
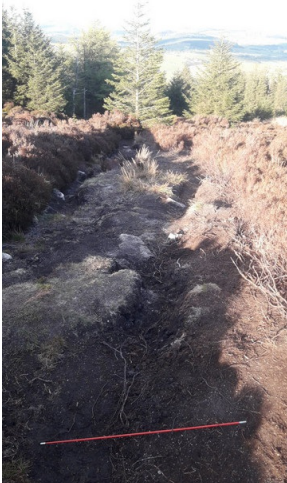
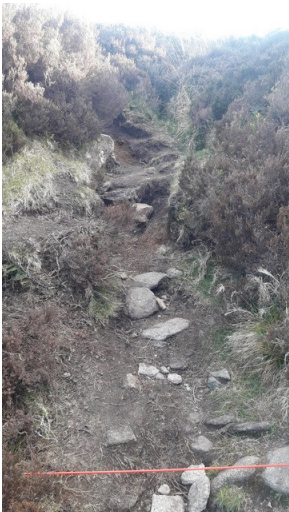
Prince William's Seat loop (Section 6) Start: O 18069 18431 (± 4m)  
Section description: Boggy wide trampled patch at the end of previous section

| Eroded depth (m) | 0 | 0.2 | 0.3 |

| minor_repair | 8 days labour | Stone pitching on lower steep and eroded stretches |
