**Overall description:** Route from forestry up the eastern flank of Scarr

# Scarr / Oldbridge (Section 1)

**Scarr / Oldbridge (Section 2)**  
**Section description:** Wall and decrease slope

**Scarr / Oldbridge (Section 3)**  
**Section description:** Increase slope down to forest

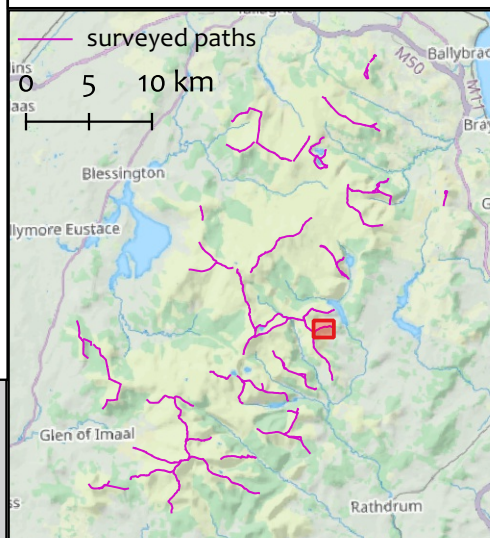
**Overall assessment:** Lower sections have had moorland burning and there are signs of scrambler bike use

**Work summary:** minor works could be done if land management is changed (including removal of scramblers)

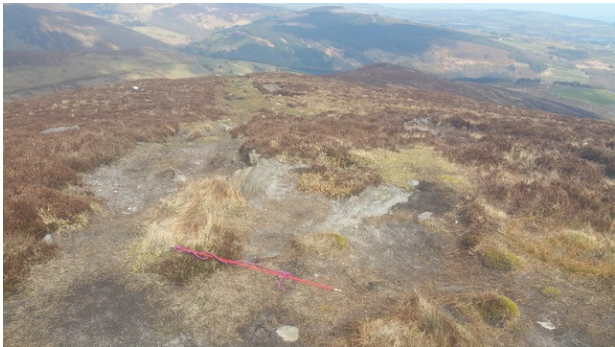
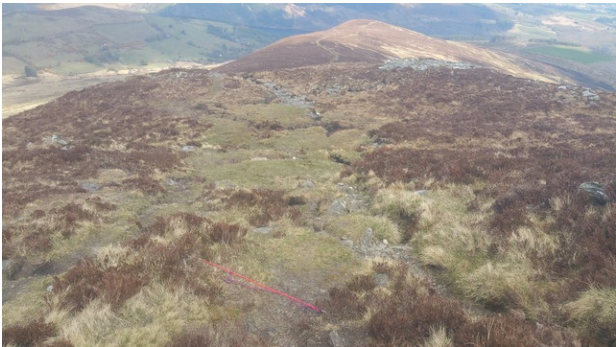
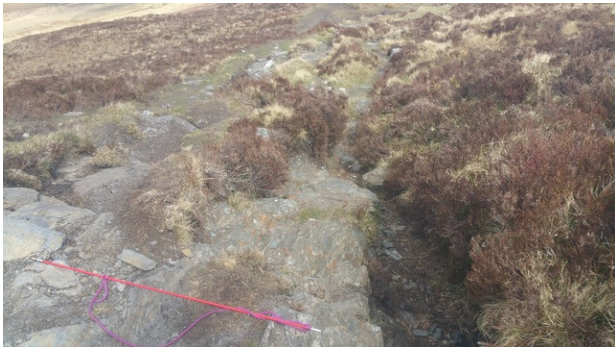
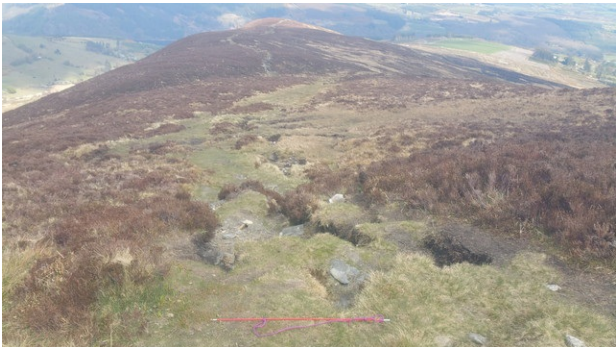
Section description: Junction on ridge

Site Assessment: Scrambler bike track evident.

| Work type | Estimated input | Work Summary |
|---|---|---|
| early_intervention | 10 days labour | Drainage - 10 water bars |

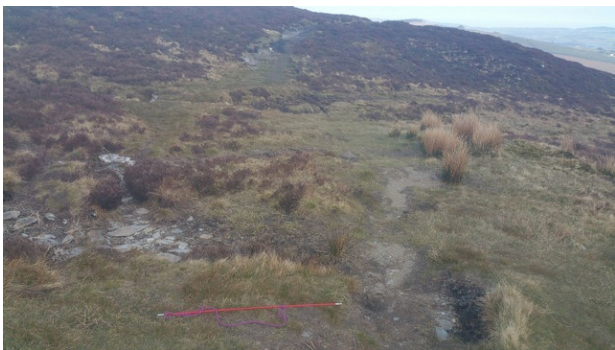
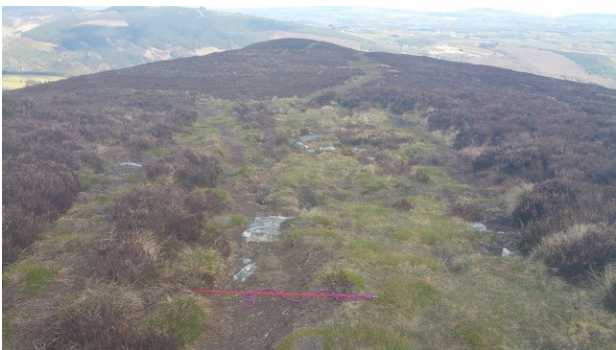
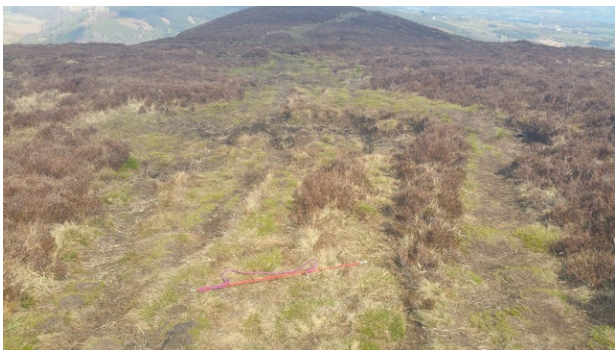
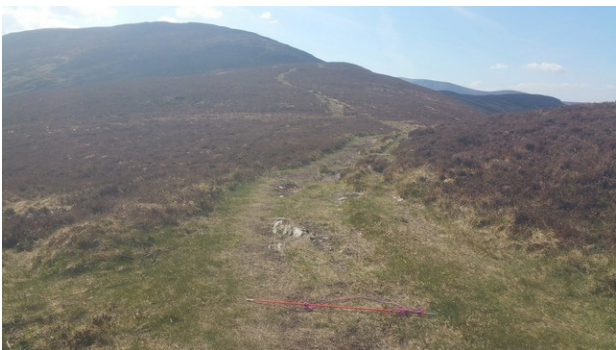
**Site Assessment:**Easy access in via forestry track

| Work type | Estimated input | Work Summary |
|---|---|---|
| early_intervention | 5 days labour | Landschap in to close braids |

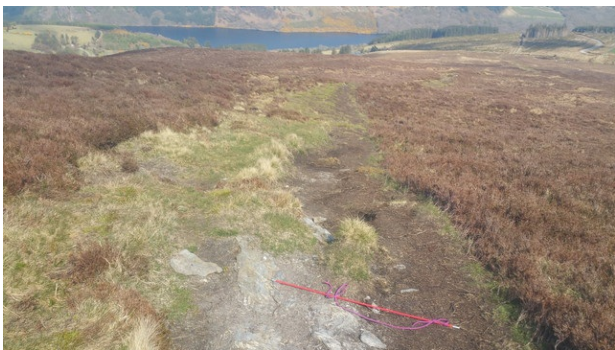
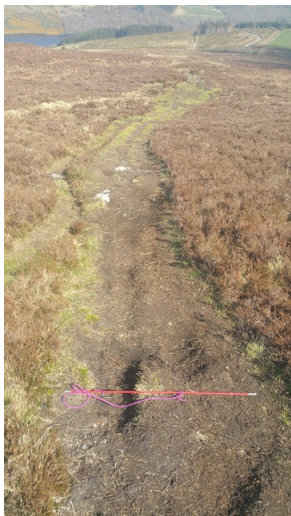
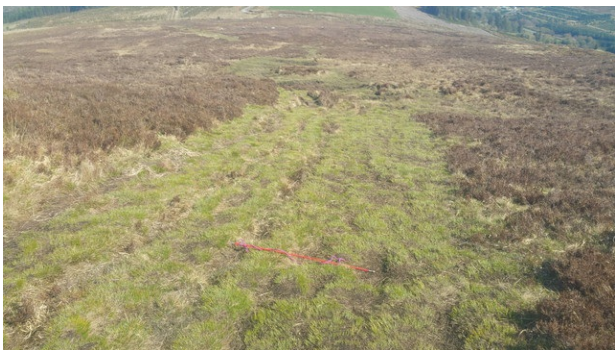
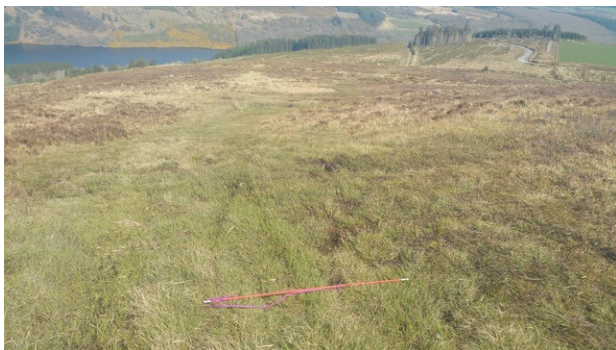
**Site Assessment:**Heather and gorse recently burnt

| Work type | Estimated input | Work Summary |
|---|---|---|
| early_intervention | 5 days labour | Drainage - 5 water bars |

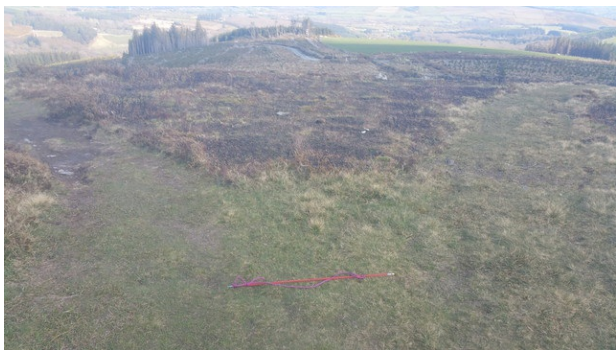
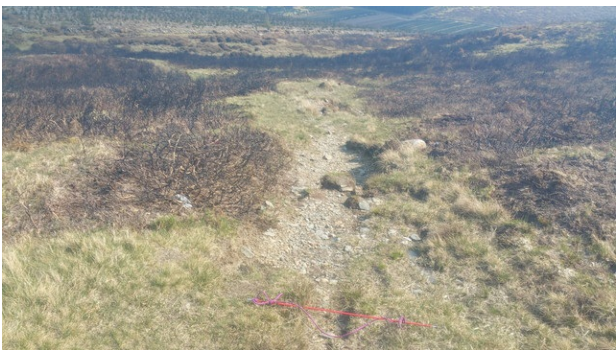
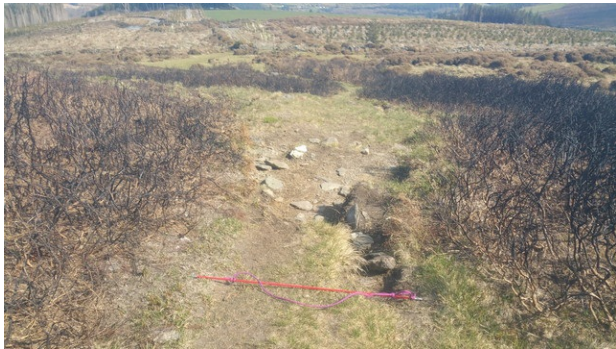
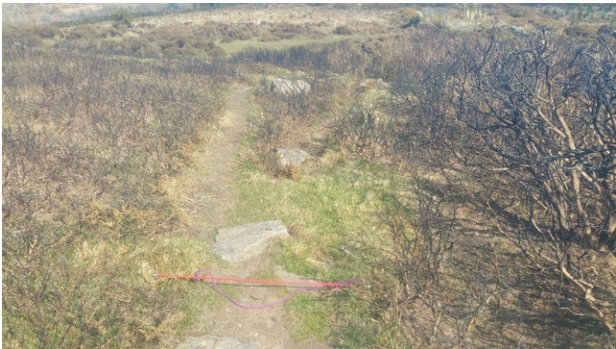
Section description: Junction

Site Assessment:Has been burnt

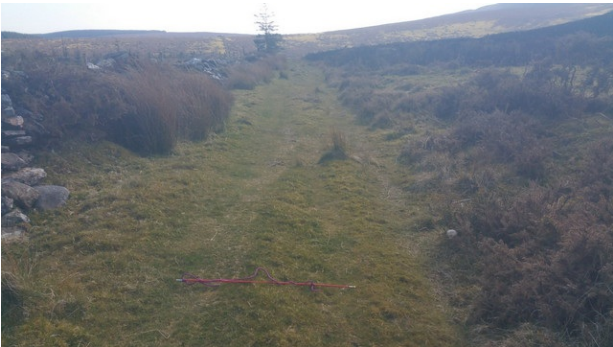
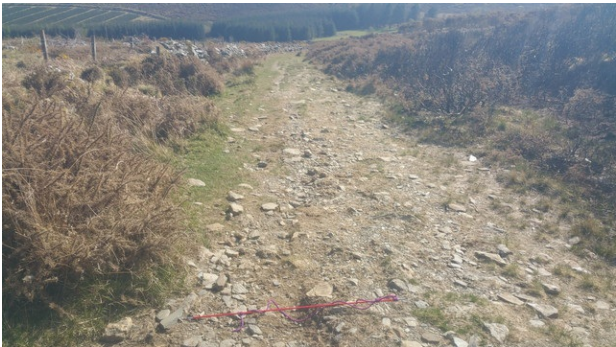
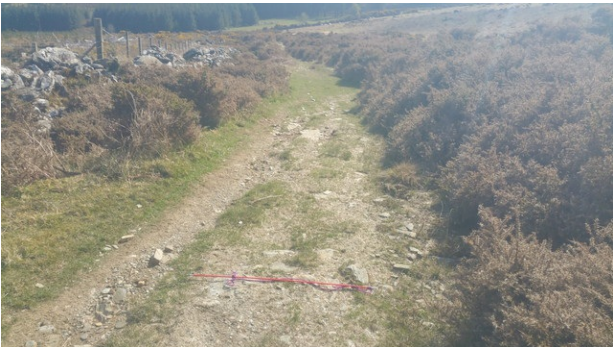
Site Assessment:Old farm track
