**Overall description:** Path traverses the edge of the firing range adjacent to forest plantation

**Overall assessment:** Significant erosion and gullyng of unconsolidated material is taking place due to poor drainage. Vegetation burning has taken place recently on the firing range

# Seahan (Section 3)

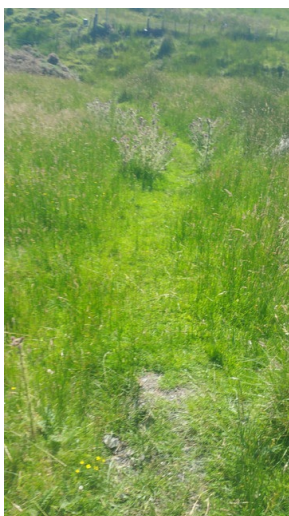
1626603441465.jpg - O 06735 18706 (± 3m)

Current Condtion

| Length (m) | Max gradient (%) | Min gradient (%) | Crossfall (%) |
| 41 | 15 | 0 | 0 |

| Substrate | Peat Depth (cm) |
| peat | 20 |

| | Minimum | Maximum | Typical |
| Trampled width (m) | 0.5 | 0.5 | 1 |
| Bare width (m) | 0 | 0 | 0.3 |
| Eroded depth (m) | 0 | 0 | 0.1 |

Site Assessment:Ditch / small stream crossing

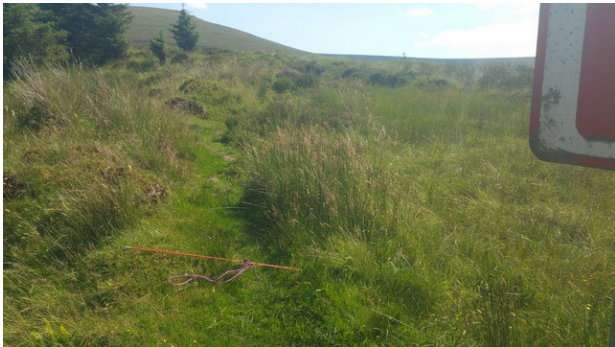
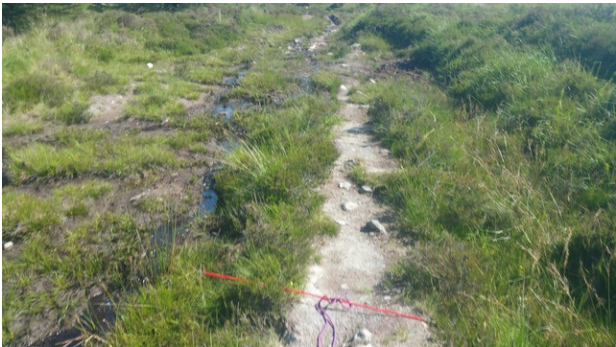
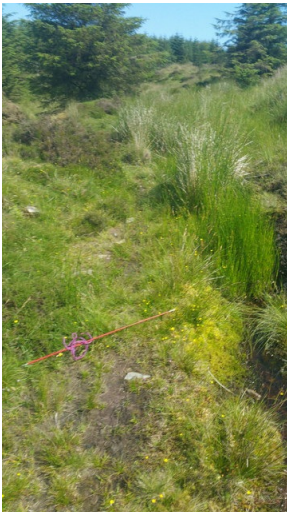
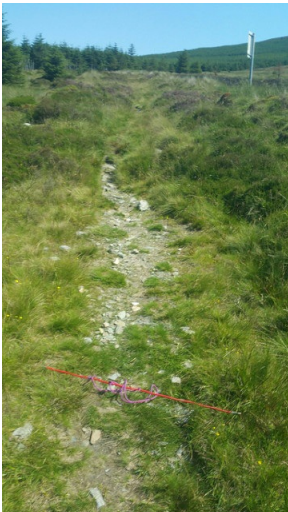
| Length (m) | Max gradient (%) | Min gradient (%) | Crossfall (%) |
| 574 | 8 | 5 | 0 |

| | Minimum | Maximum | Typical |
|---|---|---|---|
| Trampled width (m) | 0.5 | 1 | 3 |
| Bare width (m) | 0.3 | 0.4 | 1.5 |
| Eroded depth (m) | 0 | 0.1 | 0.3 |

**Site Assessment:**Power barrow access

| Work type | Estimated input | Work Summary |
|---|---|---|
| part_repair | 30 days labour | Drainage and line definition: 2 water bars 8 cross drains; 30m ditch<br>200m line definition |

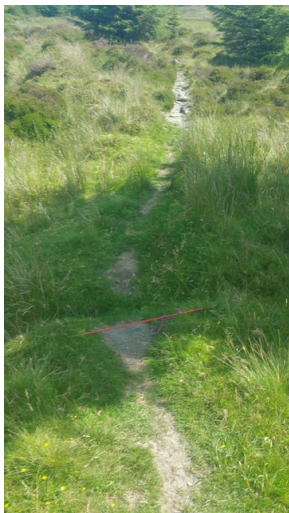
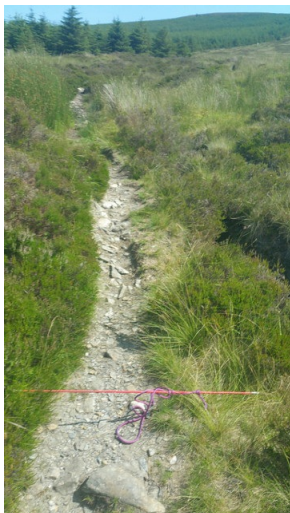
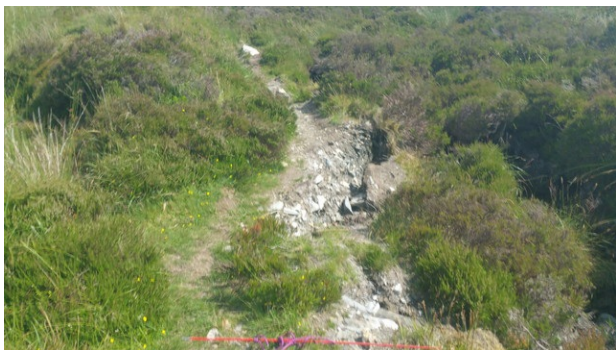
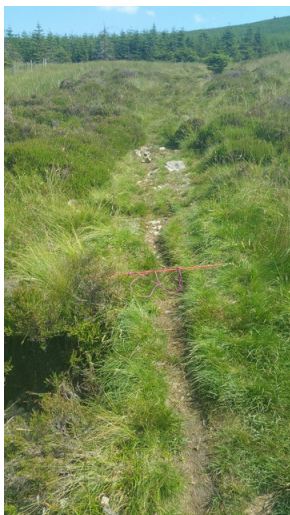
Section description: Starts at concrete boundary pillar

| 412 | 15 | 8 | 0 |

| Trampled width (m) | 1.5 | 2 | 5 |
| Bare width (m) | 0.3 | 0.5 | 2 |
| Eroded depth (m) | 0.1 | 0.2 | 1.3 |

**Site Assessment:** Accessible by machine if required

| early_intervention | 4 days labour | Drainage: Run drains out into firing range. 3 cross drains. High and dry path would be an option (full construction) |

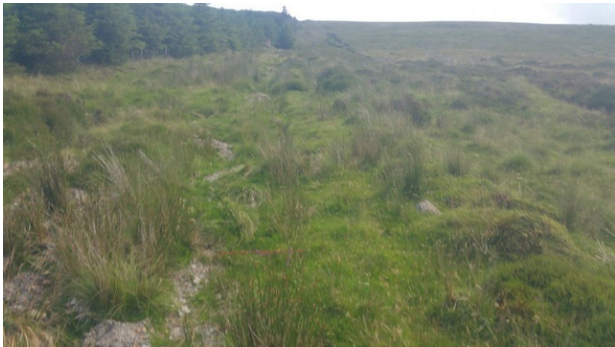
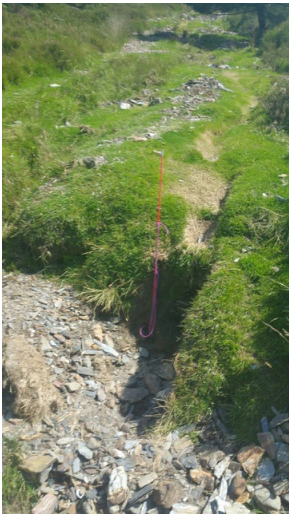
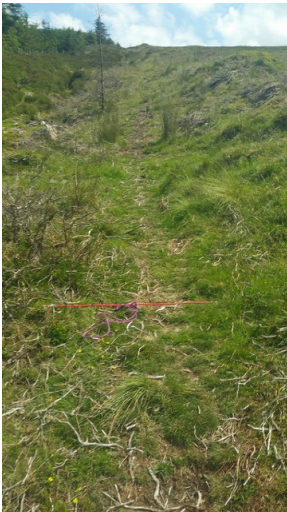
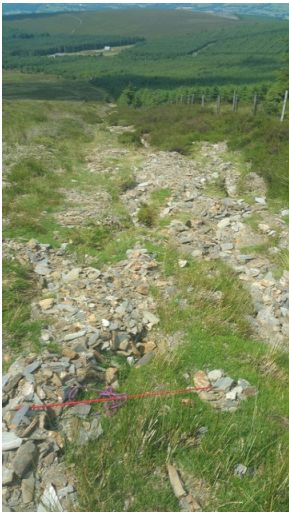
Section description: Wonky sign post - multiple braids

| Length (m) | Max gradient (%) | Min gradient (%) | Crossfall (%) |
|---|---|---|---|
| 329 | 22 | 20 | 0 |

| | Minimum | Maximum | Typical |
|---|---|---|---|
| Trampled width (m) | 4 | 6 | 15 |
| Bare width (m) | 0.6 | 4 | 6 |
| Eroded depth (m) | 0.2 | 0.3 | 0.8 |

| Work type | Estimated input | Work Summary |
|---|---|---|
| early_intervention | 8 days labour | Drainage - 8 water bars |

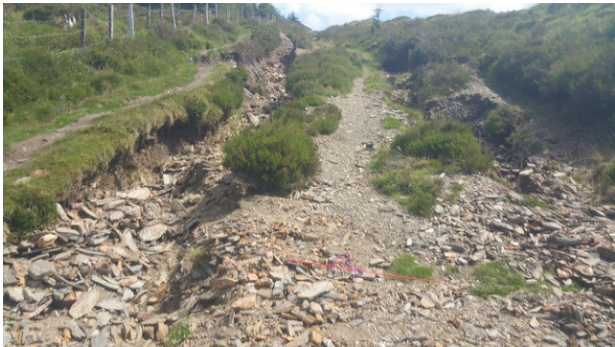
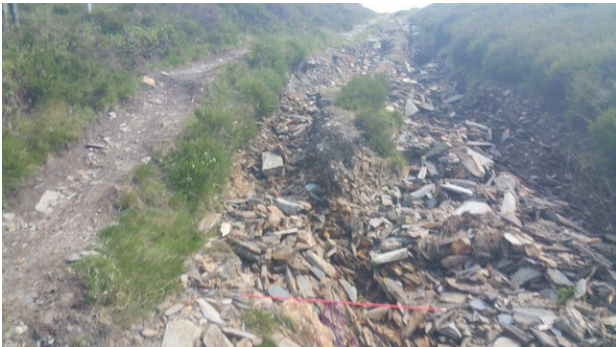
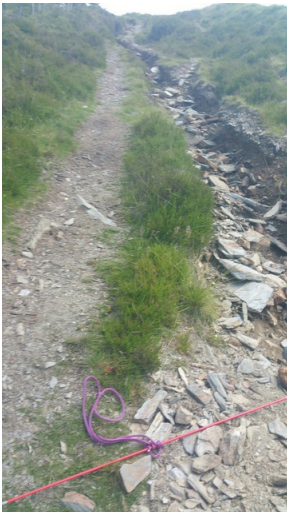
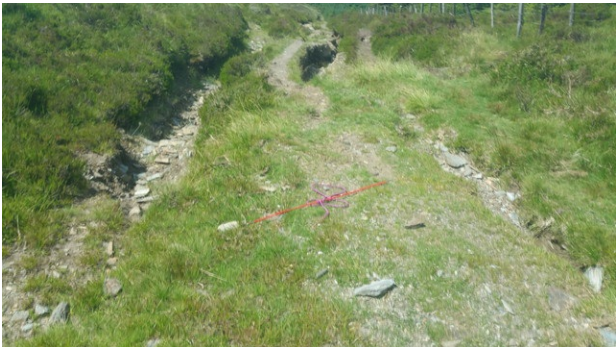
Section description: Gate from forestry up to corner of plantation - heavily eroded

| Length (m) | Max gradient (%) | Min gradient (%) | Crossfall (%) |
|---|---|---|---|
| 123 | 22 | 20 | 0 |

| | Minimum | Maximum | Typical |
|---|---|---|---|
| Trampled width (m) | 5 | 5 | 12 |
| Bare width (m) | 1 | 1.5 | 3 |
| Eroded depth (m) | 0.4 | 0.6 | 1.6 |

Availability of Materials: Good  
 Site Assessment:Scramblers using bog

| Work type | Estimated input | Work Summary |
|---|---|---|
| early_intervention | 4 days labour | Install a big ditch at the top (20m) to disperse water away from the path below |

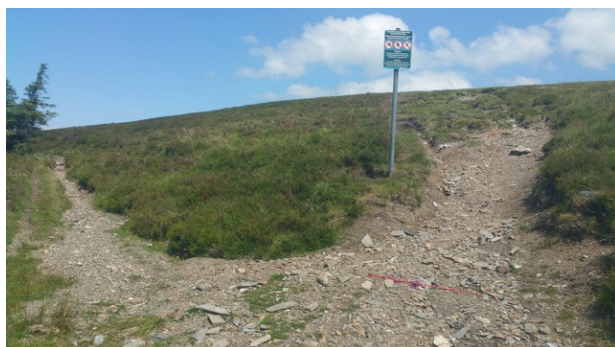
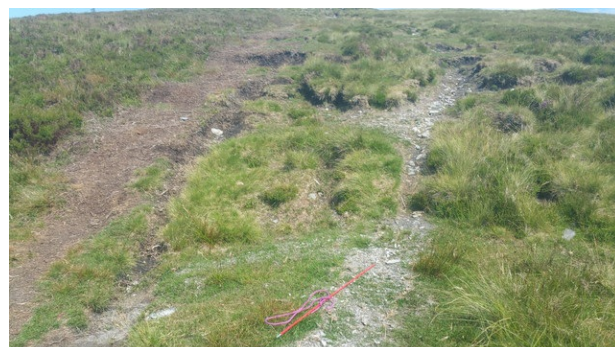
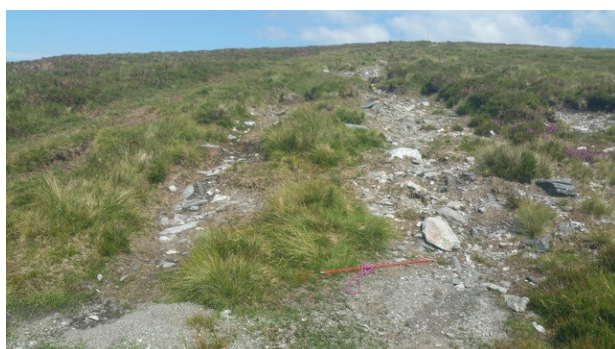
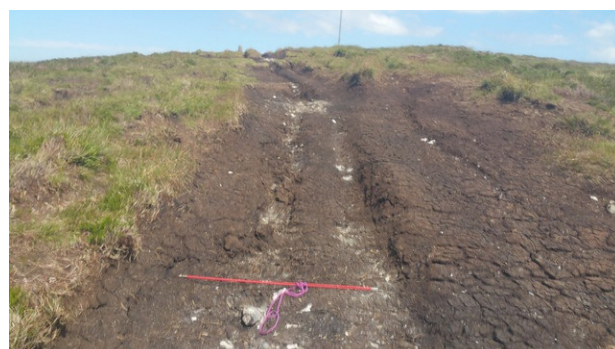
**Section description:** Corner of forestry to summit of Seahan

| Length (m) | Max gradient (%) | Min gradient (%) | Crossfall (%) |
|---|---|---|---|
| 366 | 20 | 10 | 0 |

| | Minimum | Maximum | Typical |
|---|---|---|---|
| Trampled width (m) | 6 | 8 | 12 |
| Bare width (m) | 3 | 4 | 8 |
| Eroded depth (m) | 0.1 | 0.2 | 0.4 |

**Site Assessment:** Scramblers. No deep peat

| Work type | Estimated input | Work Summary |
|---|---|---|
| early_intervention | 15 days labour | Drainage (3 water bars or grade reversals) line definition and landscaping |
