# Sorrel hill

Survey date: Jul 17, 2021

**Overall description:** Well used path to summit

**Overall assessment:** Deep peat at top showing signs of degradation

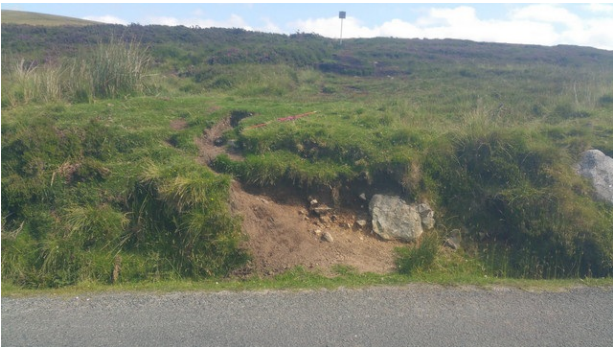
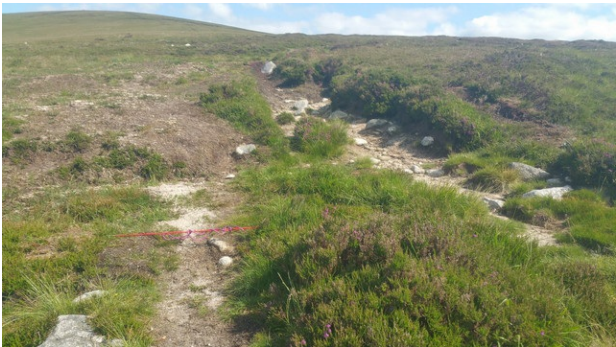
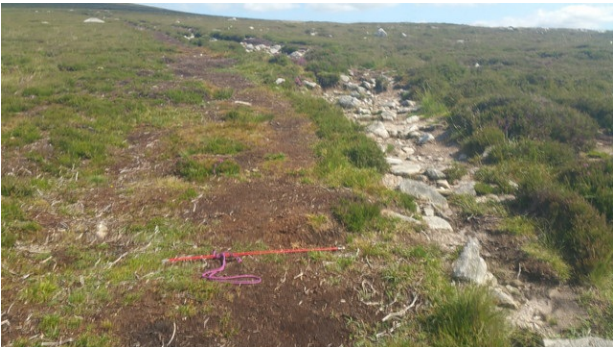
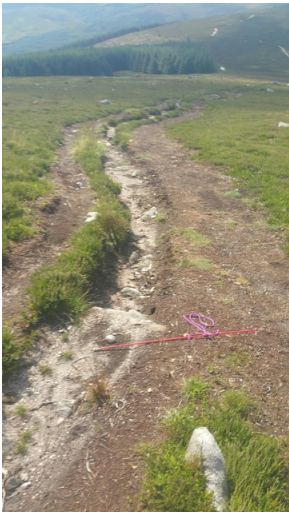
**Sorrel hill (Section 1)**  
**Section description:** Roadside

**Availability of Materials:** Block stone adequate but small

**Site Assessment:**Access from road is good

| Work type | Estimated input | Work Summary |
|---|---|---|
| early_intervention | 8 days labour | Drainage and line definition with landscaping; 5 water bars 200m deroughening. Block braids |

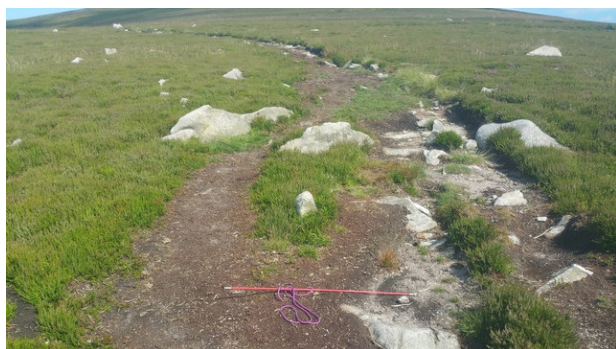
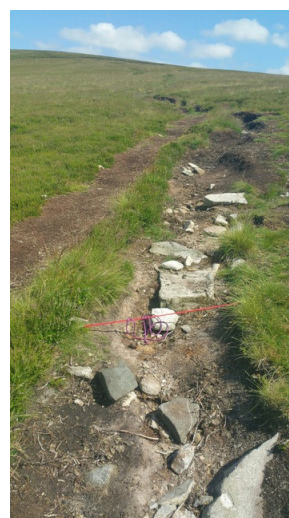
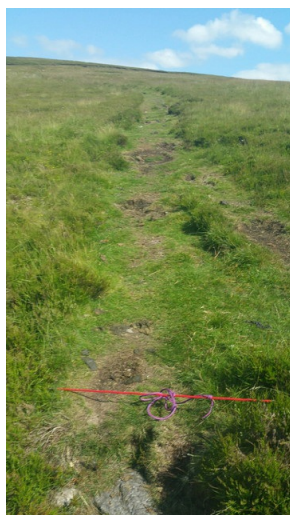
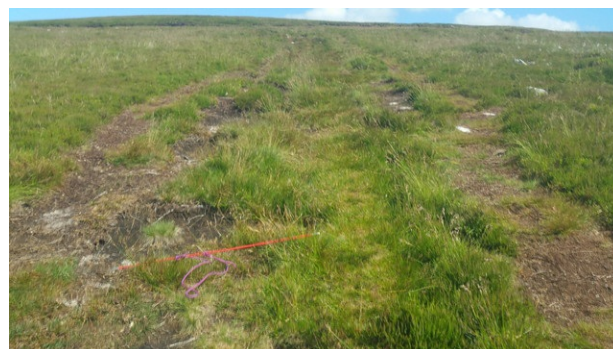
**Section description:** Large boulder across path by bend

**Availability of Materials:** Limited. May be possible to collect some stone away from path line

**Site Assessment:** Good access for power barrow

| Work type | Estimated input | Work Summary |
|---|---|---|
| early_intervention | 10 days labour | Drainage - 10 water bars |

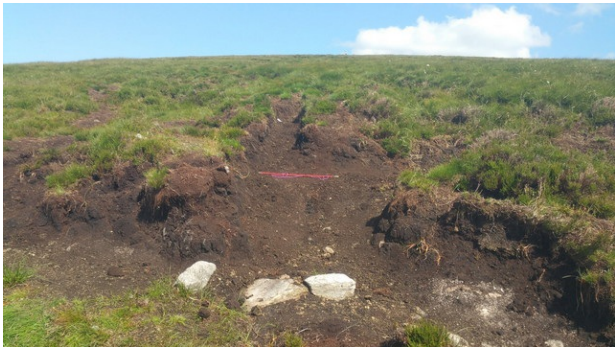
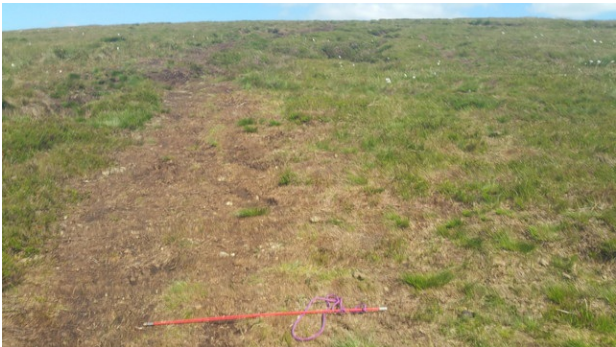
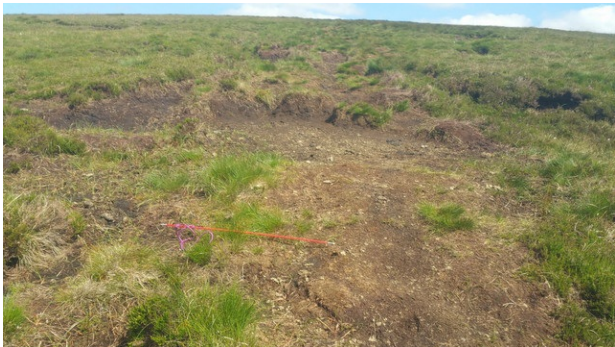
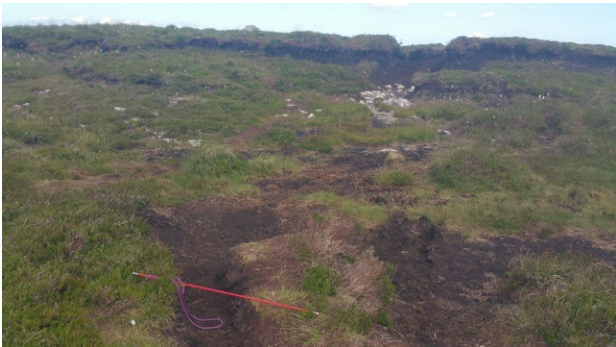
Section description: Peat bank

Availability of Materials: None

Site Assessment:Heavily used by sheep

| none | | Deep peat |
