# Table to Oiltiagh Bridge

| Survey date: Jul 20,2021 | Length: 2435m | Sections: 5 |

**Overall description:** Route traverses the firing range from forestry plantation

**Overall assessment:** The upper part of the route is on an old track and is reasonably robust. Potential for military to assist?

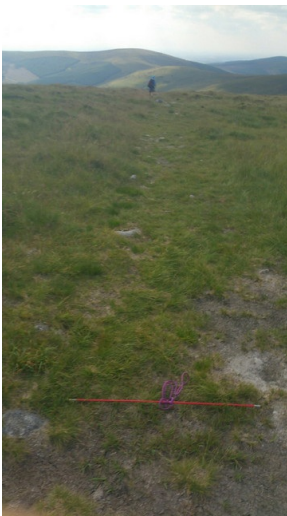
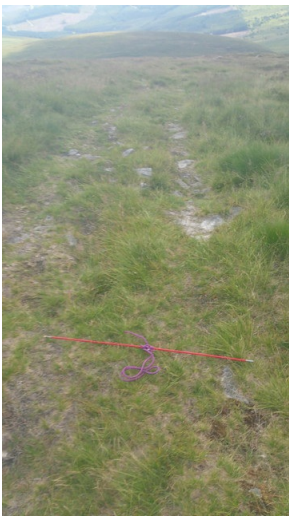
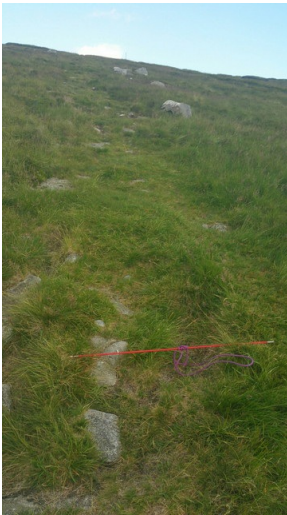
Section description: Table track

| Length (m) | Max gradient (%) | Min gradient (%) | Crossfall (%) |
| 346 | 20 | 10 | 0 |

| Substrate | Peat Depth (cm) |
| peat | 50 |

| | Minimum | Maximum | Typical |
|---|---|---|---|
| Trampled width (m) | 1.8 | 1.8 | 2 |
| Bare width (m) | 0 | 0.5 | 0.5 |
| Eroded depth (m) | 0 | 0 | 0.1 |

| Work type | Estimated input | Work Summary |
|---|---|---|
| minor_repair | 3 days labour | 3 Water bars |

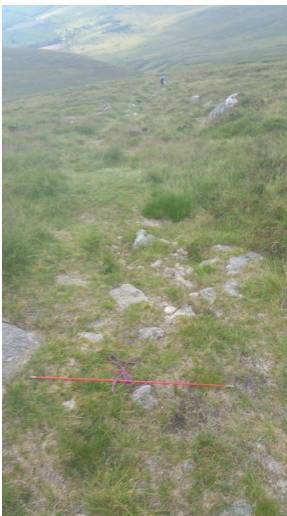
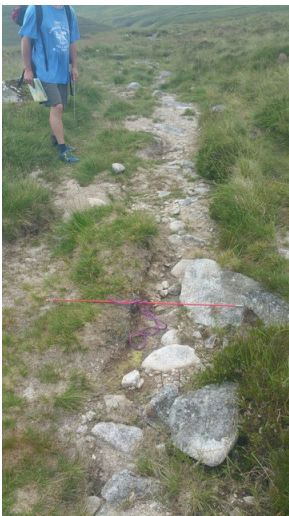
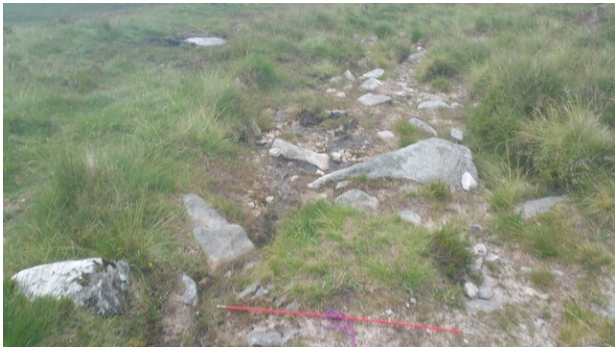
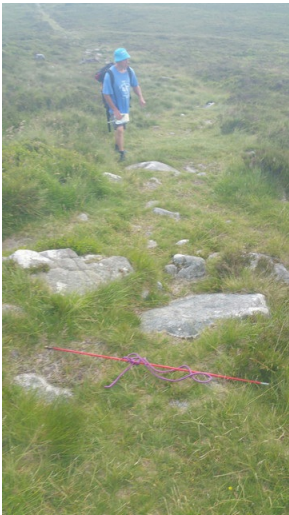
Section description: Corner with boulder

| Length (m) | Max gradient (%) | Min gradient (%) | Crossfall (%) |
| 496 | 25 | 20 | 0 |

| Substrate | Peat Depth (cm) |
| peat | 20 |

| | Minimum | Maximum | Typical |
|---|---|---|---|
| Trampled width (m) | 1.5 | 2 | 3.5 |
| Bare width (m) | 0.5 | 0.5 | 1.2 |
| Eroded depth (m) | 0 | 0.1 | 0.3 |

| Work type | Estimated input | Work Summary |
|---|---|---|
| minor_repair | 10 days labour | Drainage - 10 water bars |

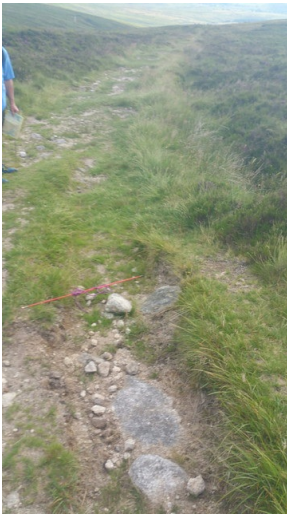
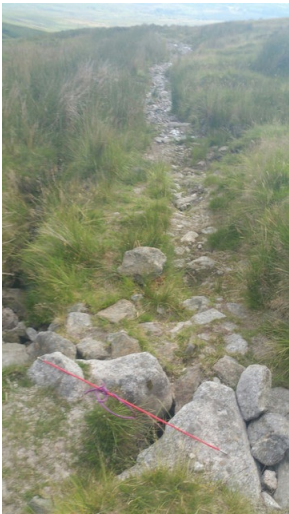
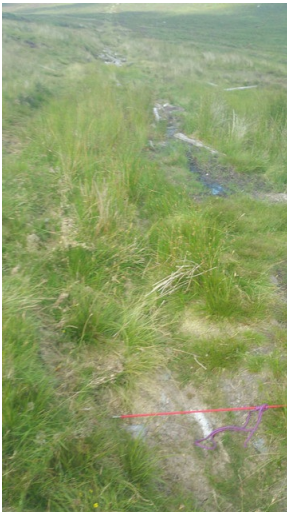
Section description: Junction

| Length (m) | Max gradient (%) | Min gradient (%) | Crossfall (%) |
| 1291 | 25 | 0 | 0 |

| Work type | Estimated input | Work Summary |
|---|---|---|
| minor_repair | 3 days labour | Minor drainage - 3 water bars |

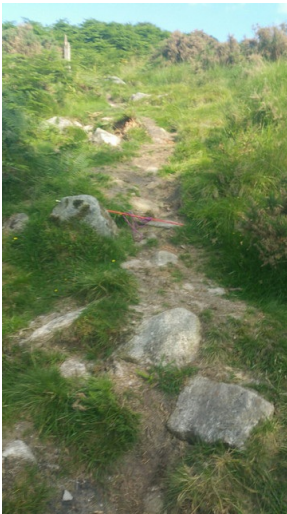
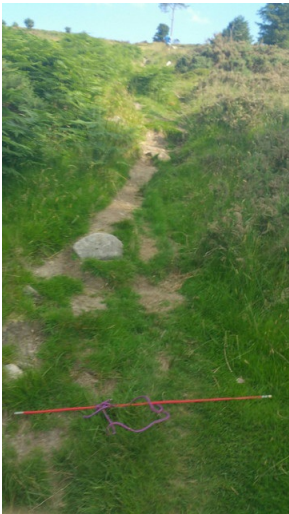
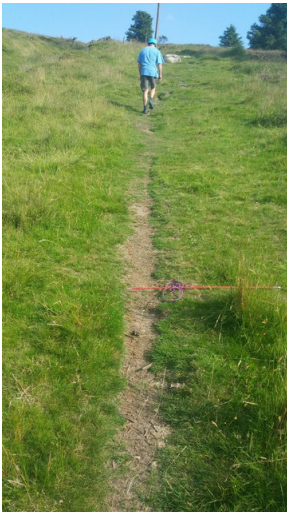
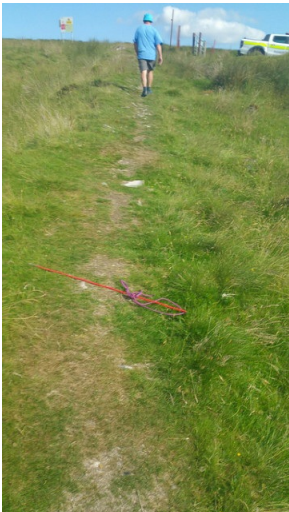
Section description: Larch

| Length (m) | Max gradient (%) | Min gradient (%) | Crossfall (%) |
| 245 | 30 | 20 | 0 |

| Substrate | Peat Depth (cm) |
| peat | 20 |

| | Minimum | Maximum | Typical |
|---|---|---|---|
| Trampled width (m) | 1 | 1.5 | 2 |
| Bare width (m) | 0 | 0.3 | 0.5 |
| Eroded depth (m) | 0 | 0.1 | 0.3 |

Site Assessment:Vehicle access from above

| Work type | Estimated input | Work Summary |
|---|---|---|
| early_intervention | 5 days labour | Drainage 5 water bars |

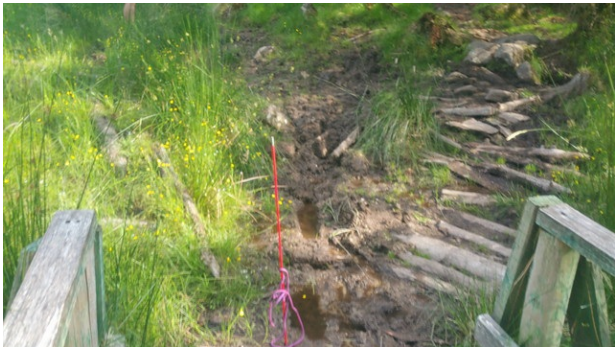
1626798929771.jpg - S 99983 96550 (± 4m)

Section description: Junction

| Length (m) | Max gradient (%) | Min gradient (%) | Crossfall (%) |
| 57 | 55 | 50 | 20 |

| Substrate | Peat Depth (cm) |
| mineral_soil | 0 |

| | Minimum | Maximum | Typical |
|---|---|---|---|
| Trampled width (m) | 0.5 | 0.8 | 1 |
| Bare width (m) | 1 | 0.5 | 0.5 |
| Eroded depth (m) | 0 | 0.5 | 0.6 |

Site Assessment: Steep ground

| Work type | Estimated input | Work Summary |
|---|---|---|
| major_repair | 60 days labour | 8m causeway 45m pitch 15 aggregate path to larch |
