# Tonagalee - Lough Ouler circuit

Survey date: Apr 19, 2021

**Overall description:** Circuit from Glenmacnass (car park) with a number of route options

**Overall assessment:** Long route with sections of deep peat on steep gradients

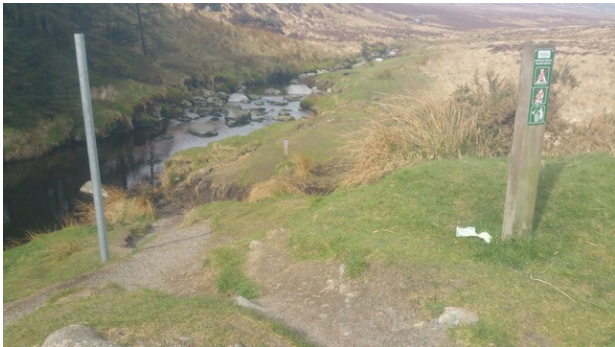
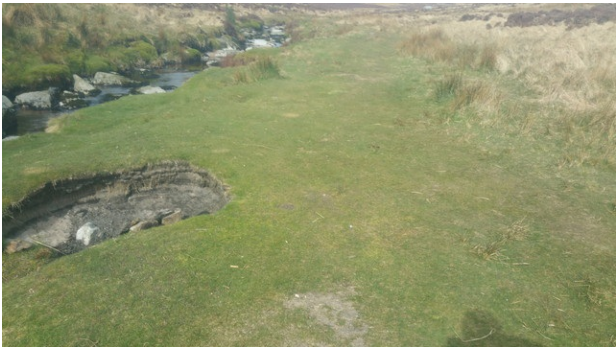
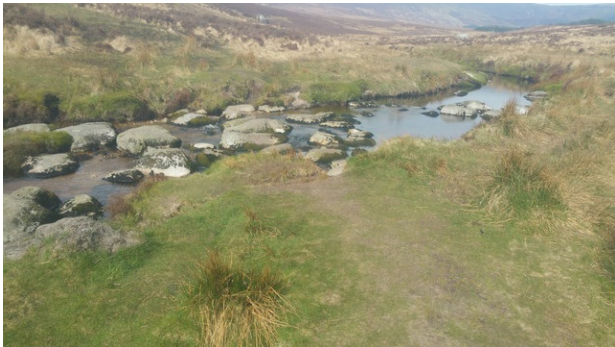
**Section description:** Car park - this area is used for informal recreation by the river bank

**Site Assessment:**Robust river bank - easy access

| Work type | Estimated input | Work Summary |
|---|---|---|
| minor_repair | 2 days labour | Cross drain at start and 10m surfacing - divert path away from river bank to heal peat erosion |

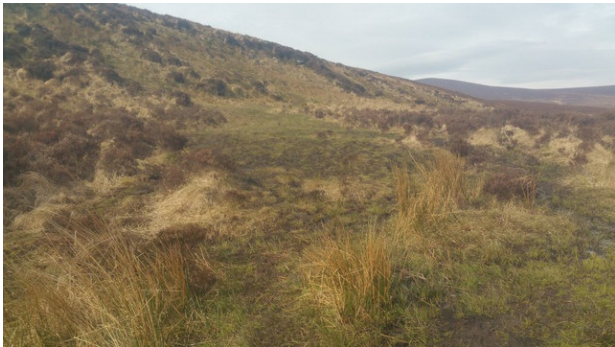
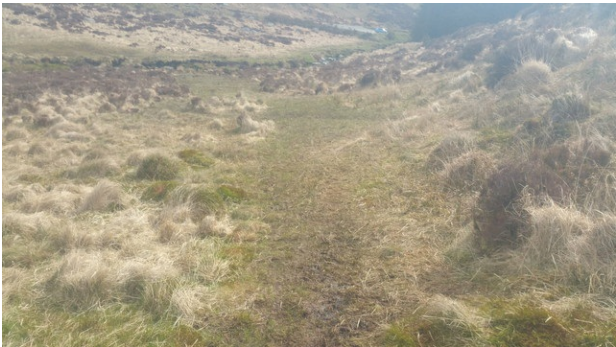
**Section description:** This section starts at the river and cross the flood plain to the change of slope.

**Site Assessment:**River crossing

| Work type | Estimated input | Work Summary |
|---|---|---|
| none | | Would require full floated path or nothing - no intermediate options are available due to deep peat - 120m floated aggregate would be required |

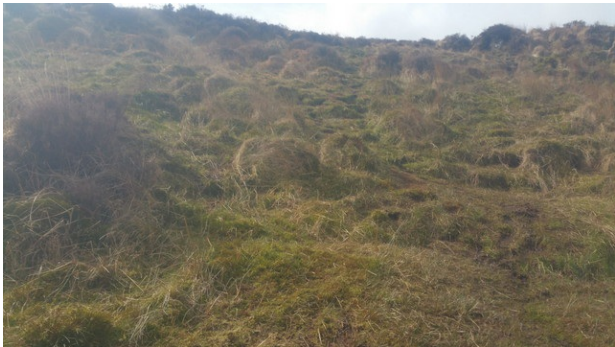
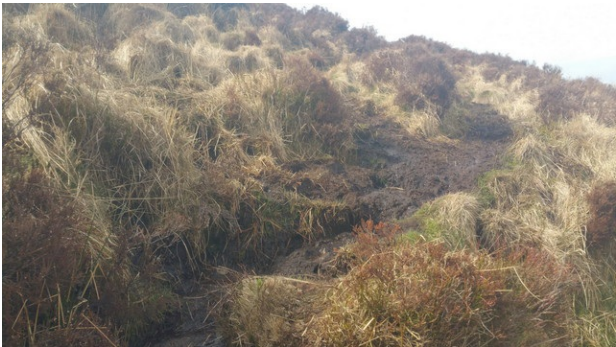
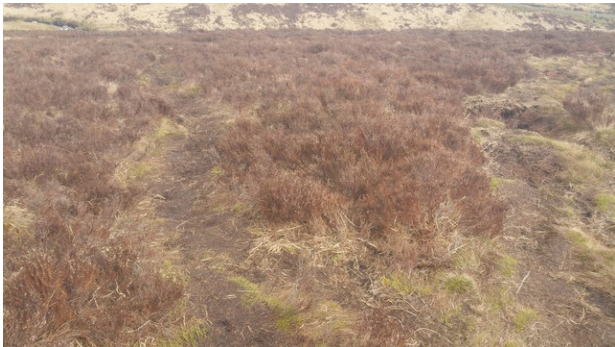
**Section description:** Section starts at the base of the slope and is a direct line up hill

**Site Assessment:**Alternative route to that shown on the map

| Work type | Estimated input | Work Summary |
|---|---|---|
| none | | If any work is done on this it would require full build - 50m pitching on the steepest; 90m mixed ptching and aggregate surface (50:50) |

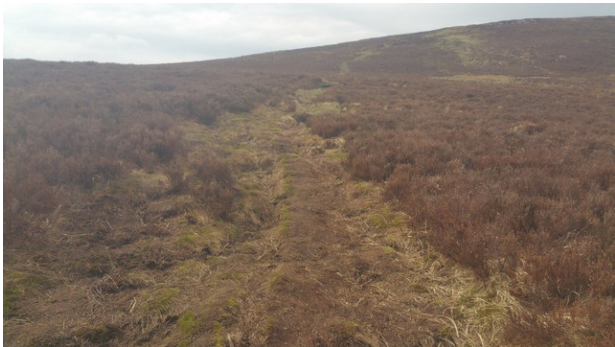
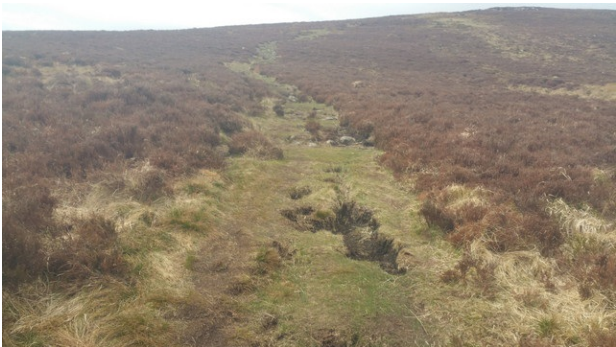
**Section description:** Section starts at junction with other braids and is on a more gentle slope than previous section.

**Site Assessment:**Easy full build if required

| Work type | Estimated input | Work Summary |
|---|---|---|
| none | | Currently not in urgent need of work |

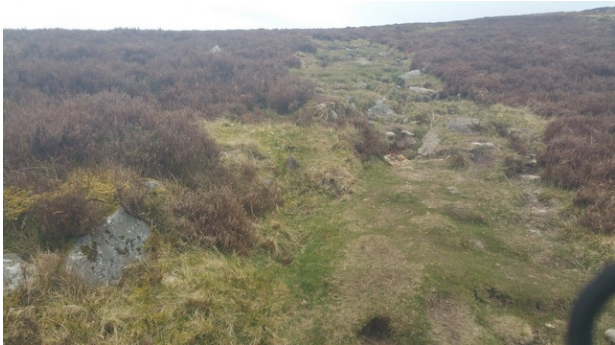
1618828946762.jpg - O 11019 02766 (± 4m)

**Section description:** Section starts at change in slope. Boulders exposed in places

| | Minimum | Maximum | Typical |
|---|---|---|---|
| Eroded depth (m) | 0 | 8 | 0.2 |

**Site Assessment:** May be on the cusp of rapid deterioration

| Work type | Estimated input | Work Summary |
|---|---|---|
| early_intervention | 10 days labour | Drainage would help reduce the loss of surface vegetaton - 5 cross drains and 50m of ditching. Needs careful thought due to possibility of encouraging more walkers (highly visible) |

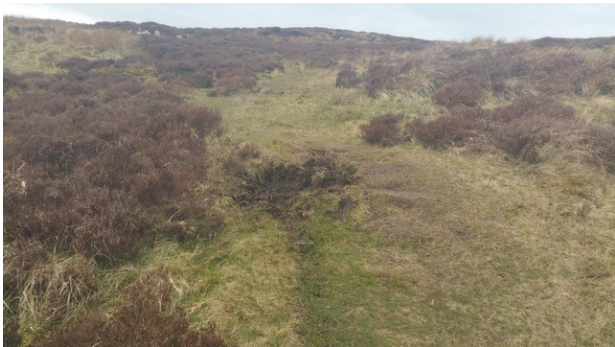
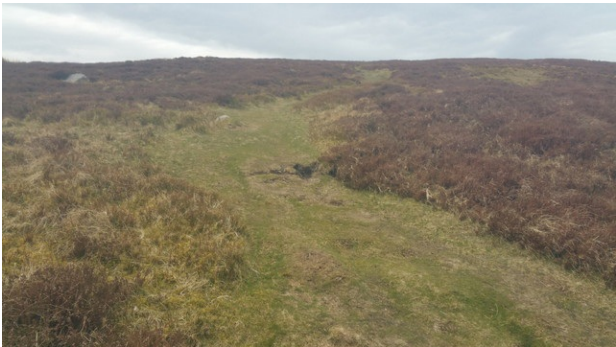
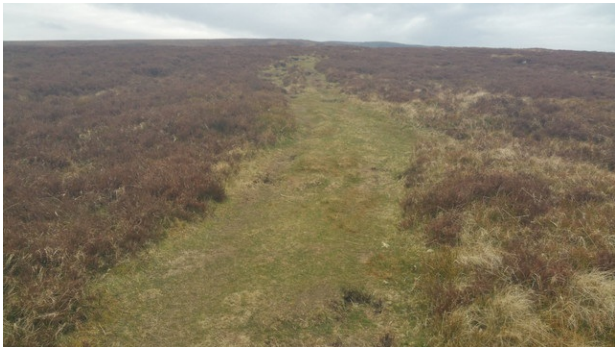
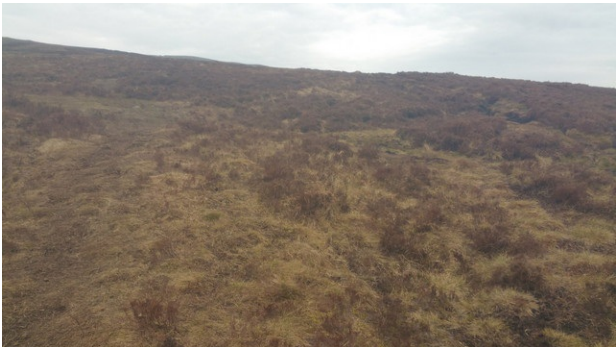
Section description: Section starts at boulder outcrop at a change of slope

Site Assessment:Open moorland.

| Work type | Estimated input | Work Summary |
|---|---|---|
| none | | Deep peat 40 - 90cm. Floated path would be the only option - not recommended |

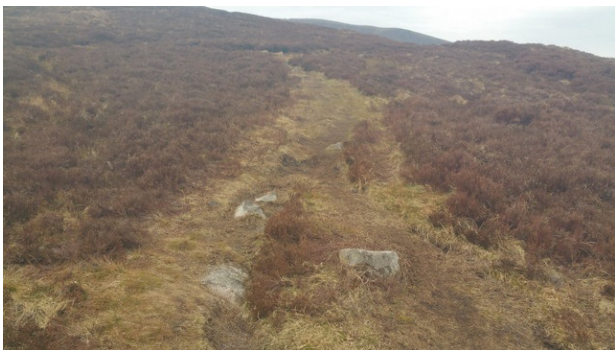
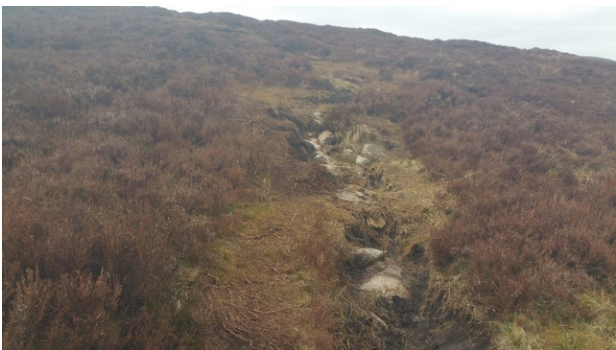
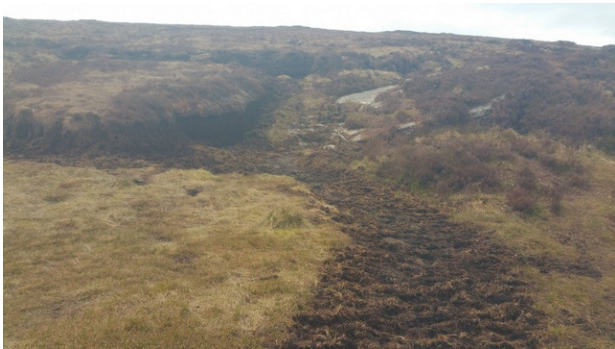
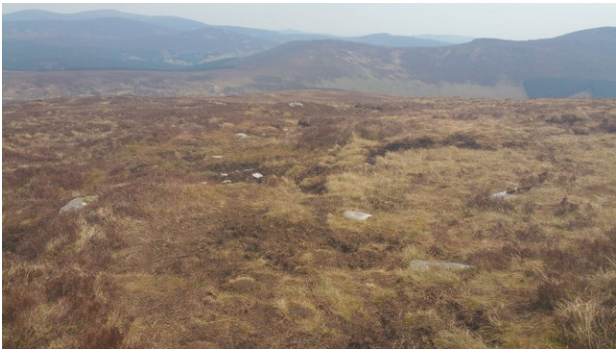
**Section description:** Section starts at flat area with boulders at surface and passes through deep eroded peat

**Site Assessment:** Deep peat

| Work type | Estimated input | Work Summary |
|---|---|---|
| none | 8 days labour | 20m of Hag restoration to reduce the exposed peat and drainage (20m of drain and 1 cross drain). May not be viable. |

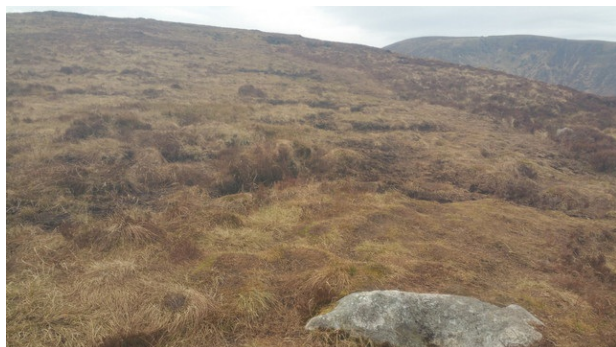
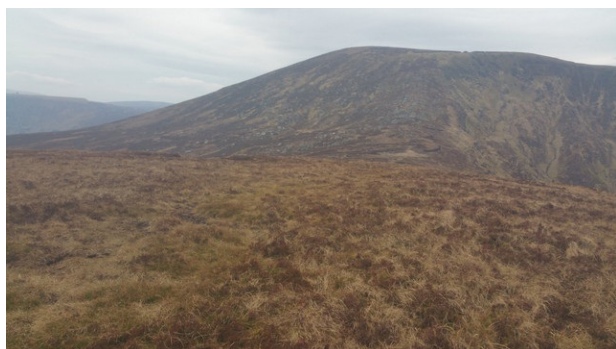
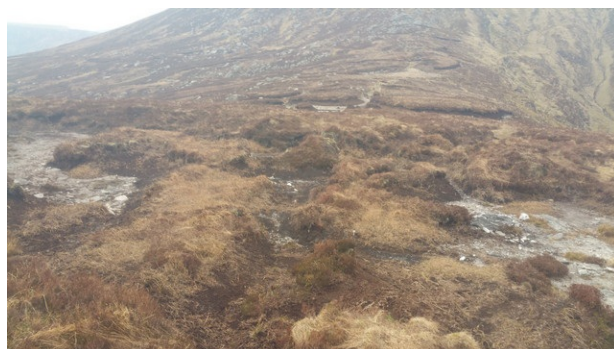
**Section description:** Difficult area to define the start (featurless) but it is the beginning of an open slope. The path climbs to Tonelagee NE top and drops back to a col and crosses areas of deep peat with hags

**Site Assessment:** Deep peat with erosion features

| Work type | Estimated input | Work Summary |
|---|---|---|
| none | 20 days labour | Reduce impacts near col through hag restoration |

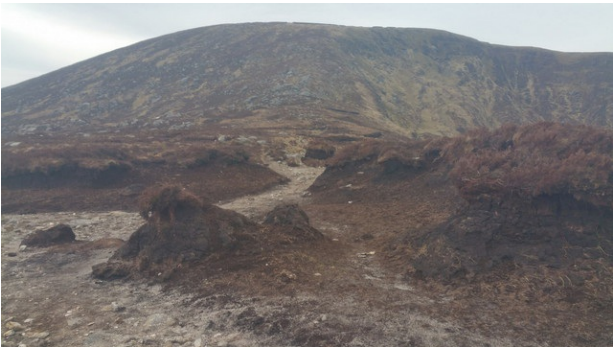
1618837805461.jpg - O 09301 01825 (± 4m)

Site Assessment:Badly damaged but too remote for machinery to undertake peat restoration (not viable)

| Work type | Estimated input | Work Summary |
|---|---|---|
| none | 20 days labour | 290m line definition. |

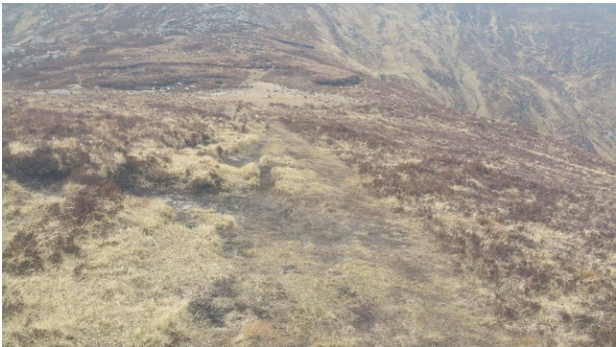
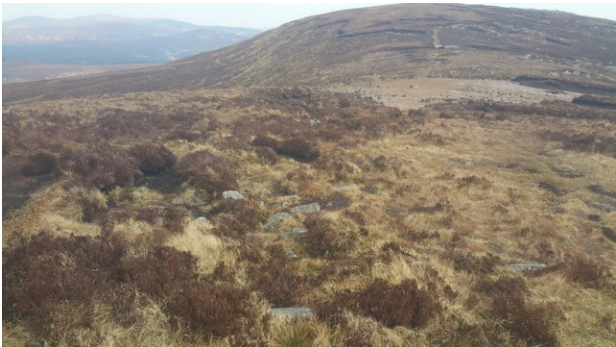
Section description: Section crosses the col - badly eroded peat hags

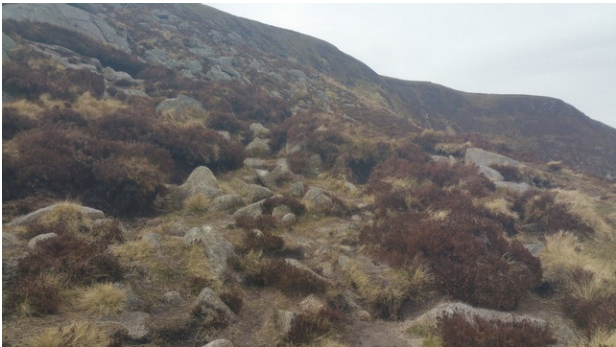
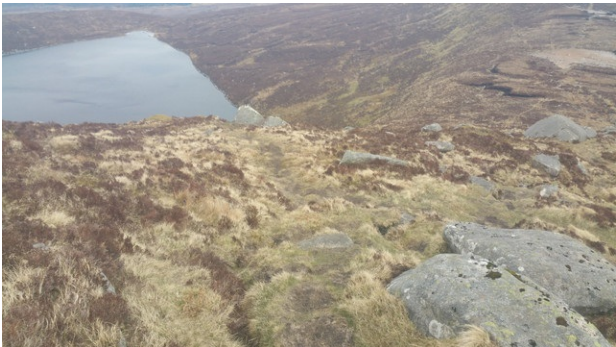
**Section description:** Section starts at boulders and ascends steeply to a braid junction

**Site Assessment:**Steep ground with large boulders

| Work type | Estimated input | Work Summary |
|---|---|---|
| none | | If work were considered, it would require line definition for approximately 150m and pitching approx 50m |

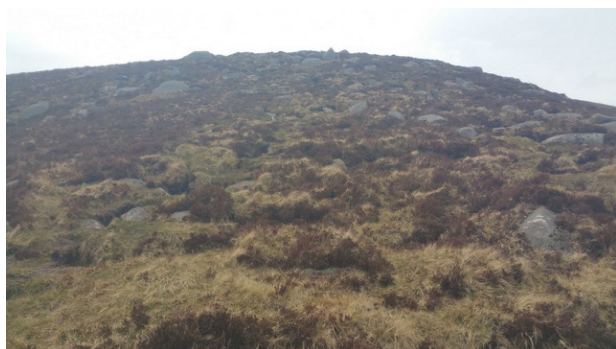
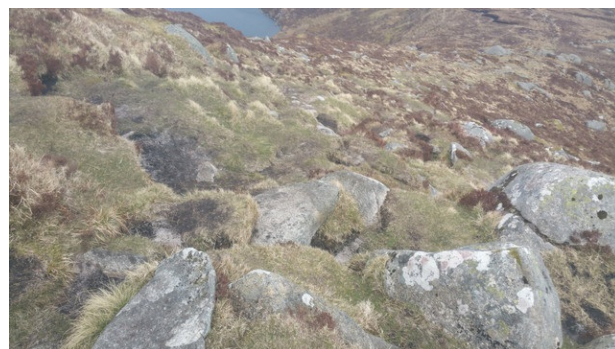
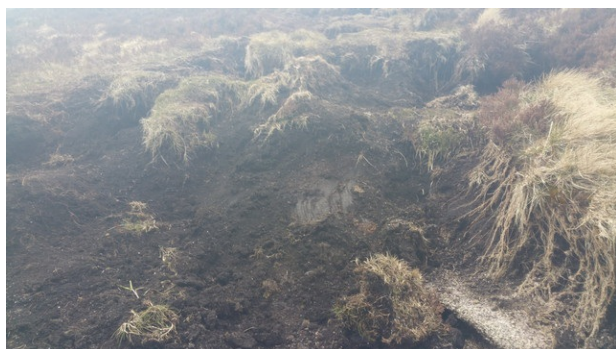
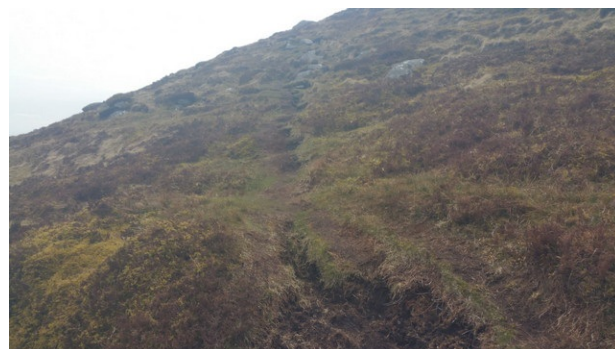
**Section description:** Section starts at path junction and runs up to the summit trig point. It is not obvious on upward direction

**Site Assessment:** Variable along length. Peat restoration options (too remote and high for machinery)

| Work type | Estimated input | Work Summary |
|---|---|---|
| none | 15 days labour | 50m line containment at bottom; 60m line definition to trig point |

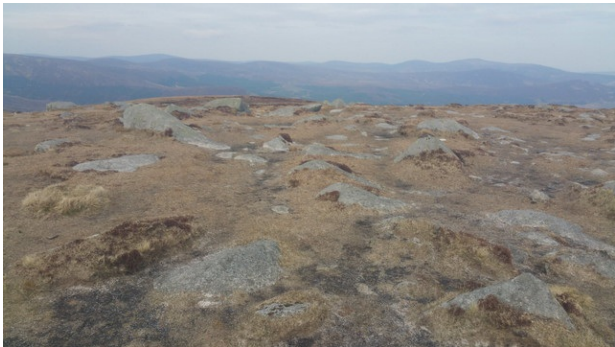
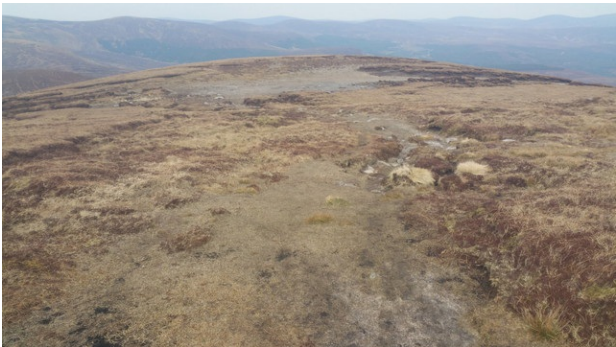
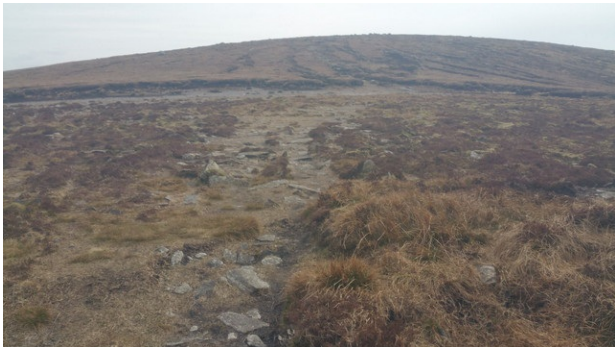
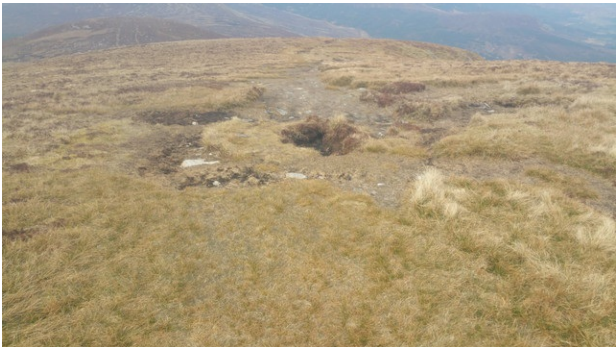
**Section description:** Section starts at trig point and crosses the broad summit - the route avoids areas of deep peat which has eroded sufficiently to allow access

**Site Assessment:**High altitude short season

| Work type | Estimated input | Work Summary |
|---|---|---|
| none | 20 days labour | The impact of walkers would be lessened by 150m line definition across bare areas and 40m hag reprofiling (which would have to be done manually) |

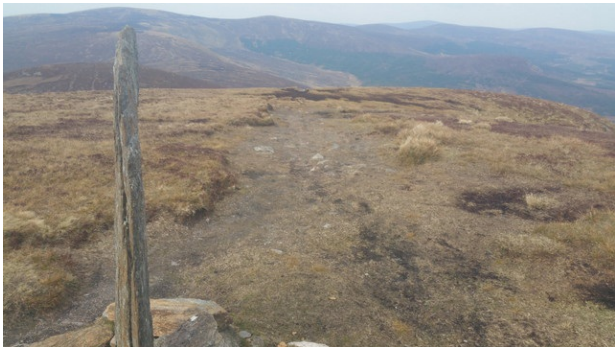
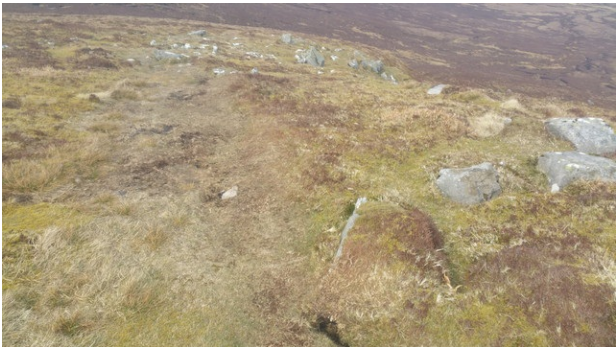
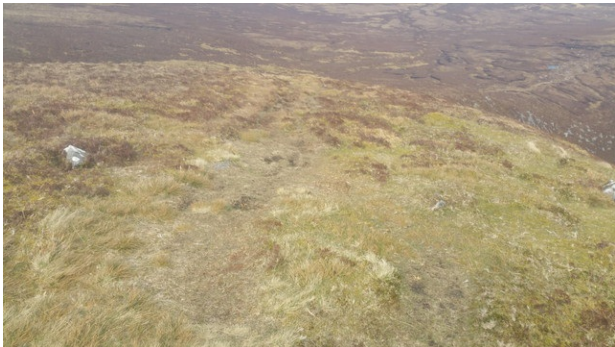
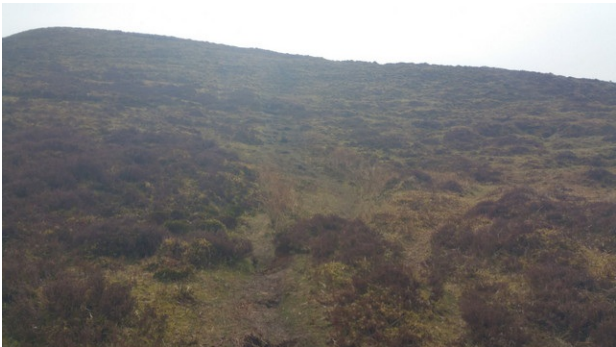
**Section description:** Section starts at cairn by viewpoint down to Lough Ouler and runs steeply down the slope

**Site Assessment:**Steep ground

| Work type | Estimated input | Work Summary |
|---|---|---|
| none | | Not highly impacted. Difficult to do anything short of full construction on steep ground |

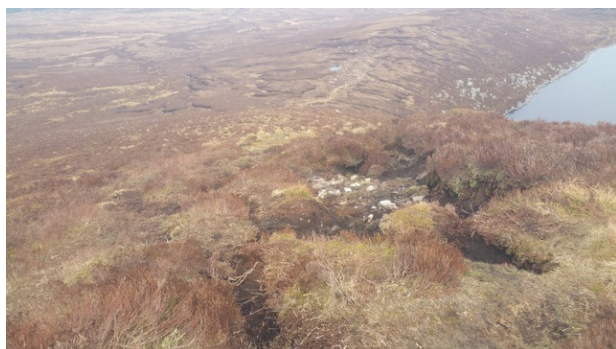
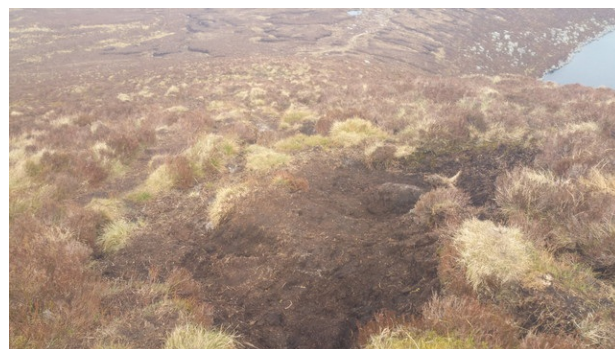
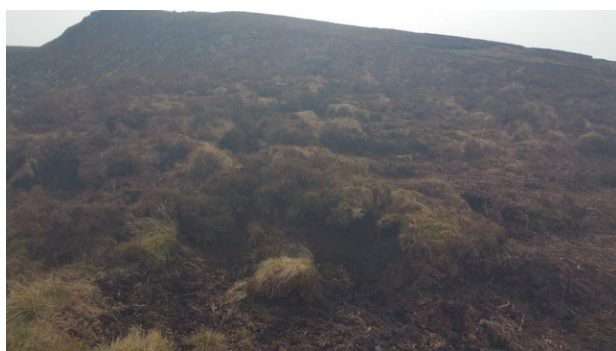
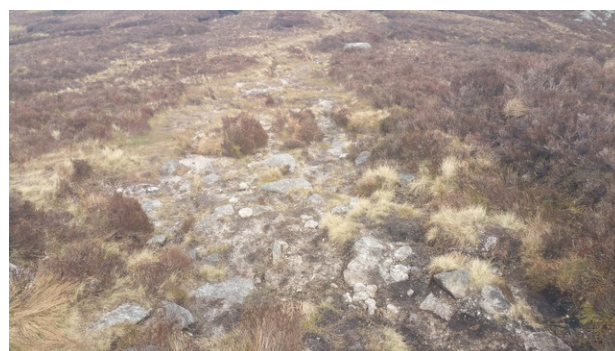
**Section description:** Section starts at break in slope and continues down the shoulder of the corrie. There are pockets of deep peat

**Site Assessment:** It would be a challenge to do anything except full build and the deep peat makes that more difficult to achieve

| Work type | Estimated input | Work Summary |
|---|---|---|
| none | 20 days labour | Experimental: Peat stabilisation could be attempted using 15 wooden dams to deflect water away from path line |

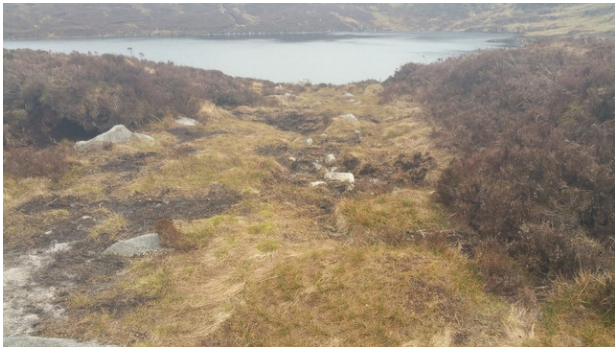
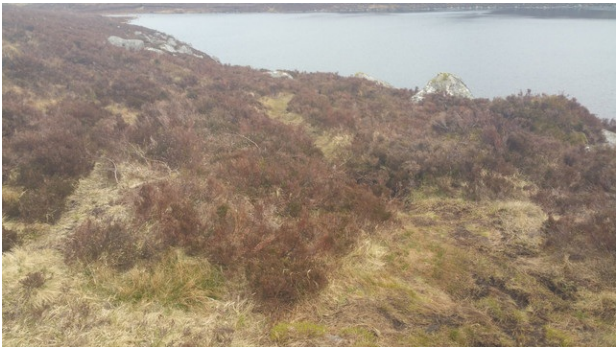
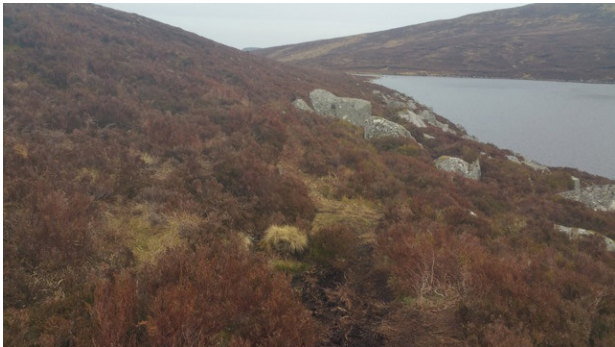
Section description: At bottom of slope. Path turns towards lough

Site Assessment:Remote site

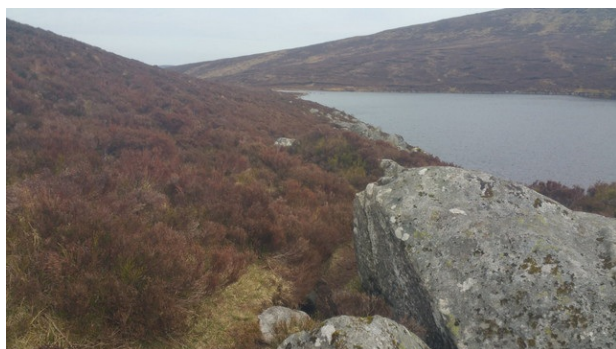
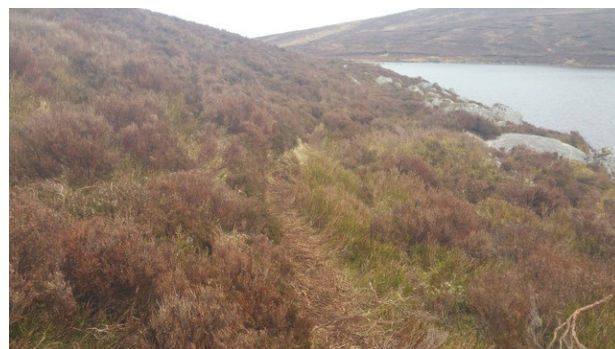
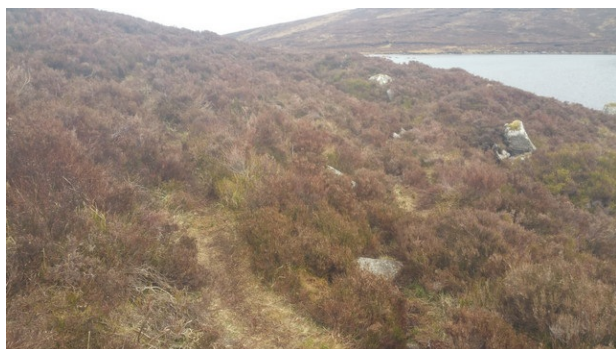
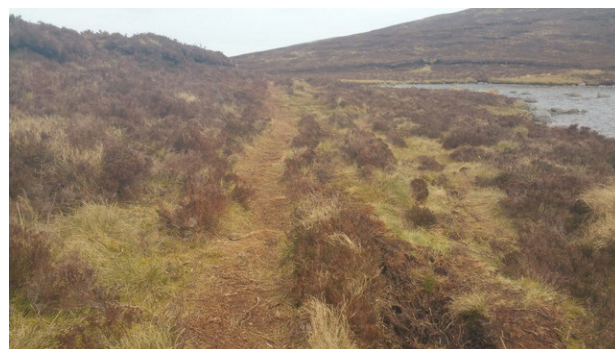
**Section description:** Section starts at boulders on cross slope and leads down to Lough Ouler (more obvious route on the ground than continuing on the ridge)

**Site Assessment:** Cross slope constraints

| Work type | Estimated input | Work Summary |
|---|---|---|
| none | | None required with current level of use |

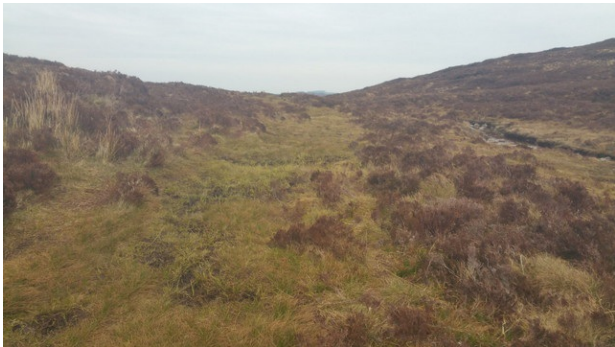
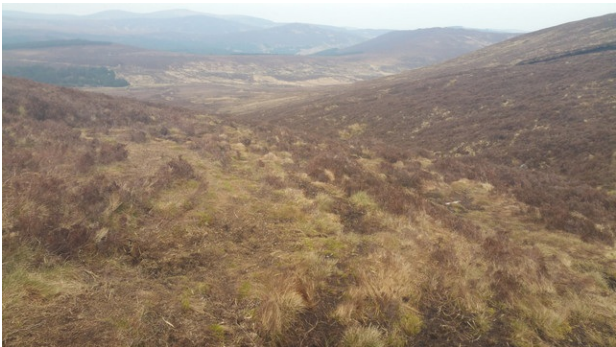
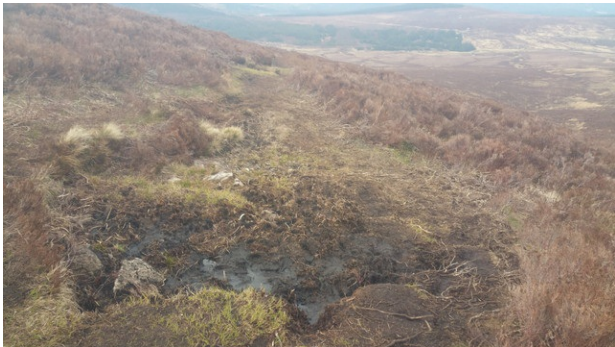
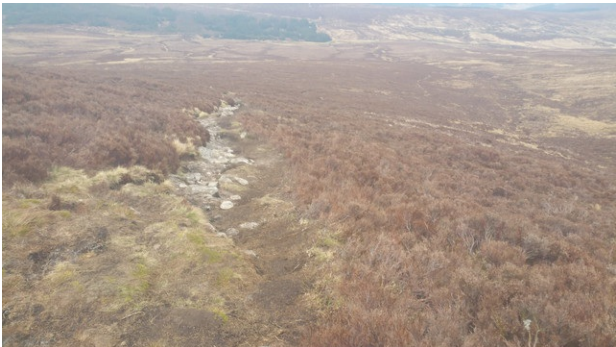
**Section description:** Section starts at lough outlet and runs parallel to the stream. Multiple short / minor braids

**Site Assessment:** Easy work - access from below

| Work type | Estimated input | Work Summary |
|---|---|---|
| Light_touch | 15 days labour | Line definition to de-roughen the path for approx 80m and drainage with 10 water bars to shed surface water |

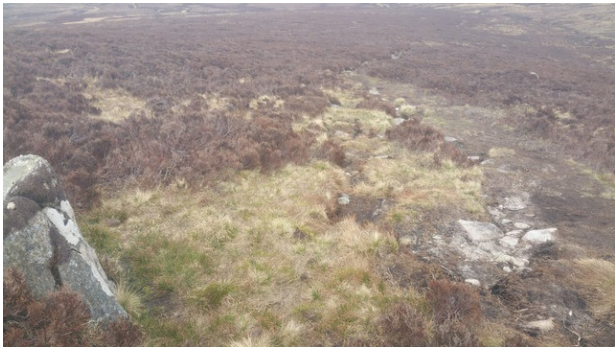
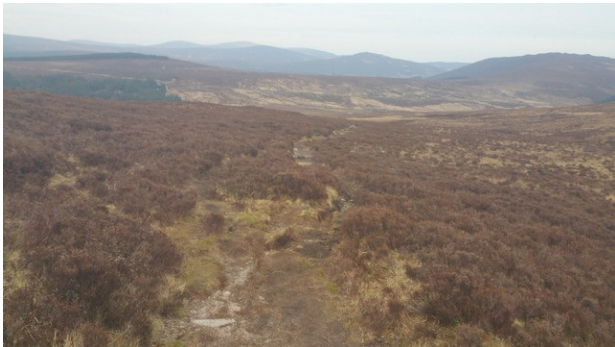
**Section description:** Section starts at pointy boulder next to path and runs parallel to the stream as far as the crossing on flatter ground. Well defined route

**Site Assessment:**Simple work on easy ground

| Work type | Estimated input | Work Summary |
|---|---|---|
| Light_touch | 10 days labour | Remove surface water from the path line with 10 water bars |

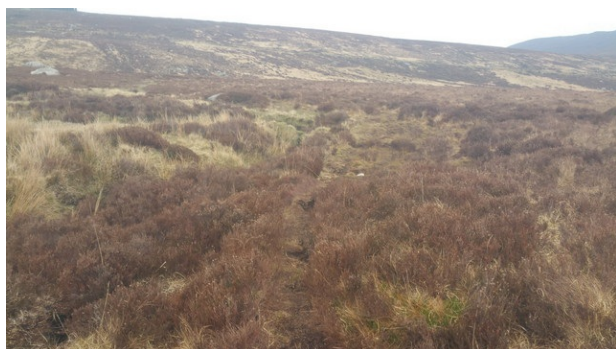
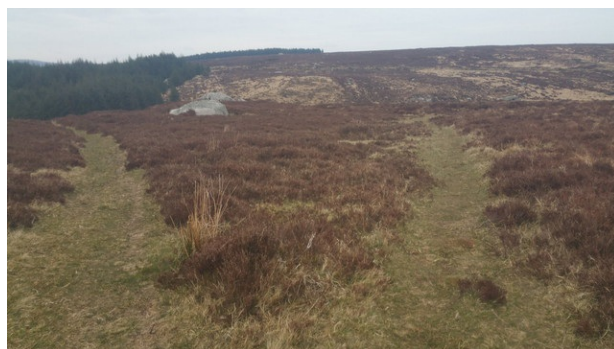
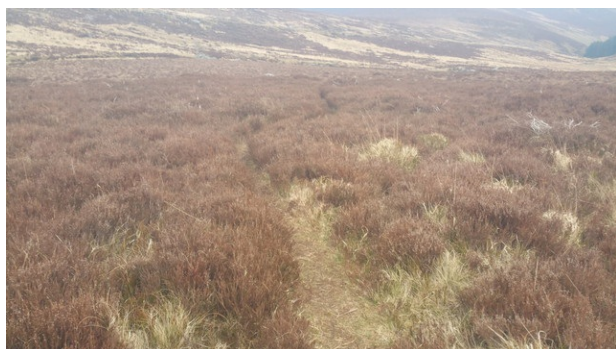
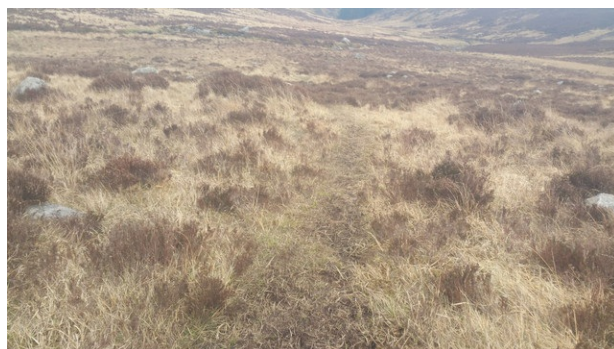
**Section description:** Section starts a stream crossing and crosses open ground to reach the main river. This appears to be a relatively new braid as a short cut back to the car park. Other braids exist on either side of the river and directly to the road

**Site Assessment:** Deep peat

| Work type | Estimated input | Work Summary |
|---|---|---|
| none | | None |

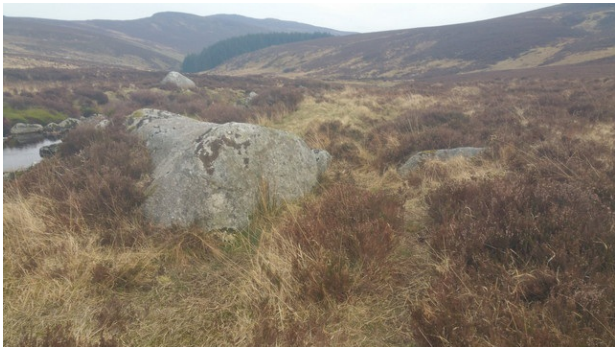
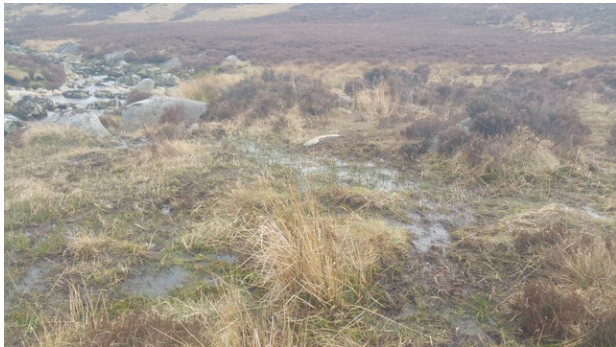
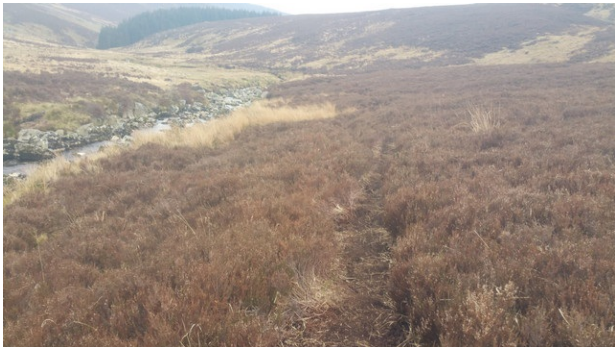
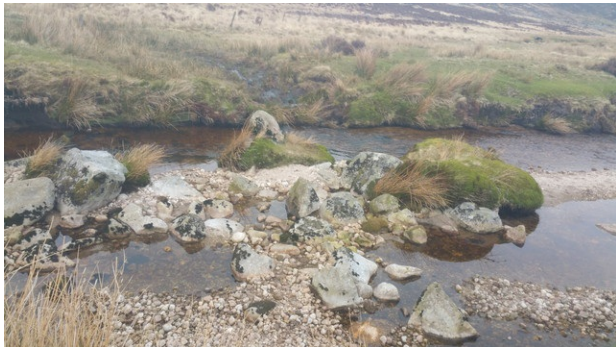
**Section description:** Section joins another braid at a large boulder by the river and continues to a crossing

**Site Assessment:**Deep peat

| Work type | Estimated input | Work Summary |
|---|---|---|
| none | | Would require full build of floated path or no intervention |
