# Tonelagee to Mullaghcleevaun

Survey date: Apr 21, 2021

Length: 5632m

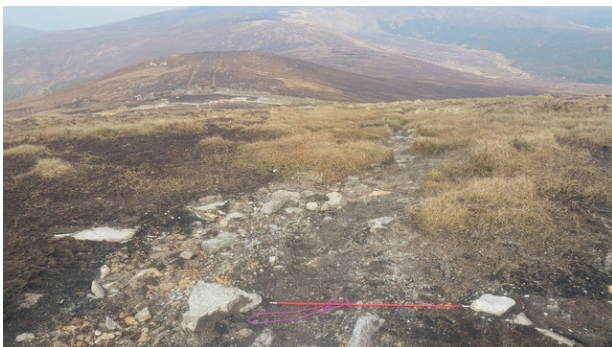
1619004543087.jpg - O 08578 02075 (± 3m)

**Site Assessment:**Relatively simple path work.

| Work type | Estimated input | Work Summary |
|---|---|---|
| none | 10 days labour | 10 water bars could be installed |

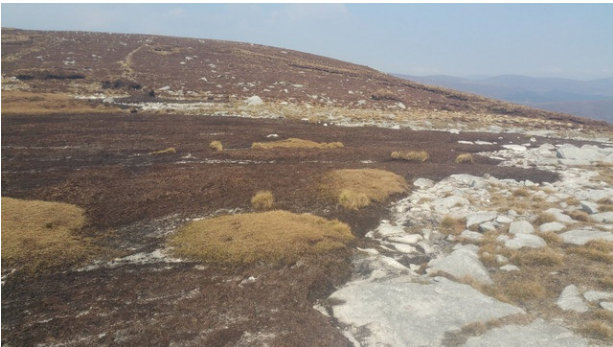
1619007248549.jpg - O 08374 02479 (± 3m)

**Site Assessment:**Major peat erosion issue dwarfs any path work

| Work type | Estimated input | Work Summary |
|---|---|---|
| none | | Peat restoration |

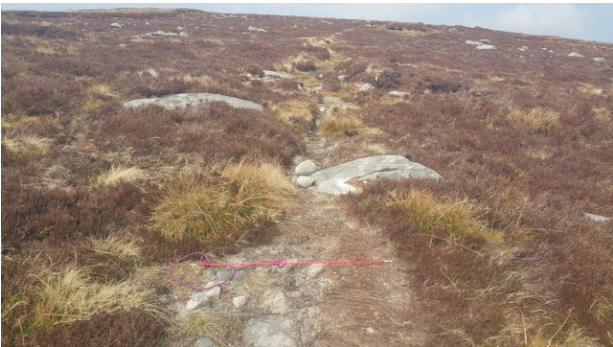
1619008074165.jpg - O 08340 02556 (± 9m)

**Site Assessment:** Could make this te main path.  
Avoids deeper peat to west

| none | 5 days labour | Drainage: 5 water bars if any work to be done |

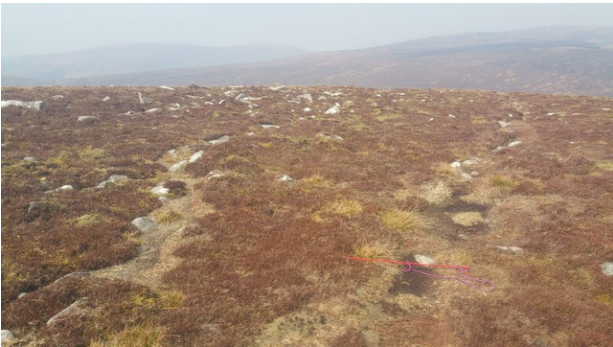
1619008817487.jpg - O 08268 02726 (± 3m)

Site Assessment:Grades slowly to horror

| none | | Not viable |

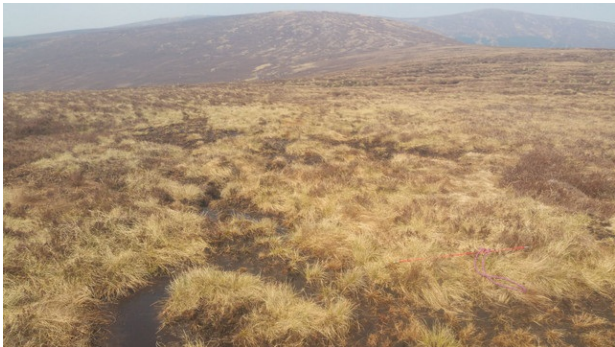
161901167949.jpg - O 08149 03177 (± 3m)

Site Assessment:Don't touch for recreation

| none | | Peat restoration project |

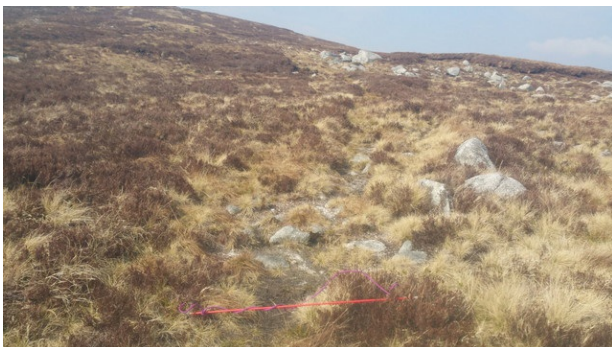
1619014553667.jpg - O 08028 04055 (± 9m)

**Site Assessment:** Remote site

| Work type | Estimated input | Work Summary |
|---|---|---|
| none | 5 days labour | Drainage: 5 water bars |

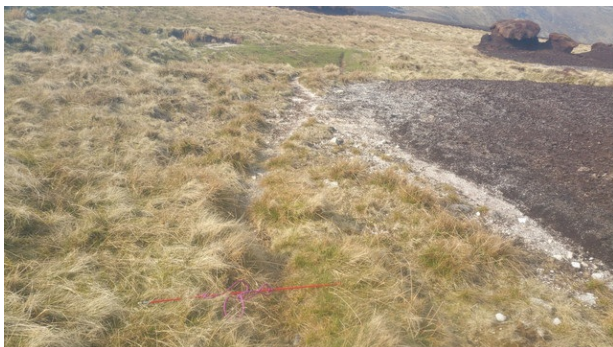
1619016665521.jpg - O 07712 04819 (± 3m)

**Site Assessment:**No path

| Work type | Estimated input | Work Summary |
|---|---|---|
| none | | Peatland restoration |

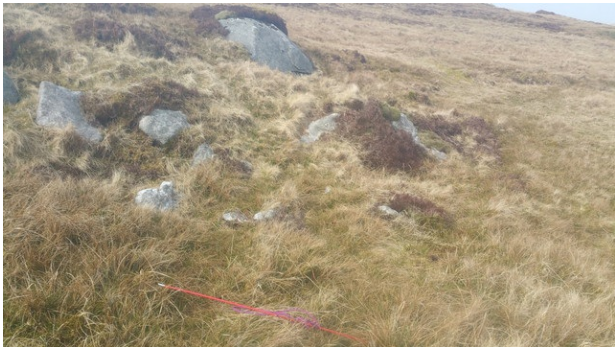
1619018588082.jpg - O 07481 05860 (± 3m)

Site Assessment:Dead bog

| none | | Peatland restoration |

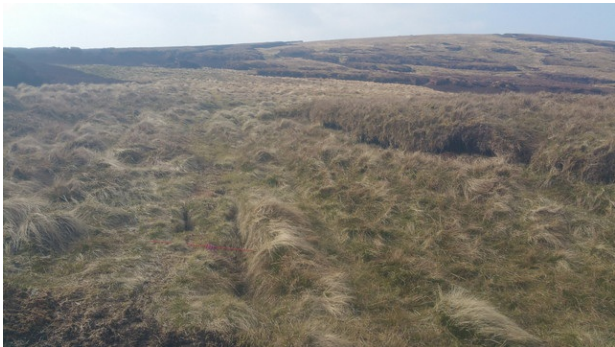
1619019676083.jpg - O 07394 06355 (± 3m)

Site Assessment:No Path

| none | | No path |
