# Two Rock approach

Survey date: Apr 30, 2021

Length: 800m

Sections: 5

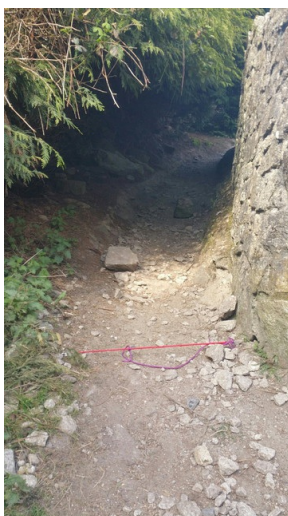
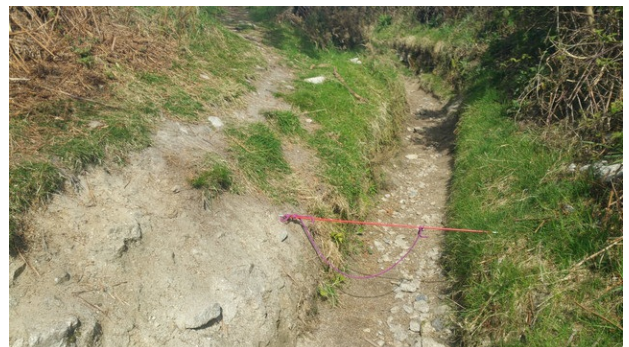
**Section description:** Start of path between residential gateways (constrained route) - heavily eroded with gullying.

Length (m)	Max gradient (%)	Min gradient (%)	Crossfall (%)
71	20	0	0

Substrate	Peat Depth (cm)
mineral_soil	0

Minimum	Maximum	Typical
Trampled width (m)	0.8	1	3
Bare width (m)	0.5	0.8	1.2
Eroded depth (m)	0.4	0.5	0.8

Work type	Estimated input	Work Summary
major_repair	20 days labour	Due to the restricted space and level of erosion this needs to be a full build or nothing - intermediate measures will be ineffective. Construct 1.5m wide path with landscaping. 70m Base and surface 3 water bars or grade reversals. Outlet for drains into forest

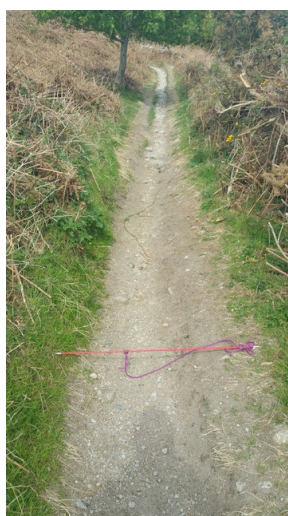
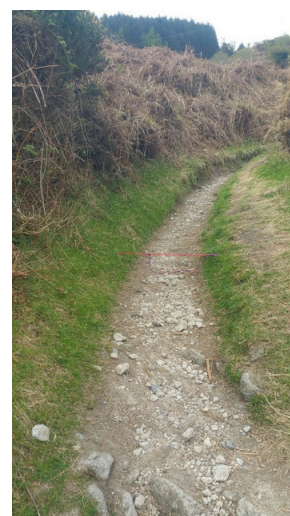
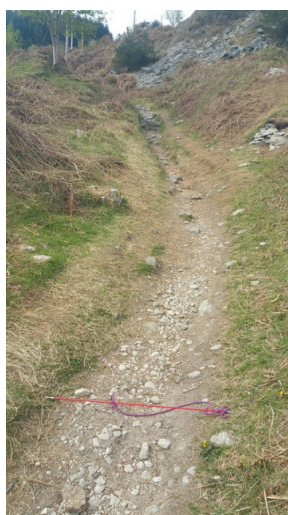
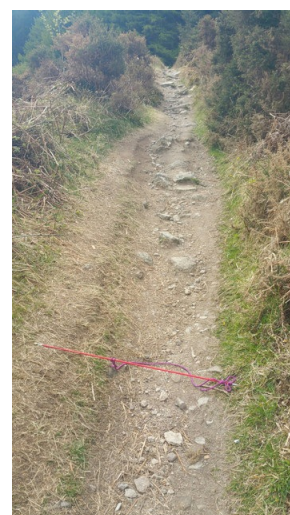
**Section description:** Section starts at junction with braid and zig-zags on slightly steeper gradient than section 1. Gullying of the route is significant. Sightlines are not good in places

Length (m)	Max gradient (%)	Min gradient (%)	Crossfall (%)
314	25	10	0

Substrate	Peat Depth (cm)
mineral_soil	0

Minimum	Maximum	Typical
Trampled width (m)	1	1.2	2.5
Bare width (m)	0.5	0.8	1.5
Eroded depth (m)	0.3	0.4	0.6

Work type	Estimated input	Work Summary
major_repair	75 days labour	Will require hardcore base with surfacing to produce 1.5m wide path. Approximately 30 anchor bars and 5m of pitching are needed along with 3 cross-drains on corners.

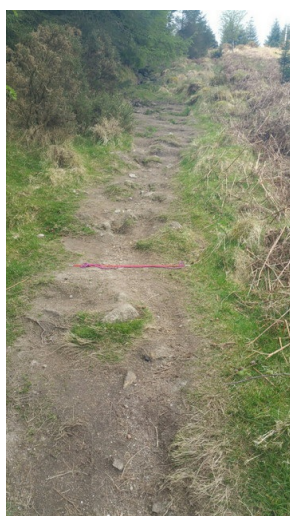
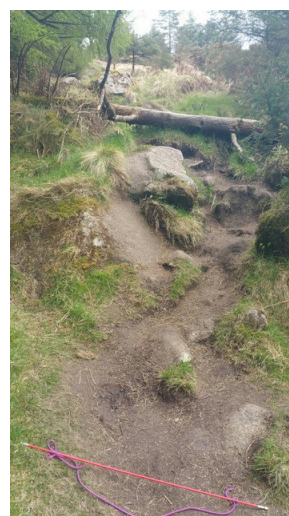
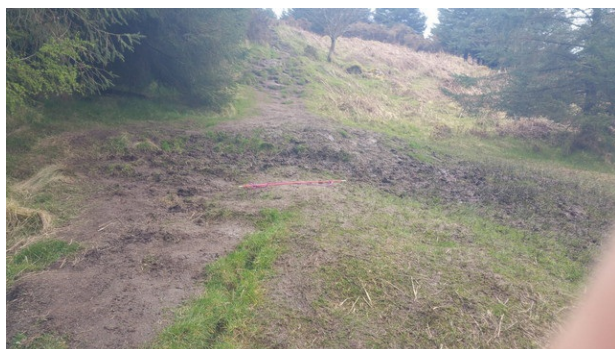
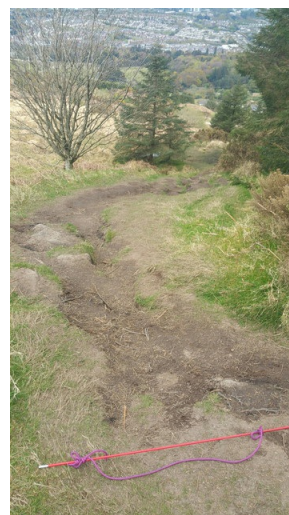
**Section description:** Section begins at vehicle track junction and follows the edge of plantation forestry directly upslope. One area of peaty / marshy ground

Length (m)	Max gradient (%)	Min gradient (%)	Crossfall (%)
157	45	30	0

Substrate	Peat Depth (cm)
mineral_soil	0

Minimum	Maximum	Typical
Trampled width (m)	1.5	2.5	6
Bare width (m)	0.5	1	2
Eroded depth (m)	0	0.2	0.6

Work type	Estimated input	Work Summary
part_repair	25 days labour for part repair or 110 days labour for full repair	As a minimum this section needs drainage and short surfaced section: 15m floating path over marsh 150m side ditch. For full repair this would require 50m pitch and 100m of mixed (70:30) pitching:aggregate

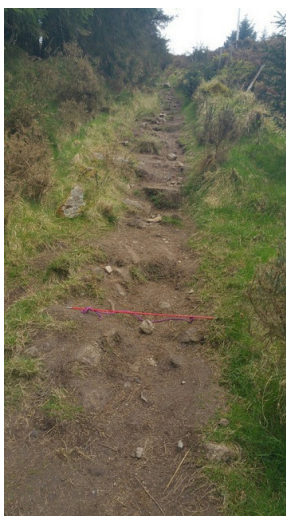
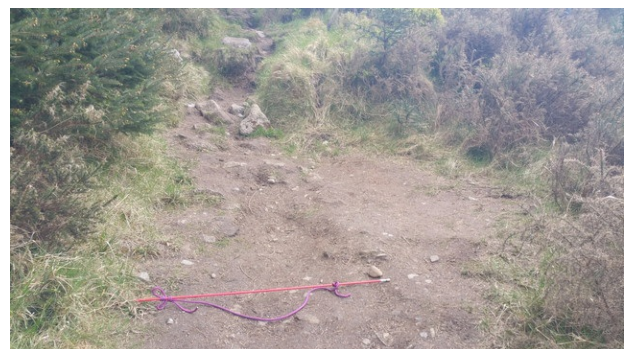
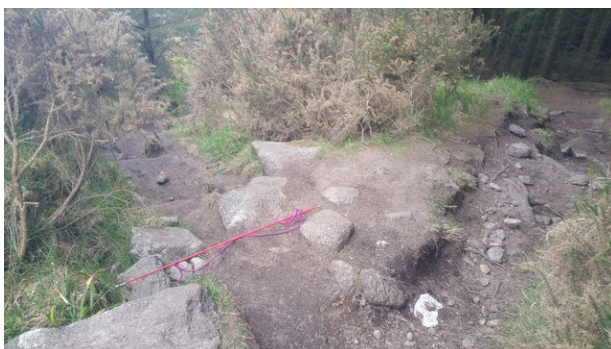
**Section description:** Section starts at Forest ride as far as the end of the plantation.

Length (m)	Max gradient (%)	Min gradient (%)	Crossfall (%)
79	40	25	0

Substrate	Peat Depth (cm)
mineral_soil	0

Minimum	Maximum	Typical
Trampled width (m)	1	1.2	2.5
Bare width (m)	0.5	0.8	2.5
Eroded depth (m)	0.2	0.3	0.4

**Site Assessment:** Access at forest ride. Fast mountain bike crossing part way. Measures needed to slow bikes.

Work type	Estimated input	Work Summary
early_intervention	10 days labour for early intervention or 45 for full upgrade	Deroughen the existing line and open sight line by informal mountain bike trail crossing. Full upgrade would be possible with mixed surfacing 70:30 pitch:aggregate

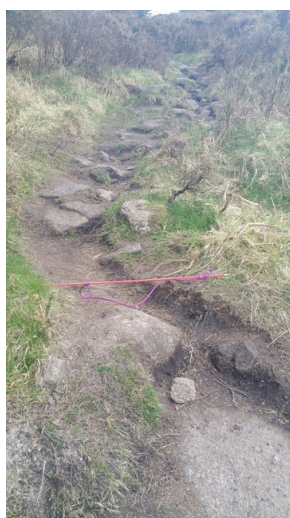
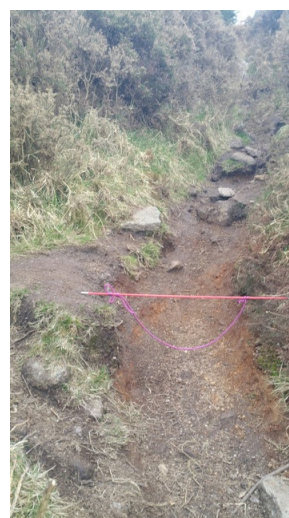
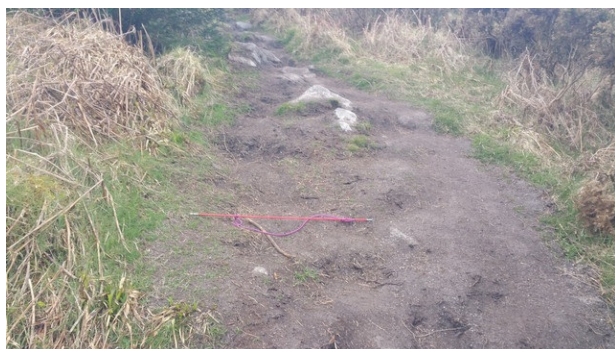
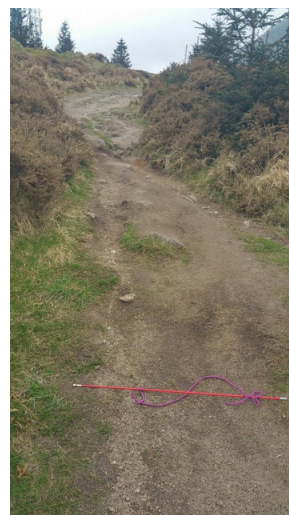
**Section description:** This section runs from a junction with another path to a vehicle track below the masts

Length (m)	Max gradient (%)	Min gradient (%)	Crossfall (%)
179	35	25	0

Substrate	Peat Depth (cm)
mineral_soil	0

Minimum	Maximum	Typical
Trampled width (m)	0.8	1.5	4
Bare width (m)	0.5	0.8	1.5
Eroded depth (m)	0	0.3	0.5

Work type	Estimated input	Work Summary
none		Path is reasonably stable so is not requiring urgent work. Full upgrade would involve aggregate surfacing and anchor bars (40 days labour)
