# Two Rock and Three Rock Mountains

Survey date: Apr 30, 2021

Length: 2230m

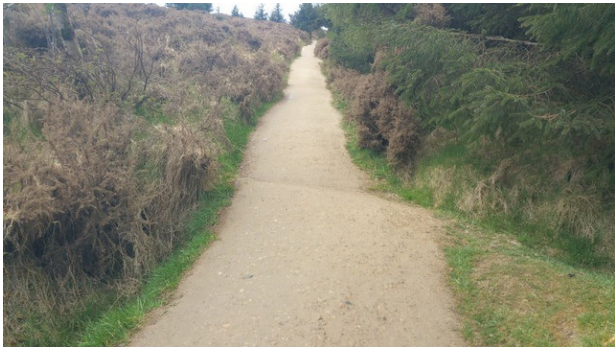
1619781748055.jpg - O 17552 23186 (± 9m)

**Section description:** Constructed section of mixed pitching and aggregate that runs adjacent to forestry plantation. Low gradient for pitching and some users are avoiding the pitching.

Minimum	Maximum	Typical
Trampled width (m)	1	1.2	4
Bare width (m)	1	1.2	2
Eroded depth (m)	0	0	0.1

Work type	Estimated input	Work Summary
minor_repair	4 days labour	Adjust start. Install culvert by barrier to stop erosion of surface. Extend barrier to secure the path

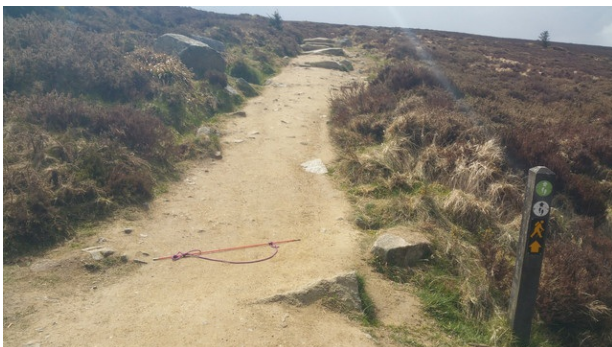
1619783013619.jpg - O 17413 22858 ( $\pm 9\text{m}$ )

Section description: End of plantation

Minimum	Maximum	Typical
Trampled width (m)	1.5	2	4
Bare width (m)	1.5	1.8	2.5
Eroded depth (m)	0	0.1	0.2

Work type	Estimated input	Work Summary
part_repair	30 days labour	Resurface 250m and adjust 10 anchors

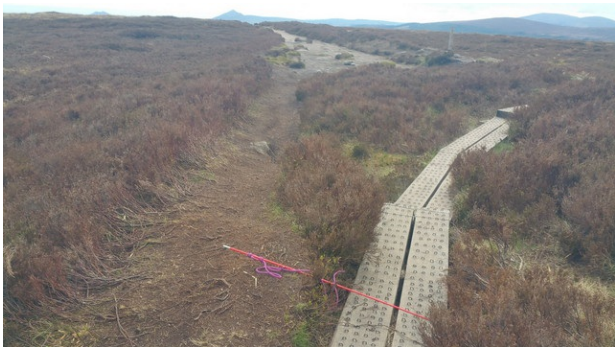
5 1619784432706.jpg - O 17230 22383 (± 4m)

**Section description:** Section starts at summit of Two Rock Mountain and runs across the plateau. Low gradient means that this section is relatively stable.

Minimum	Maximum	Typical
Trampled width (m)	3	4	16
Bare width (m)	2	2.5	3.5
Eroded depth (m)	0.2	0.2	0.5

Work type	Estimated input	Work Summary
Light_touch	5 days labour	50m line definition and landscaping to reduce the width of the path

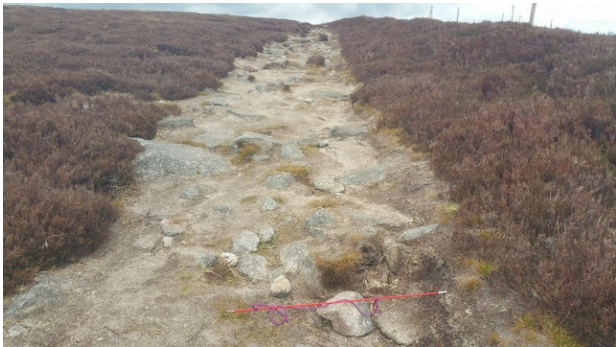
1619785613678.jpg - O 17536 22047 (± 9m)

**Section description:** Section starts at path junction and runs north along a cross slope.

Minimum	Maximum	Typical
Trampled width (m)	1.5	2.5	4
Bare width (m)	1.2	2.5	3
Eroded depth (m)	0.1	0.2	0.3

Work type	Estimated input	Work Summary
Light_touch	30 days labour	Drainage (4 cross drains and 200m ditch) and line definition

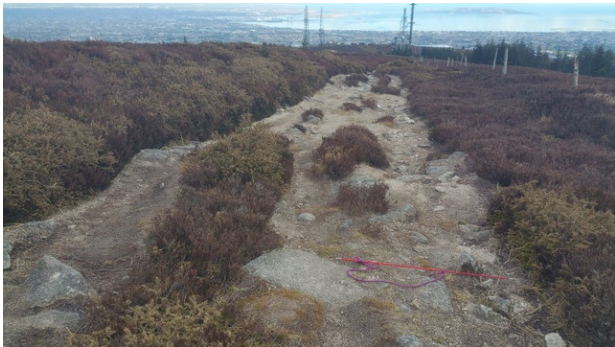
1619786477469.jpg - O 17425 22558 (± 7m)

**Section description:** Section starts at corner and where there is an increase in gradient. Informal path with exposed boulders.

Minimum	Maximum	Typical
Trampled width (m)	1.5	3	4.5
Bare width (m)	1	2.5	3.5
Eroded depth (m)	0.1	0.2	0.4

Work type	Estimated input	Work Summary
Light_touch	20 days labour	Drainage (10 water bars) and line definition / deroughening

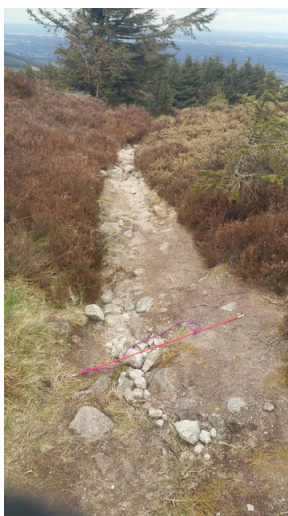
1619787875487.jpg - O 17454 22804 ( $\pm 8\text{m}$ )

Section description: Junction and trees

Minimum	Maximum	Typical
Trampled width (m)	0.3	0.5	2.5
Bare width (m)	0.3	0.5	1.5
Eroded depth (m)	0.2	0.2	0.5

Work type	Estimated input	Work Summary
early_intervention	10 days labour	Drainage: 5 water bars and side drain 1 cross drain
