# Wicklow gap to Tonelagee

Survey date: Apr 21, 2021

Length: 1796m

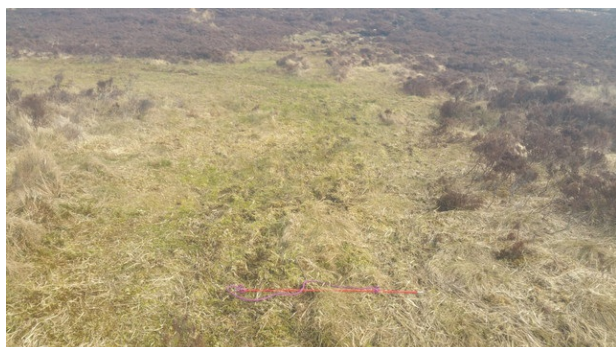
1618996088098.jpg - O 07632 00219 ( $\pm 3m$ )

**Section description:** Roadside - the section heads directly up the slope towards the summit - there are a number of different lines that have developed.

Minimum	Maximum	Typical
Trampled width (m)	1	2	10
Bare width (m)	0	1	4
Eroded depth (m)	0	0.1	0.6

**Site Assessment:** Ditch by roadside is an access blocker

Work type	Estimated input	Work Summary
early_intervention	5 days labour	Deep peat in places along this section means that construction of a path could be challenging. Some small scale interventions to keep water away from the path line where there is minimal peat could be useful. This is highly visible so any path work would be likely to attract attention and therefore increase use.

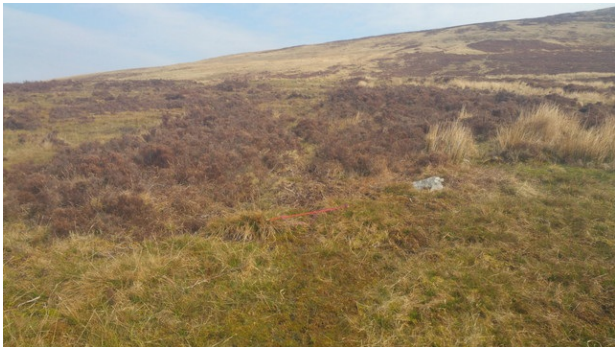
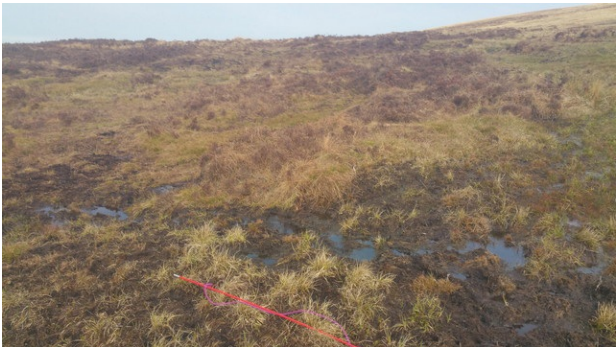
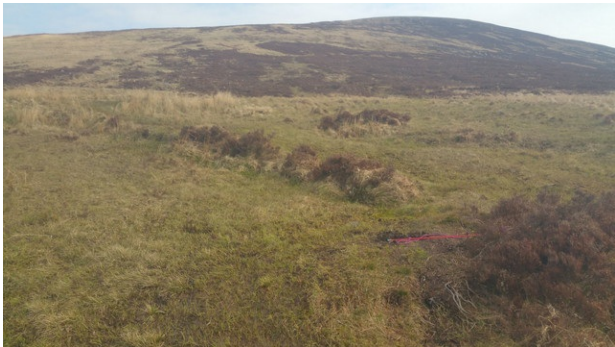
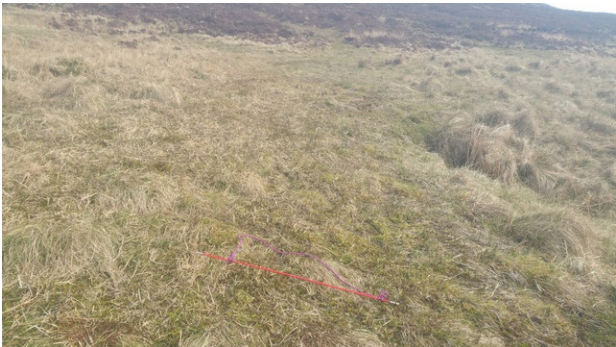
**Section description:** Section starts at a break in slope and continues across deep wet peat. Brading and spreading around wet areas

Minimum	Maximum	Typical
Trampled width (m)	5	7	20
Bare width (m)	0	0	1
Eroded depth (m)	0	0	0.1

**Site Assessment:**Wet peat

Work type	Estimated input	Work Summary
none		Deep peat means that any work would need to be 'floated' - this is possible with the gradient but may not be desirable due to proximity to the road.

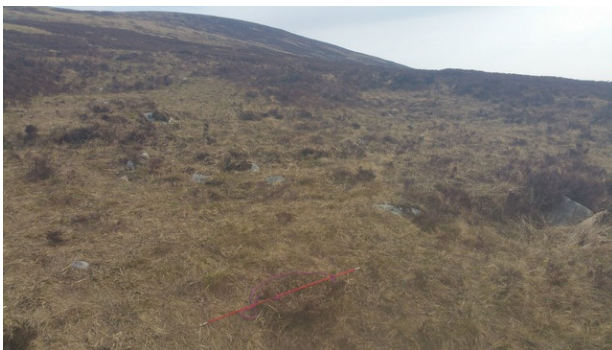
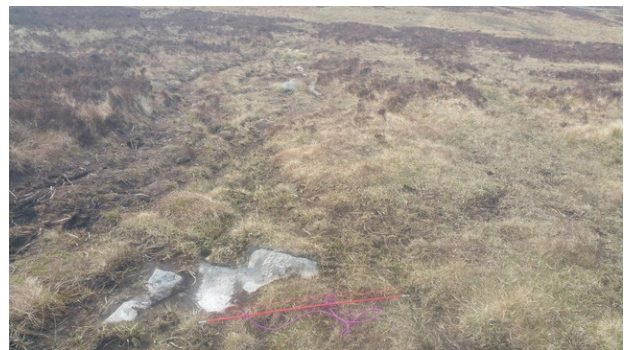
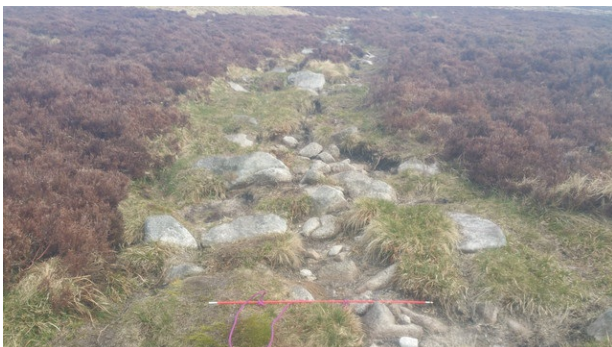
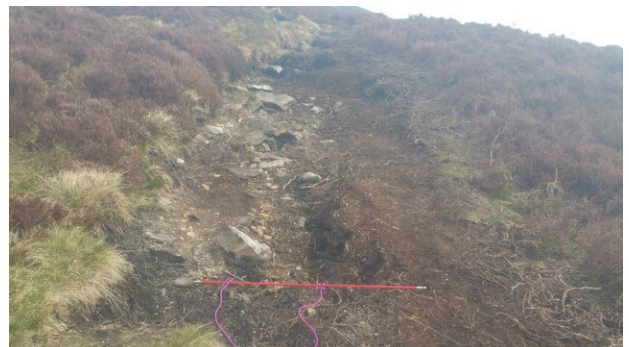
Section description: Section starts at increase slope - there are multiple choices of line but one active

Minimum	Maximum	Typical
Trampled width (m)	1.5	2	5
Bare width (m)	0	0.8	2
Eroded depth (m)	0	0.1	0.2

**Site Assessment:** Some variability of peat depth within section

Work type	Estimated input	Work Summary
early_intervention	15 days labour	Drainage to reduce flow of water on the path could be undertaken - this would slow the deterioration of the route but needs to be done with low visibility. 5 water bars required; steep section would benefit from 10m of pitching.

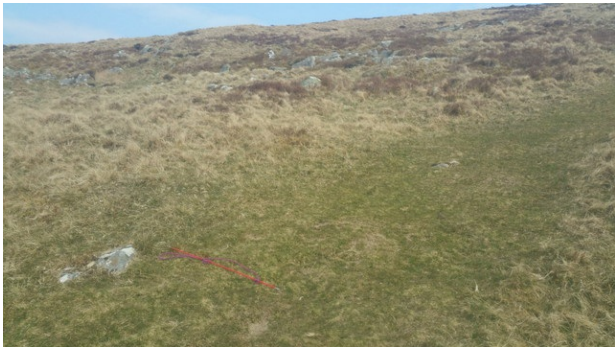
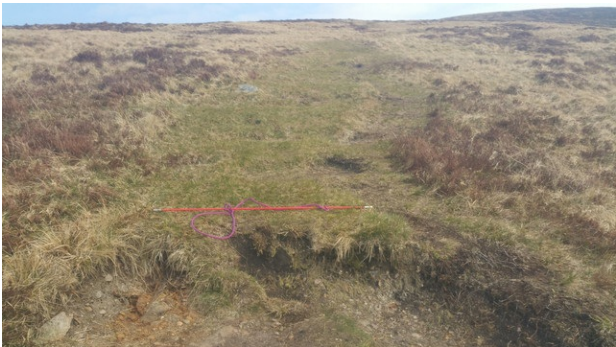
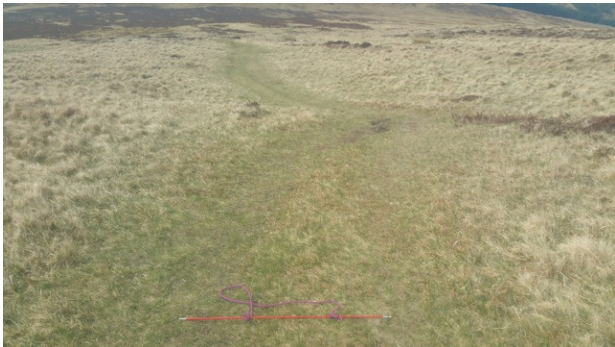
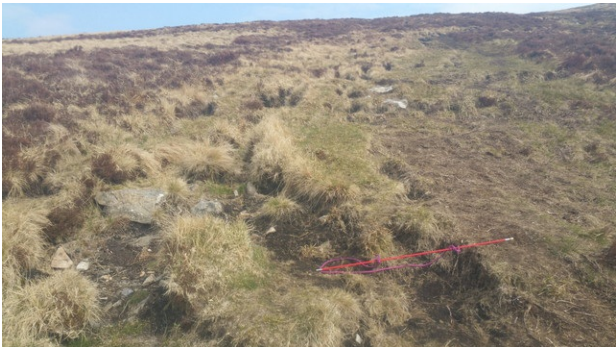
**Section description:** Section starts adjacent to boulder scree and is a well defined line. In places the vegetation layer is breaking down

Minimum	Maximum	Typical
Trampled width (m)	1	1.5	4
Bare width (m)	0	0	1.5
Eroded depth (m)	0	0	0.2

**Site Assessment:**Variable damage along section

Work type	Estimated input	Work Summary
early_intervention	10 days labour	Deflection of surface water would help slow the deterioration of the vegetation layer - 10 water bars

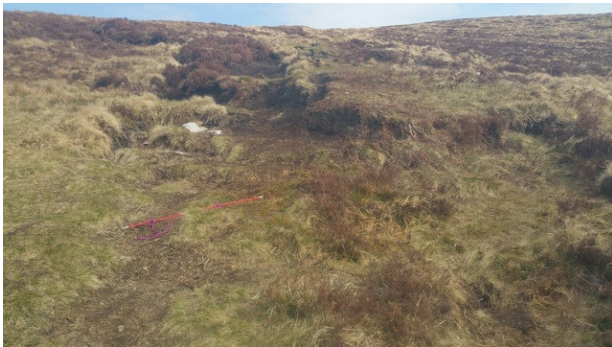
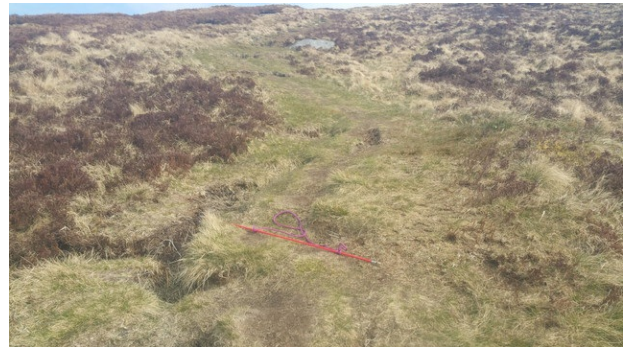
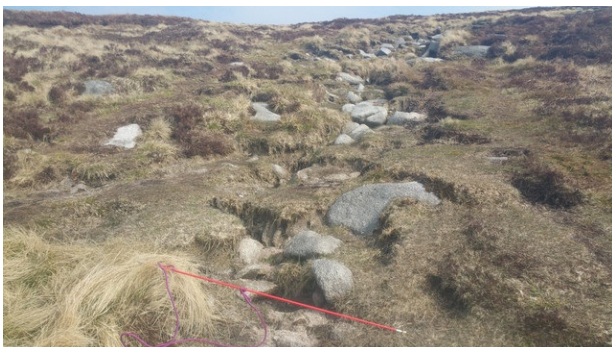
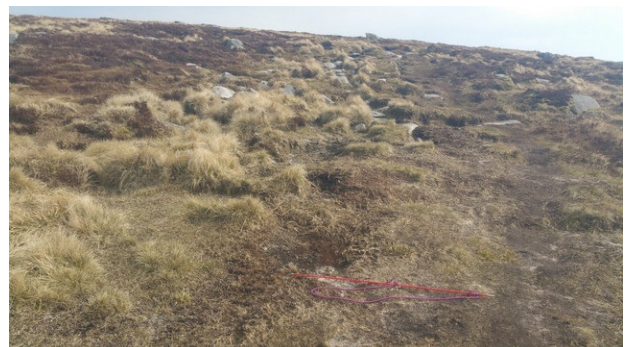
Section description: Section starts at the 'leading edge' of a large peat hag and continues straight up the slope.

Minimum	Maximum	Typical
Trampled width (m)	1.5	2	5
Bare width (m)	0	0.8	2
Eroded depth (m)	0	0.1	0.3

Work type	Estimated input	Work Summary
early_intervention	10 days labour	Deflection of surface water - 10 water bars. Careful selection of a route avoiding peat could be helpful to reduce peat erosion.

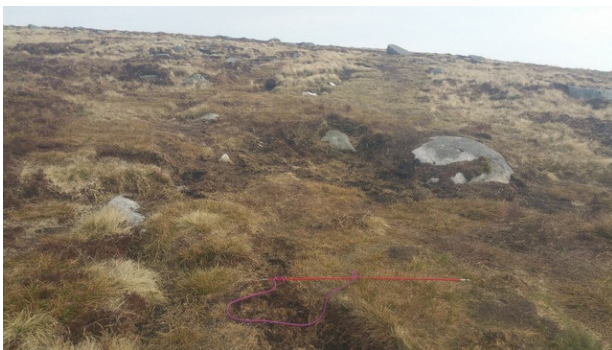
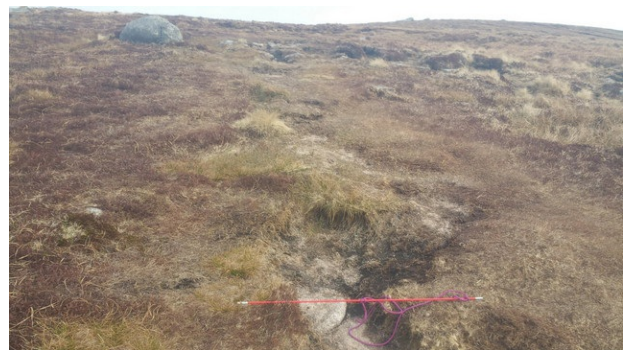
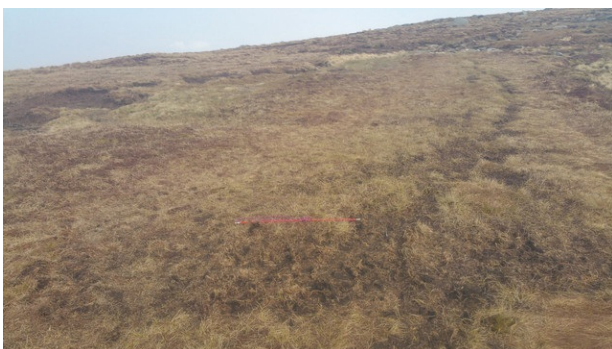
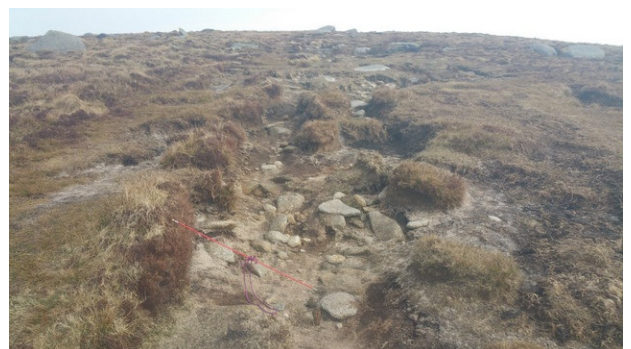
Section description: Section starts at a distinctive pointy boulder by path and is a slightly shallower slope

Minimum	Maximum	Typical
Trampled width (m)	2.5	3	7
Bare width (m)	0	0.5	2
Eroded depth (m)	0	8	0.6

Work type	Estimated input	Work Summary
Light_touch	20 days labour	Some line definition and subtle drainage would help to reduce the impact of walkers
