Ballybeg Commonage

2020 Ecological Survey

Final Report

21st April 2021

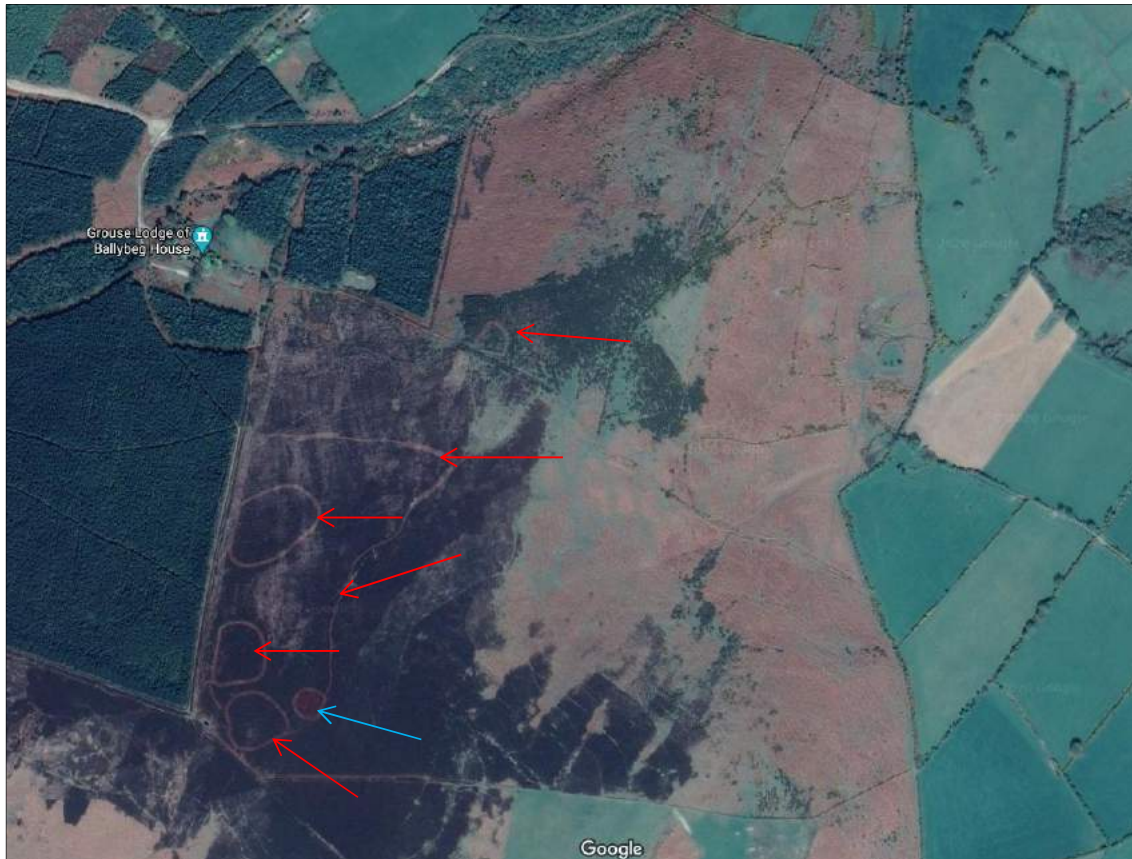
A number of firebreaks for controlled burning were created on the 26th February 2019 on the hillside using a flail mulcher behind a tractor. These can be seen in the Bing Maps imagery of the commonage as presented on **Figure 1** below.

Figure 1. New firebreaks cut on Ballybeg in 2019 (Bing Maps). The area which was burnt in 2019 is indicated by the blue arrow.

One area was burnt on 28th February 2019. The burning here appeared to be very intense and uniform compared with what was done on Glasnamullen which allowed some areas to have remained unburnt. The burn here may have been too intense as there are large areas of bare peat (this may be what was beneath the leggy heather if no bryophyte (moss) layer was present and had been shaded out by the tall heather).

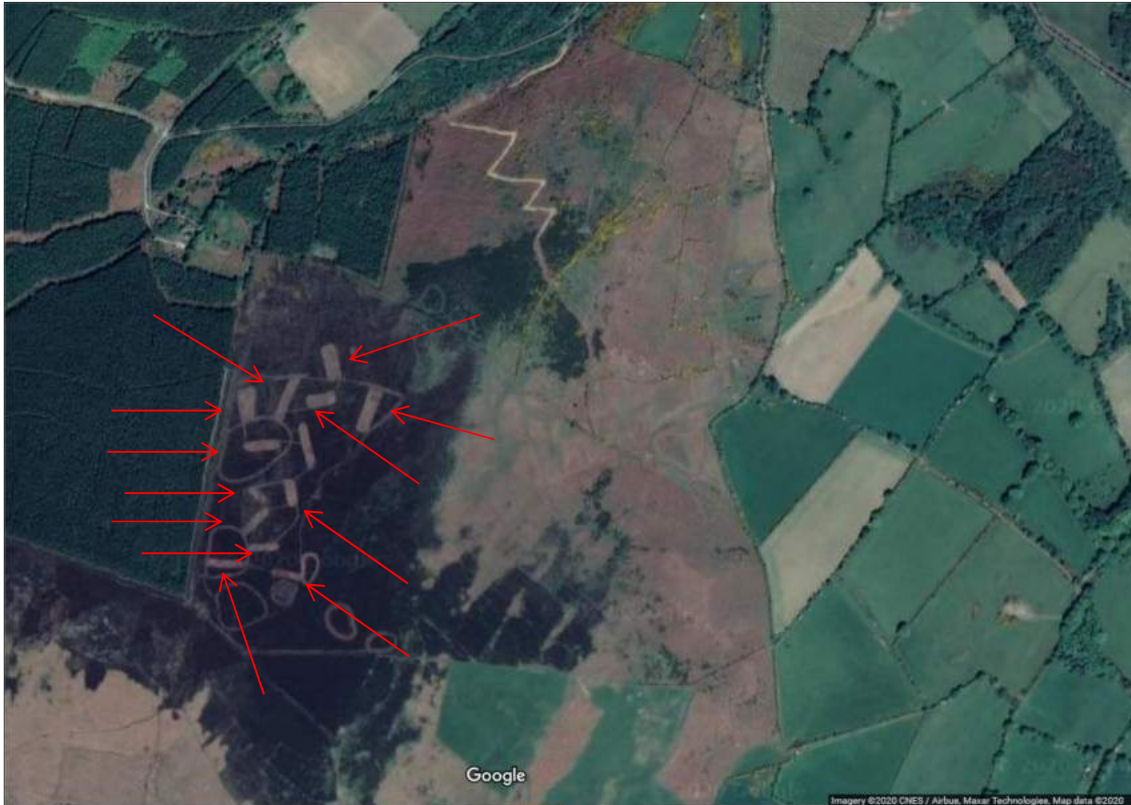
New areas of habitat were mulched using a tractor mounted mulcher on 18th February 2020 as can be seen on **Figure 2** below. There was no weather available to do any controlled burning.

Figure 2. New areas cut in 2020 (Google Maps).

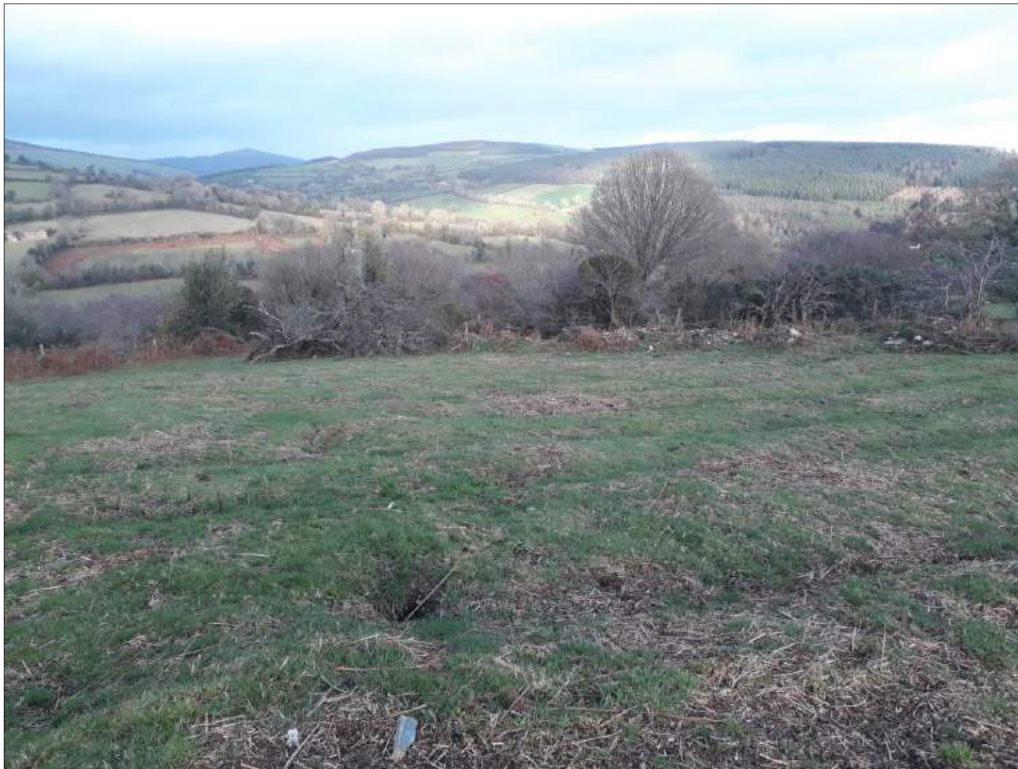
Plate 6. Bracken control in Area 19 in 2020.

It is therefore recommended that another session of bracken bruising in early summer followed by a second session of bracken bruising at the end of the summer in 2021 will help to inform the long term outcome of using this non-chemical technique.

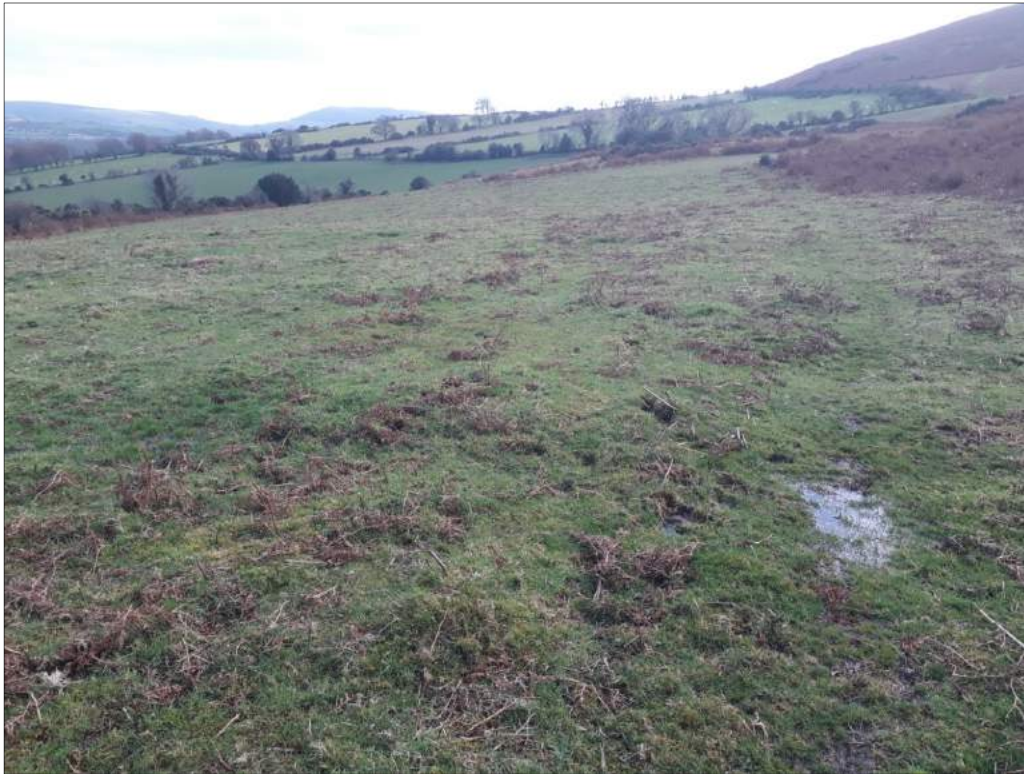
Plate 7. Bracken control in Area 8 in 2020.

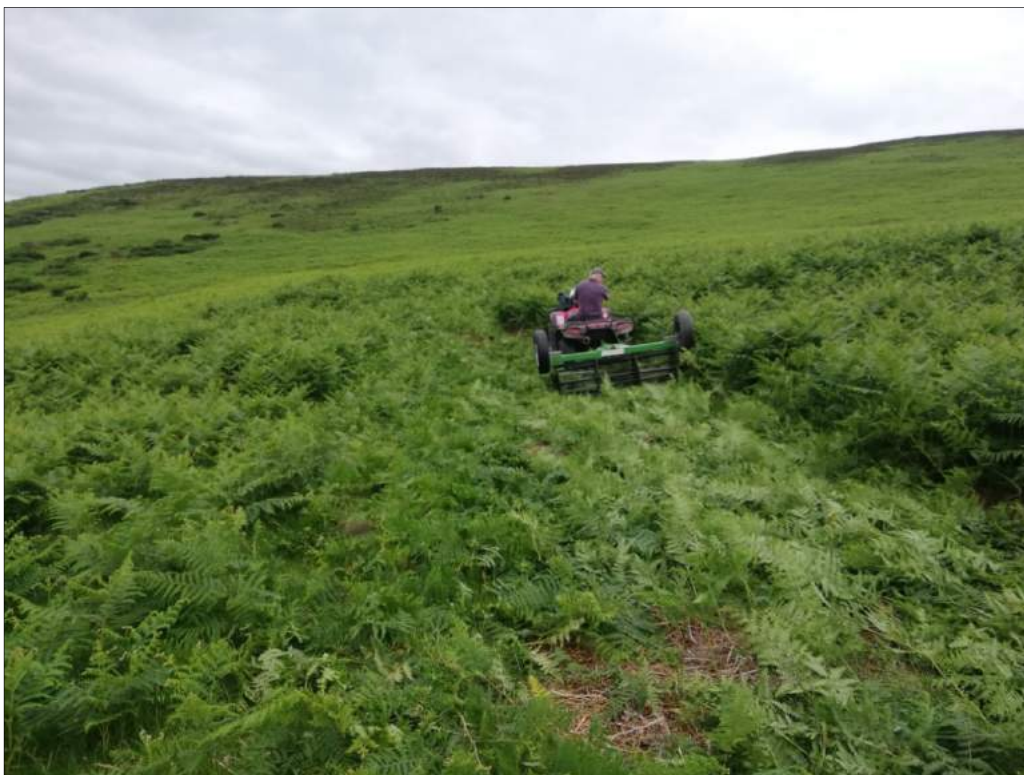
Plate 8. Bracken bruiser in operation in Area 27 in 2019 showing previous density of bracken on these slopes.

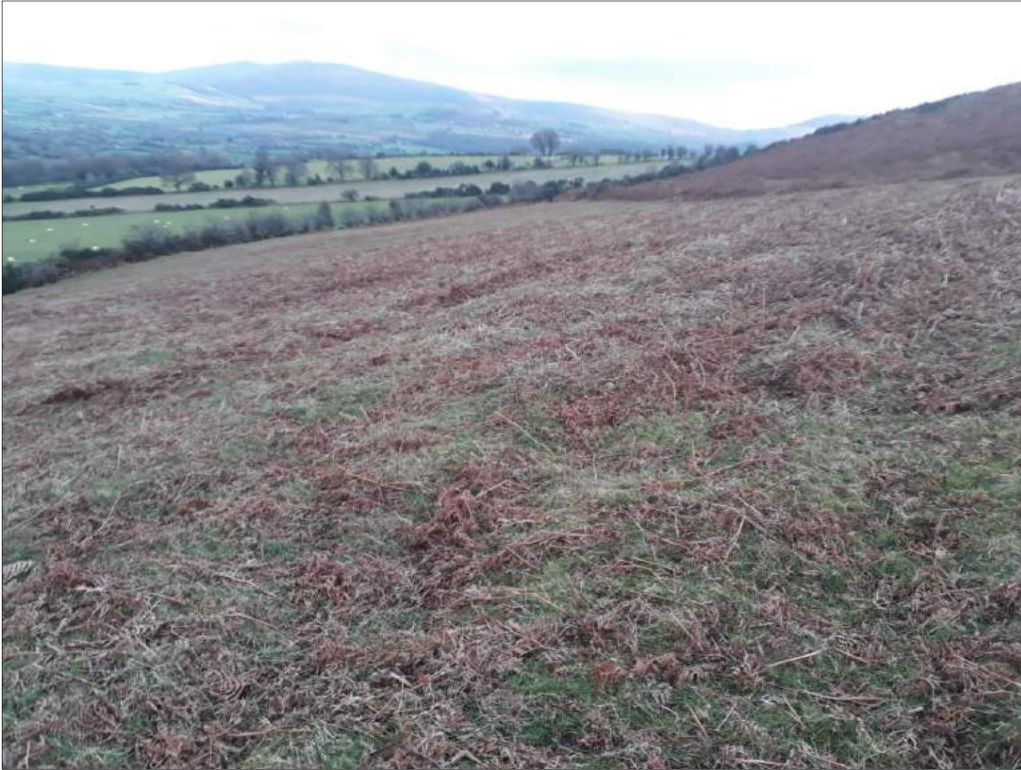
Plate 8. Bracken control in Area 27 in 2020 following the use of the bracken bruiser.

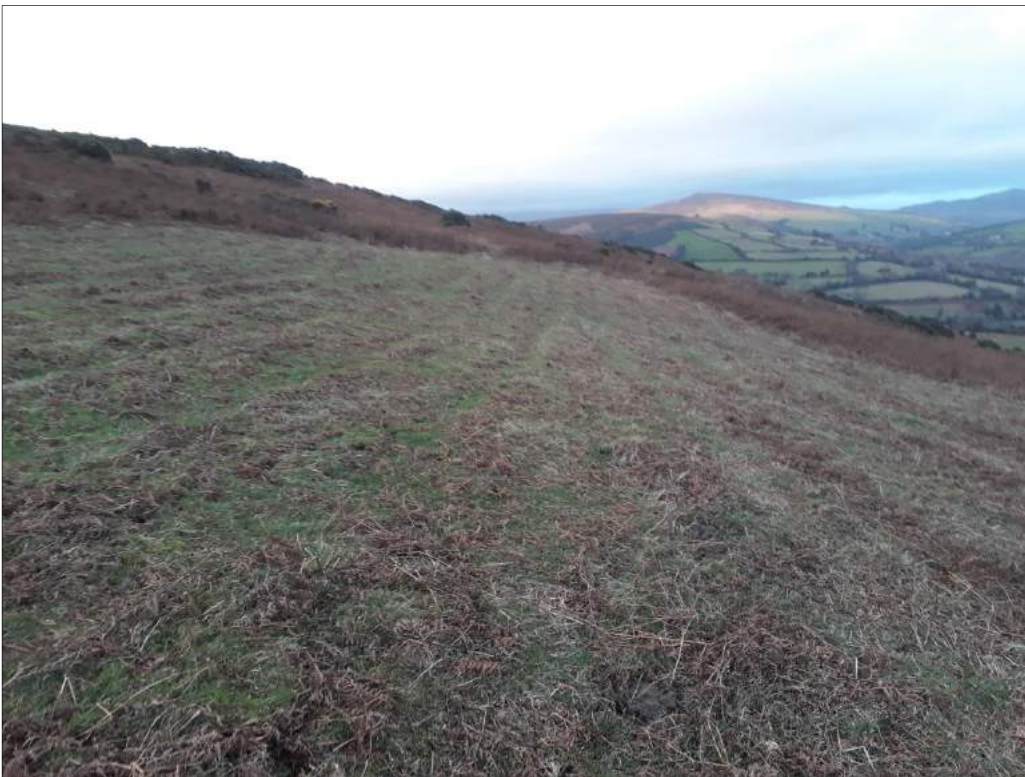
Plate 9. Bruised v's unbruised areas in Area 27 in 2020 – exposing lazy beds on the hill previously visually obscured at this time of year.

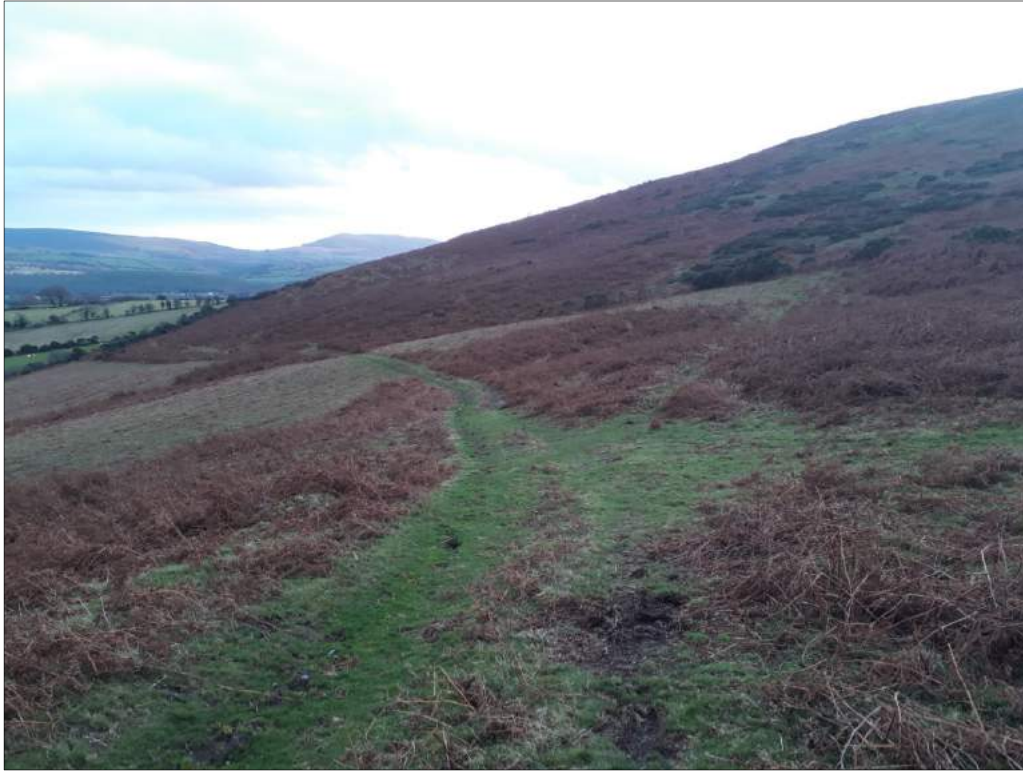
Plate 10. Bracken control on the upper valley slopes will continue in 2021 and the treatment/control measure used will be influenced by the results from 2019/2020.

Areas should also be trialled for cutting – this could apply to some of the upper slopes where a machine cannot travel and where native non-invasive ferns are present, which should not be sprayed.

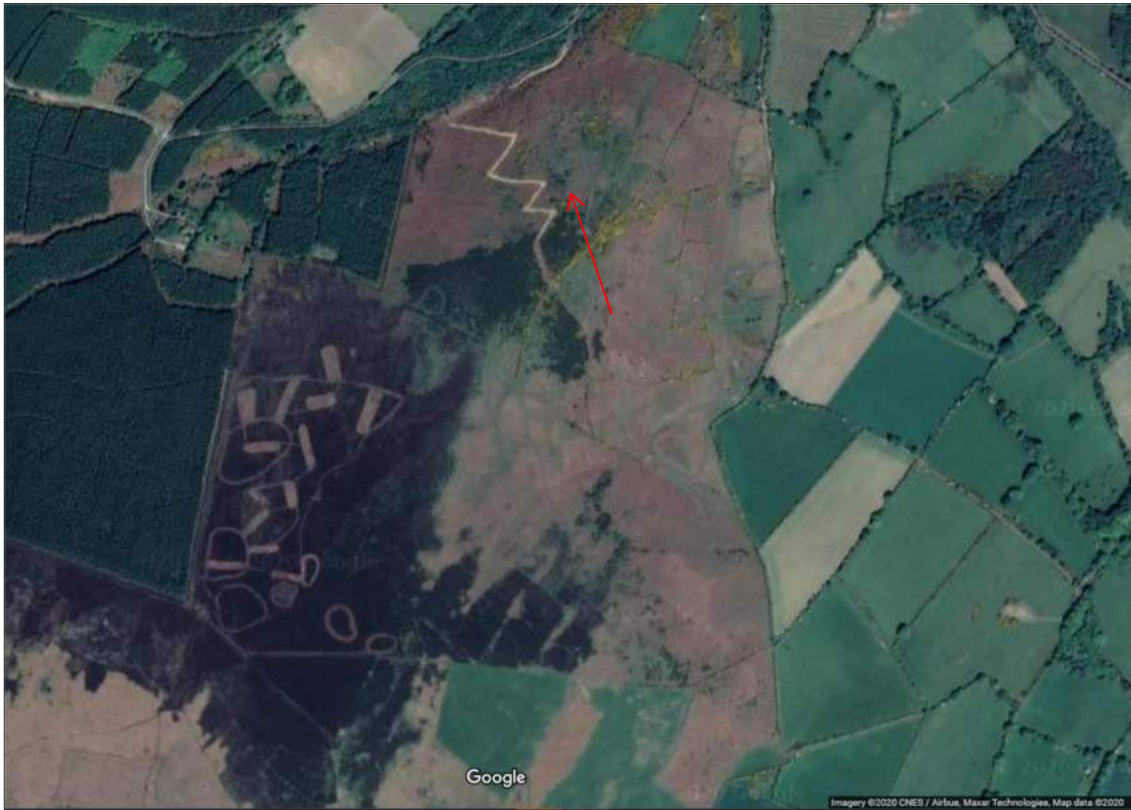
This track can be clearly seen on the Google Maps imagery for the commonage as shown on **Figure 3** below. This track was inspected from the perspective of ecology on 11th May 2020. The results of that inspection are presented in **Appendix 2**.

- Damaged areas of habitat across the commonage must be reinstated,
- Siltation risk to the Ballycumber Stream with subsequent impacts on water quality and fisheries habitat must be remediated,

A programme of remediation works was then agreed with members of the SUAS steering group who also inspected the impacts of the new track. These works are not yet complete. To date water bars have been installed, the drains blocked in the floodplain and the grass seeding was done in 2020. The

willow wattle fencing and tree planting has not yet been completed. On completion all the works will then be assessed.

Figure 3. New track (Google maps).

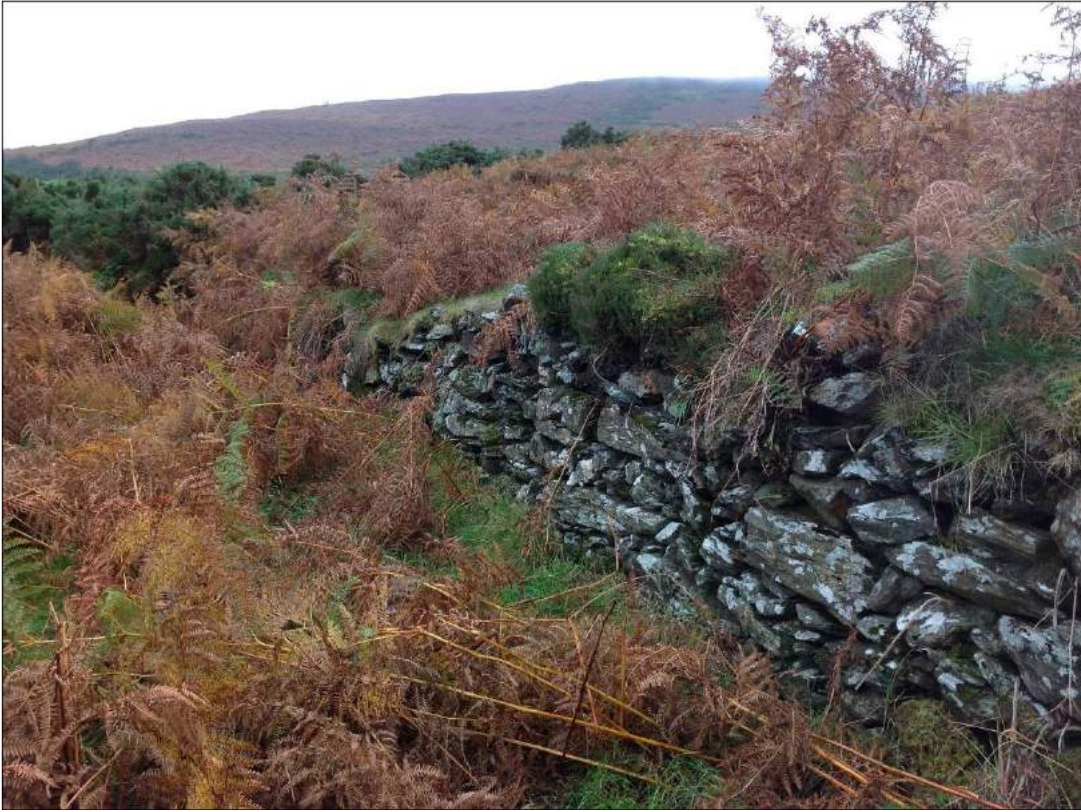
Stone faced bank on the commonage - recorded in 2018. Note rich lichen communities.

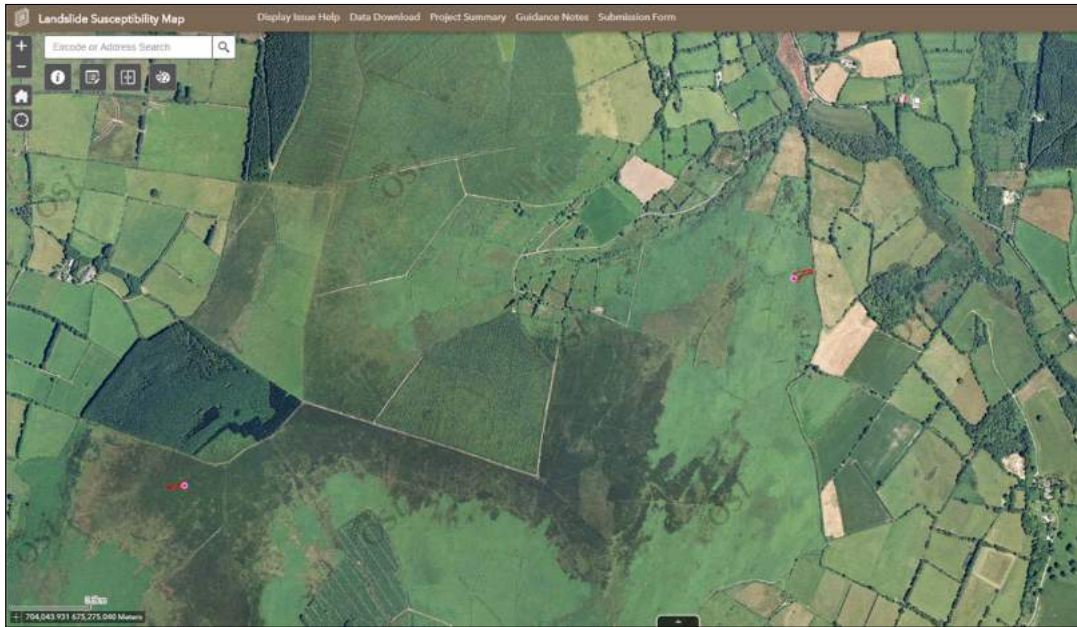
The Geological Survey of Ireland have mapped a historic landslide event on the commonage and the north western facing slopes of the commonage above the Ballycumber Stream are mapped as high risk on their landslide susceptibility mapping as shown below.

Historic landslide event within the Ballybeg Commonage (Source: GSI).

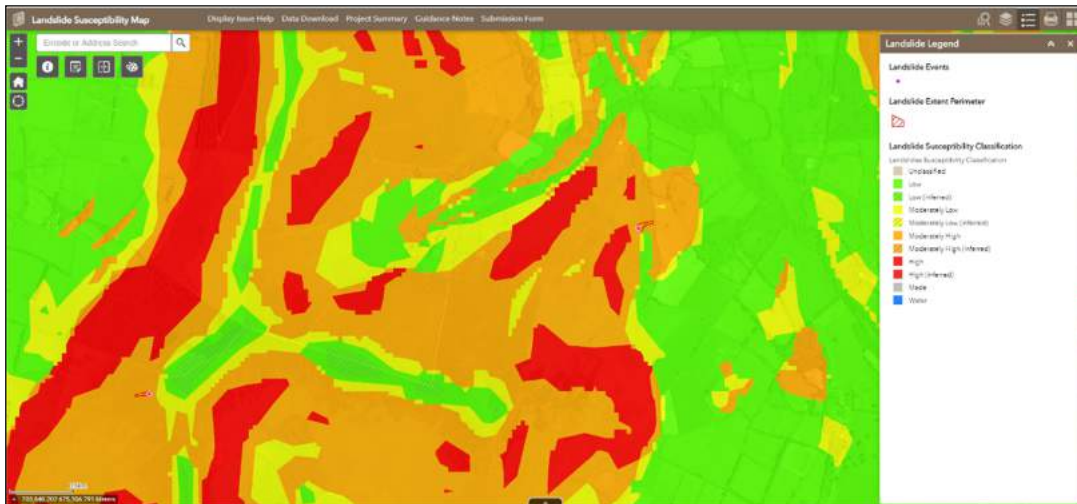
These slopes are mapped as having a high susceptibility to landslides by the GSI.

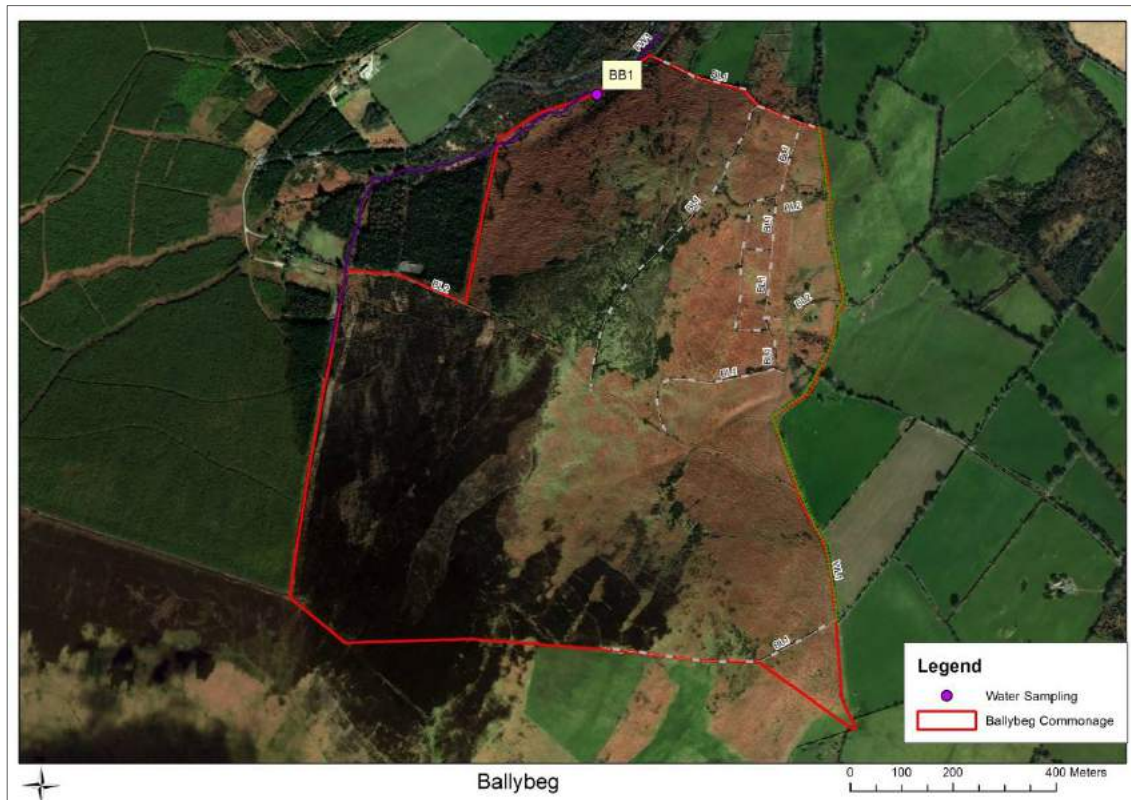
‘A water sample was taken on the Ballycumber South Stream in February 2019 at one sampling location as shown on **Figure 5** below. This location was chosen as the other areas of the watercourse in the commonage adjoin a conifer plantation (WD4). The water sample was assessed by Carl Dixon. The Ballycumber South Stream (BB1) was assessed as ‘Indeterminate – may be at risk of not achieving ‘Good’ water quality status ‘.

Figure 5. Water quality sample location at Ballybeg.

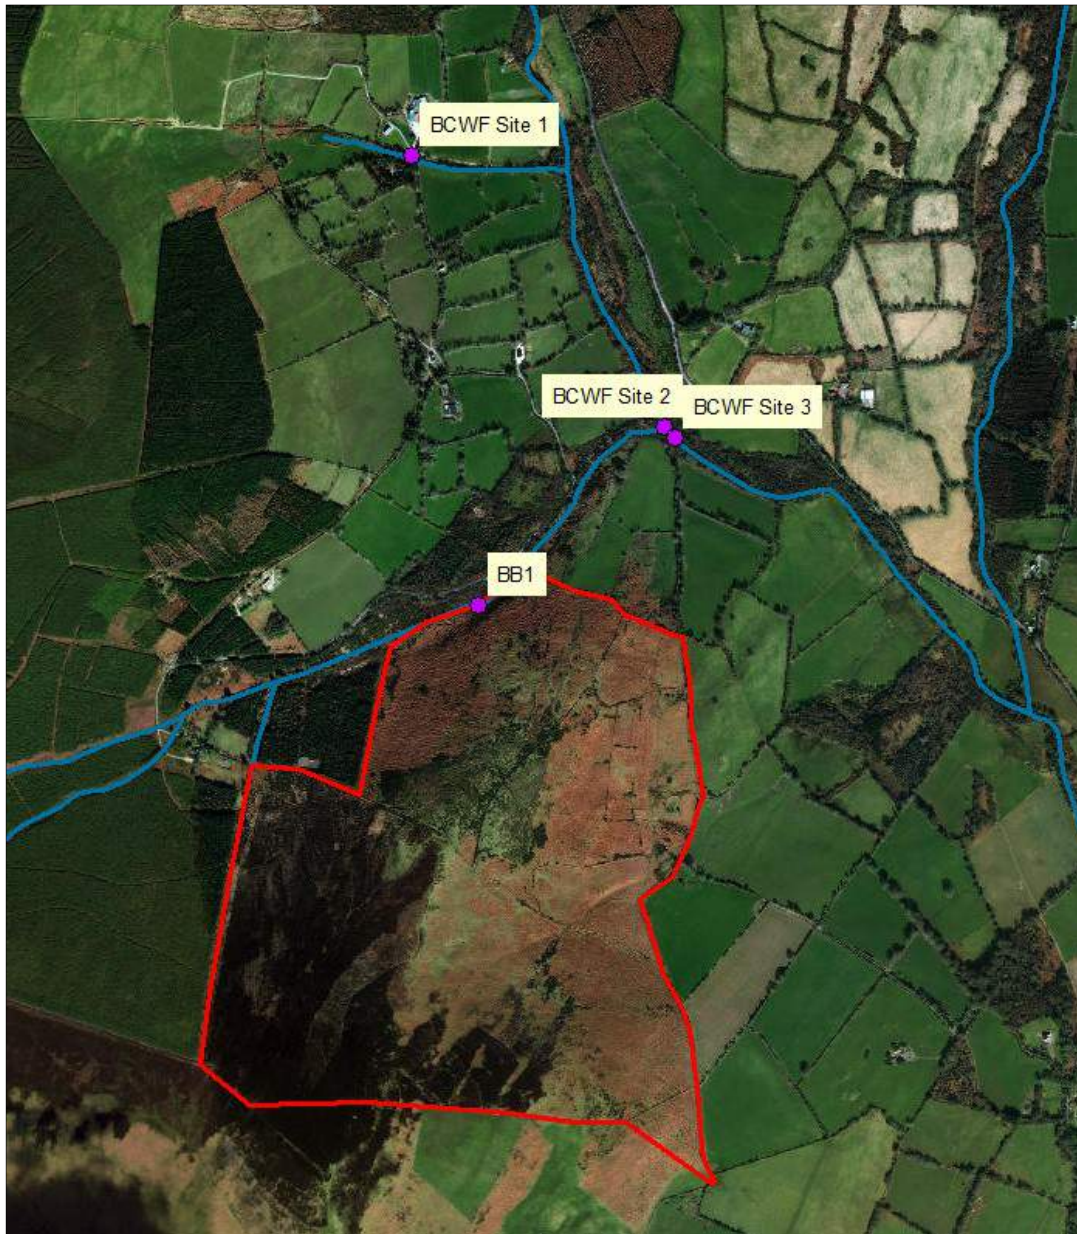
These results show a decline in biological water quality from 2009 to 2012 at the three sites where the Q-scheme can be applied. The drop to Q3-4 at the bridge at Tinahealy on the Derry River was also reported by EPA in 2010 (Appendix 3).

This water sampling shows that Stream 2, which is the stream coming off the Ballycumber Ridge and through the commonage, has shown a decrease in water quality from Q4-5 in 2009 to Q4 in 2012.

Figure 6. Water sampling locations associated with the Ballycumber Windfarm near Ballybeg Commonage. Site 2 is located downstream of the commonage on Ballycumber Stream South.
