Glassavullaun Commonage

2021 Ecological Survey

Final Report

1st October 2021

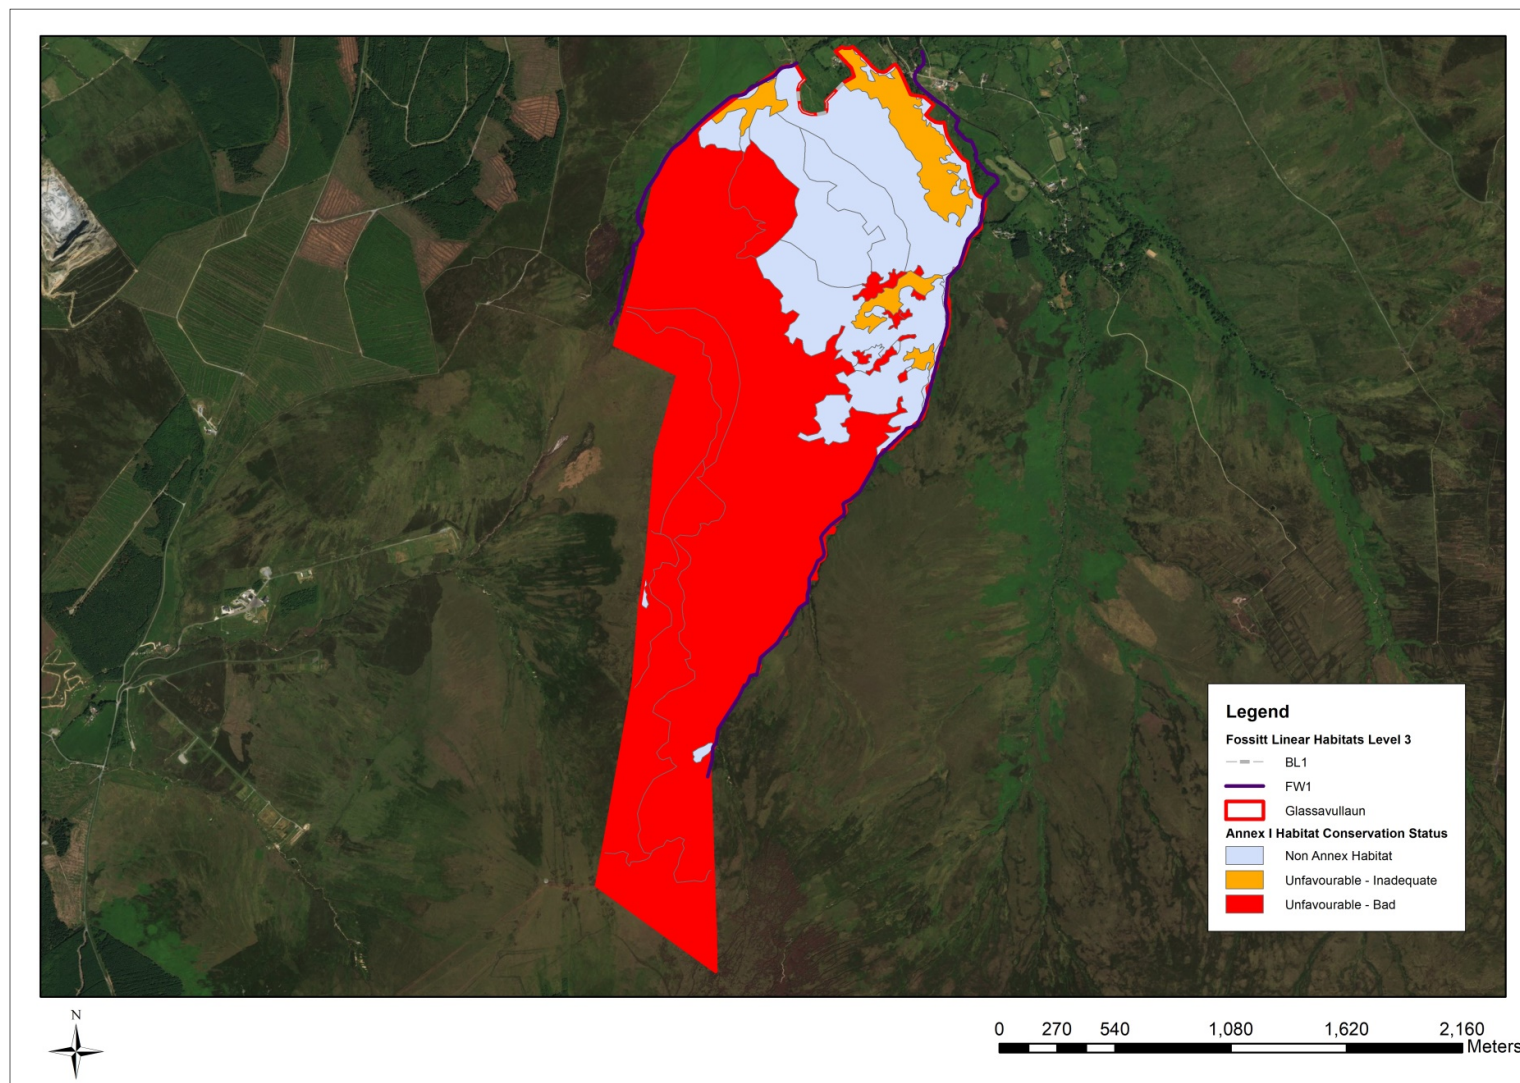
Figure 3. Habitat Condition Assessment for Glassavullaun Commonage.

The extent of habitats present within the commonage and their affinities to either Fossitt (Level 3) or Annex I habitats on the Glassavullaun Commonage were mapped as presented on **Figures 1 and 2 (See Appendix 1)** and their conservation status was assessed and mapped as shown on **Figure 3 (See Appendix 1)**. A series of management prescriptions were drawn up for the commonage as detailed in **Table 1** below and mapped on **Figure 4 (See Appendix 1)**.
