Great Sugarloaf

Great Sugarloaf (Section 1)

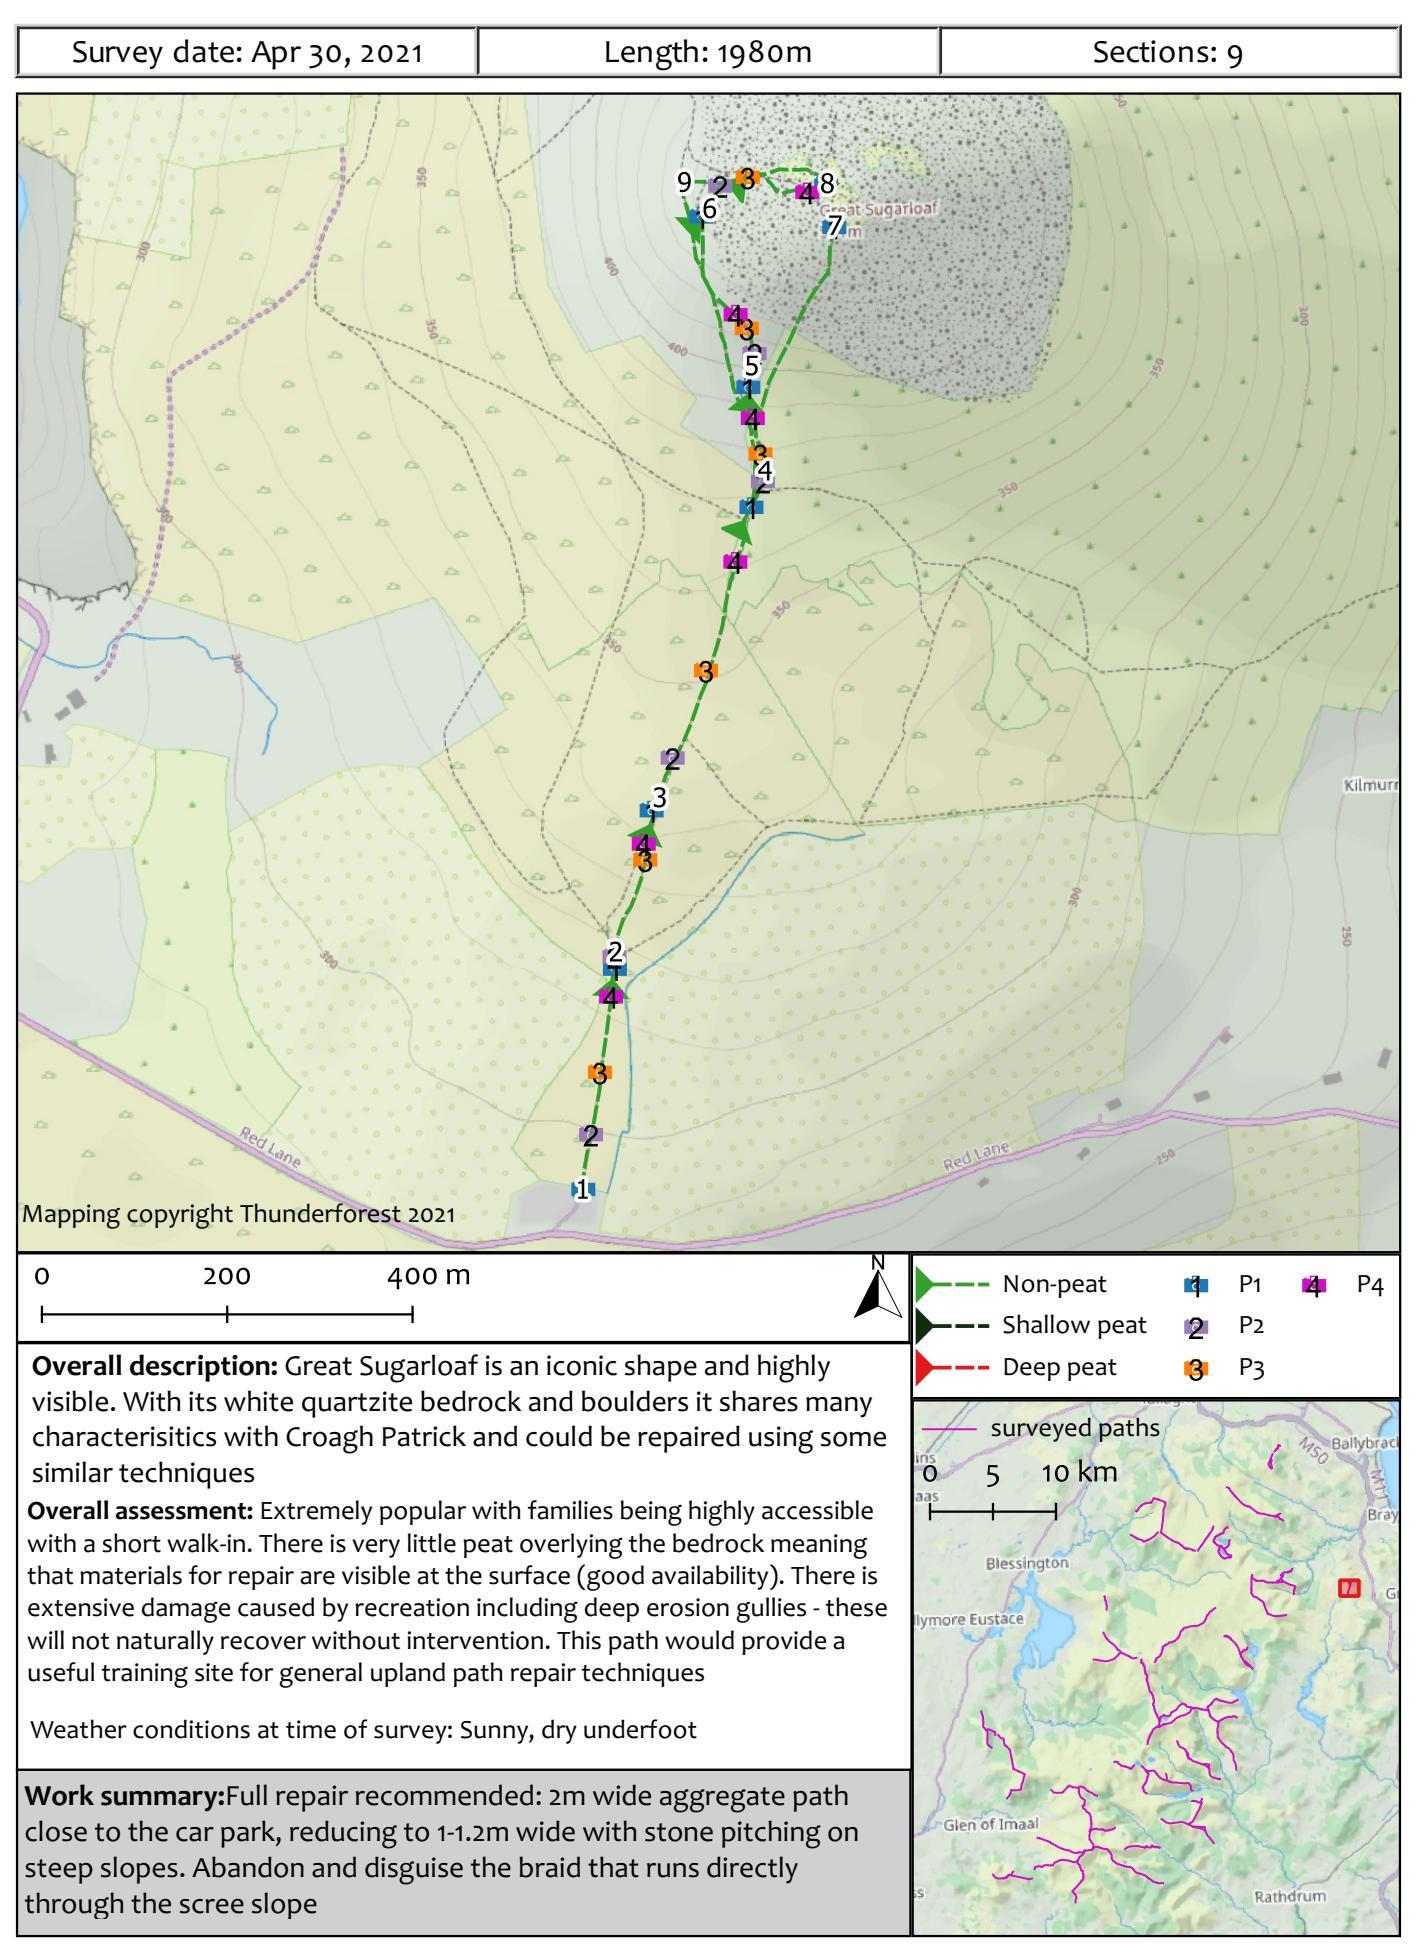
Section description: Start of path. Wide track with extensive trampling. Difficult to constrain people on open ground. Some signs of surface water erosion.

Length (m)	Max gradient (%)	Min gradient (%)	Crossfall (%)
230	7	0	0

Substrate		Peat Depth ((cm)	Availability of Materials: None required
mineral_soil		0		
				Site Assessment: Easy access for machinery from
	Minimum	Maximum	Typical	car park - easiest completed with excatator
Trampled width (m)	2.5	8	8	(supervised) - 0.5 day's work
Bare width (m)	1.2	1.5	3	
Eroded depth (m)	0.1	0.1	0.2

Work type	Estimated input	Work Summary
minor_repair	20 days labour	Create three grade reversals across the track to intercept water with ditches to soakaways - could improve line definition (narrow to 2m if not used for agricultural access)
